Geotechnical Investigation The Chancery of the Canadian High Commission Bridgetown, St. Michael Parish, Barbados

Report Number: 10-1121-0089-1

**GEOTECHNICAL INVESTIGATION
THE CHANCERY OF THE CANADIAN HIGH COMMISSION
BRIDGETOWN, ST. MICHAEL PARISH, BARBADOS**

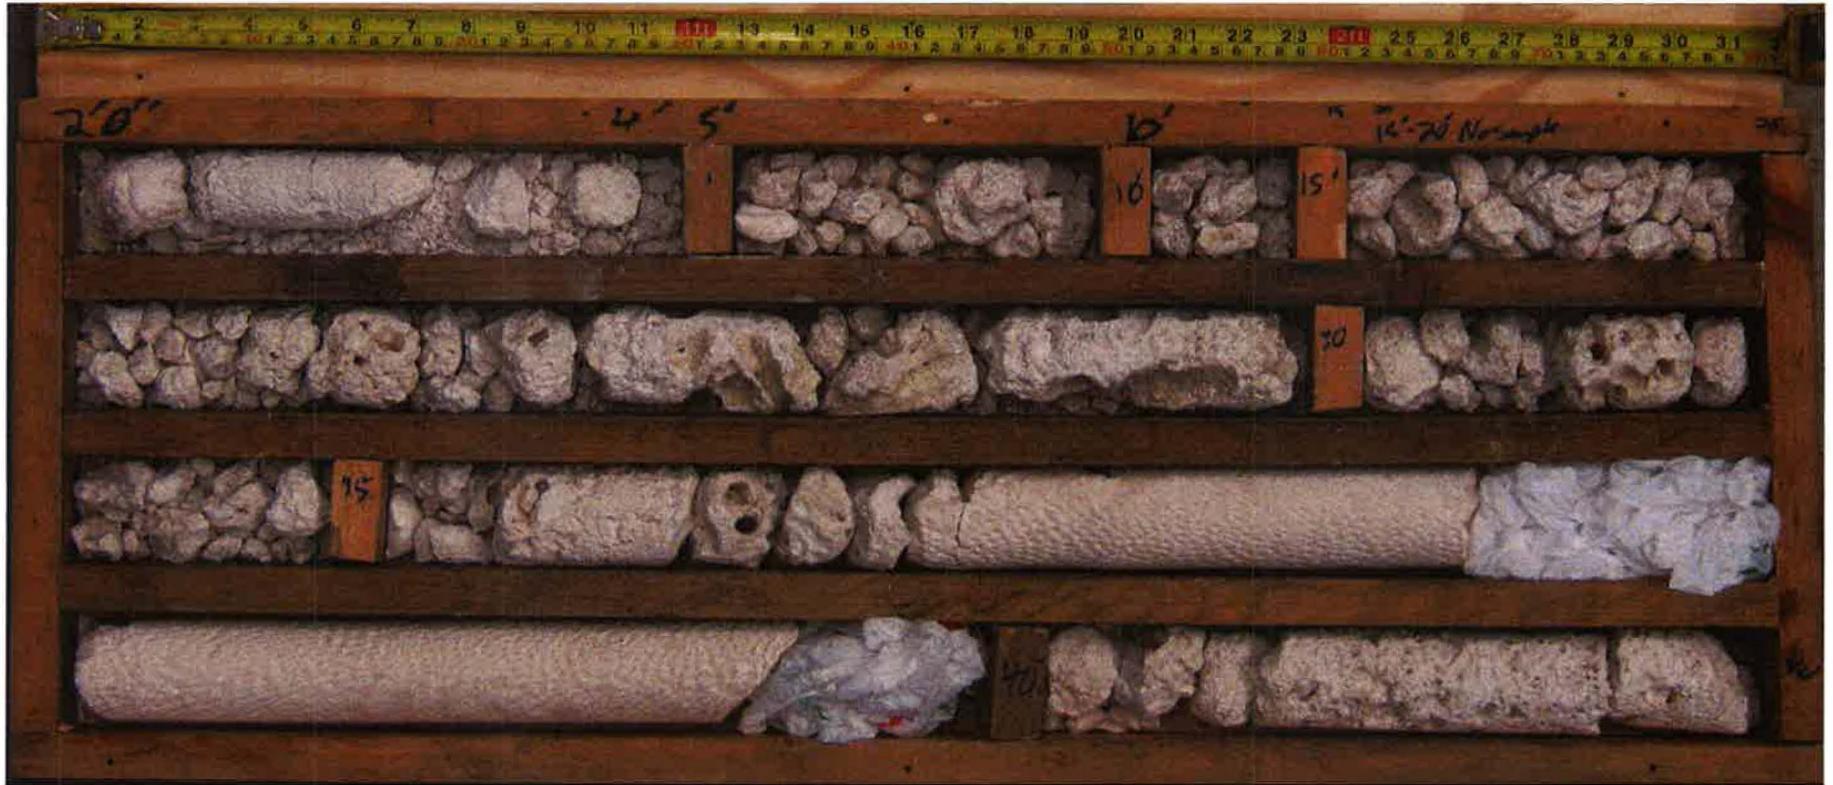
Bedrock Core from Borehole C11-4

Depth 0.06 m to 12.80 m

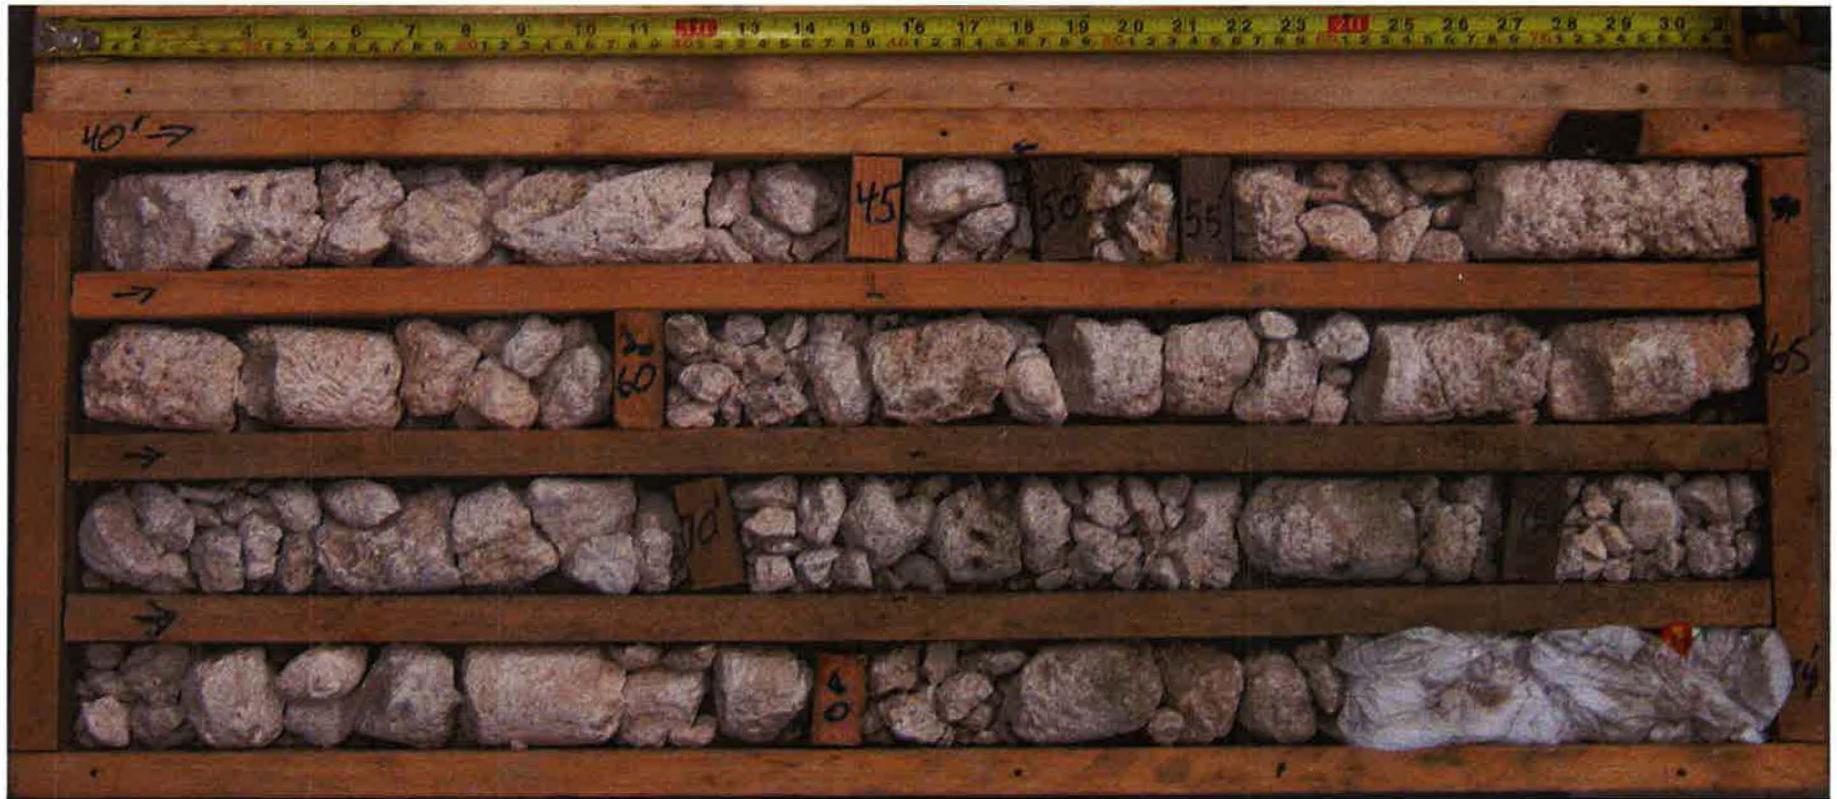
Bedrock Core from Borehole C11-4

Depth 12.80 m to 25.91 m

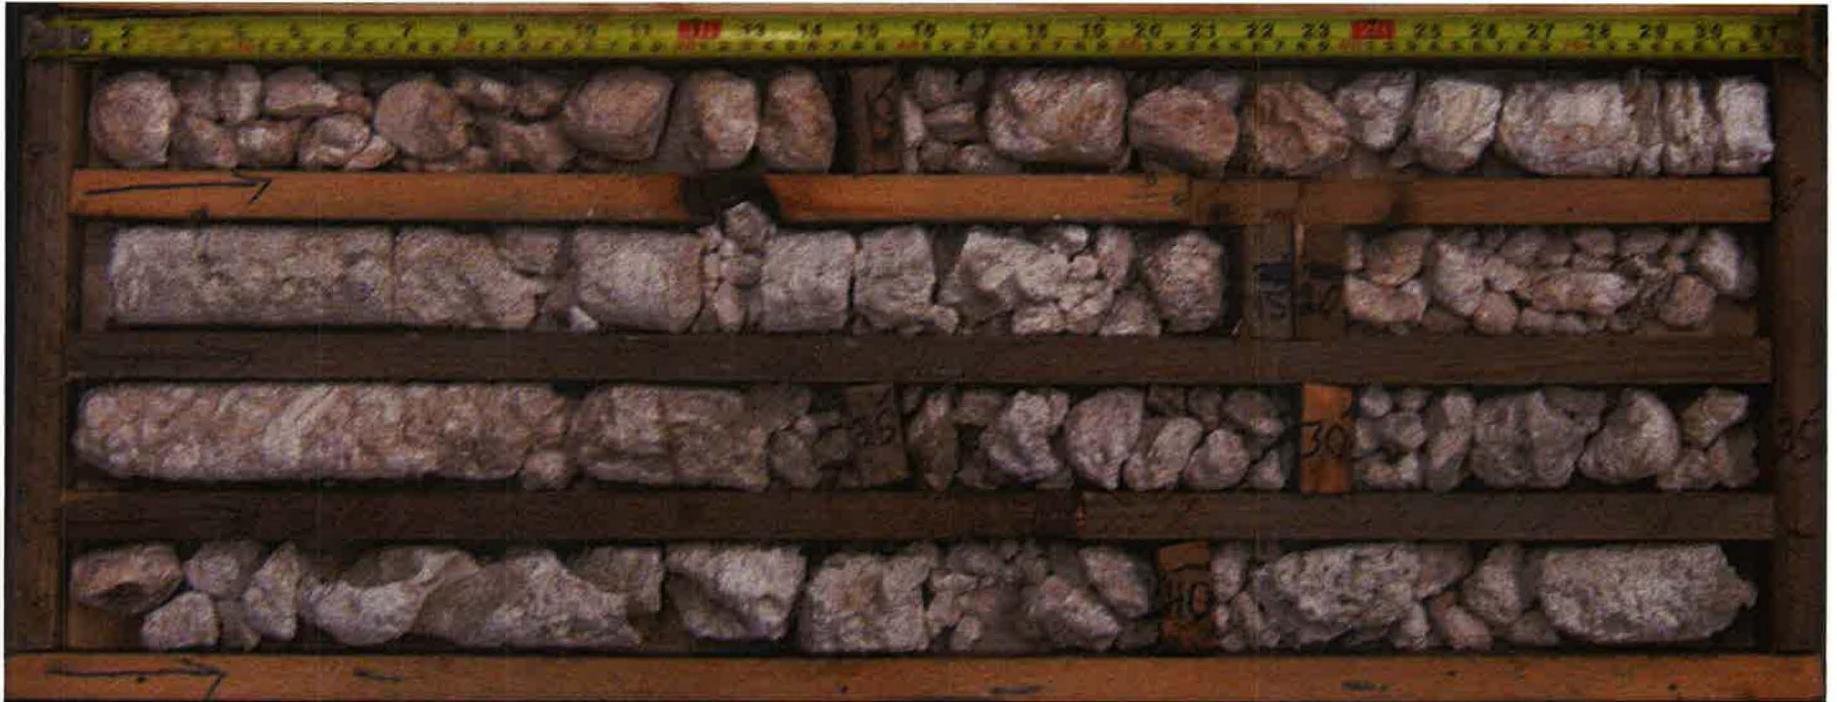
Bedrock Core from Borehole C11-5

Depth 2.13 m to 12.95 m

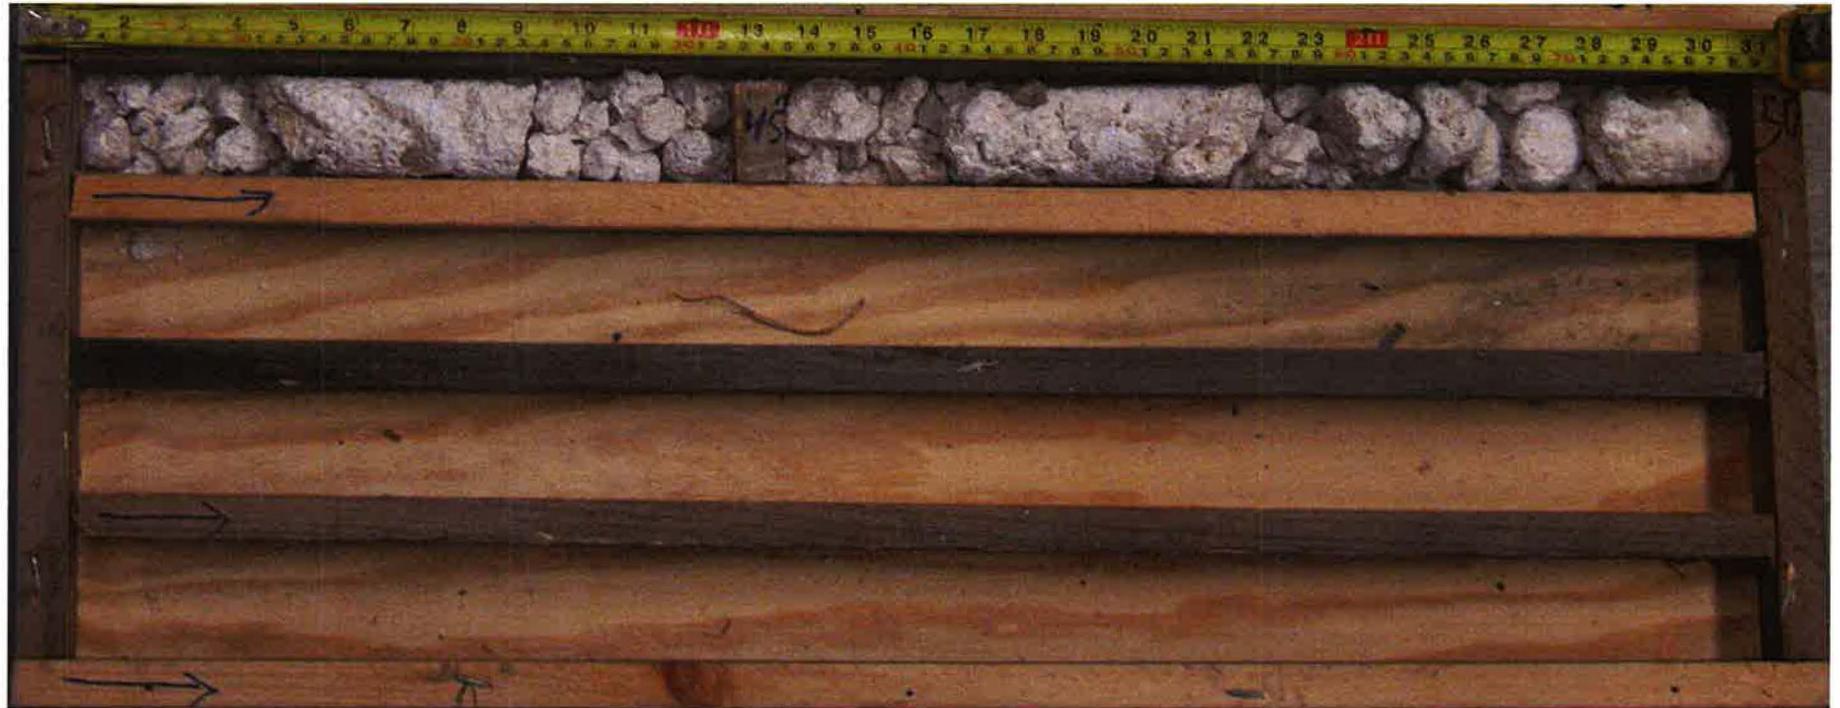
Bedrock Core from Borehole C11-5

Depth 12.95 m to 15.24 m

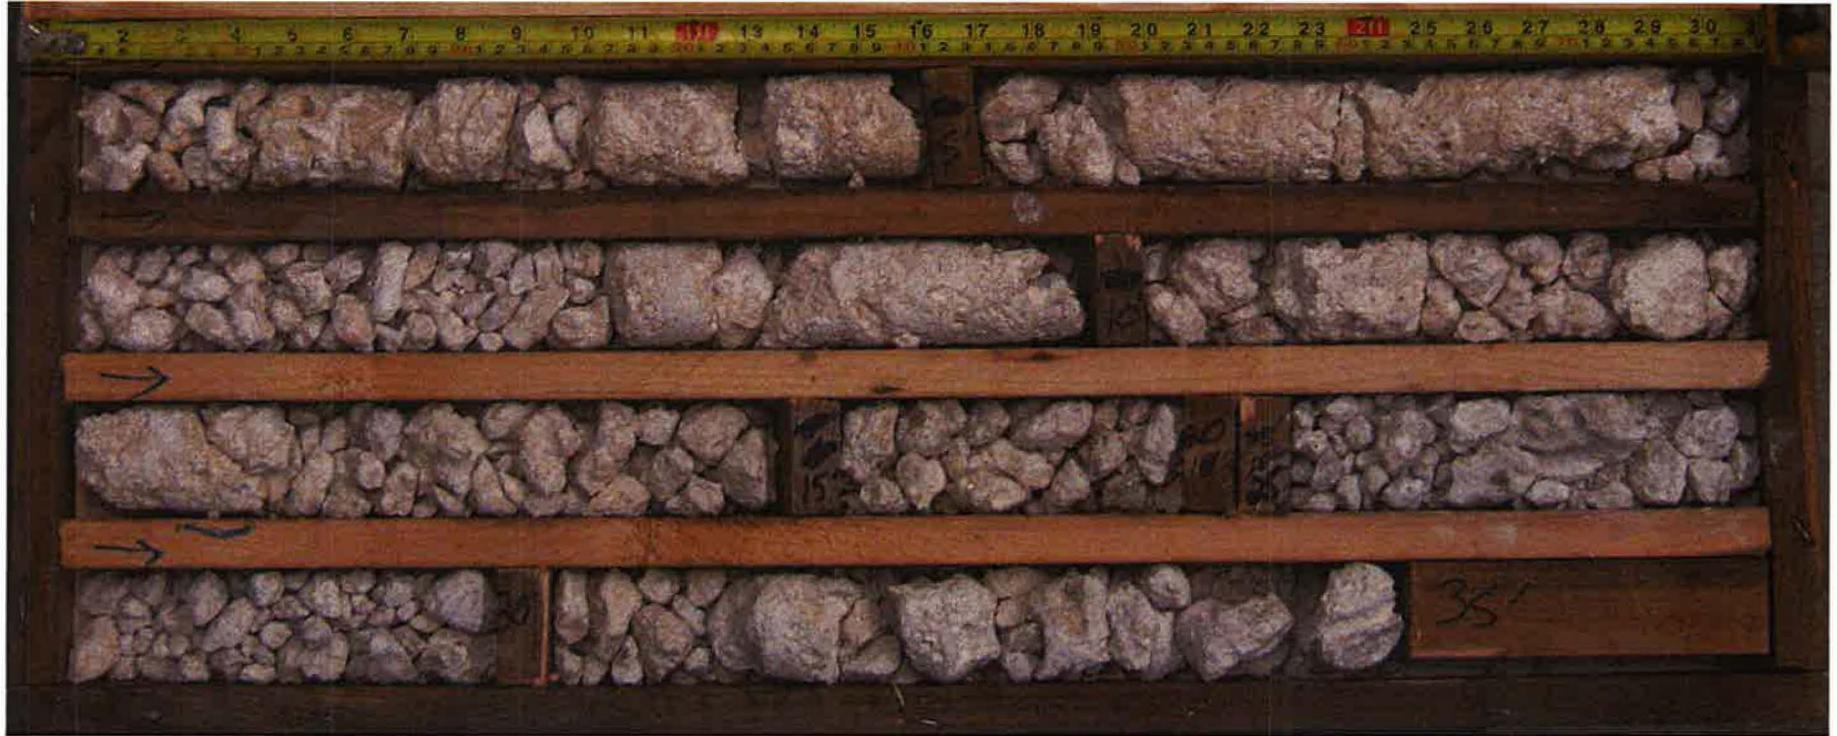
Bedrock Core from Borehole C11-6

Depth 0.30 m to 10.67 m

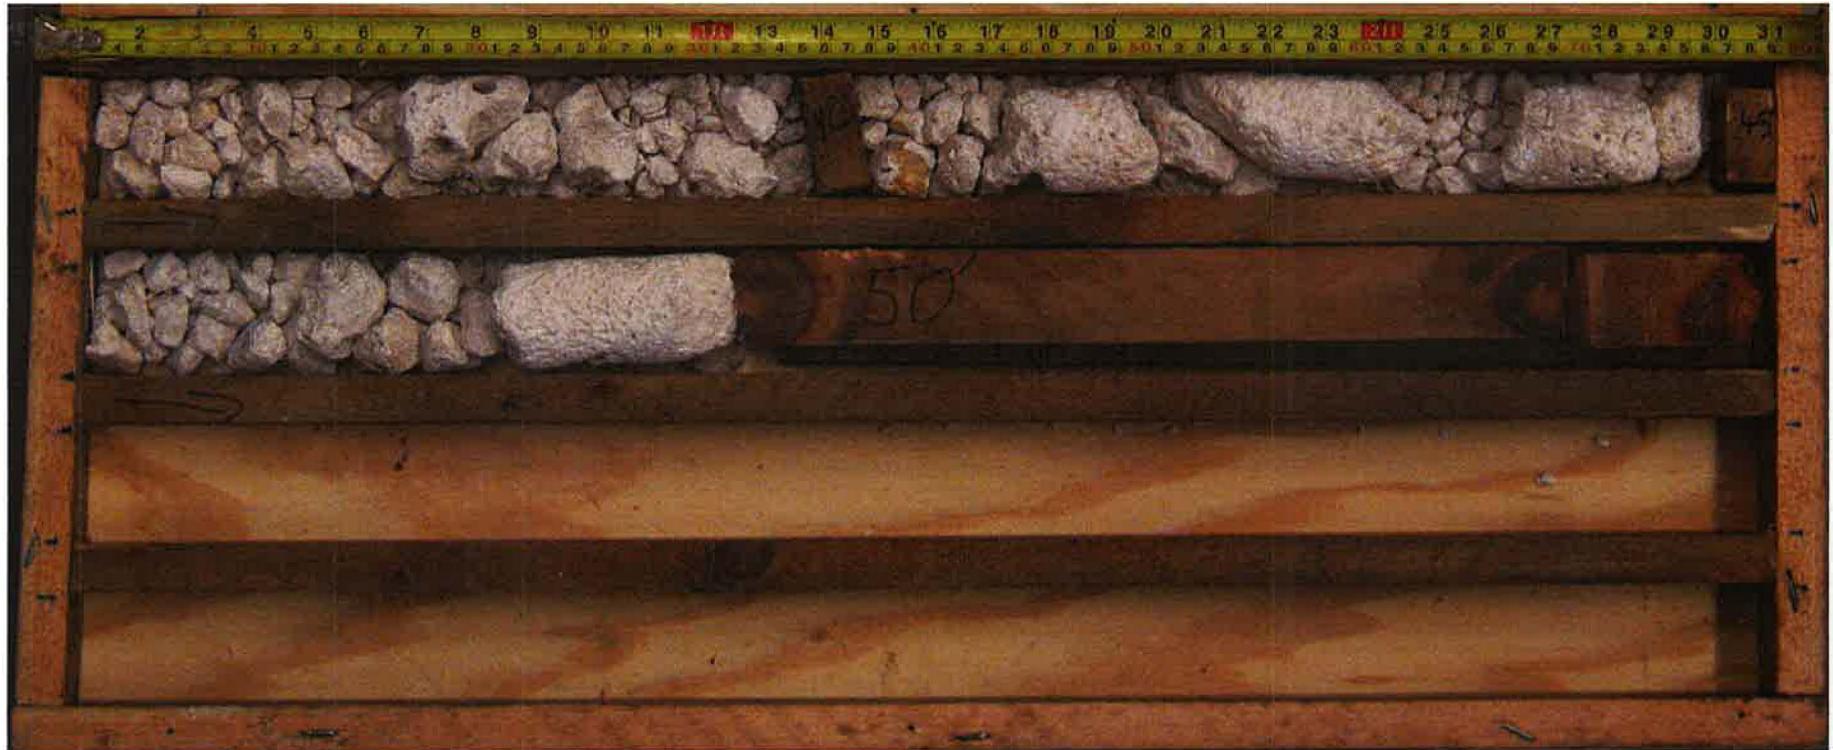
Bedrock Core from Borehole C11-6

Depth 10.67 m to 15.24 m

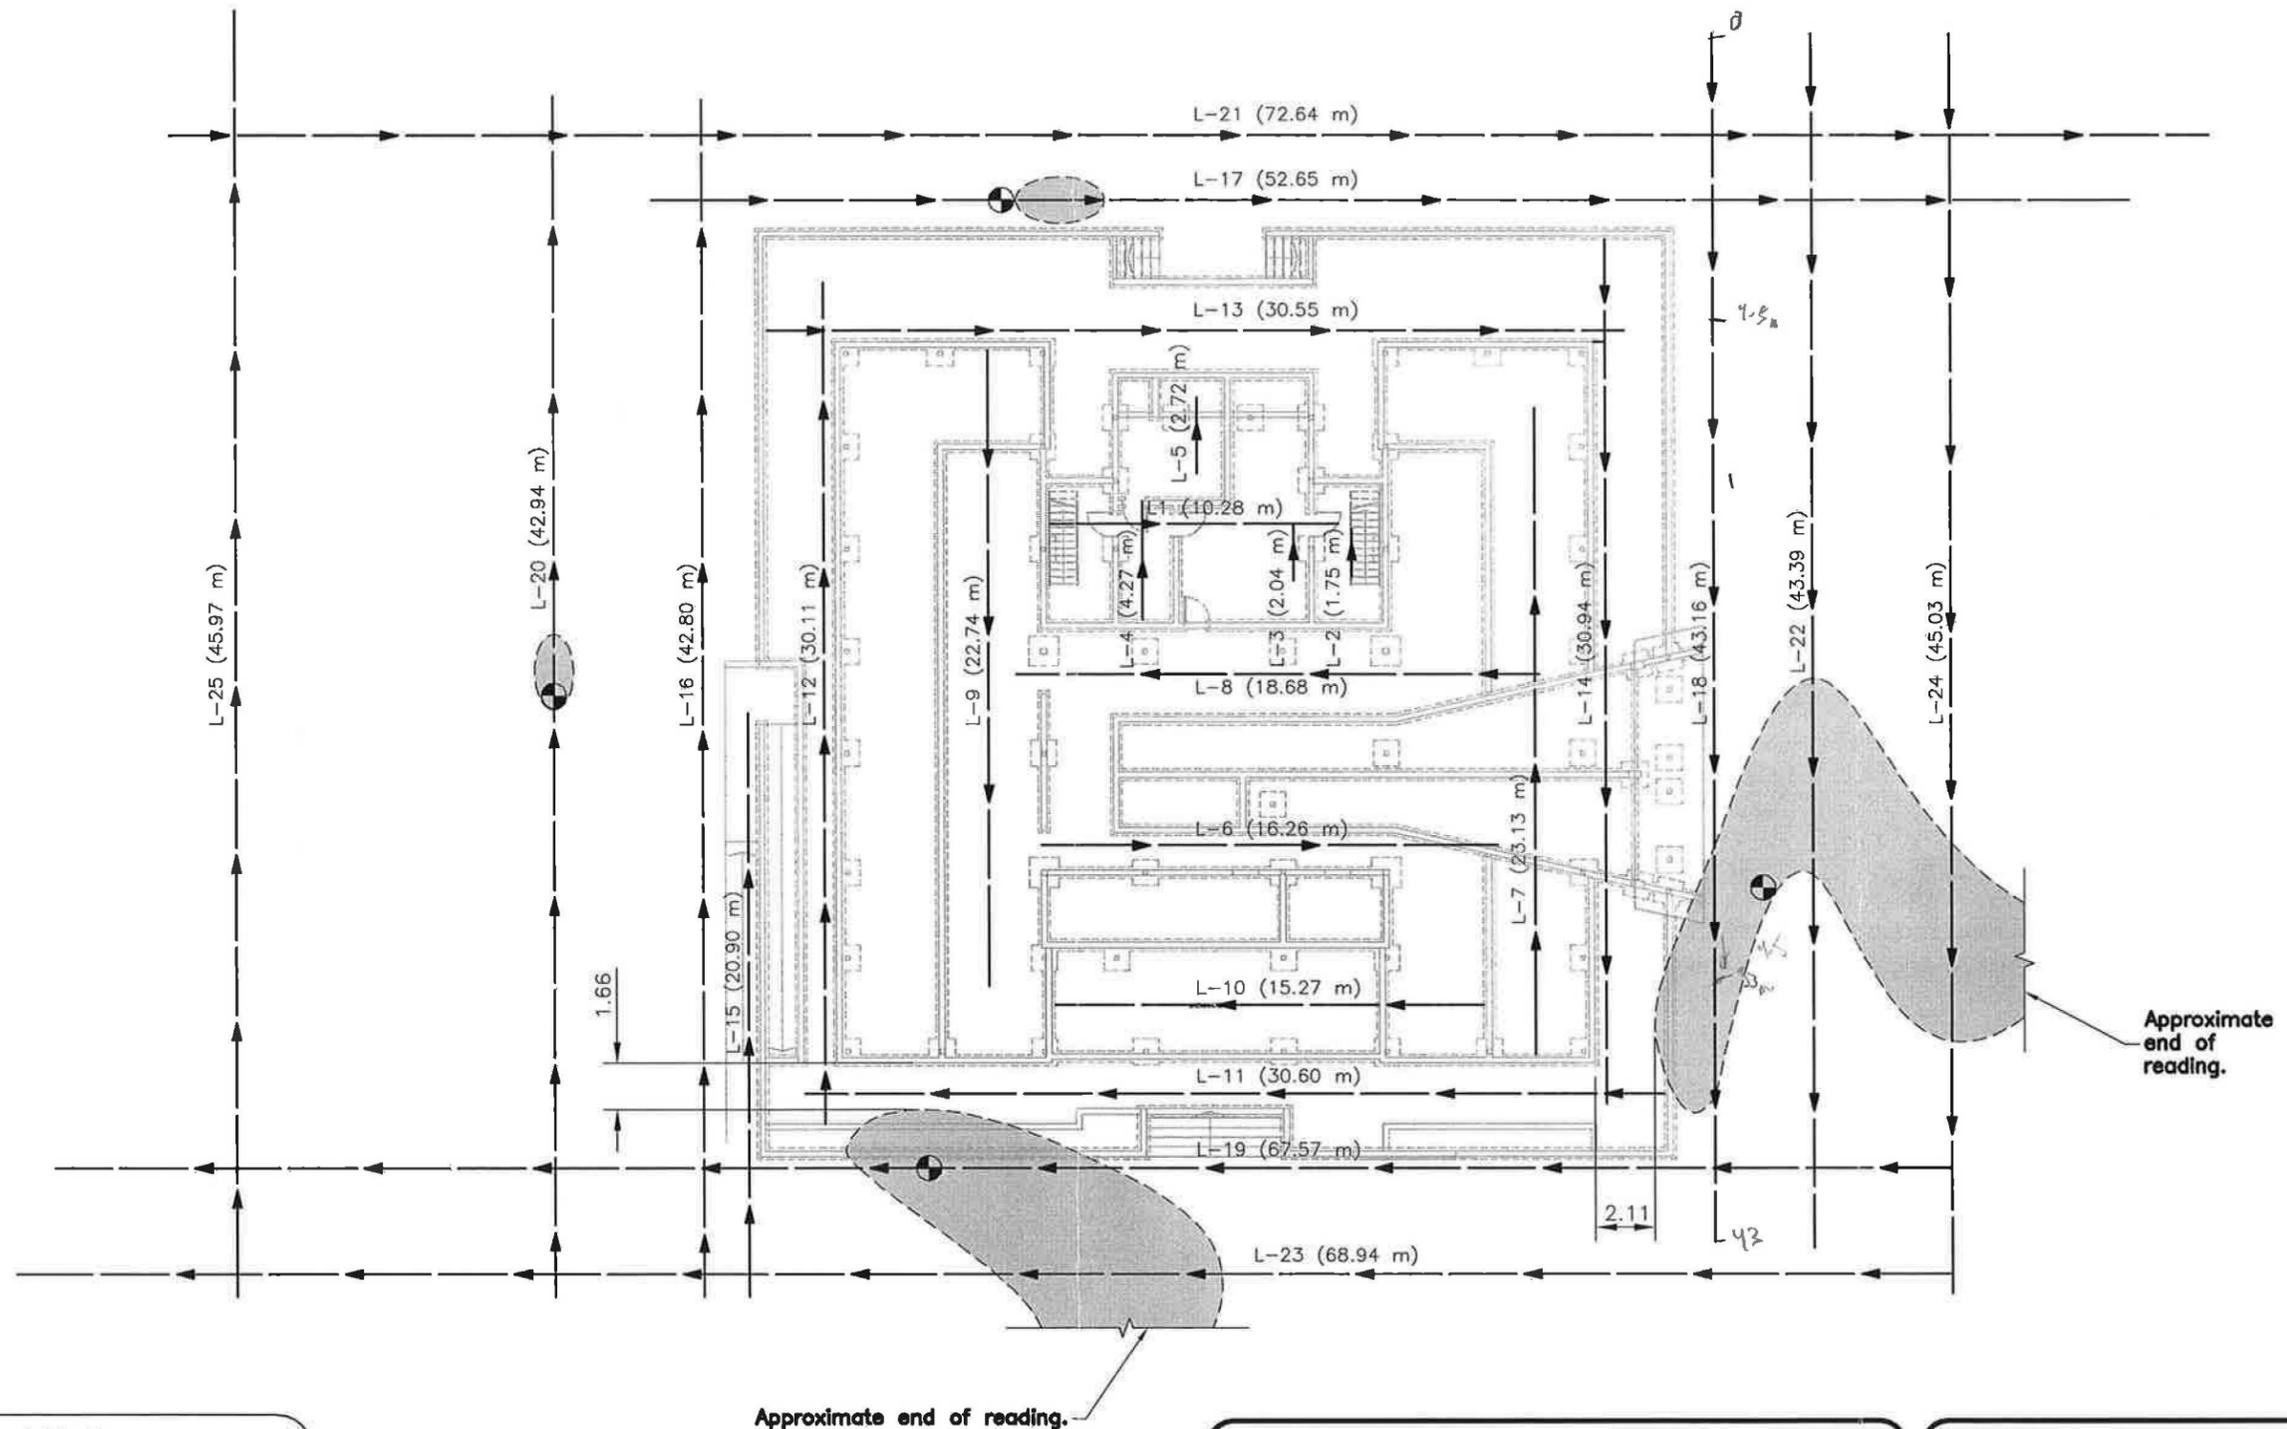
LEGEND	
	GEORADAR LINE
	POSSIBLE KARSTIC FORMATION
	POTENTIAL TARGET OF DRILLING

The geophysical investigation previously carried out by Dessau around the immediate vicinity of the Chancery building, indicated several small karst formations outside the south and east portions of the Chancery building. These karst formations were observed in the confirmatory boreholes and consisted of voids/cavities with dimensions of 300 to 1,400 millimetres in size within the coral limestone. These voids/cavities were observed at depths ranging from 5.0 to 7.6 metres below the existing ground surface.

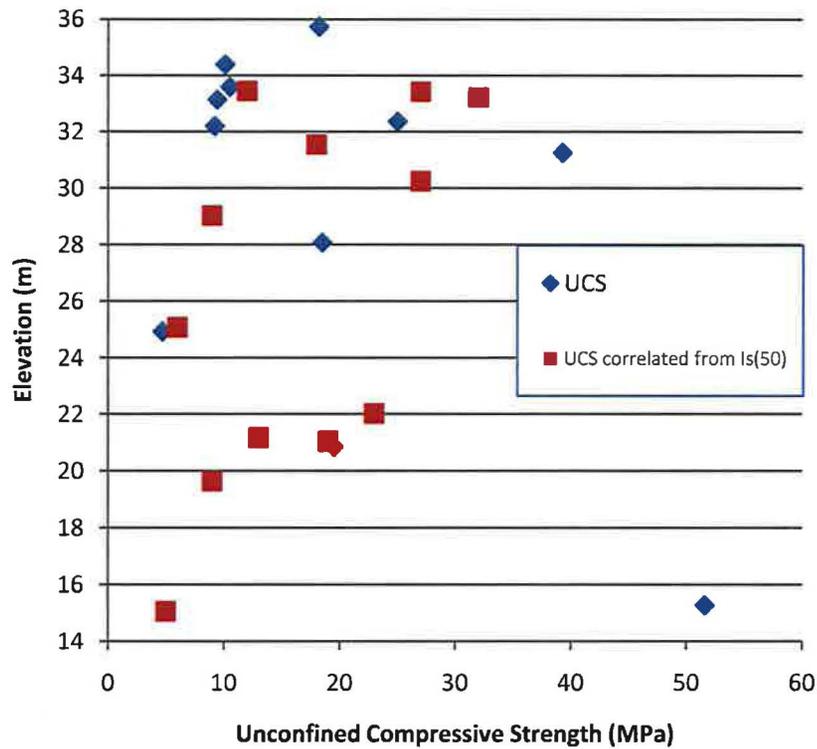
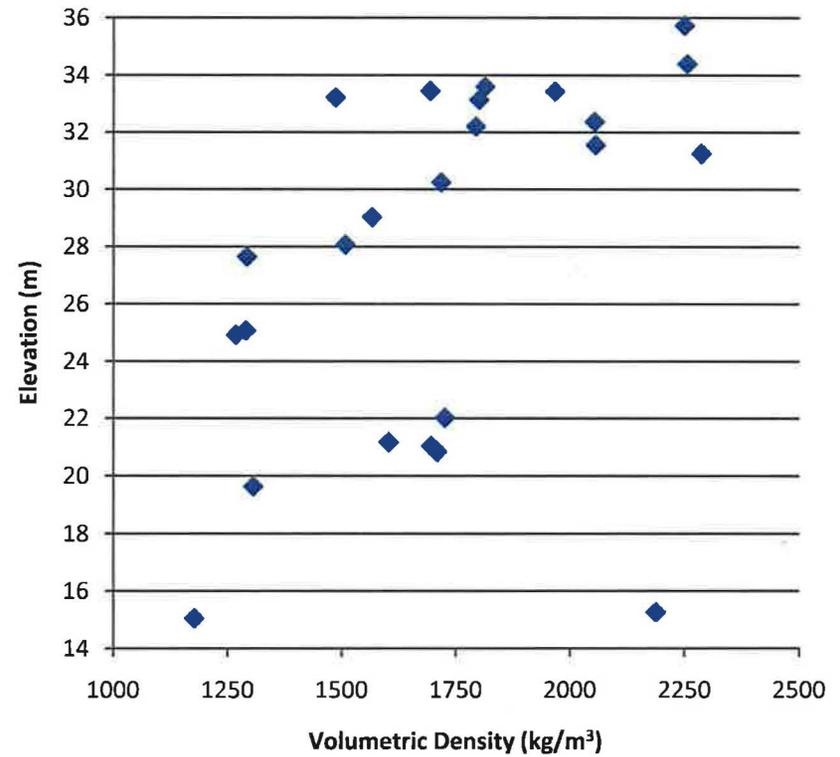
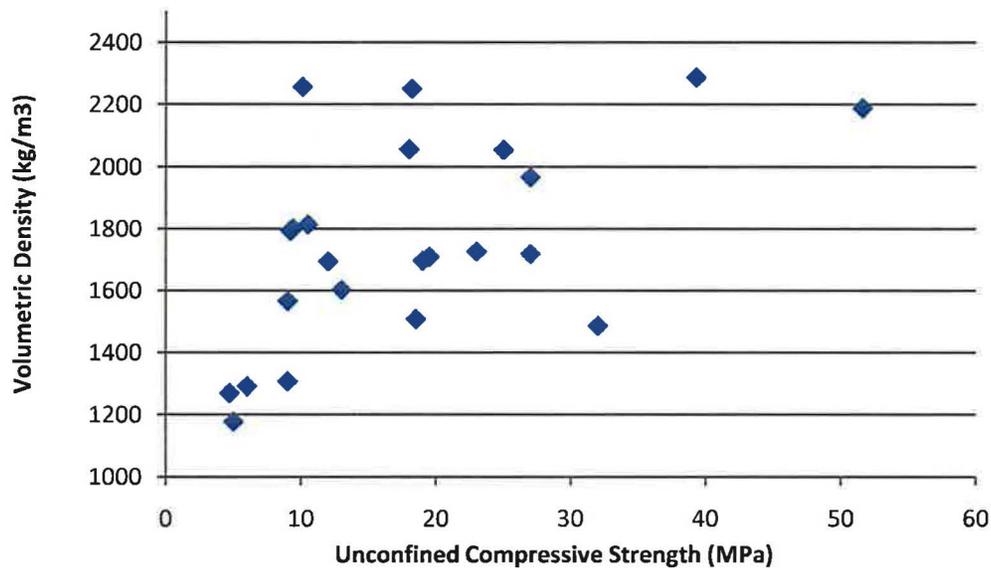
**SUMMARY OF UNCONFINED COMPRESSIVE
STRENGTHS AND VOLUMETRIC DENSITIES**

** : Correlation factor "C" found to be approx. 6.9 based on adjacent UCS testing

The laboratory test results on samples of the coral limestone indicate a bedrock compressive strength which ranges widely from 5 to 52 megapascals. It should be noted that much of the rock core recovered during the current investigation was too small for proper testing and the compressive strength indicated below are from the limited samples that fit the proper dimensions for testing and could be providing the upper limits of compressive strength for this formation and may not be entirely representative of the entire formation. The density varies widely within the tested samples, as well. From the data points collected there is a very loose correlation between density and compressive strength, with lower densities having lower compressive strengths as shown in Figure D1 in Appendix D. However, at the higher densities there is a wider range of compressive strengths.
