PRIORITIZED ROCK SLOPE STABILIZATION WORK

Mt. Revelstoke National Park & Glacier National Park

INSPECTION OF HIGH PRIORITY ROCK AND SOIL SLOPES MOUNT REVELSTOKE NATIONAL PARK TRANS CANADA HIGHWAY MEADOWS IN THE SKY PARKWAY NELS NELSEN ROAD

INSPECTION OF HIGH PRIORITY ROCK AND SOIL SLOPES GLACIER NATIONAL PARK TRANSCANADA HIGHWAY

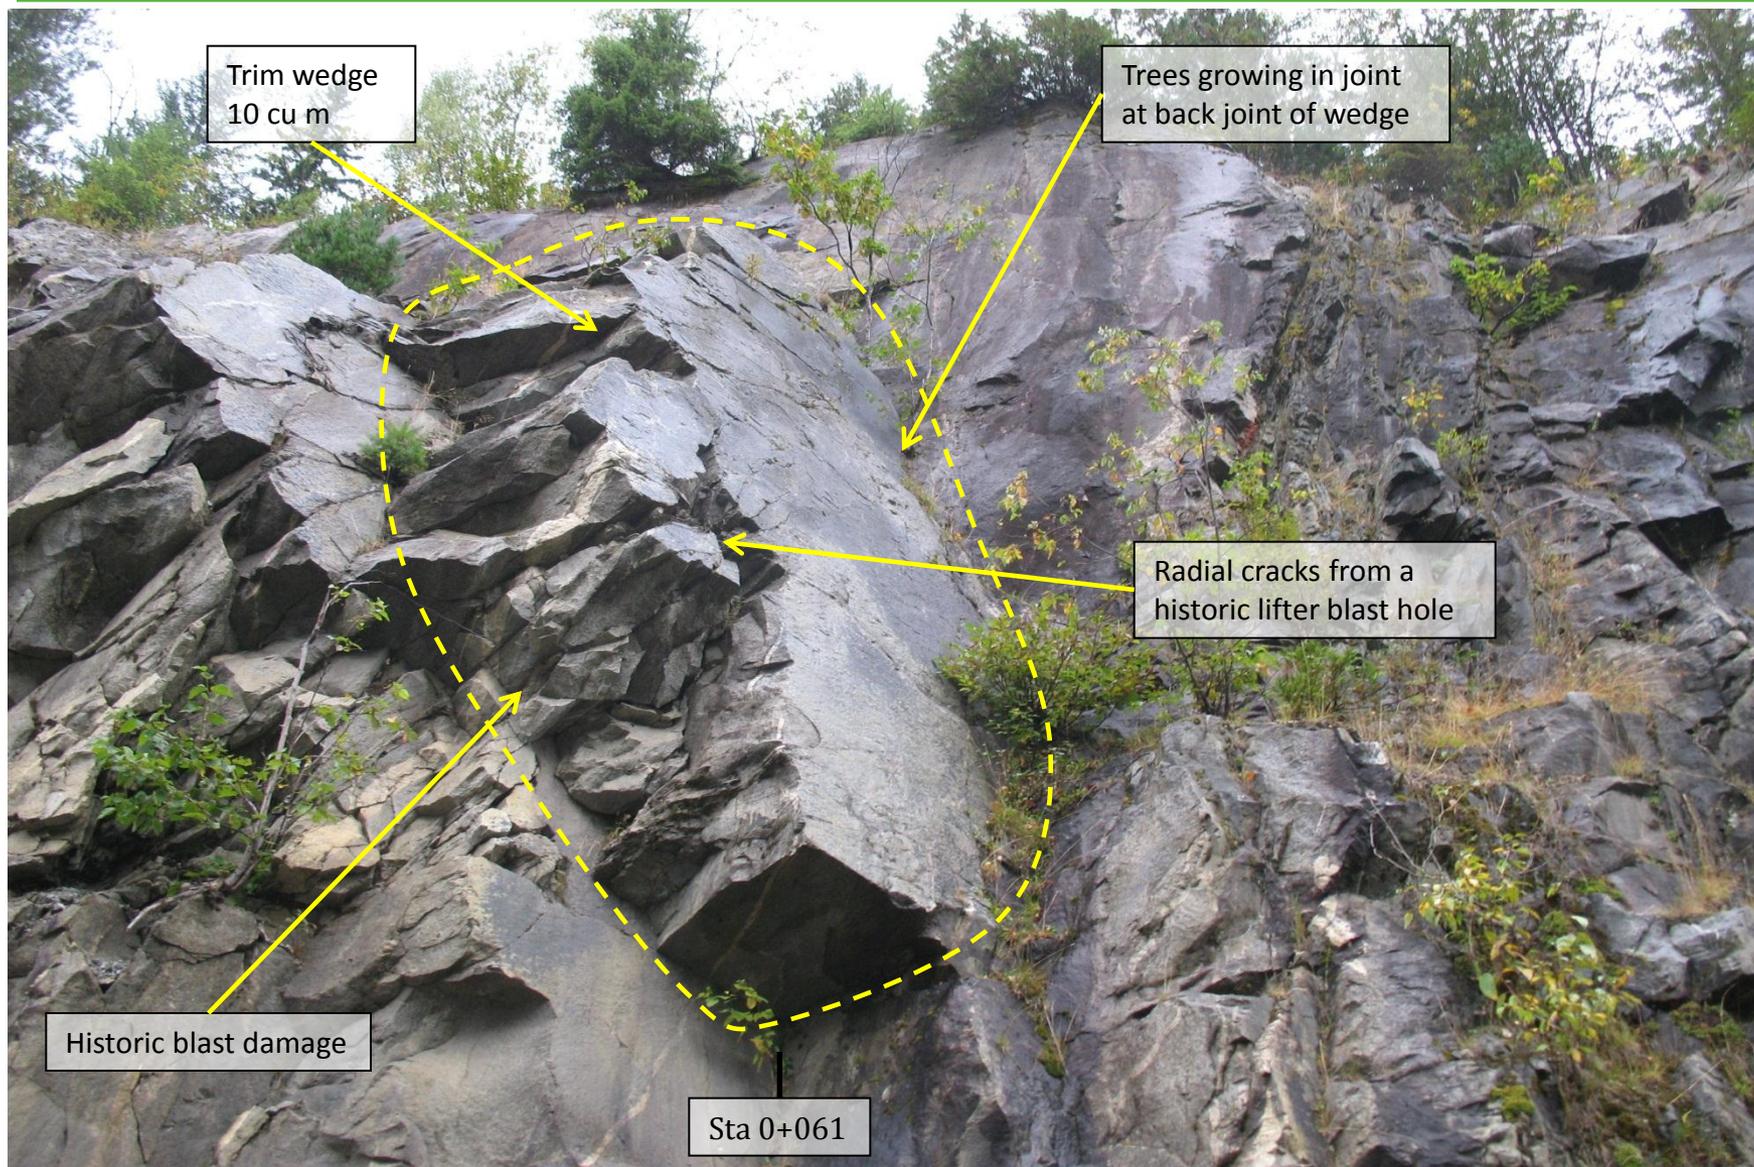
Sta 0+028

Allow 4x 4 m
rock bolts

EBA's site inspectors noted a large wedge at Sta 0+028. This wedge is starting to show signs of dilation. The wedge should be removed by trim blasting. Another wedge was noted at Sta 0+061. The base of this wedge has suffered historical blast damage. Trees are growing out of the back joint of the wedge, and eventually they will lever the block from the face. The ditch beneath this wedge is 4.75 m wide and is unlikely to contain the wedge if it was to fail as a single block.

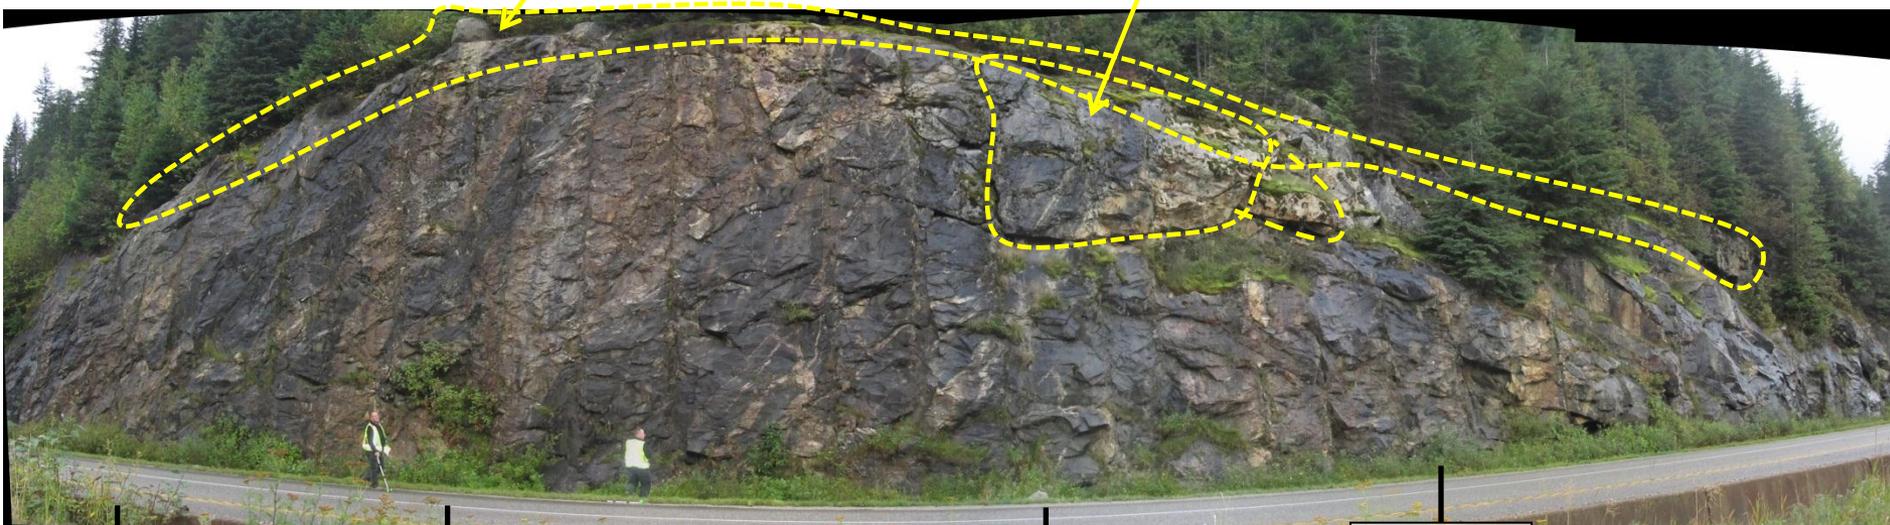
See 24.949e

Scale loose material at crest
25 hrs

The east end of this slope corresponds with the end of the previous slope and km 24.949. The slope comprises granodiorite in which large wedges formed as the igneous rock cooled. One of these large wedges has started to detach from the rock face and should be trimmed because the ditch is unlikely to contain rock mass failures of this size. The rock face is located on the inside of a curve.
