# KING MOUNTAIN TRAIL RESTORATION GATINEAU PARK

SUMMARY OF ISSUES AND PROPOSED INTERVENTIONS

The current document focuses on the King Mountain Trail (approximate length 1.8 km), located in the southern part of Gatineau Park. A summary analysis of the issues is presented, as well as their associated proposed interventions.

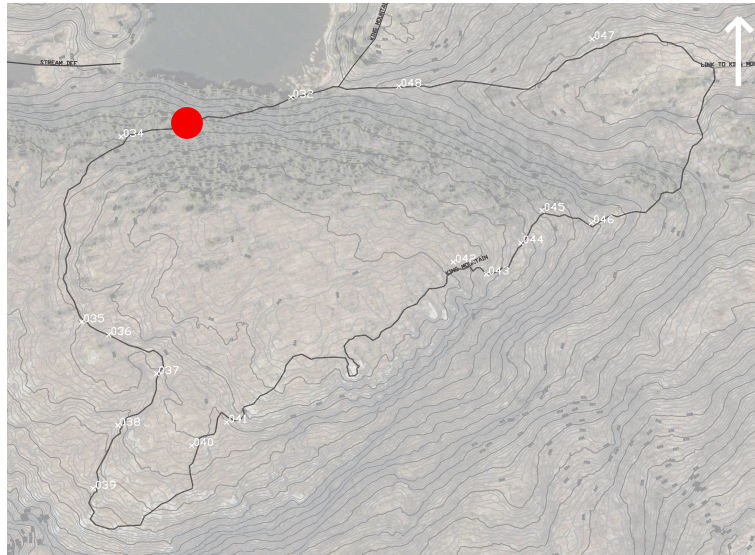
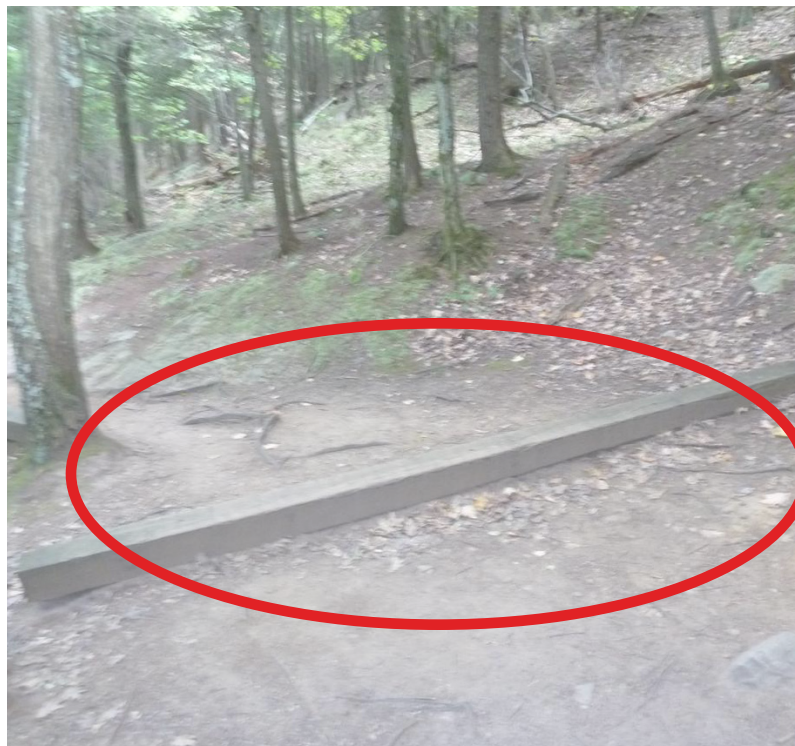
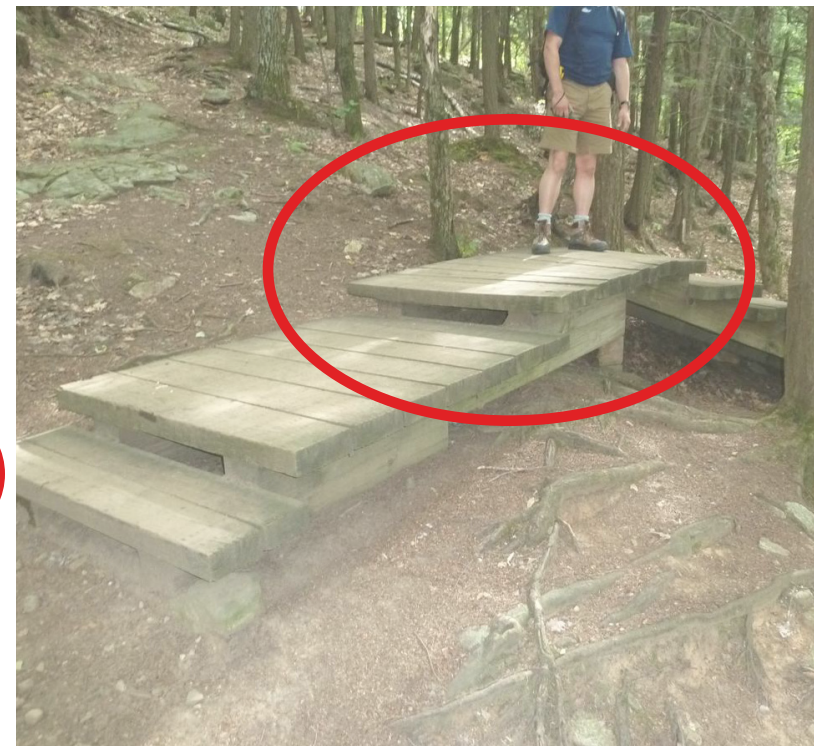
## POINT 033

- An unnecessary square timber across the center of the trail
- Staircase with excessive height does not encourage use

High

- Clear the path of unnecessary obstacles and recuperate the square timber
- Lower the upper plateau of the stairs by one level and make a one-riser approach

- **A-1** Install 'stay on the trail' signage to direct people to use the designated path and avoid the naturalized area
- **A-3** Install wood timbers – simple obstacles (before the stairs: opposite to the alternative trail)
- **A-3** Installer wood timbers - simple bordures (after stairs : for 10 metres)
- **D-3** Install a landing with a handrail and remove the upper landing of the existing stairs, recuperating materials if possible

- Boardwalk and handrail : 4 metres
- Removal of square wood timber and of upper landing of existing stairs, recuperate materials if possible
- 1 row of wood timber - simple obstacle (before stairs)
- 5 rows of wood timber - simple bordure (after stairs)

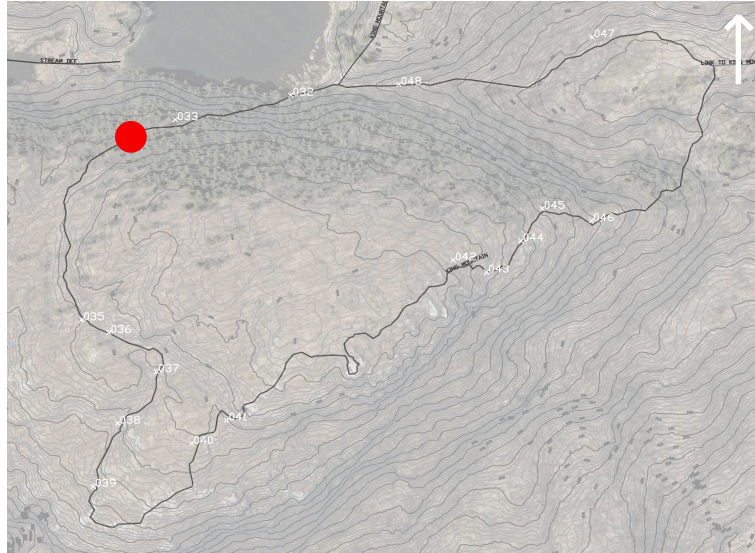
## POINT 034

- An unnecessary square timber step in the center of the trail

High

- Clear the path of unnecessary obstacles and recuperate the square timber for use with other interventions
- Recuperate nearby existing natural stones to level the ground

- **A-3** Remove the simple timber and level the surface with existing materials found on the site. Recuperate the existing timber if possible, otherwise dispose off-site.

- Removal of existing wood timber and levelling of the surface
- Fill with granite stone dust mix if necessary

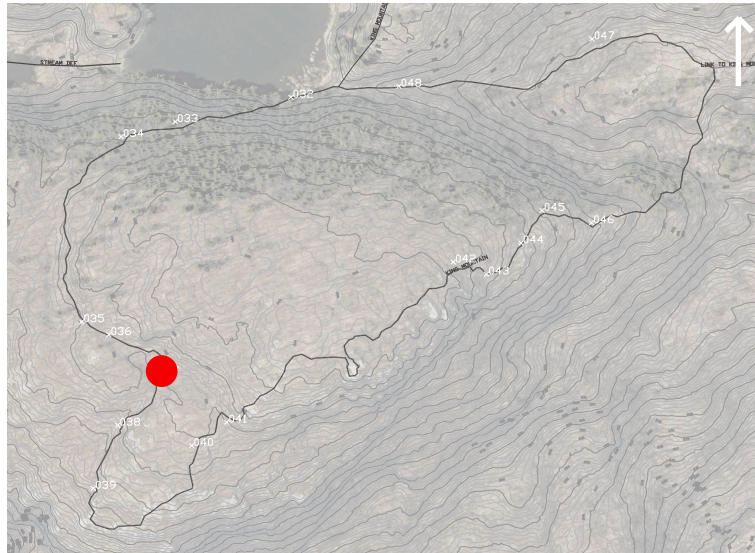
## POINT 037

- Three square timber steps are unstable and too high
- Indications of erosion caused by surface runoff

High

- Stabilise the timbers to create steps and adjust their levels

**D-2** Remove the existing timber and install a step. Recuperate the existing timber if possible, otherwise dispose off-site.

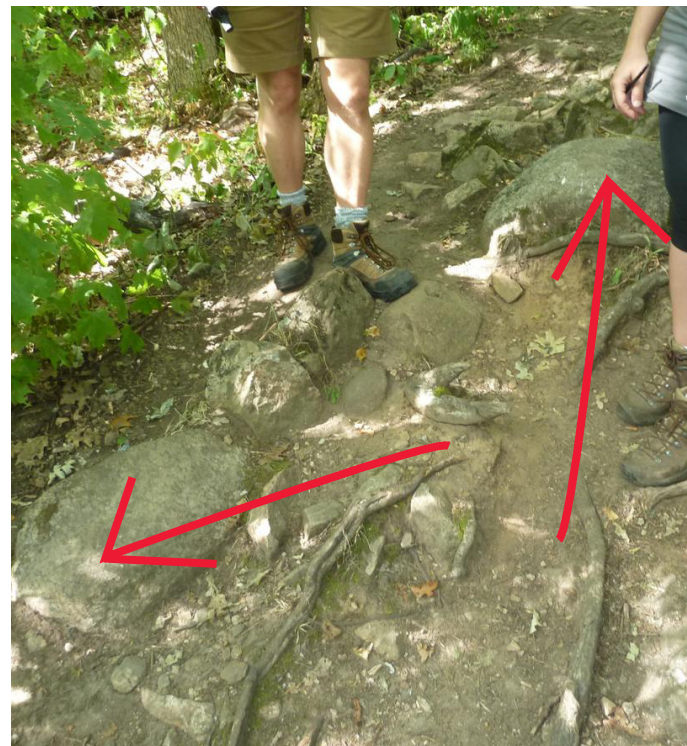
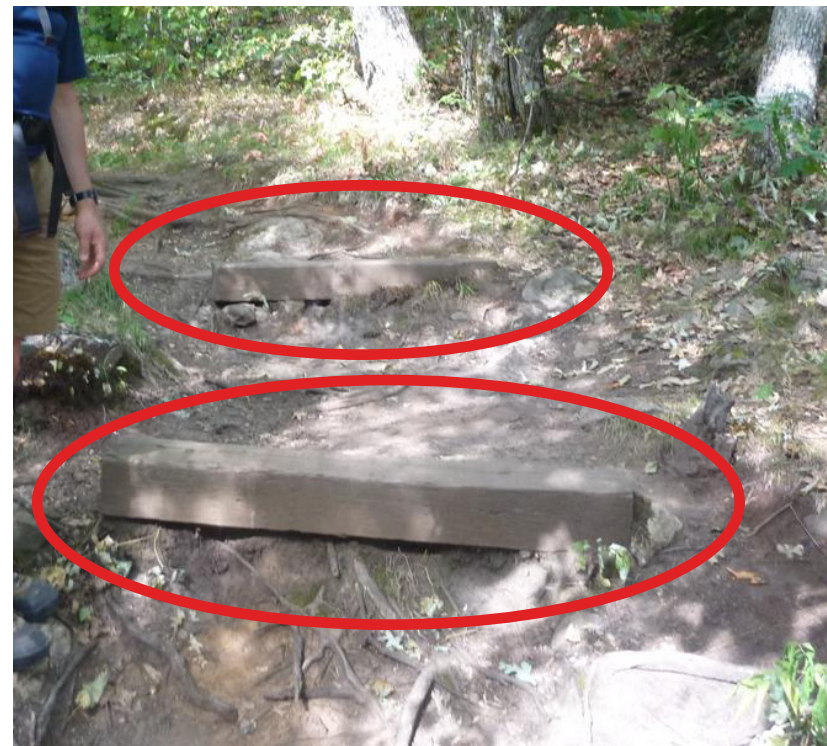
- Barriers created at the center of the path by natural stones and roots
- Three square timber steps are unstable and too high
- Indications of erosion caused by surface runoff

- Clear the path to ensure safe passage
- Stabilise the timbers to create steps and adjust their levels

- **A-4** Remove the natural stones, recuperating and relocating on-site.
- **D-2** Remove the existing timber and install a step. Recuperate the existing timber if possible, otherwise dispose off-site.

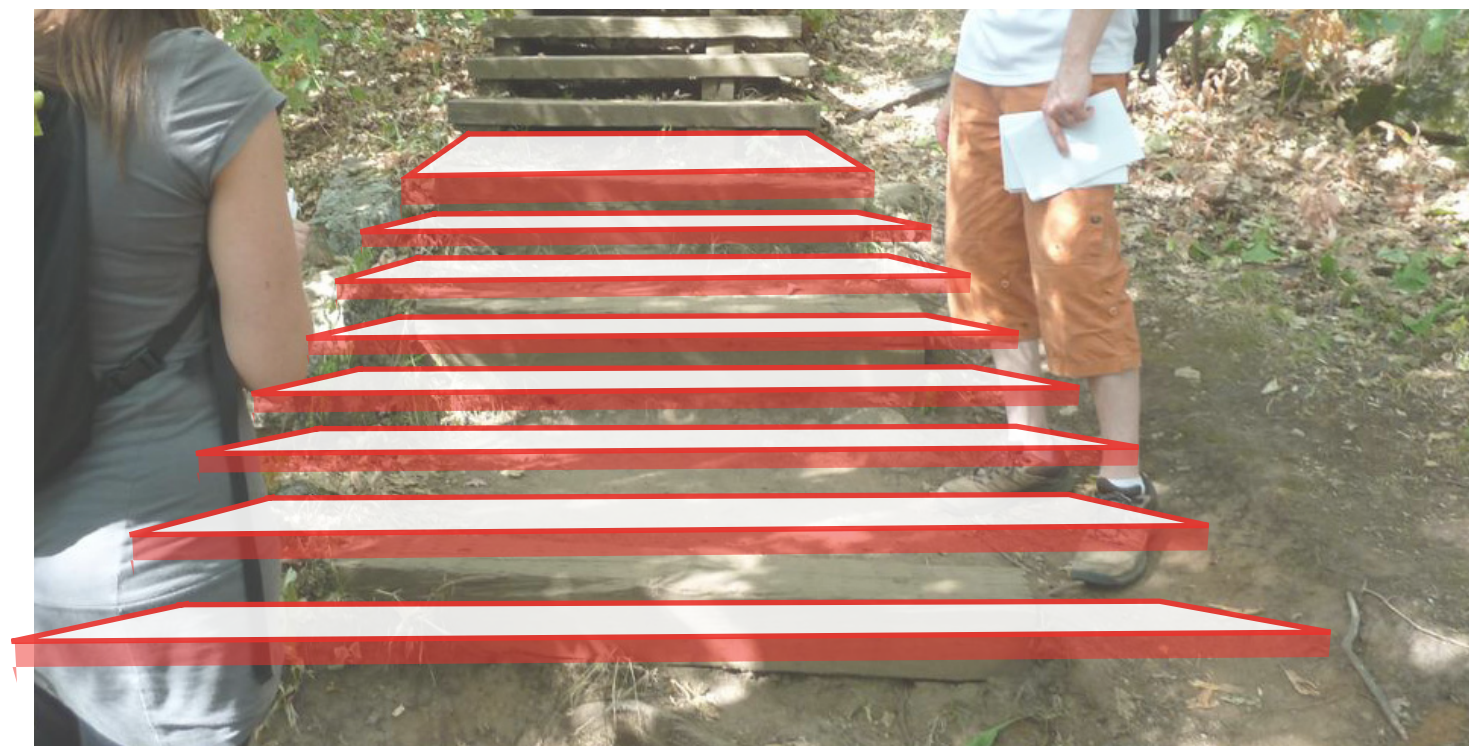
- Three square timber steps are unstable and too high

- Remove 3 timbers to create a continuous elevated staircase with a landing

- D-1 Remove the existing timbers and install an elevated staircase with a landing

- Removal of existing wood timbers (3)
- Install a staircase with a landing : 3 metres long, 1.2 metres wide

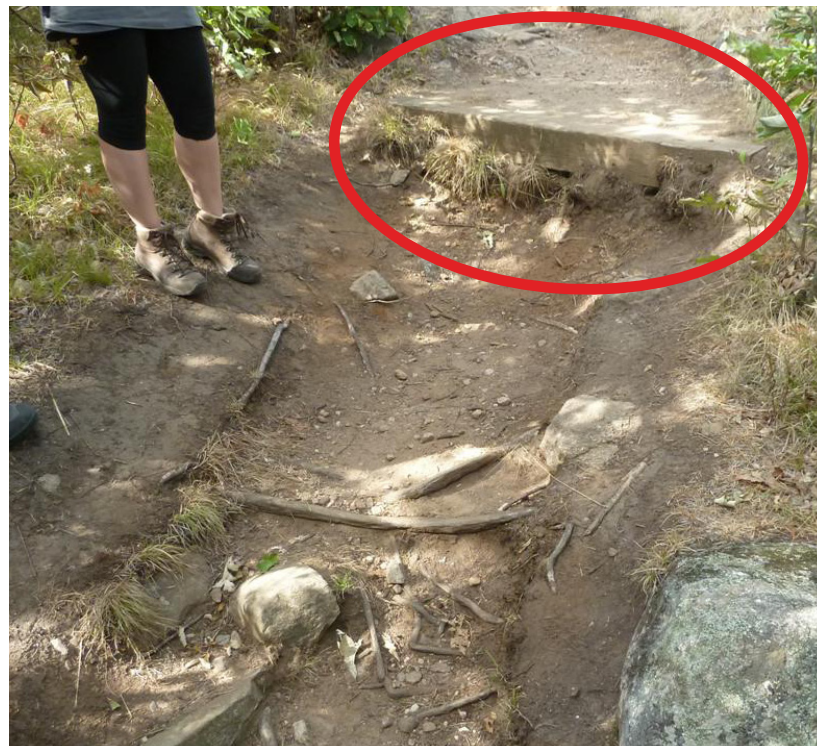
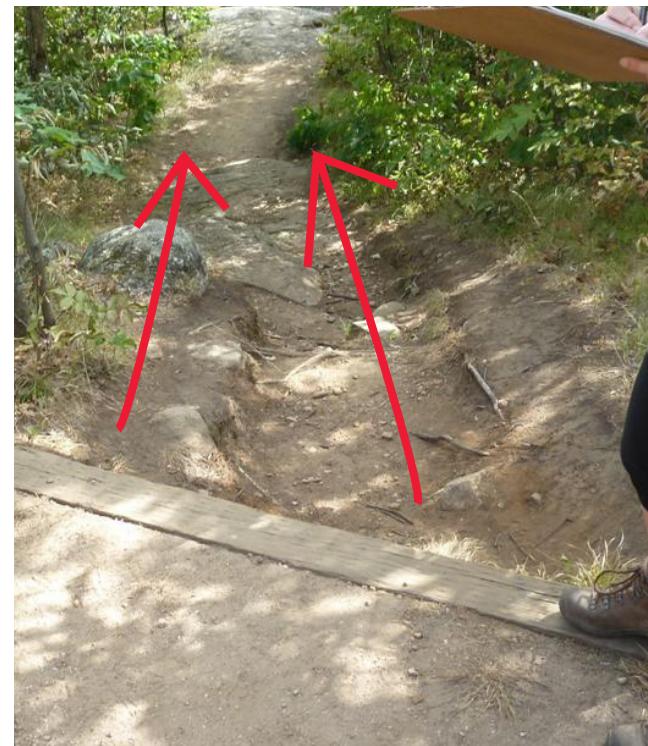
- One square timber step is unstable and too high
- Indications of erosion caused by surface runoff

- Stabilise the timbers to create steps and adjust their levels
- Fill and adjust levels to drain water more slowly

- C-1 Fill the trail with granite stone dust mix, 0-19 mm dia, compacted with plate tamper
- D-2 Remove the existing timber and install a step. Recupérate the existing timber if possible, otherwise dispose off-site.

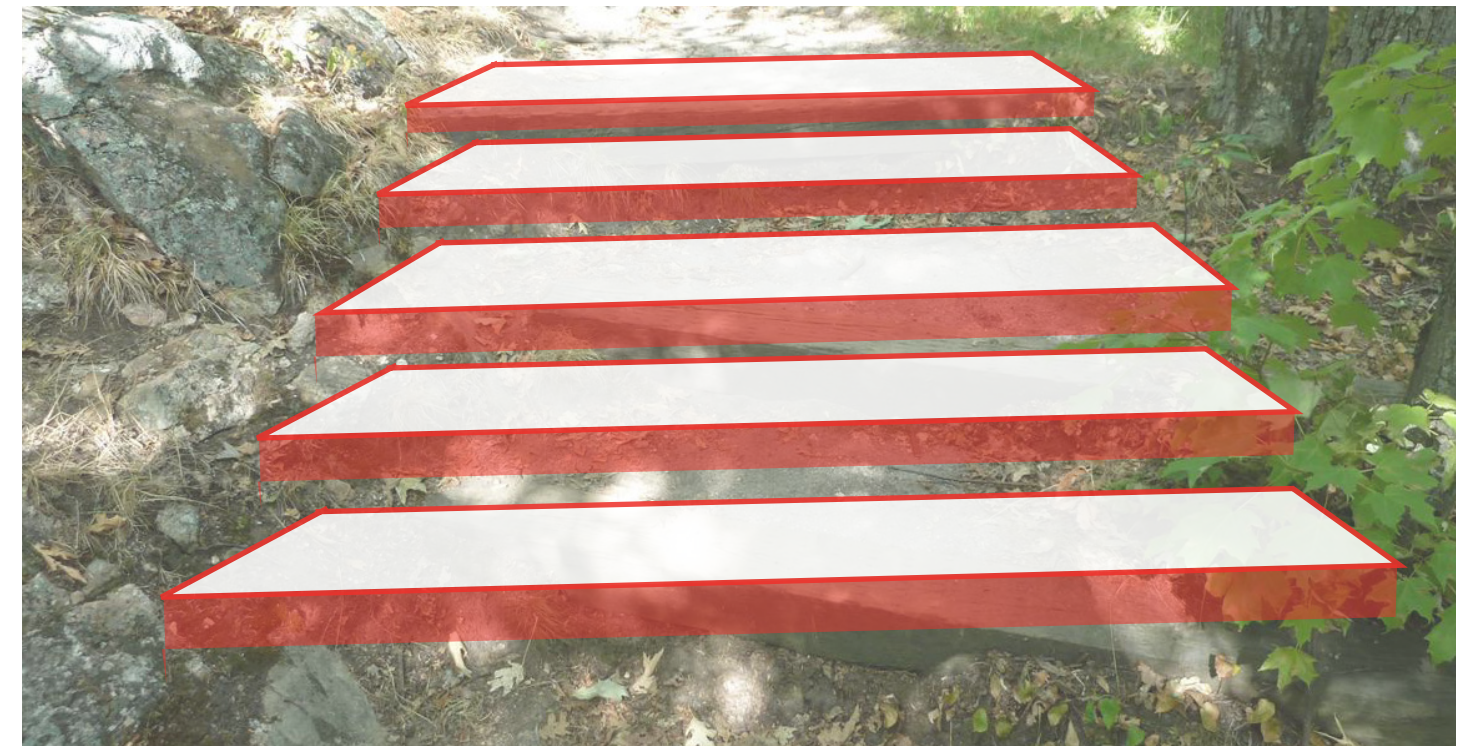
- Three square timber steps are unstable and too high
- Indications of erosion caused by surface runoff

- Remove 3 timbers to create a continuous elevated staircase

- D-1 Remove the existing timbers and install an elevated staircase with a landing

- Removal of existing wood timbers (3)
- Install an elevated staircase :  
3 metres long, 1.5 metres wide

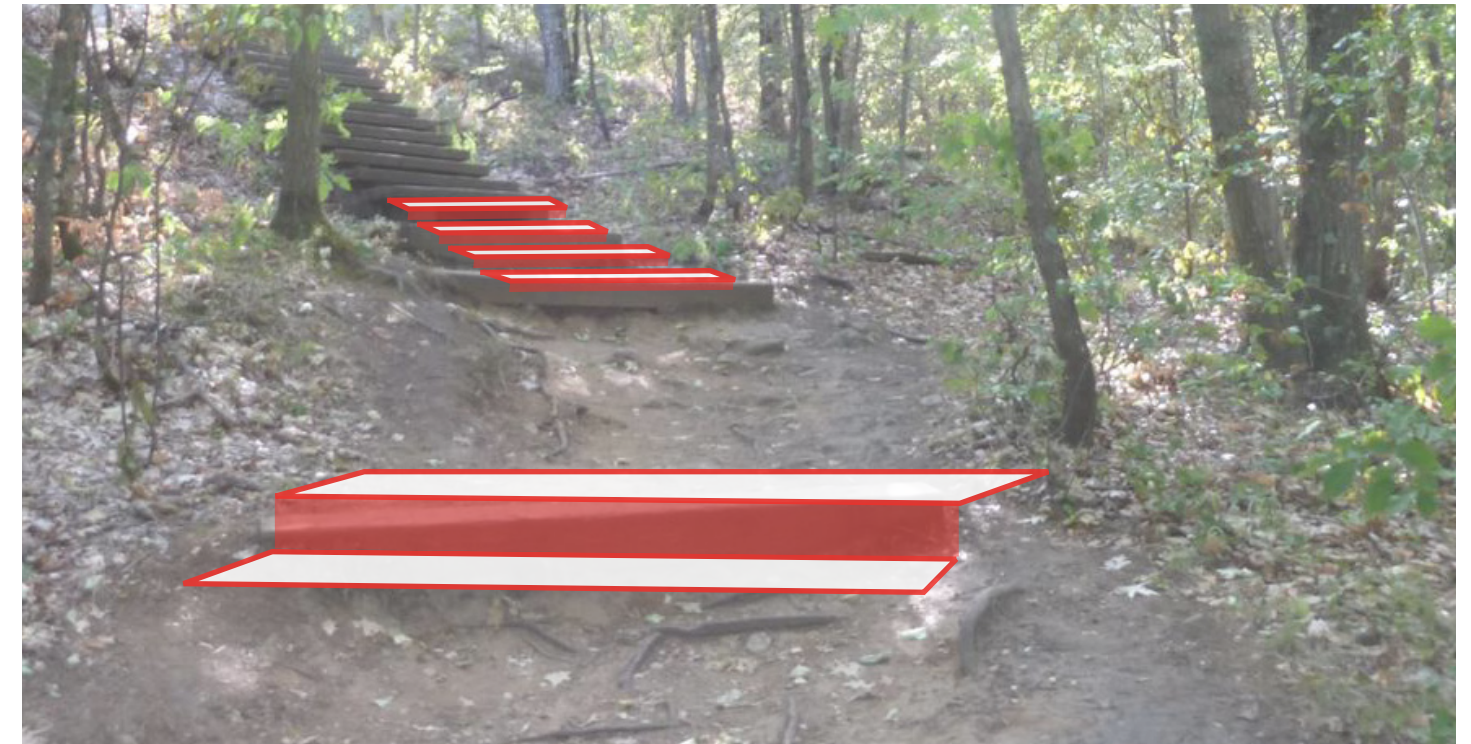
- Two square timber steps, at the bottom of the stairs, are unstable and too high
- One square timber step is unstable and too high : located after the stairs
- Indications of erosion caused by surface runoff

- Remove the 2 steps to create a continuous elevated staircase
- Stabilise the timbers to create steps and adjust their levels
- Lengthen the existing staircase to protect the path

- D-1 Remove the existing timbers and install an elevated staircase (allow for approximately 2 landings)
- D-2 Remove the existing timber and install a step. Recupérate the existing timber if possible, otherwise dispose off-site.

- Removal of existing wood timbers (3)
- Install one (1) step : 1.5 metres wide
- Install an elevated staircase : 6.7 metres long, 1.5 metres wide

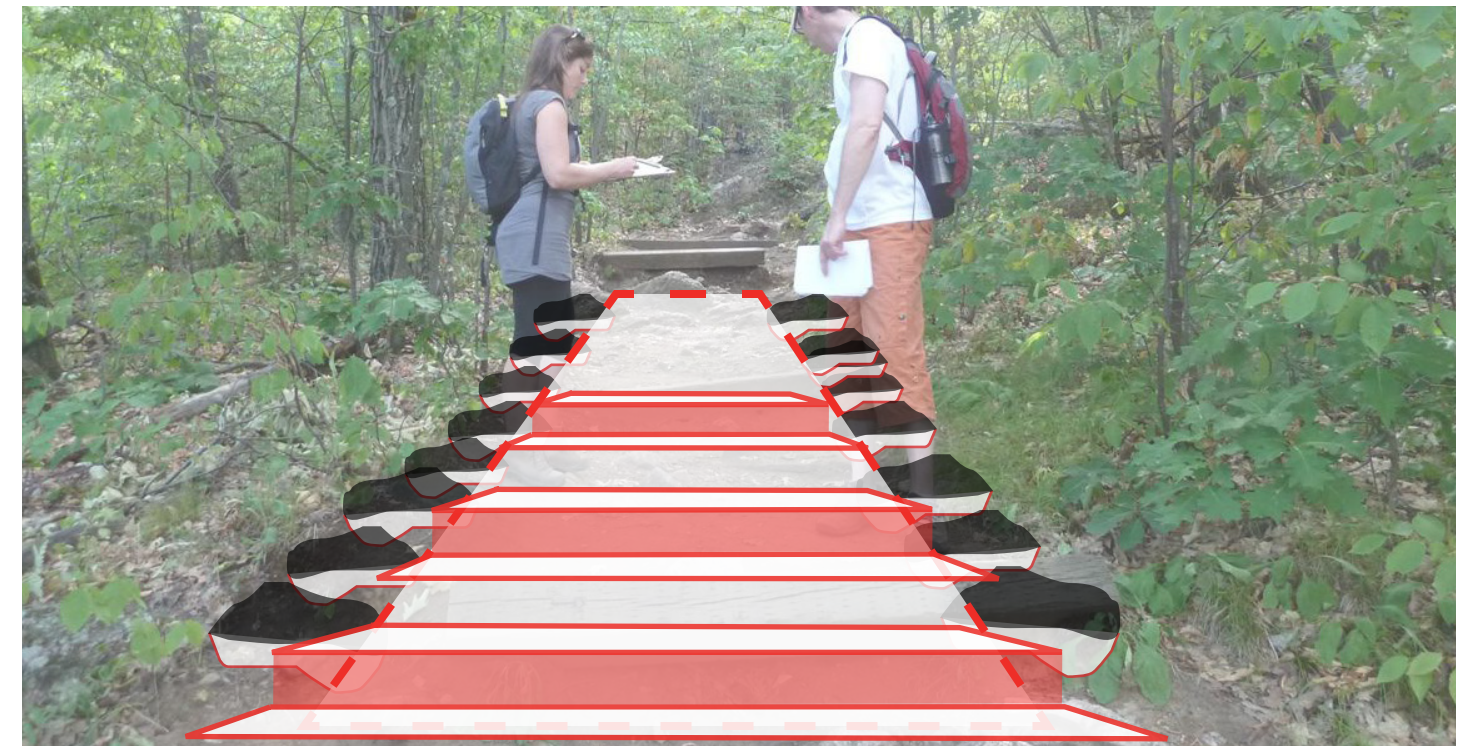
- Two square timber steps, at the center of the trail, are unstable and unnecessary
- Indications of erosion caused by surface runoff

- Remove the 2 timbers, leveling the trail and placing the existing stones to create a safe route of passage
- Install the timbers to create steps and adjust their levels

- **C-1** Fill the central portion of the trail, raising the area with granite stone dust mix, 0-19 mm dia., compacted with plate tamper. Align the natural stones to delineate the edges of the path to take.
- **D-2** Remove existing timbers and install the steps. Recupérate the existing timbers if possible, otherwise dispose off-site.

- Removal of existing wood timbers (2)
- Install three (3) steps : 1.75 metres wide
- Fill with granite stone dust mix over a surface of 12.25 m<sup>2</sup> to a depth of 300 mm (7 m x 1.75 m x 300 mm) : volume 3.7 m<sup>3</sup>

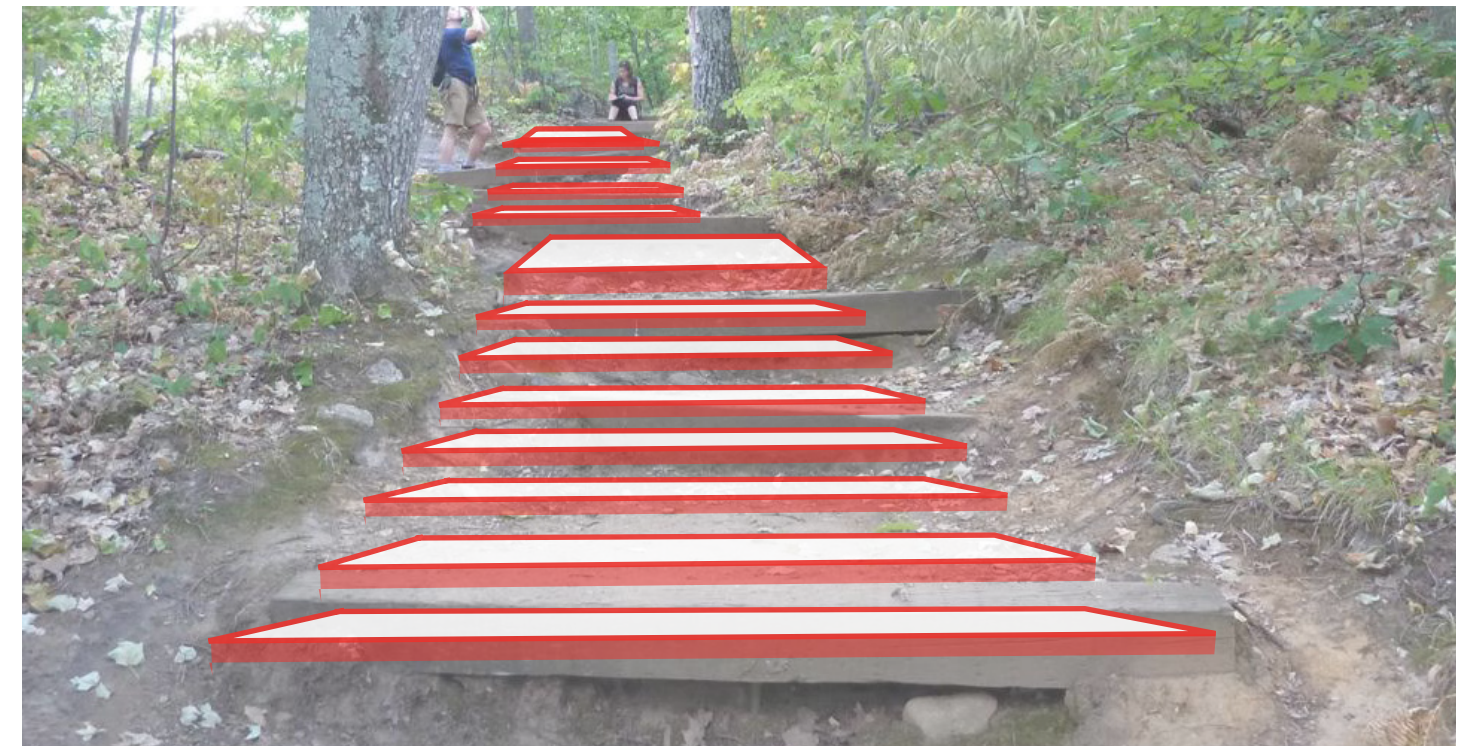
- About 12 square timber steps, in the center of the trail, are unstable
- Indications of erosion caused by surface runoff

- Remove the timbers to create a continuous elevated staircase
- Recuperate the square timbers for use in other interventions

- D-1 Remove the existing timbers and install an elevated staircase (allow for approximately 8 landings, 1.5 metres long)

- Removal of existing wood timbers (about 12)
- Install an elevated staircase : 34 metres long, 1.5 metres wide
- Adjustment of soil grades

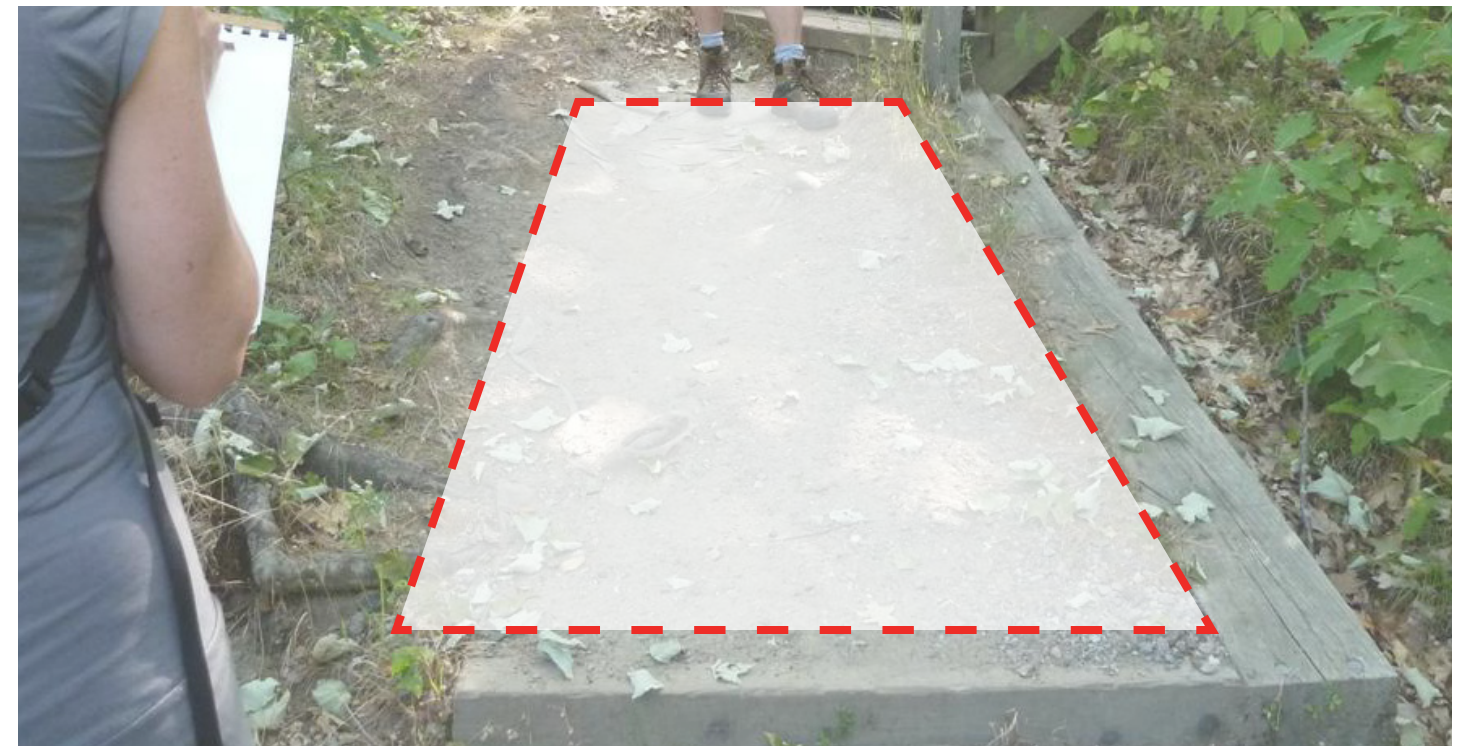
- Visible geotextile caused by : steep slope and the gravel mix is washing off the surface
- The staircase of this portion does not have a handrail and is steep

- Keep the path safe by cutting the excess geotextile and levelling the trail as needed
- Install a handrail for the portion of the existing staircase

- **C-1** Remove the geotextile and level the material on-site. As needed, fill with granite stone dust mix, 0-19 mm dia., compacted with plate tamper.
- **D-3** Install handrail for existing staircase

- Removal of geotextile
- Fill with granite stone dust mix over a surface of 2 m<sup>2</sup> to a depth of 200 mm (2 m x 1 m x 100 mm) : volume 0.2 m<sup>3</sup>
- Install a handrail according to the length evaluated on-site

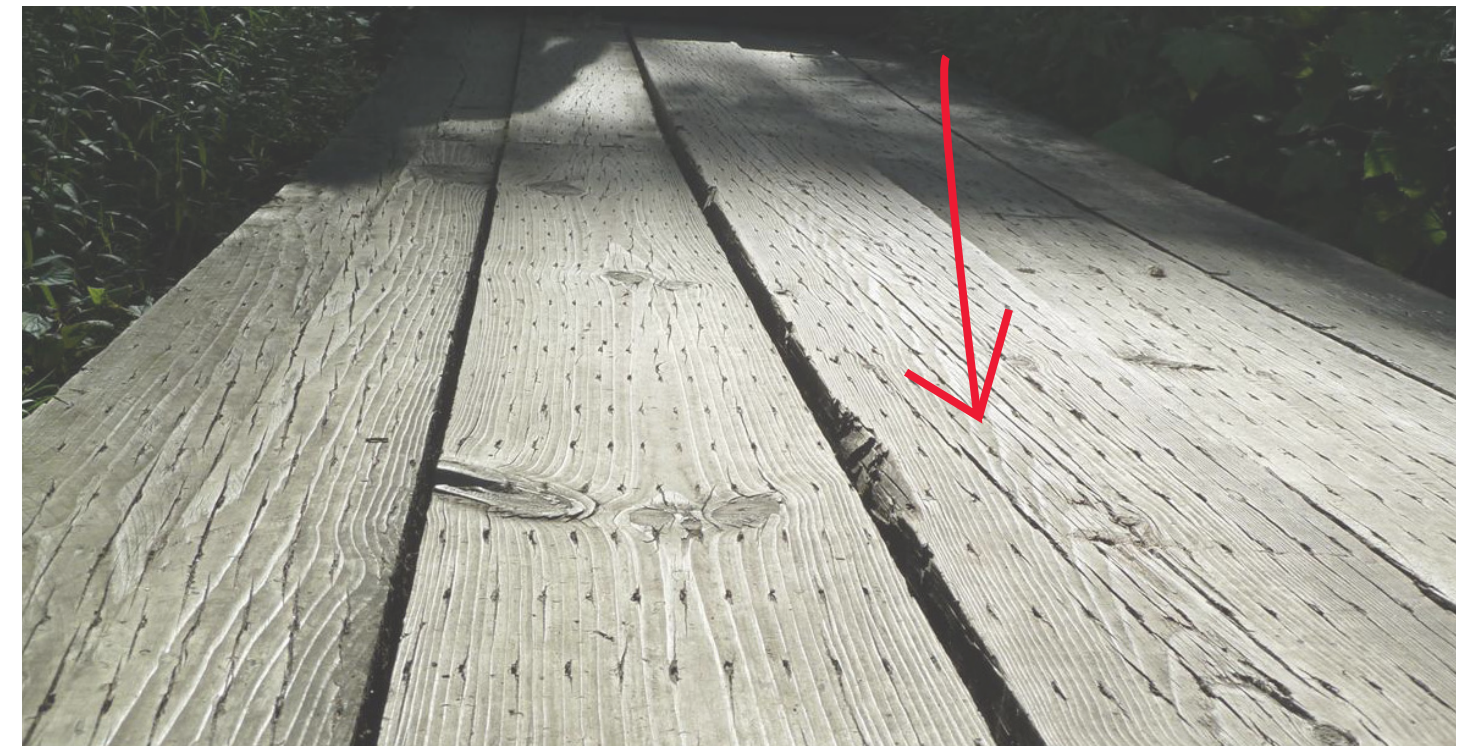
- A square timber on the boardwalk is too high

- Replace the timber to create safe passage

- Adjust the elevated timber on the existing boardwalk as shown in the previous picture

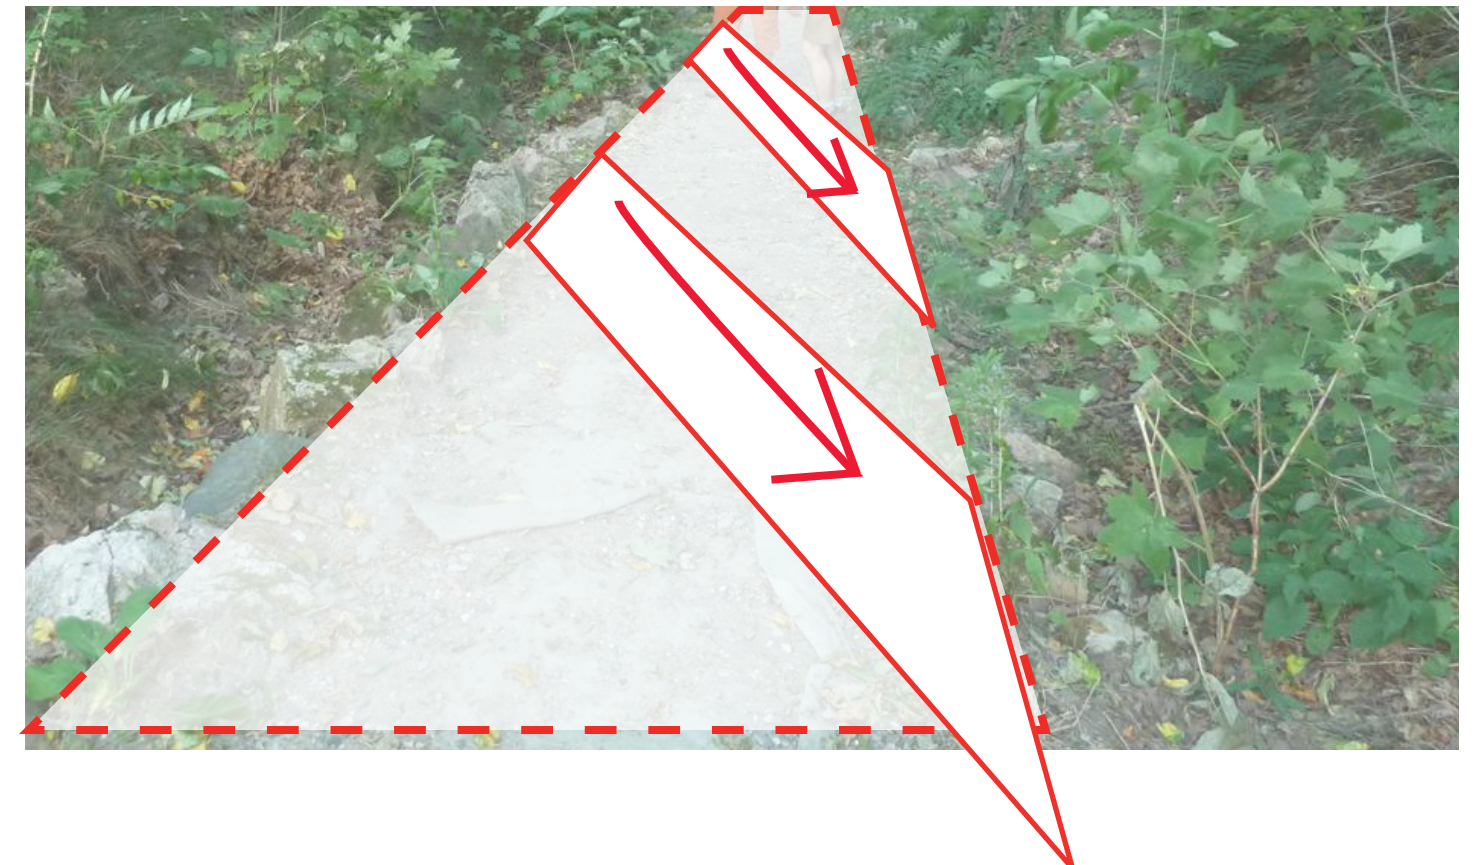
- Long trail with steep slope showing geotextile caused by the washing away of gravel

- Remove the geotextile and realign the water drainage
- Intervene at the source and direct the water to the lowest grade point, preventing it from running along the length of the path
- Focus interventions on three zones of the trail to optimize water captation

- B-1 Install cross drains along the trail (3 interventions)
- C-1 Fill the central portion of the trail with granite stone dust mix, 0-19 mm dia., compacted with plate tamper, after having removed the geotextile
