**Public Works Government Service Canada (PWGSC)**

**Project Number: R.041804.001**

**Big Chaudiere Dam  
Geotechnical Study Report  
August 2011**

**KGS**  
**GROUP**  
**CONSULTING**  
**ENGINEERS**

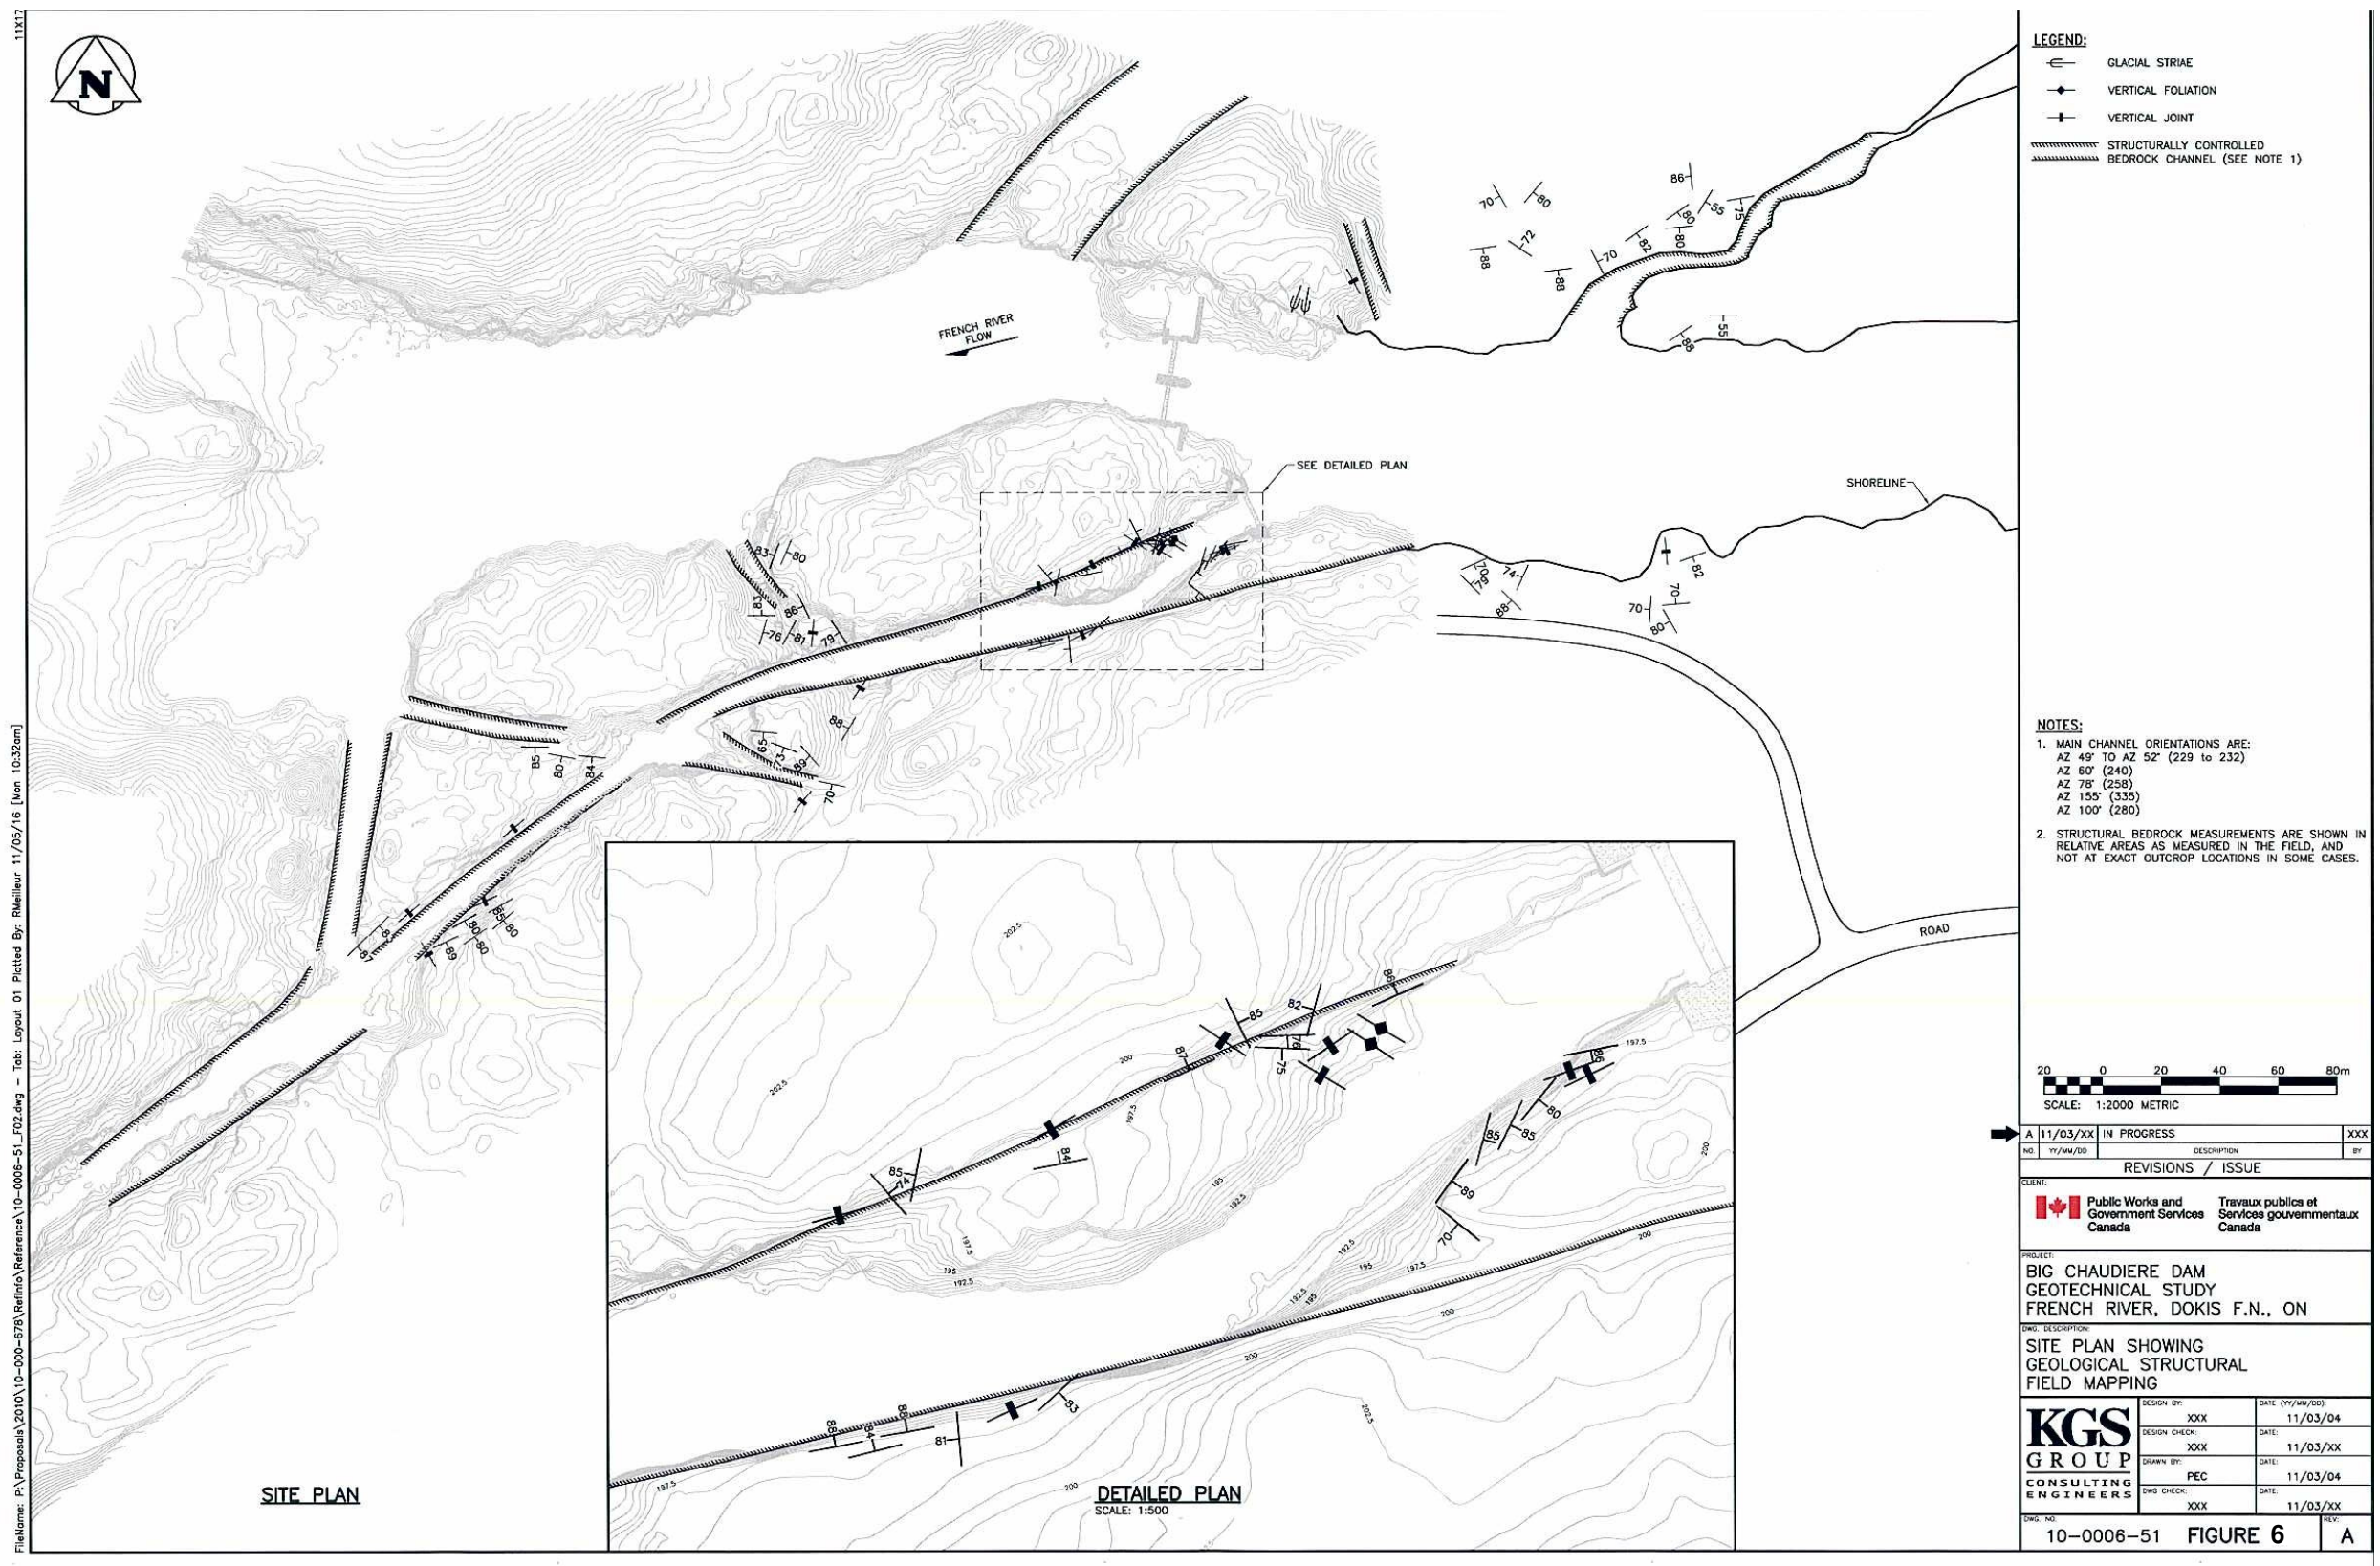
**FIGURE 6:** Site Plan Showing Geological Structural Field Mapping

support significant lateral movement along the south channel via fault displacements (see **Figure 6**).

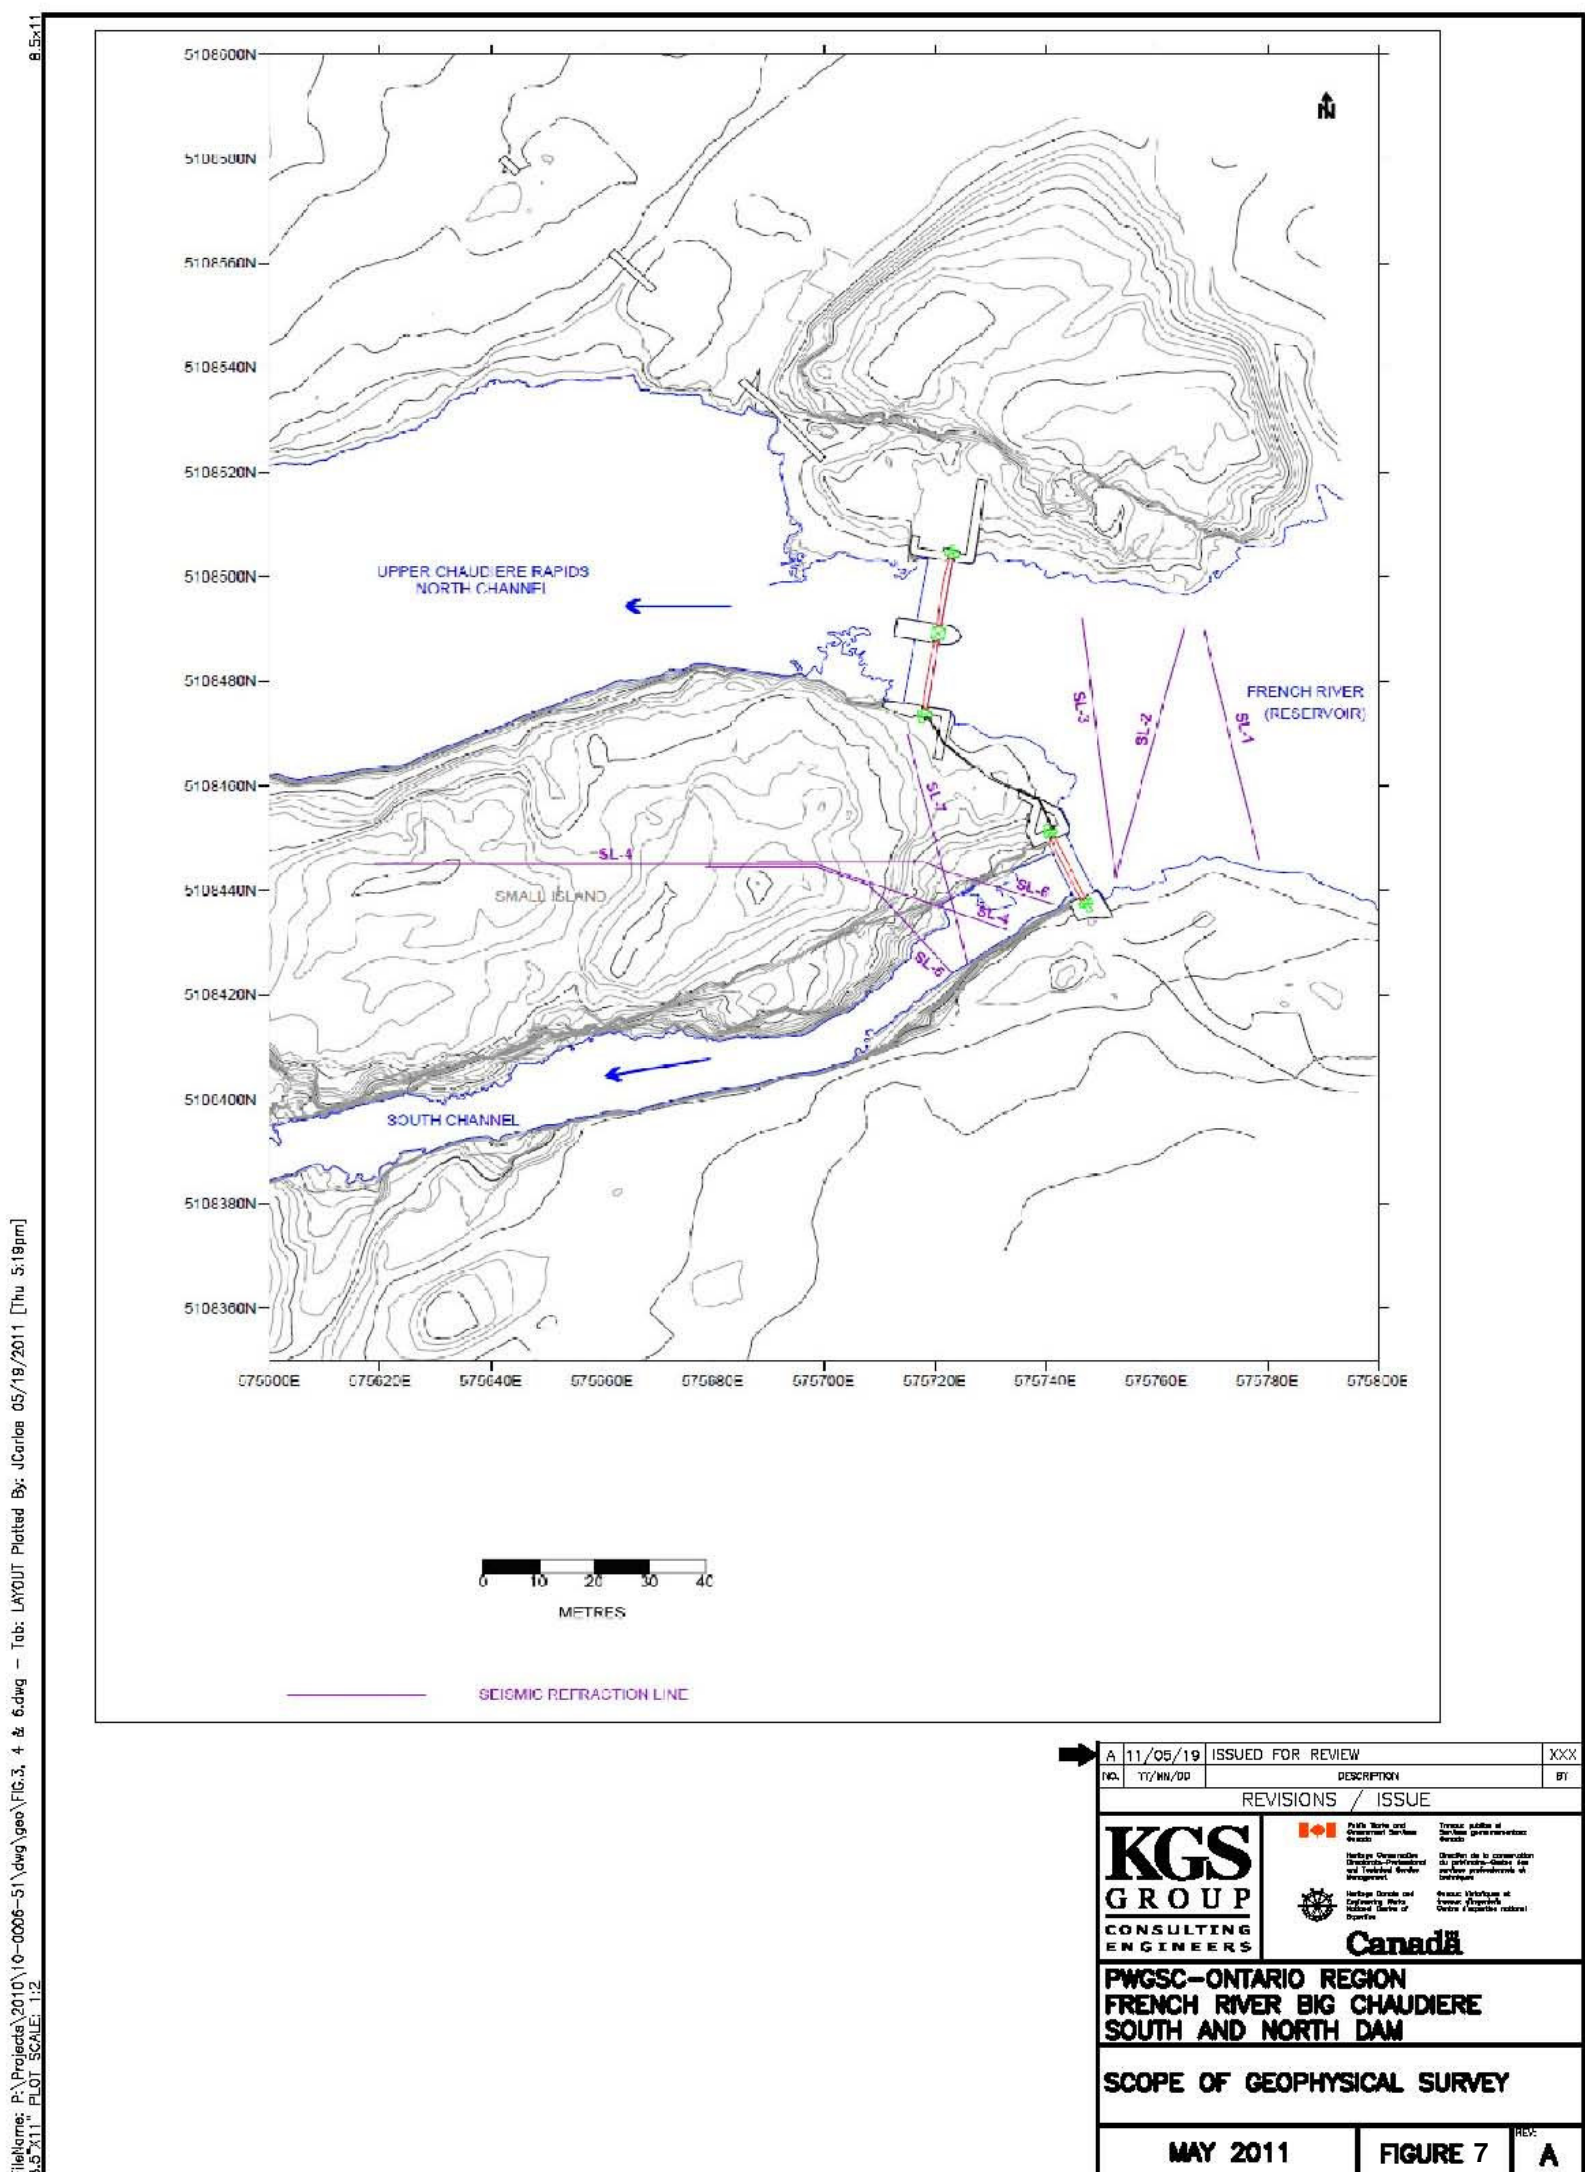
A seismic refraction survey of the South Channel dam was completed as a part of the current geotechnical study on the upstream and downstream sides of the dam as shown on **Figure 7**. In total, approximately 420 m of seismic refraction lines were setup, shot, and results recorded using combinations of geophones (on land) and hydrophones (in water). A black powder, 8 gauge seismic shotgun was used as a source, and multiple shots were used to record data along each line of geophones/hydrophones. A five meter geophone/hydrophone spacing was utilized, which generally reflects the scale of bedrock features that could be easily resolved by this type of survey, and sensor layout. A 5 m spacing allows resolution of a feature that is approximately 1/3 the width of the south channel, for example. This spacing was deemed appropriate in the field based on the use of the geophysical work as a screening tool to assess to the bedrock conditions within the South Channel, and overall site logistics and challenging accessibility, with steep channel sides, and difficult access to the South Channel along steep rock slopes. The hydrophones placed in the water on the downstream side of the South dam were also terminated at the base of the steep rockface on the south side of the south channel, to minimize reflections of energy back to the survey area from the vertical rockface. These types of reflections would induce difficult to interpret “noise” within the collected data.

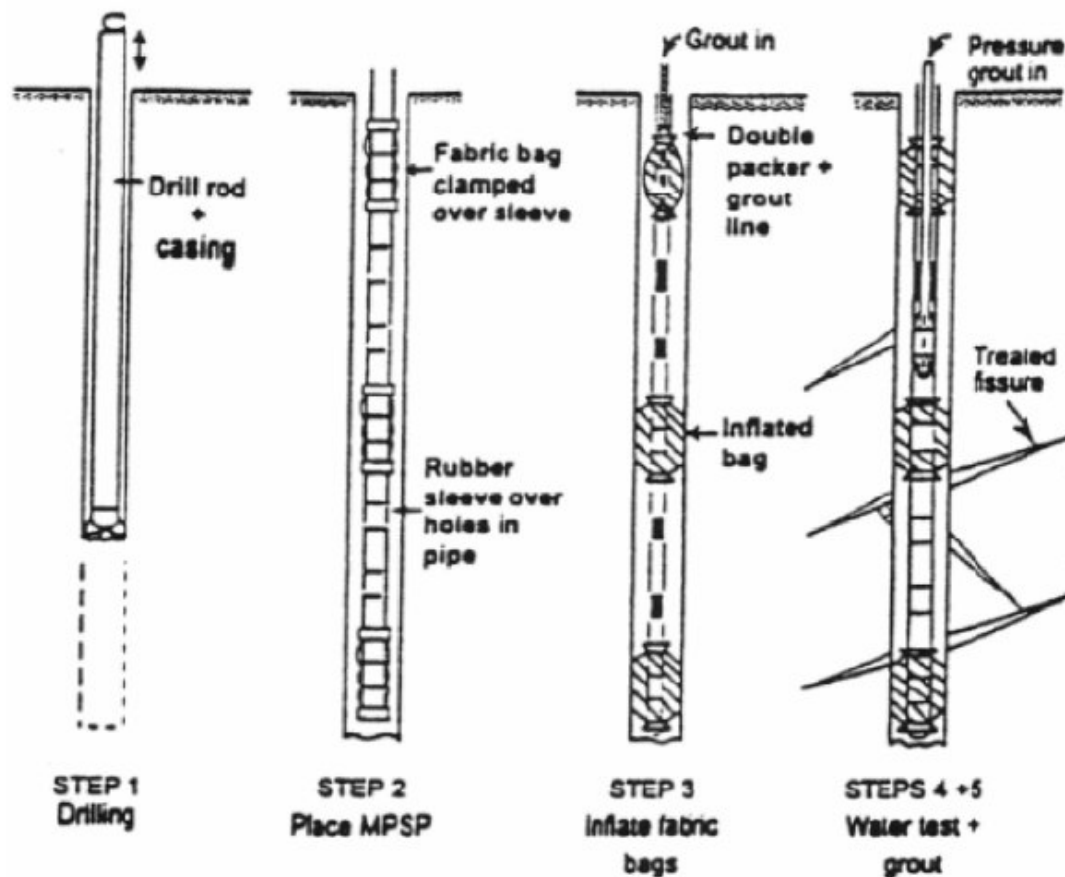
**FIGURE 10:** Multiple Packer Sleeve Pipe (MPSP) Installation and Grouting Steps - Drilling Investigation Program 2011.

For extremely weathered and/or collapsing ground conditions (as experienced during the current geotechnical study at BCD), even descending stage methods can prove impractical, and the Multiple Packer Sleeve Pipe (MPSP) Method could be the method of choice. This rockfill medium at the Big Chaudiere site is generally very difficult to drill, and none of the conventional grouting methods can be made to work due to the high flow velocities through the rock fill zone. The MPSP system is similar to the sleeved tube principle in common use for grouting soils and the softest rocks (rockfills) (reference 13). The sleeve grout in the conventional system is replaced by concentric polypropylene fabric collars, slipped around sleeve ports at specific points along the tube (**Figure 10**). After placing the tube in the hole, the collars are inflated with cement grout, via a double packer and so the grout pipe is centered in the hole, and divides the hole into stages. Each stage can then be grouted with whatever material is judged appropriate, through the intermediate sleeved ports. Considerable use has been made of MPSP in loose, incompetent, or voided rock masses and rockfills, in recent major projects in Canada, and U.S.

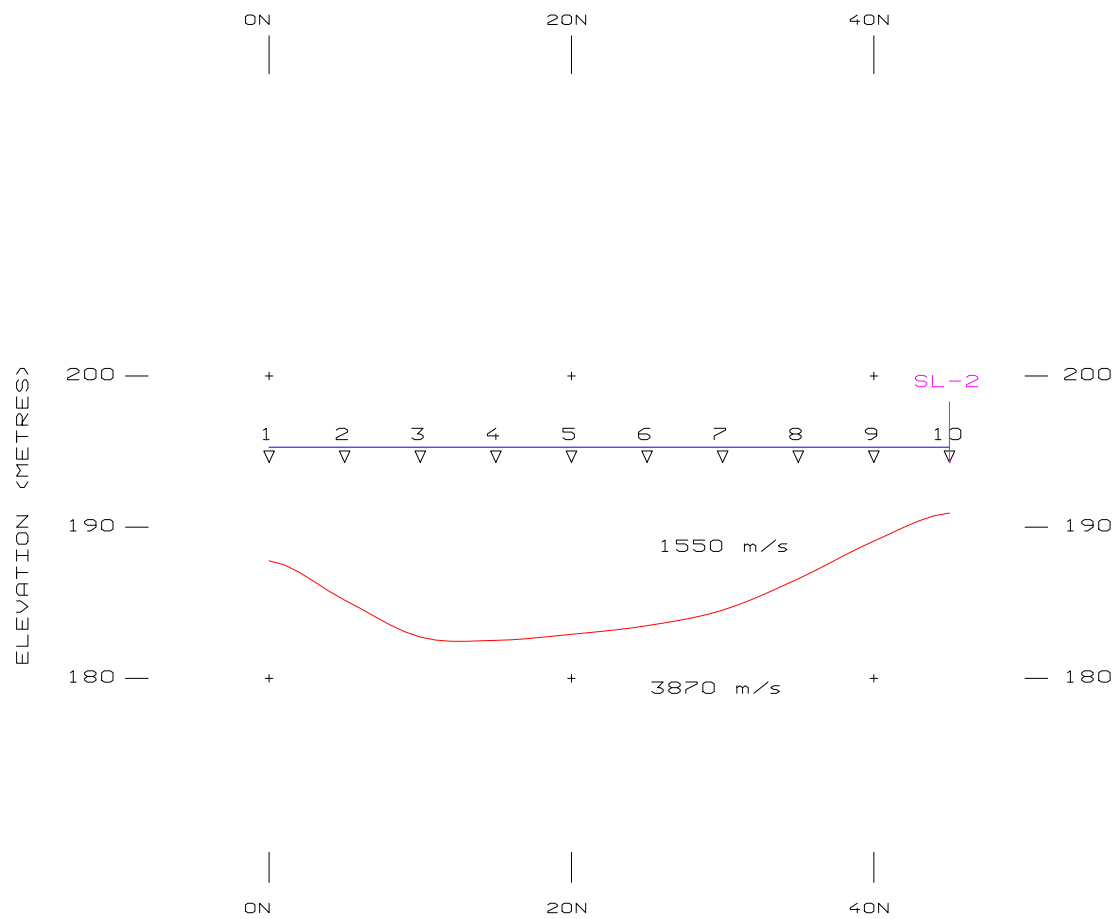
FIG. 3

The results of the interpretations for seismic lines SL-1, SL-2, and SL-3 are shown in Figures 3 through 5. The results indicate the river upstream of the dams is underlain by two distinct velocity layers. The dark blue line indicates the river surface, with the hydrophones shown at water depths of about one metre. The layer underlying the hydrophones exhibits a compressional (P) wave velocity of 1550 m/s. This layer is interpreted to be primarily the water column, possibly underlain by a thin layer of saturated sediments. As the saturated sediments have a compressional wave velocity similar to the water, the sediment-water interface could not be defined.

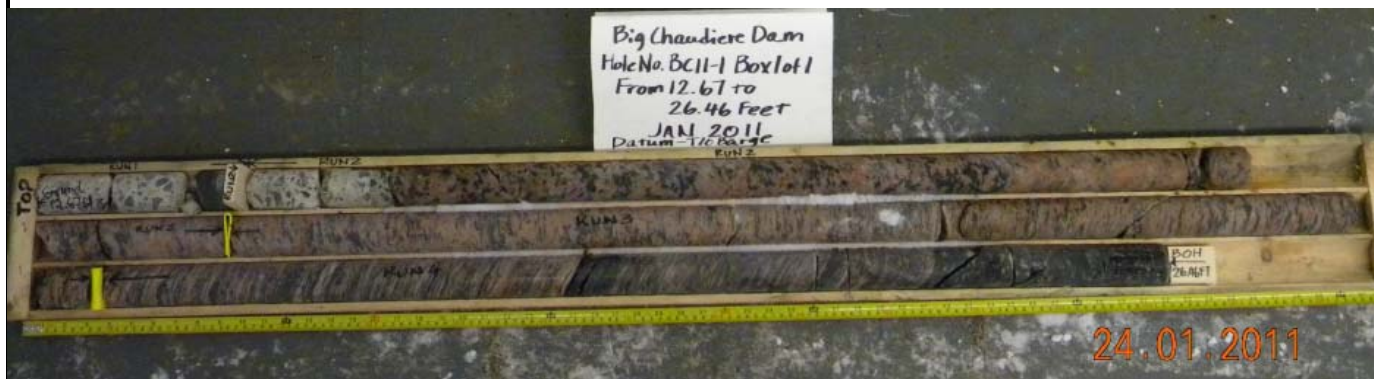
Box 1 of 1 - Depth from 3.86 m to 8.07 m (from 12.67 ft to 26.46 ft)

3.86							↓ EL. 191.34 m		
4		N/A	1				Pieces of Concrete, max. 10 cm and a piece of diabase rock. ↓ EL. 191.10 m	N/A	Run#1 End of Run - BLK.
4.10							Two pieces of concrete (~10 cm)		Run#2
5		91	2			*	<b>(Bedrock) Granitic Gneiss (Quartz-feldspar rich)</b> <b>very coarse grained, hard, competent, tight, lightly fractured.</b> from 4.28 m (EL. 189.37 m) - Coarse grained rock, gneissosity poorly defined - @ 4.4 m MB - @ 5.18 m JT 90° weathered fracture. - @ 5.21 m MB, @ 5.26 m Joint 80° ↓ EL. 189.71 m	N/A	Drilled ~ 3.5 hrs. No LW <b>Bedrock @ 4.28 m (EL. 190.92 m)</b>

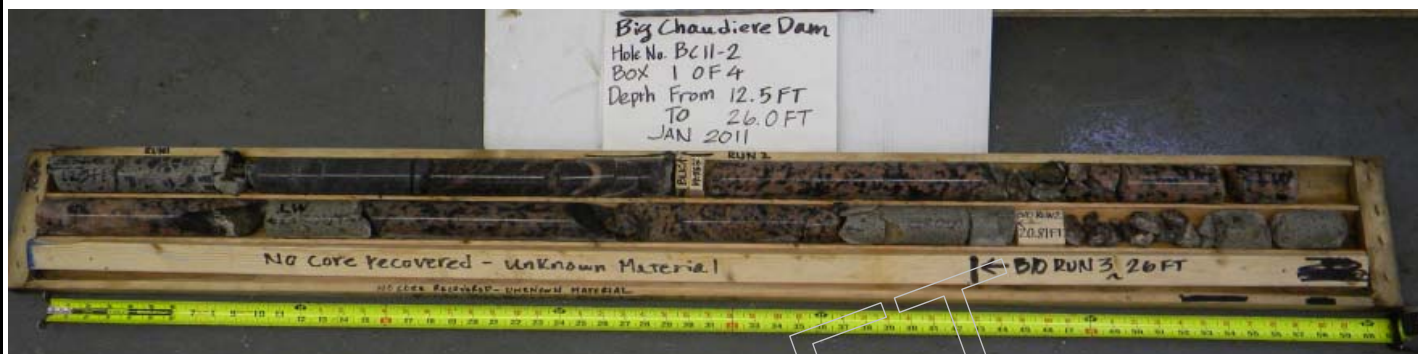
Box 1 of 4 - Depth from 3.81 m to 7.92 m (from 12.50 ft to 26.0 ft)

4.56							A mixture of granite and grout pieces. Granite: 35 cm max. 1 cm min. (broken cores). Grout: 13 cm max.		Run#2 LW @ -5.2 m
5		N/A	2					7.9 x 10 <sup>-6</sup>	
6							↓ EL. 188.86 m

6.34							Broken cores (1.25 to 2.5 cm in dia.) and some grout pieces ~ 7.5 cm max. <u>Poor core recovery</u> Soft materials (unconsolidated and/or gravels) may not be lost. then went through soft materials. The possibility of voids.	N/A	Run#3 LWTO *RD between Run#3 and #4 but no measurement was possible.
7		N/A	3

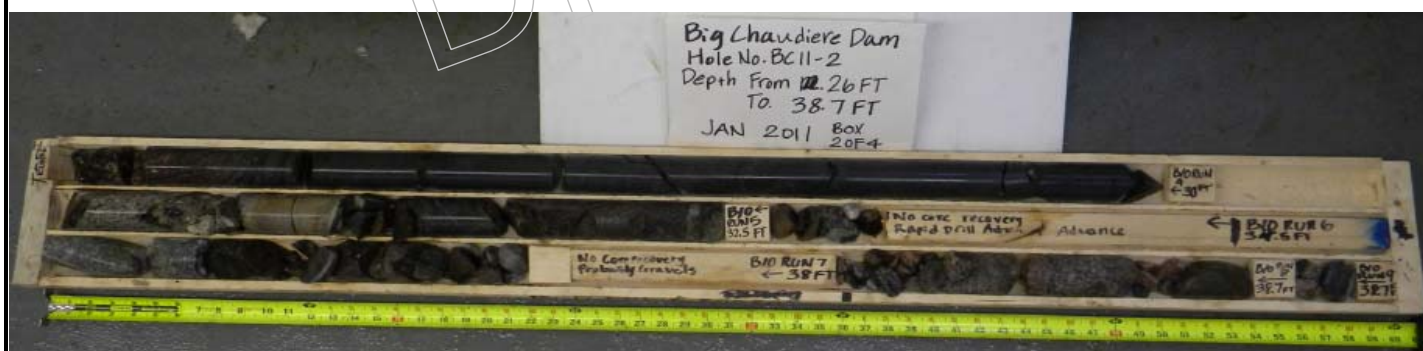
Box 2 of 4 - Depth from 7.92 m to 11.89 m (from 26.0 ft to 38.7 ft)

7.92*							↓ EL. ~ 187.28 m*		
8		N/A	4				A mixture of granite and diabase rock. Granite 0.19 m max. Diabase rock (very dark colour), lightly fractured.	N/A	Run#4 LWTO
9							↓ EL. 186.06 m

Depth (m)	Recovery (%)	RQD %	Run No.	Lithology	Structure	Attitude	Classification and Physical Condition	WPT (L:cm/s)	Remarks
10.52			6				Smooth rounded gravels 1.3 cm to 3.8 cm dia., poor core recovery. ↓ EL. 184.68 m	N/A	Run#6 Rapid drill advance - finer materials may have been washed out.
11			7				A mixture of roken cores (diabase and quartzite) with some rounded pebbles, poor core recovery. ↓ EL. 183.62 m	N/A	Run #7 The possibility of loss of finer materials (gravels).

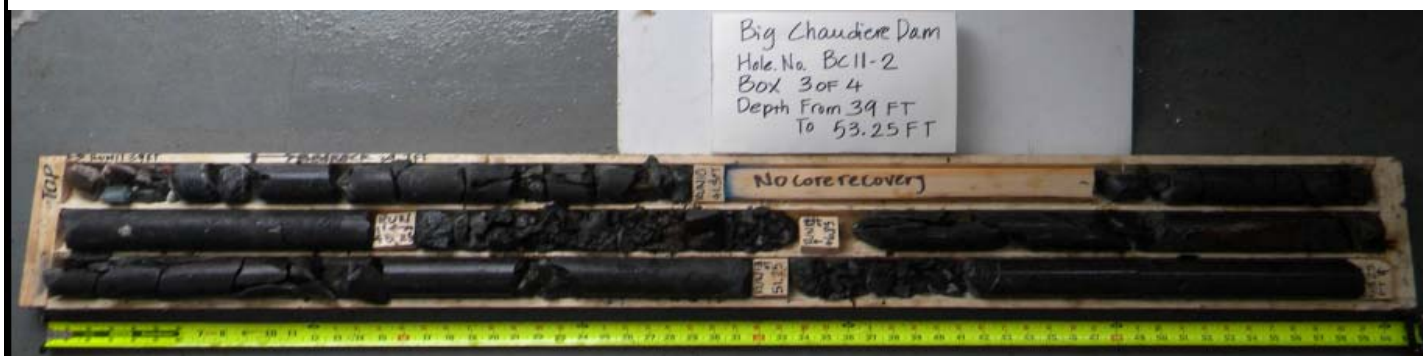
Box 3 of 4 - Depth from 11.89 m to 16.23 m to (from 38.7 ft to 53.25 ft)

12.59			11				No core recovered about 0.46 m, possible soft zone. - @ 13.15 m MB - @ 13.22 m MB - @ 13.56 m Healed joint - @ 13.69 m Healed joint	N/A	Run#11 WRTO
13		60	12				↓ EL. 181.41 m Highly fractured. Large crystals observed in the rock. ↓ EL. 180.93 m	N/A	Run#12 WRTO

13.79			13				- From 14.27 to 14.42 m, sheared, highly fractured. - From 14.6 to 14.8 m, some iron deposit (hematite) on the rock. - @ 14.80 JT 70° from the CA. - From ~14.81 to 15.19 m - vertical fracture (shear zone) @ 14.86, 14.94 and 15.01 m JT 60° from the CA. ↓ EL. 179.58 m	N/A	Run#13 WRTO
14		0	14				- From 15.62 to 15.85, highly fractured. - @ 16.05 m MB ↓ EL. 178.97 m	7	Run#14 WRTO.

14.27			15				- Highly fractured (the top, middle and bottom sections of the recovered core). - From 16.66 m to 16.79 m, a vertical fracture - @ 16.79 m MB ↓ EL. 177.93 m	2.0 x 10 <sup>-9</sup> / 3.2 x 10 <sup>-7</sup>	Run#15 WRTO. -16.8 m
15		55	16

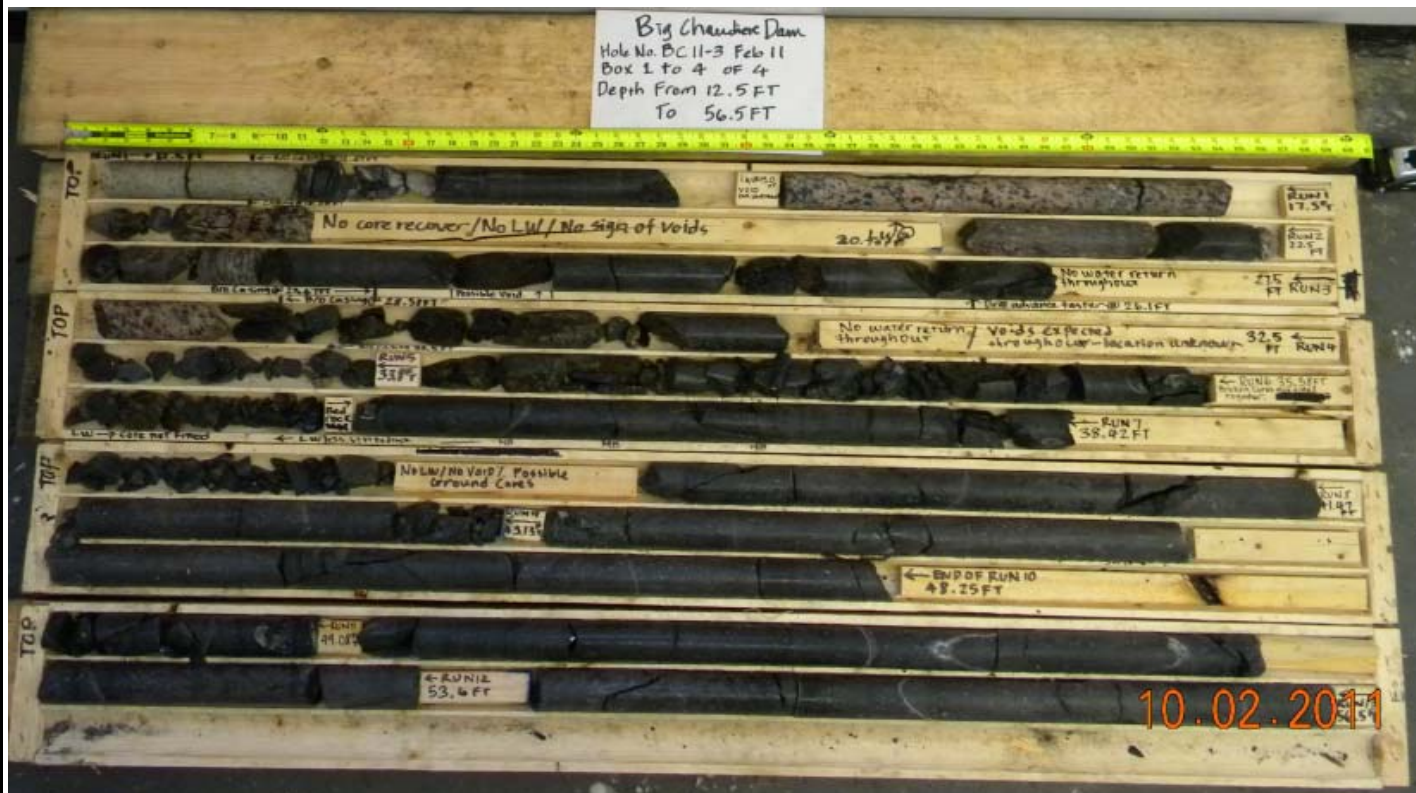
BC11-3 From 3.81 m to 17.22 m (From 12.5 FT to 56.5 FT)

<u>A mixture of granite and diabase rock, poor core recovery*.</u> Granite - broken 1.2 cm ~ 5 cm and a 22 cm piece. Diabase ~13 cm.		Run #2 *Poor core recovery - no LW and no sign of void found. LW @6.32 m RDA @~ 6.70 m

<u>A mixture of broken cores (granite and diabase).</u> Granite 1.3 to 13 cm Diabase rock, max. 13 cm, some pieces with rusted surfaces.	9.5 x 10 <sup>-6</sup>	Run #3 LWTO
8

<u>Pebbles and a mixture of broken cores (granite and diabase), poor core recovery.</u> Granite 18 cm Pebble 1.25 cm in dia. Diabase 2.5 cm to 15 cm max.	N/A	Run #4 Voids expected within this run, LWTO.

Depth (m)	Recovery (%)	RQD %	Run No.	Lithology	Structure	Attitude	Classification and Physical Condition	WPT (L:cm/s)	Remarks
10.30			5				Rounded pebbles and broken cores (QF and diabase rocks) fell down from the above, probably sequence from Run #4. ↓ EL. 184.90 m * measured value after retrieving the core barrel.		Run #5 - Drill stopped advancing → retrieved the core barrel.

10.84			6				Broken cores (diabase), stained and weathered surfaces. Two pieces of QF fragments and small gravels found in the recovered cores. ↓ EL. 184.36 m * measured value after retrieving the core barrel		Run #6 - broken cores were not fitted together well in the slot of the core box.
11		70	7		20°	✖ ✖ ✖ ✖	Broken cores (diabase), possibly caved in from the above. Some small QF pieces found. <b>BEDROCK @ EL. 184.33 m; Depth = 10.87 m</b> @ 11.05 m and 11.18 m MB @ 11.38 m MB and JT 20° from CA @ 11.49 and 11.55 m MB ↓ EL. 183.49 m	N/A	Run #7

11.71					30°		Broken cores		Run #8
12		68	8		30°	✖	No core recovered approximately 0.3 m, no sign of void and LW, possible ground cores. Bedrock ↓ @ 11.87 m JT 30° @ 12.01 m MB, @ 12.17 m MB and @ 12.38 m MB & JT 30° ↓ EL. 181.01 m

12.64						✖ ✖	@ 0.20 m from t/o core MB ~ 0.13 m broken cores from the bottom of the run. ↓ EL. 182.56 m * measured		Run #9 - drilled ~ 10 min, WRTO.
13		73	9		80°		Redrilled surfaces ~ 0.05 m @ 13.25 m JT 80° @ 13.53 m JT 80° @ 13.81 m JT 80° @ 14.14 m JT 20°, 45° and 80° @ 14.67 m MB @ 14.78 m MB ↓ EL. 180.94 m		Run #10 - core recovery is more than 1.52 m (5 ft), the bottom of the core may be broken below the bottom of the core barrel.

13.15					80°				
14		98	10		80°				
14.71					80°				
14.96		40	11		80°		No drill advancement occurred and stopped the run. ↓ EL. 180.24 m		
15					80°				
16		51	12		80°		broken cores about 0.09 m, one piece of the core has redrilled surfaces. @ 15.21 m JT 80° @ 15.32 m JT 80° @ 15.48 m NJ 80° @ 15.70 m MB @ 15.72 → 15.89 m Healed joint @ 16.28 m → bottom JT 15° ↓ EL. 178.86 m	9.2 x 10 <sup>-8</sup>

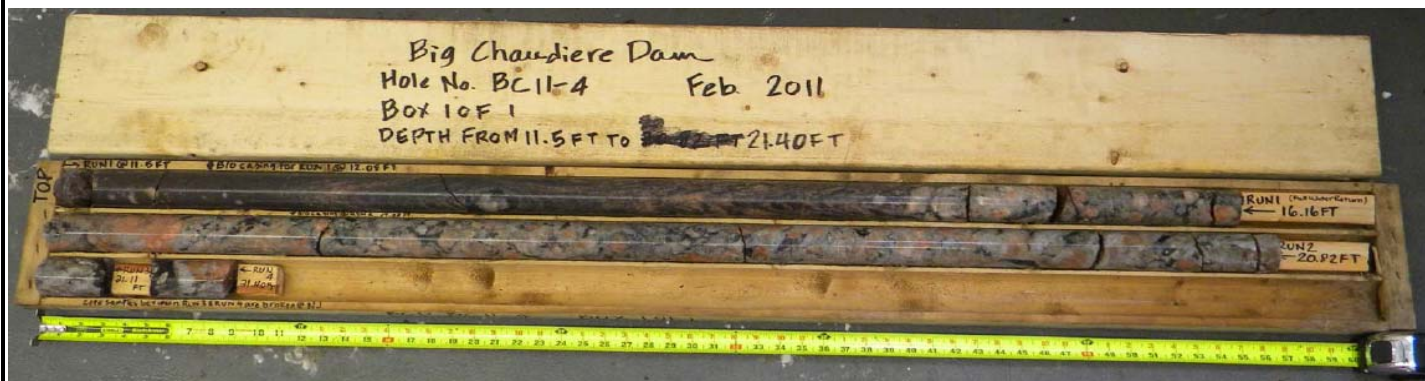
BC11-4 From 3.51 m to 6.52 m (11.5 ft to 21.40 ft)

3.51							↓ EL. 191.69 m		
4		86	1		60° 50°	✕ ✕	<b>BEDROCK (Granitic Gneiss, coarse grain, very hard, lightly fractured)</b> @ EL. 191.69, Depth = 3.51 m @ 3.63 m JT with fine sands 60° @ 3.99 m JT with fine sands 50° @ 4.59 m MB @ 4.69 m weathered surfaces, rusted. @ 4.87 m MB A bottom 0.05 may not be retrieved. ↓ EL. 190.27 m	N/A	Run #1 WRTO A piece of cobble (~ 1.5 cm), multiple cutting lines by the casing on top of the core.

4.93					60°		From 4.93 to 4.95 m, multiple drilled surfaces, probably left from Run 1.		Run #2 WRTO
5		95	2		80°		@ 5.25 m JT, weathered, 60° @ 5.73 m NJ, rusted surfaces, 80° @ 6.15 m JT, weathered surfaces, 70° @ 6.28 m JT, weathered surfaces, 70° @ 6.3 m MB	N/A	
6					70° 70°	✕	↓ EL. 188.85 m

6.35		0	3 & 4				Run #3 and #4 - broken at NJ	N/A	Run 3 & 4 WRTO
6.52							↑ EL. 188.68 m		
7									
8									
9
