Reference: Maligne River Fifth Bridge Engineering Assessment
Jasper National Park

Re: Hydrotechnical Assessment and Conceptual Design for the Maligne Canyon Fifth Bridge over the Maligne River at 06-36-045-01-W6M

ISL ENGINEERING AND LAND SERVICES LTD.			
SITE PHOTOGRAPHS			
MALIGNE RIVER 5TH BRIDGE (SW-36-045-01-W6M)			
DESIGN: M. WOOD	DRAWN: N. DYER	FIGURE 2	
CHECK: D. COOPER	DATUM: UTM NAD83-Z11

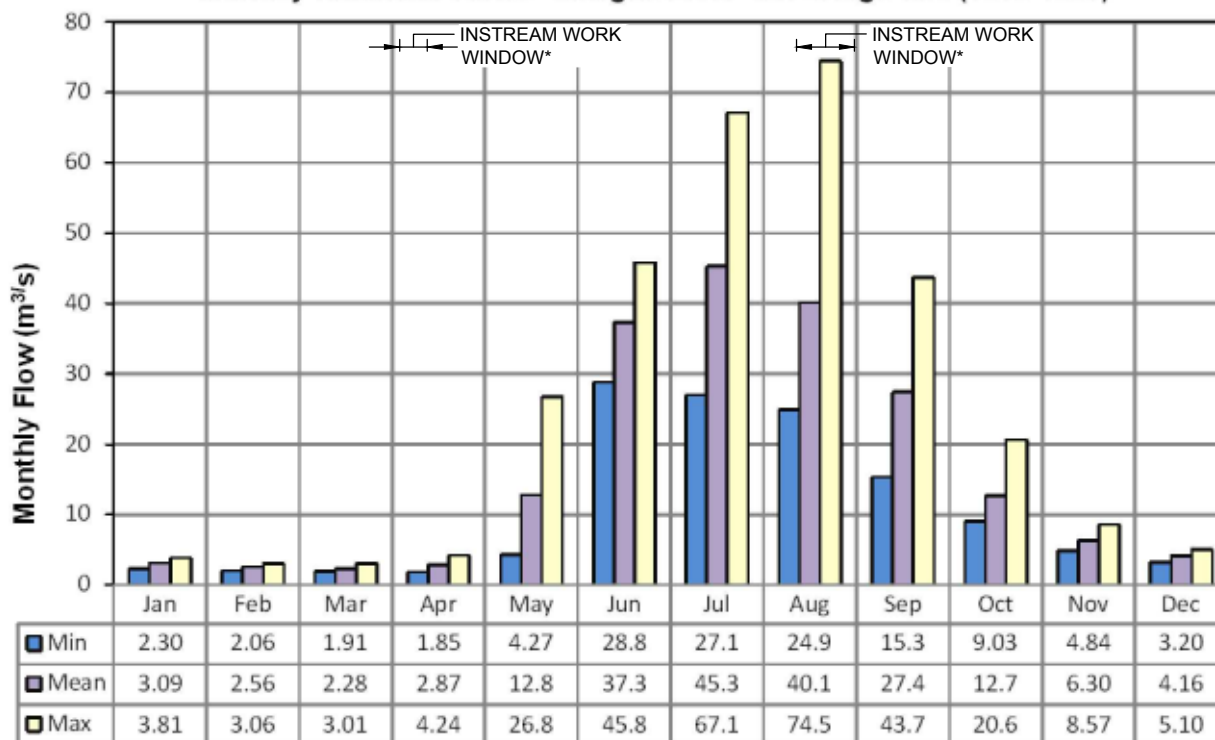
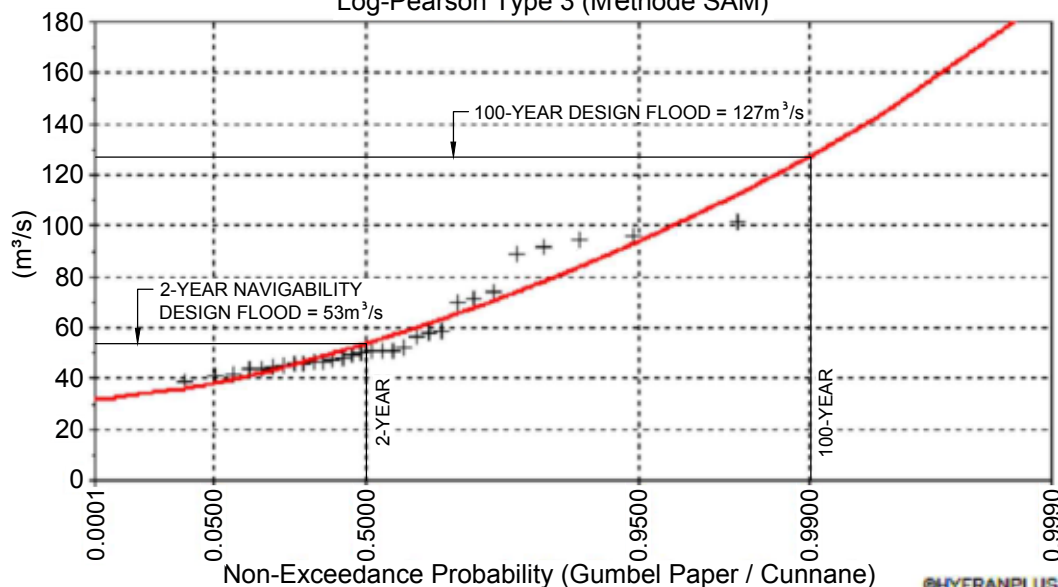
FIGURE
3

There is a Water Survey Canada Gauge located 1 km downstream of the crossing site (WSC station 07AA004 – Maligne River near Jasper). This station has a record period from 1916 to 1997. Hydrologic estimates for flood frequency and monthly flow statistics were prepared using the recorded data from the gauge. Figure 3 shows the results of the hydrologic analysis.

Figure 3 also shows the results of the monthly flow data for January through December for construction planning purposes.

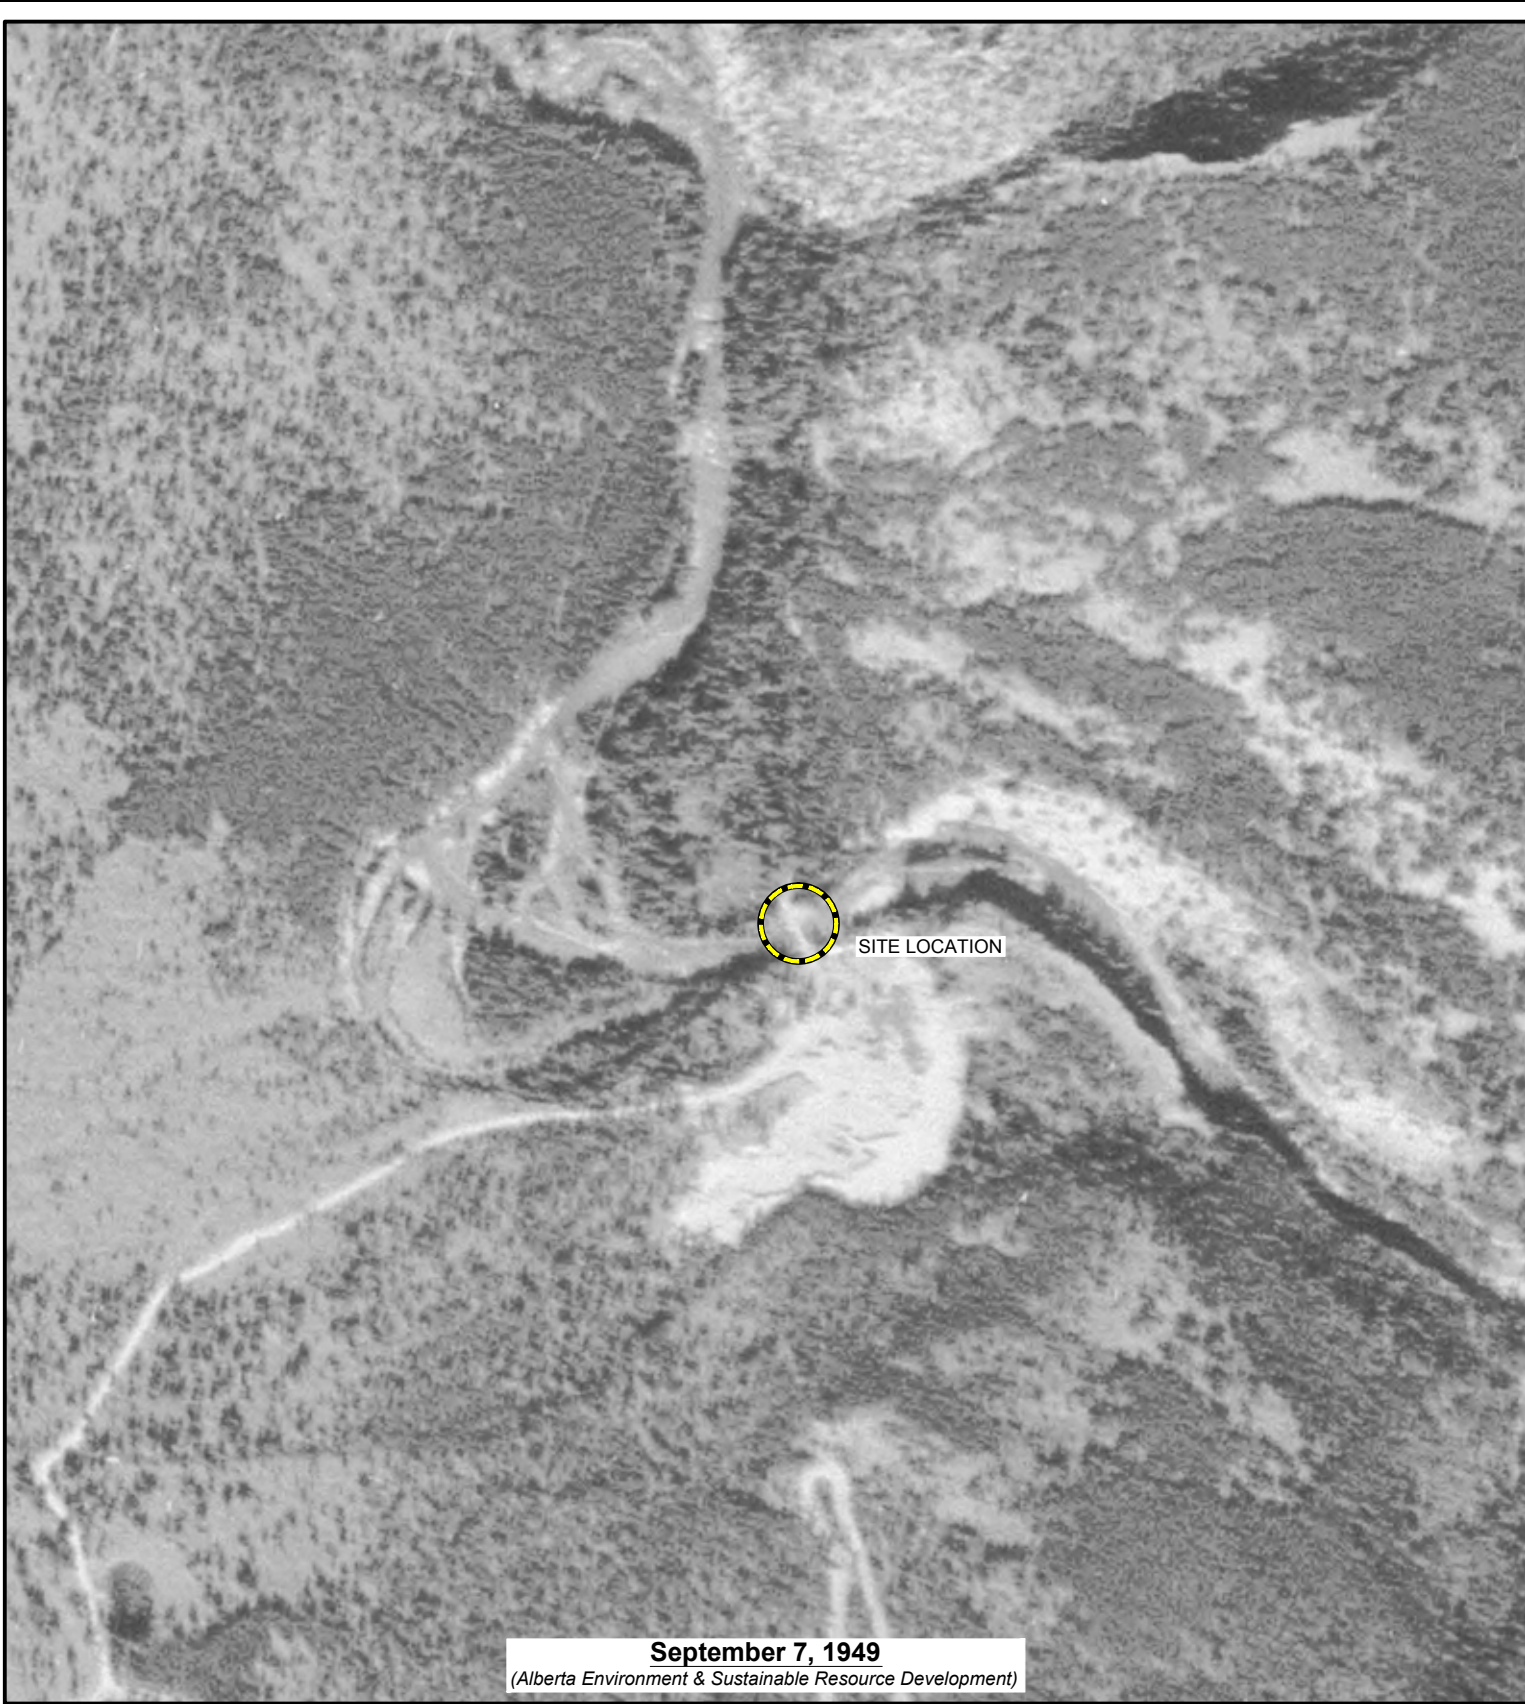
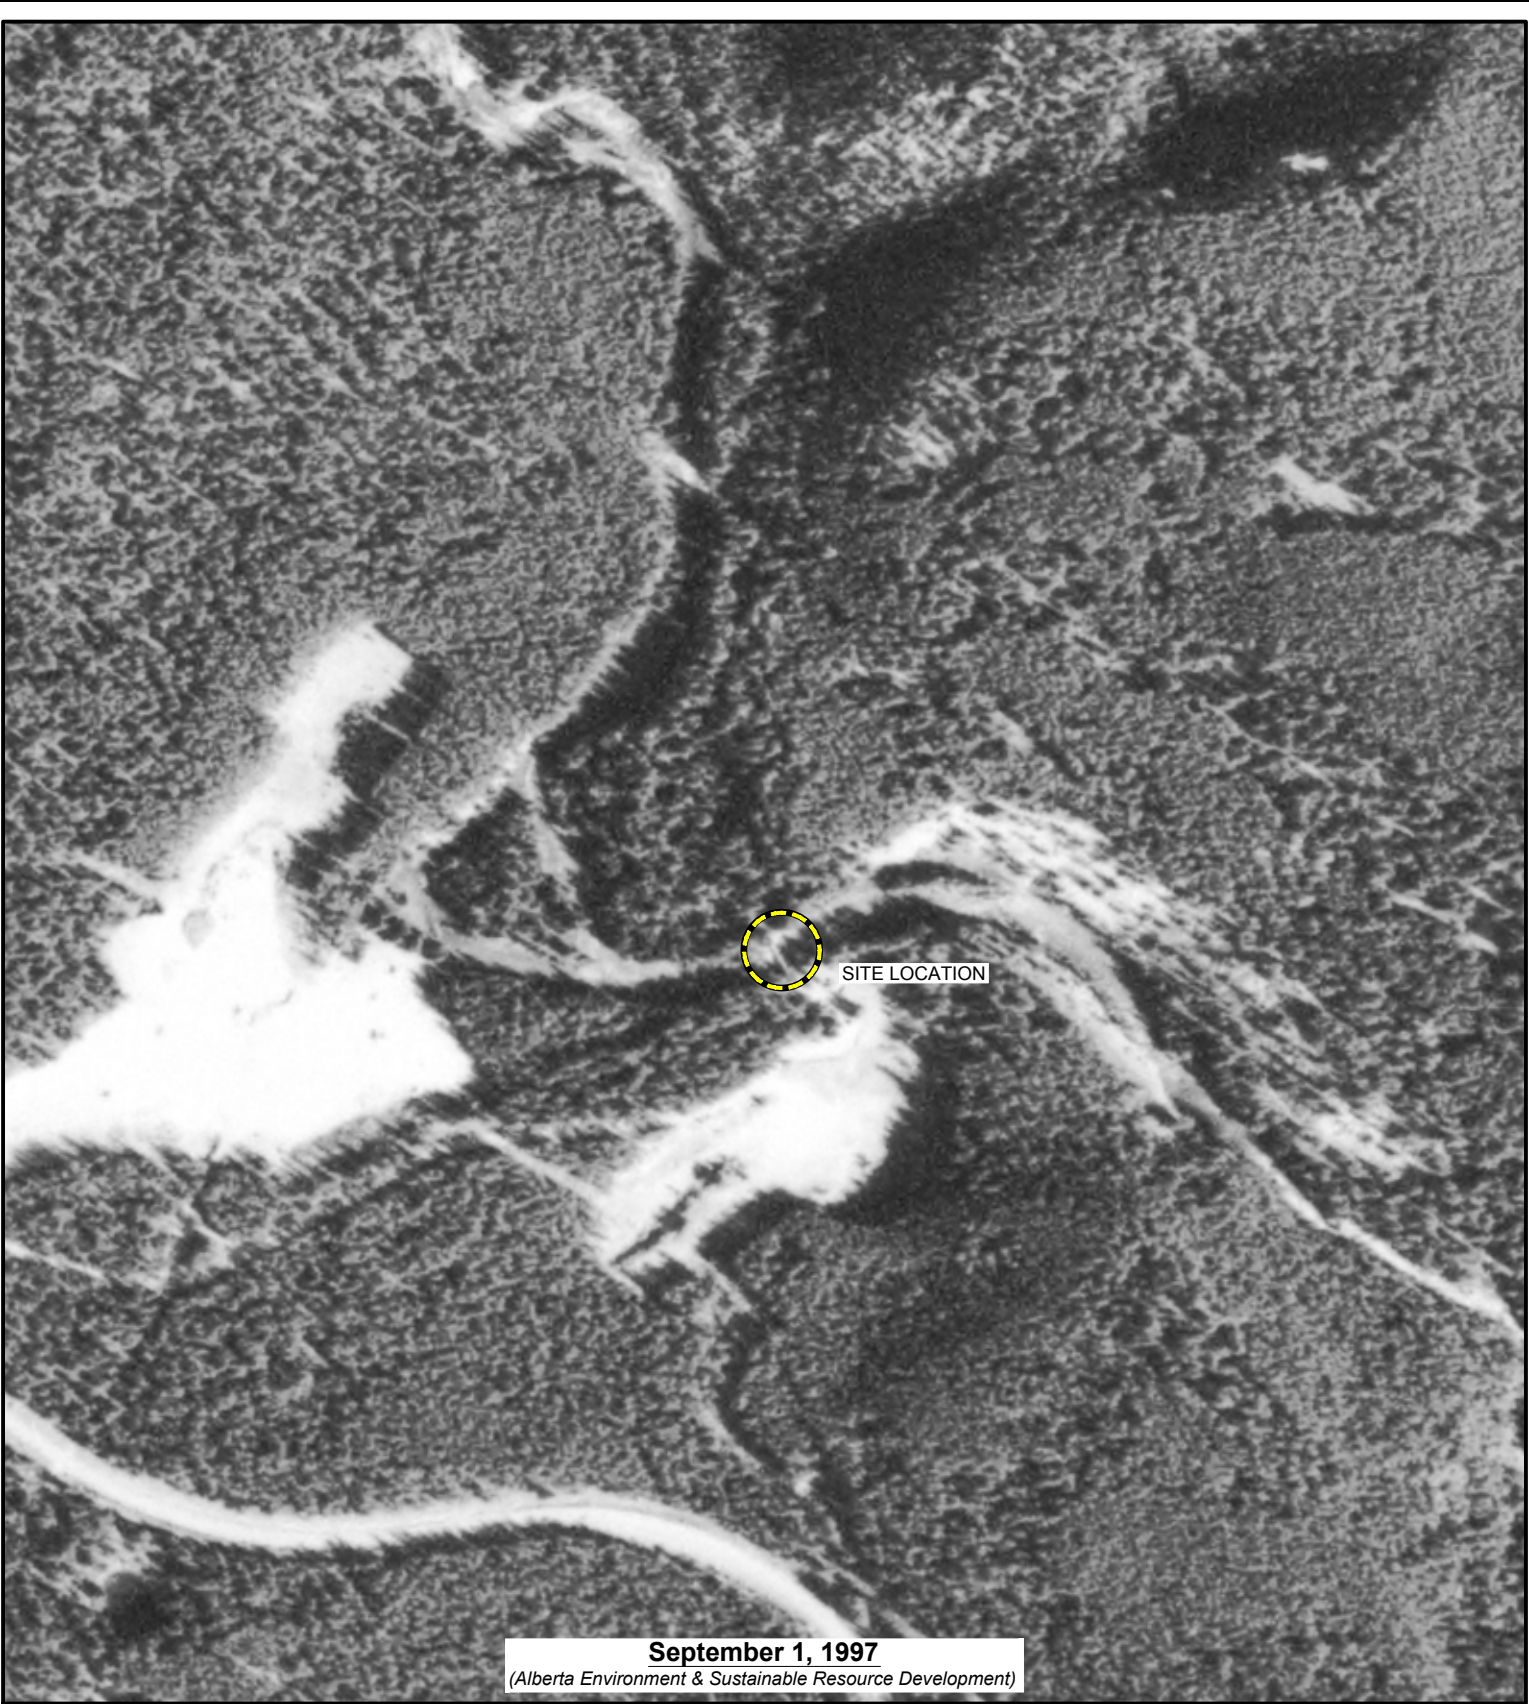
ISL ENGINEERING AND LAND SERVICES LTD.			
MALIGNE RIVER HISTORICAL AIRPHOTO COMPARISON			
MALIGNE RIVER 5TH BRIDGE (SW-36-045-01-W6M)			
DESIGN: M. WOOD	DRAWN: N. DYER	FIGURE 4	
CHECK: D. COOPER	DATUM: UTM NAD83-Z11

A geomorphic assessment was conducted using aerial photography of the site taken in 1949 and 1997. The aerial photographs used in the analysis are provided in Figure 4. The resolution of the photographs does not allow for accurate measurement of past erosion. The photos do show that there was widespread channel movement at the bend that is located 200 m downstream of the crossing site that has since vegetated and stabilized. There is potential for future erosion and channel movement at the downstream; but, this should not impact the crossing location.

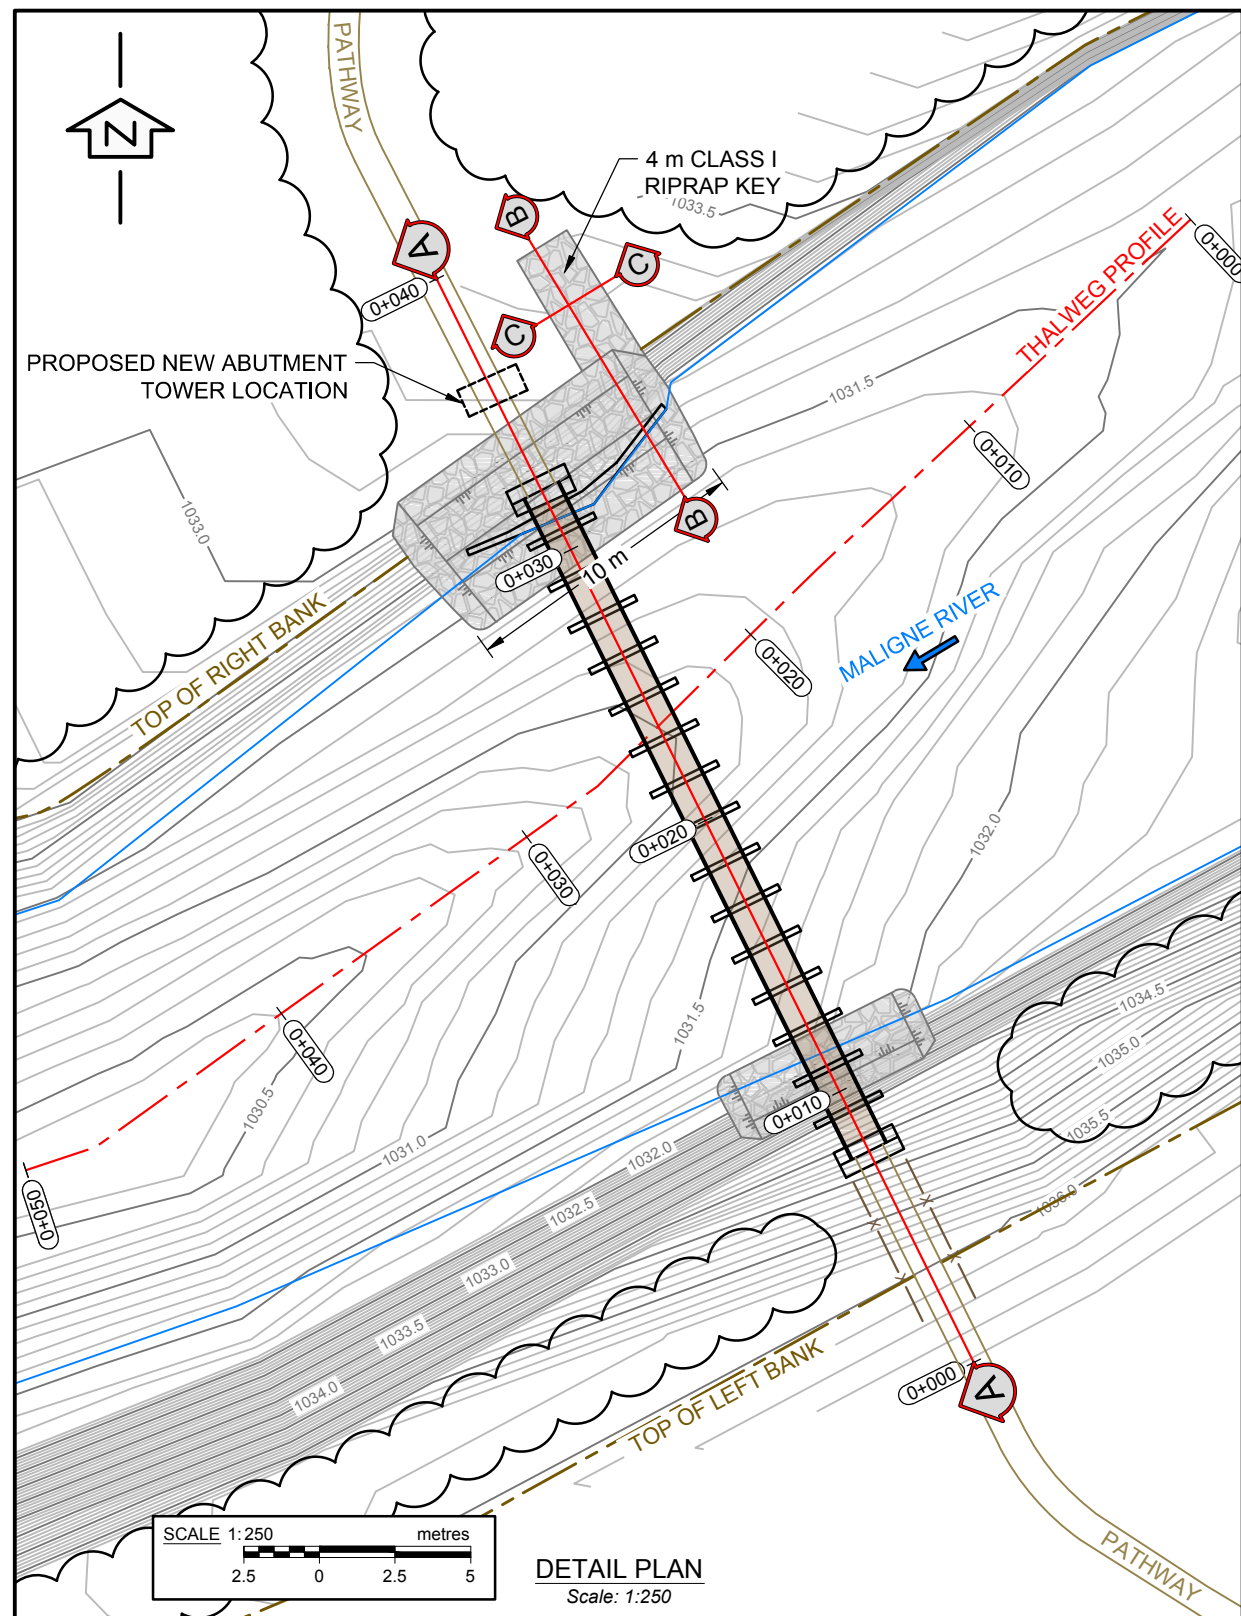
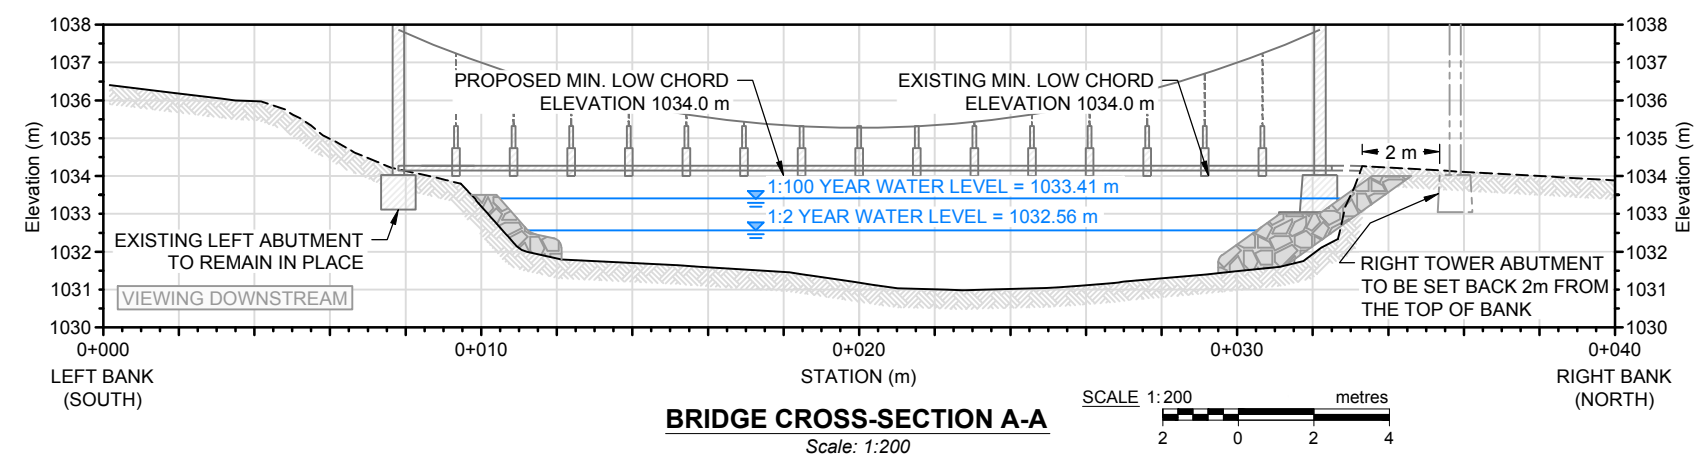
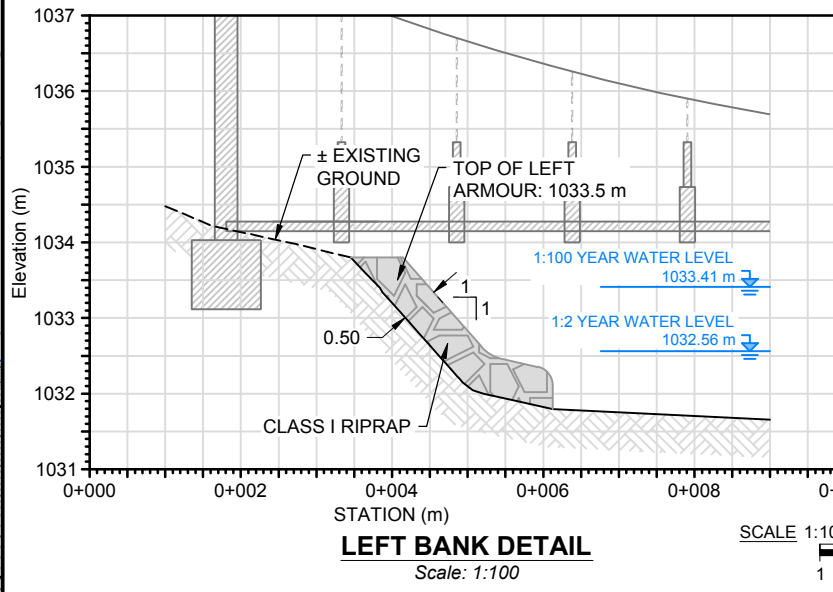
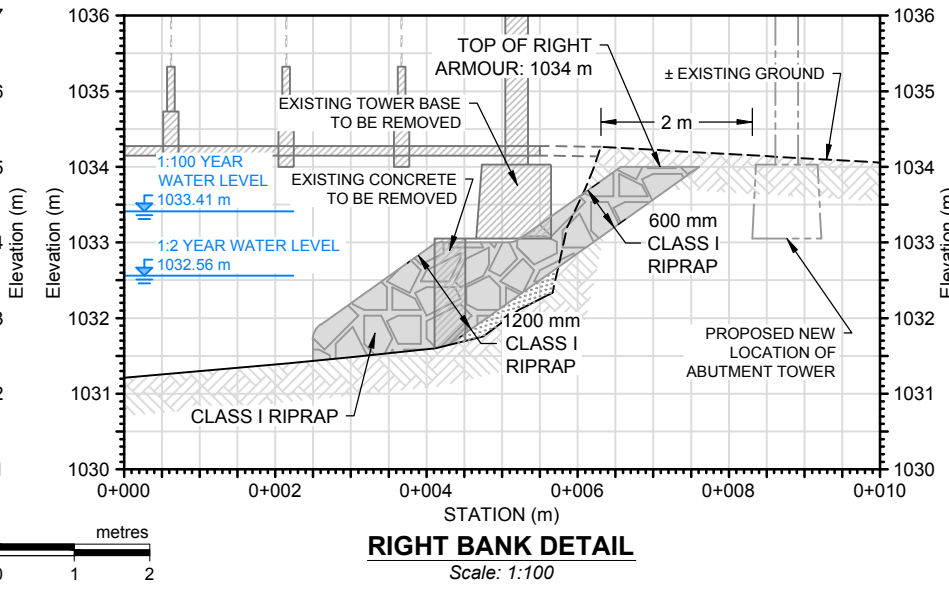
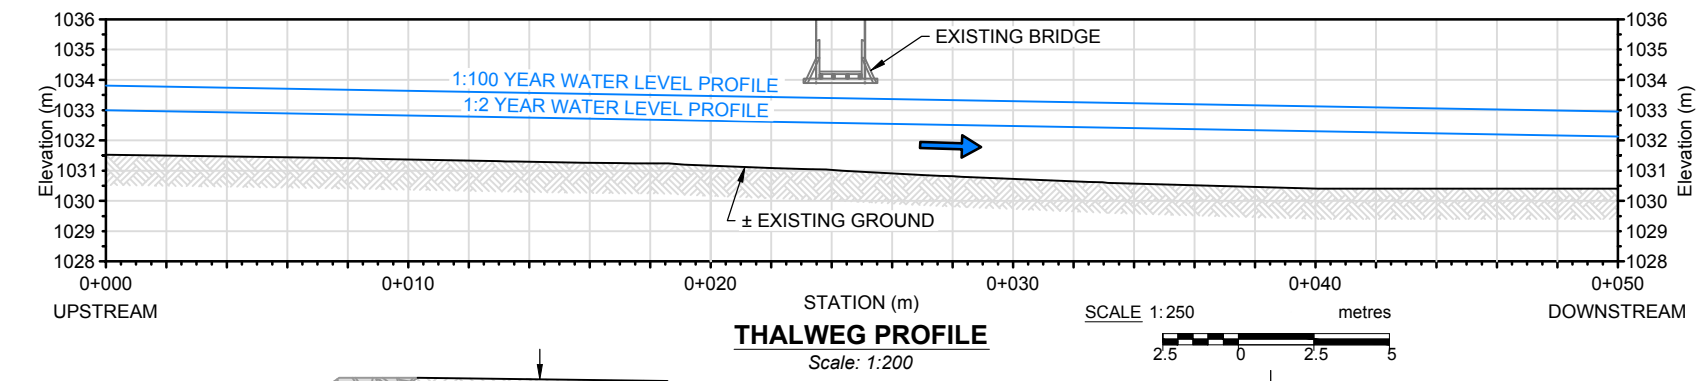
Based on the modeled hydraulics, the existing bridge design provides 0.69 m of freeboard over the 100-year water level. This freeboard is just adequate to safely convey small debris loads during the 100-year event. When restored, the minimum low chord elevation at the abutments of the bridge will need to be at, or above, the existing low chord elevation of 1034.0 m. The proposed minimum low chord elevation is shown in the context of the existing bridge in Figure 5.

The proposed rehabilitation involves salvaging as much of the existing bridge infrastructure as practical and extending its span to set the right (north) tower back from the top of bank. The rehabilitation also involves stabilizing the right bank and providing some additional erosion protection around the left abutment. The following hydrotechnical recommendations are to be used in the conceptual and detailed design of the rehabilitation. The specifications are also provided in Figure 5.

bridge. The details of the proposed armouring are provided in Figure 5. It is recommended that the existing concrete wall at the right abutment be removed to allow for proper placement of the armouring while minimizing the encroachment into the channel.

On the north (right) side of the channel, a class I rock armoured revetment is proposed around the abutment. The armouring is to extend 4 m upstream of the bridge and 4 m downstream as shown in Figure 5. A 2 m wide riprap key shall extend 4 m back into the bank to protect the abutment from any future erosion of the upstream right bank. Should monitoring reveal that future erosion progressed such that this key becomes exposed, then remedial measures on the upstream right bank will be necessary.
