PRE-DEMOLITION HAZARDOUS BUILDING MATERIALS ASSESSMENT

CSC's Mountain Institution
Buildings FB1 – FB9 and Manure Pits,
Sutherland and Humphries Road,
Agassiz, BC

FINAL REPORT

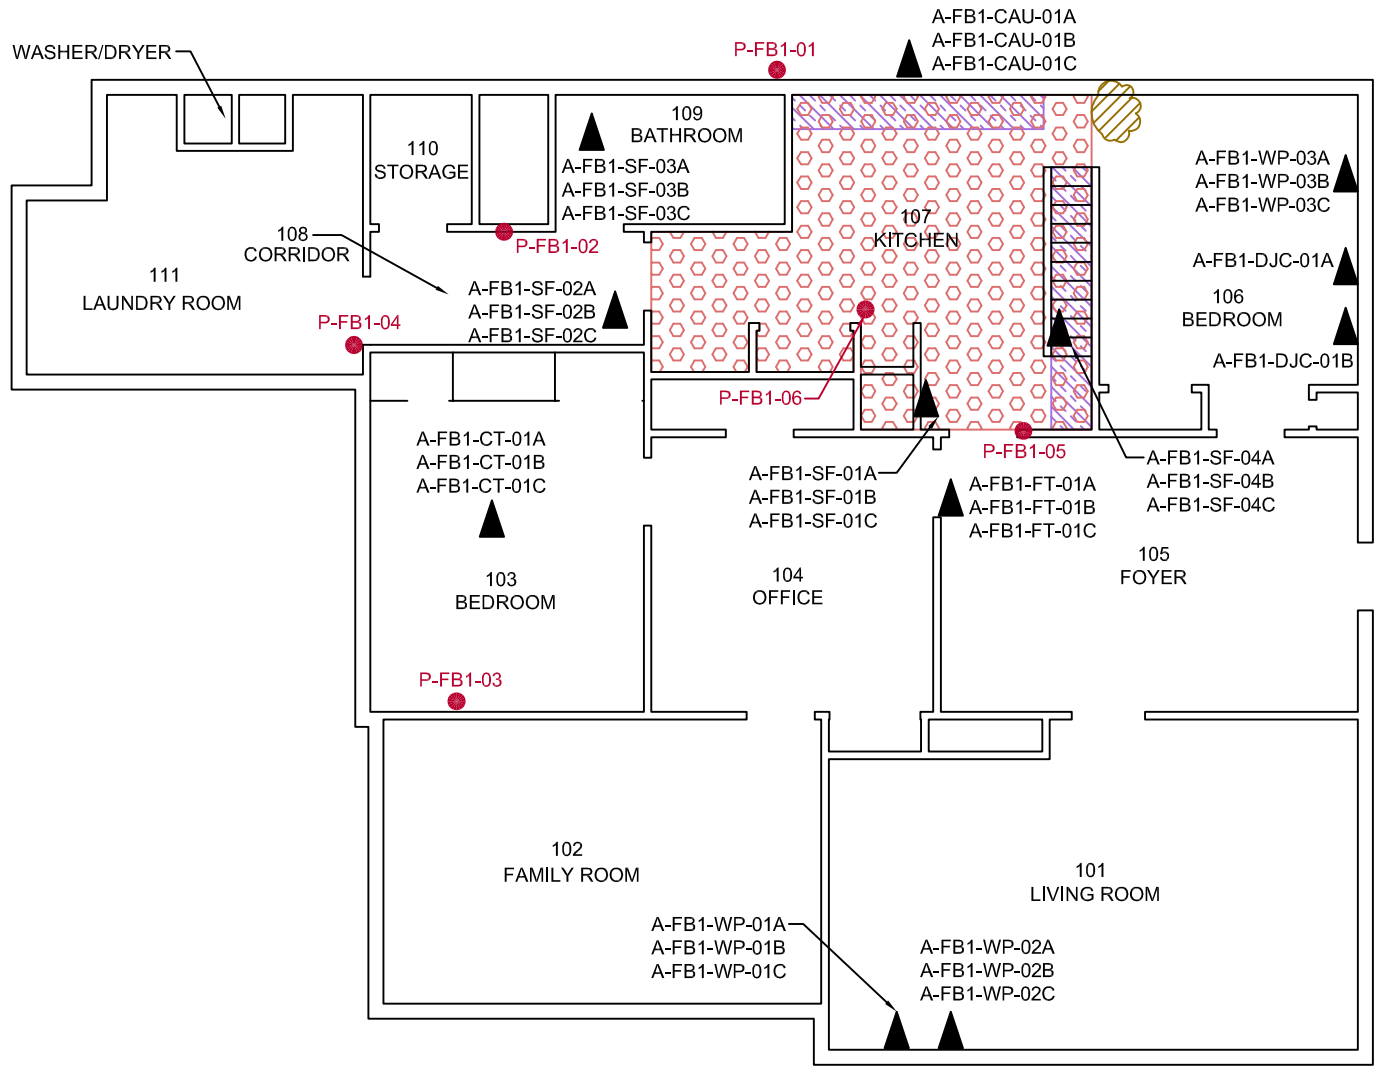
**UNIT FB1
SINGLE STOREY DWELLING**

As the impacted drywall materials are finished with asbestos-containing joint compound, the work procedures and PPE that will be required to address the asbestos will be sufficient in protecting workers and adjacent areas from exposure to mould.

When demolition within the subject building proceeds, it is expected that mould and/or moisture-impacted building materials will be removed and disposed of during that process. Due to the suspected presence of mould on building materials, and if those impacted materials are to be removed by hand, demolition workers should be notified of the presence of mould-impacted building materials and be provided with respiratory protection and/or other personal protective equipment (PPE) as deemed necessary for the work that they will be conducting.

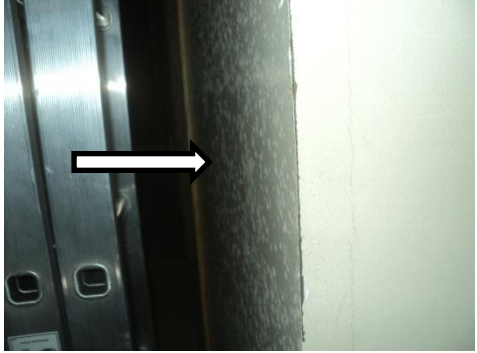
Identified Mould and/or Moisture Impacted Materials Description	Photo

When demolition within the subject building proceeds, it is expected that mould and/or moisture-impacted building materials will be removed and disposed of during that process. Due to the suspected presence of mould on building materials, and if those impacted materials are to be removed by hand, demolition workers should be notified of the presence of mould-impacted building materials and be provided with respiratory protection and/or other personal protective equipment (PPE) as deemed necessary for the work that they will be conducting.
