Title - Sujet Lead Paint Abatement	
Solicitation No. - N° de l'invitation E0225-141170/A	Amendment No. - N° modif. 001
Client Reference No. - N° de référence du client E0225-14-1170	Date 2013-10-02
GETS Reference No. - N° de référence de SEAG PW-\$PWA-123-5015	
File No. - N° de dossier PWA-3-70056 (123)	CCC No./N° CCC - FMS No./N° VME
Solicitation Closes - L'invitation prend fin at - à 02:00 PM on - le 2013-10-17	Time Zone Fuseau horaire Atlantic Daylight Saving Time ADT
F.O.B. - F.A.B. Plant-Usine: <input type="checkbox"/> Destination: <input checked="" type="checkbox"/> Other-Autre: <input type="checkbox"/>	
Address Enquiries to: - Adresser toutes questions à: Lockyer (PWA), Jeff	Buyer Id - Id de l'acheteur pwa123
Telephone No. - N° de téléphone (902) 496-5636 ()	FAX No. - N° de FAX (902) 496-5016
Destination - of Goods, Services, and Construction: Destination - des biens, services et construction:

**Re: Updated Risk Management Plan
Devil's Island Former Minor Shore Light, Halifax County, Nova Scotia**

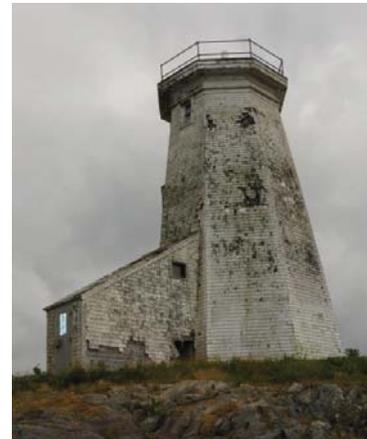
- Impacted area within the dripline of the former MSL: SS3, SS6, SS9, and SS12.

The concentration of lead in soil at SS12 (dripline sample on the western side of the former MSL) did not exceed the revised SSTL. However, this sample has been excluded from the revised EPC calculation and it is recommended that remedial action undertaken should extend around the entire dripline of the former MSL.
