HAZARDOUS BUILDING MATERIALS ASSESSMENT

WABUSH AIRPORT
WABUSH, NL

Prepared by:
Conestoga-Rovers
& Associates

MARCH 2012
REF. NO. 076653 (3)

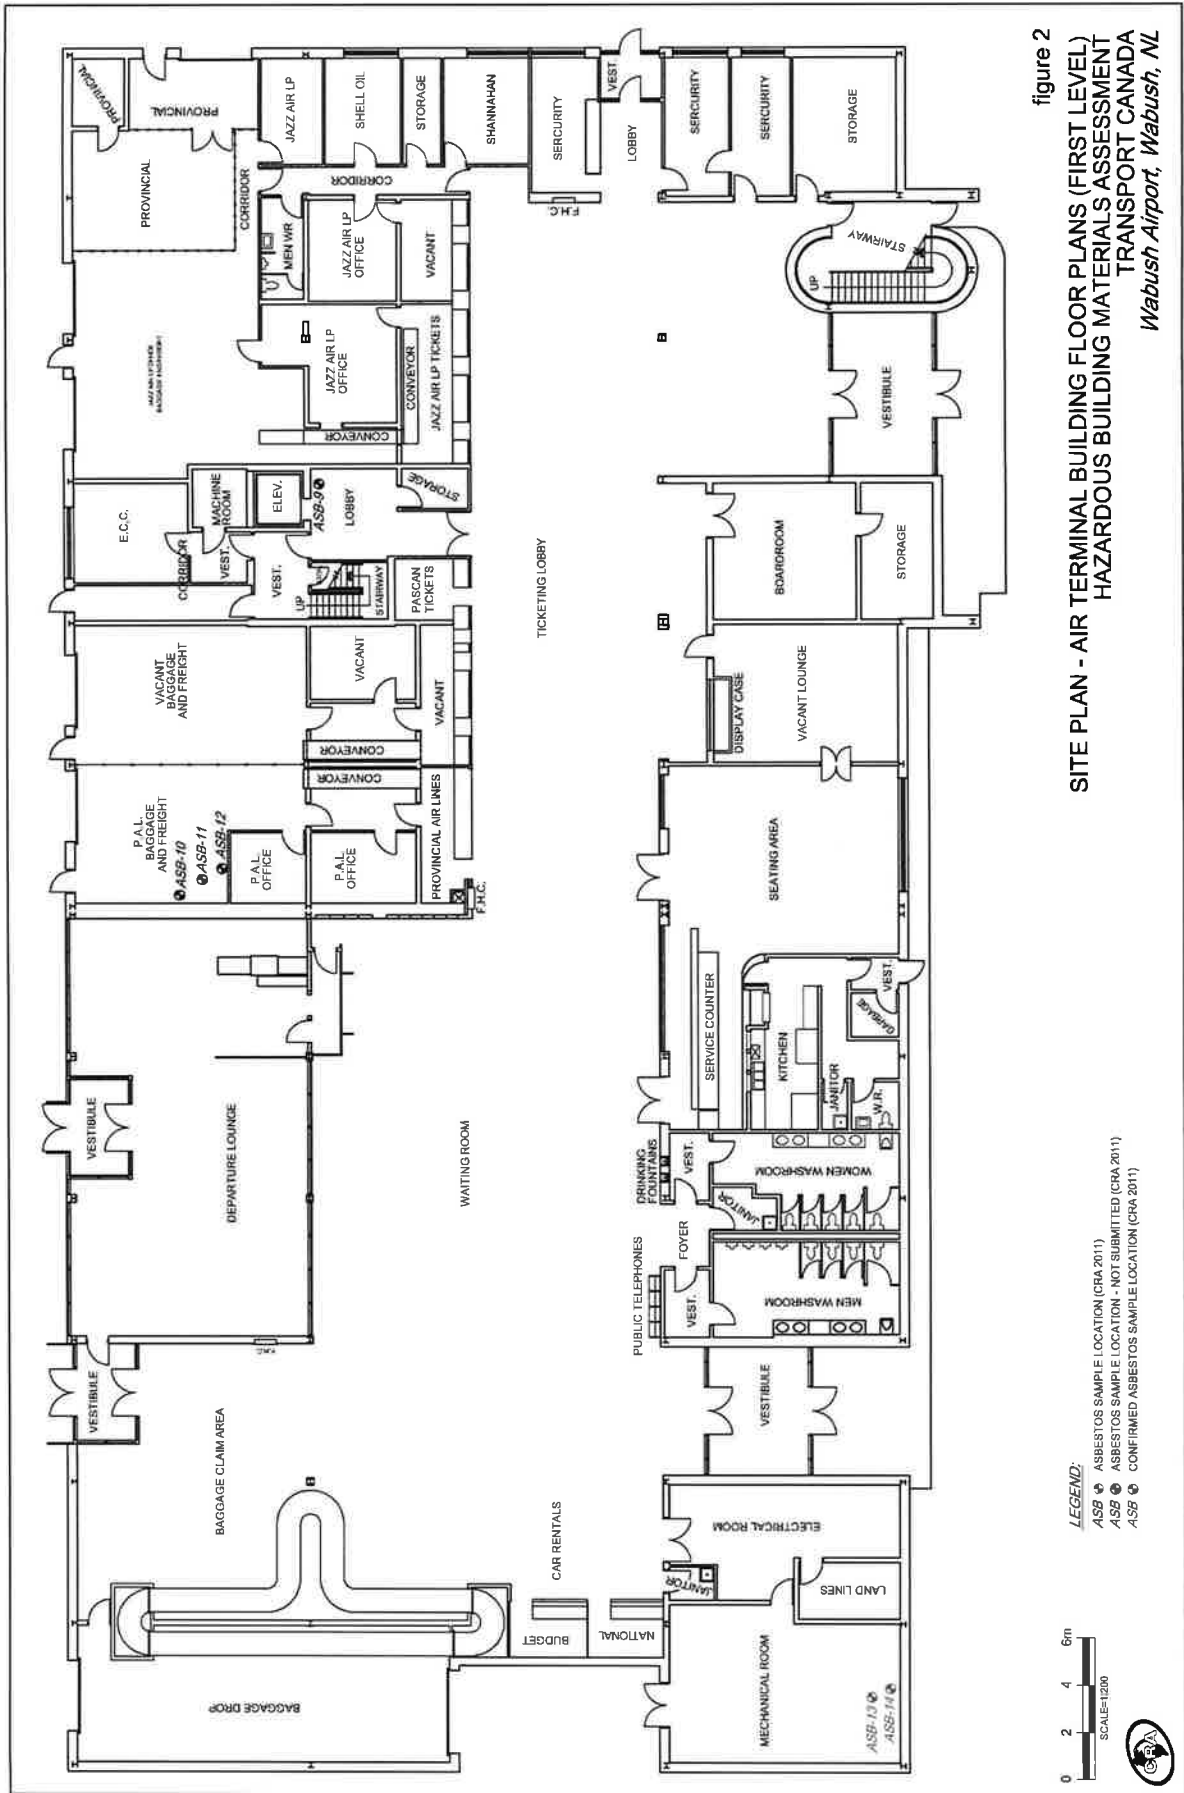
A total of 27 potential ACM samples were collected at the Wabush Airport from pipe insulation, drywall plaster, acoustic ceiling tiles, and vinyl floor tiles (16 from the ATB and 11 from the CSB). Sample locations at the Wabush Airport buildings are presented on Figures 2 to 4 for the ATB first and second levels as well as the CSB, respectively. The Wabush Airport ACM Sampling Summary is provided in Table 1.

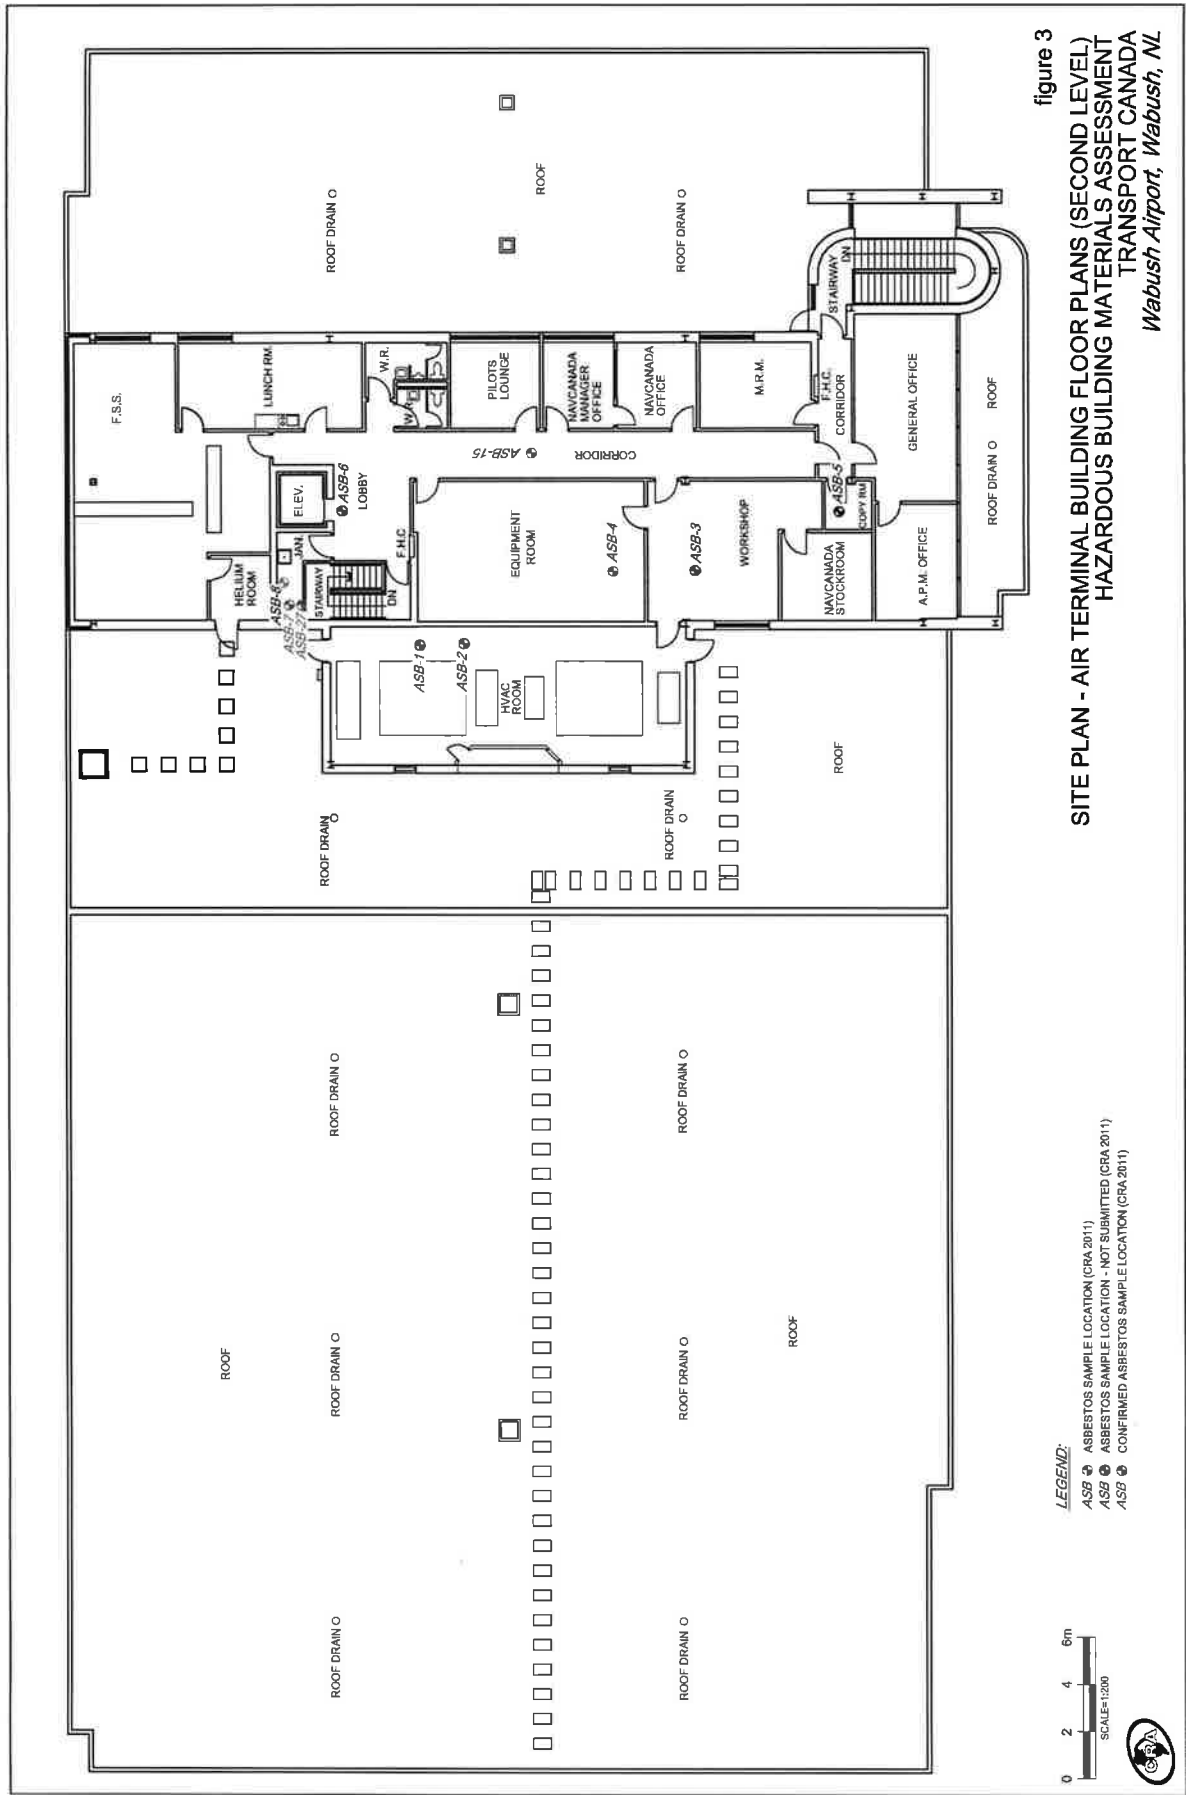
figure 3
SITE PLAN - AIR TERMINAL BUILDING FLOOR PLANS (SECOND LEVEL)
HAZARDOUS BUILDING MATERIALS ASSESSMENT
TRANSPORT CANADA
Wabush Airport, Wabush, NL

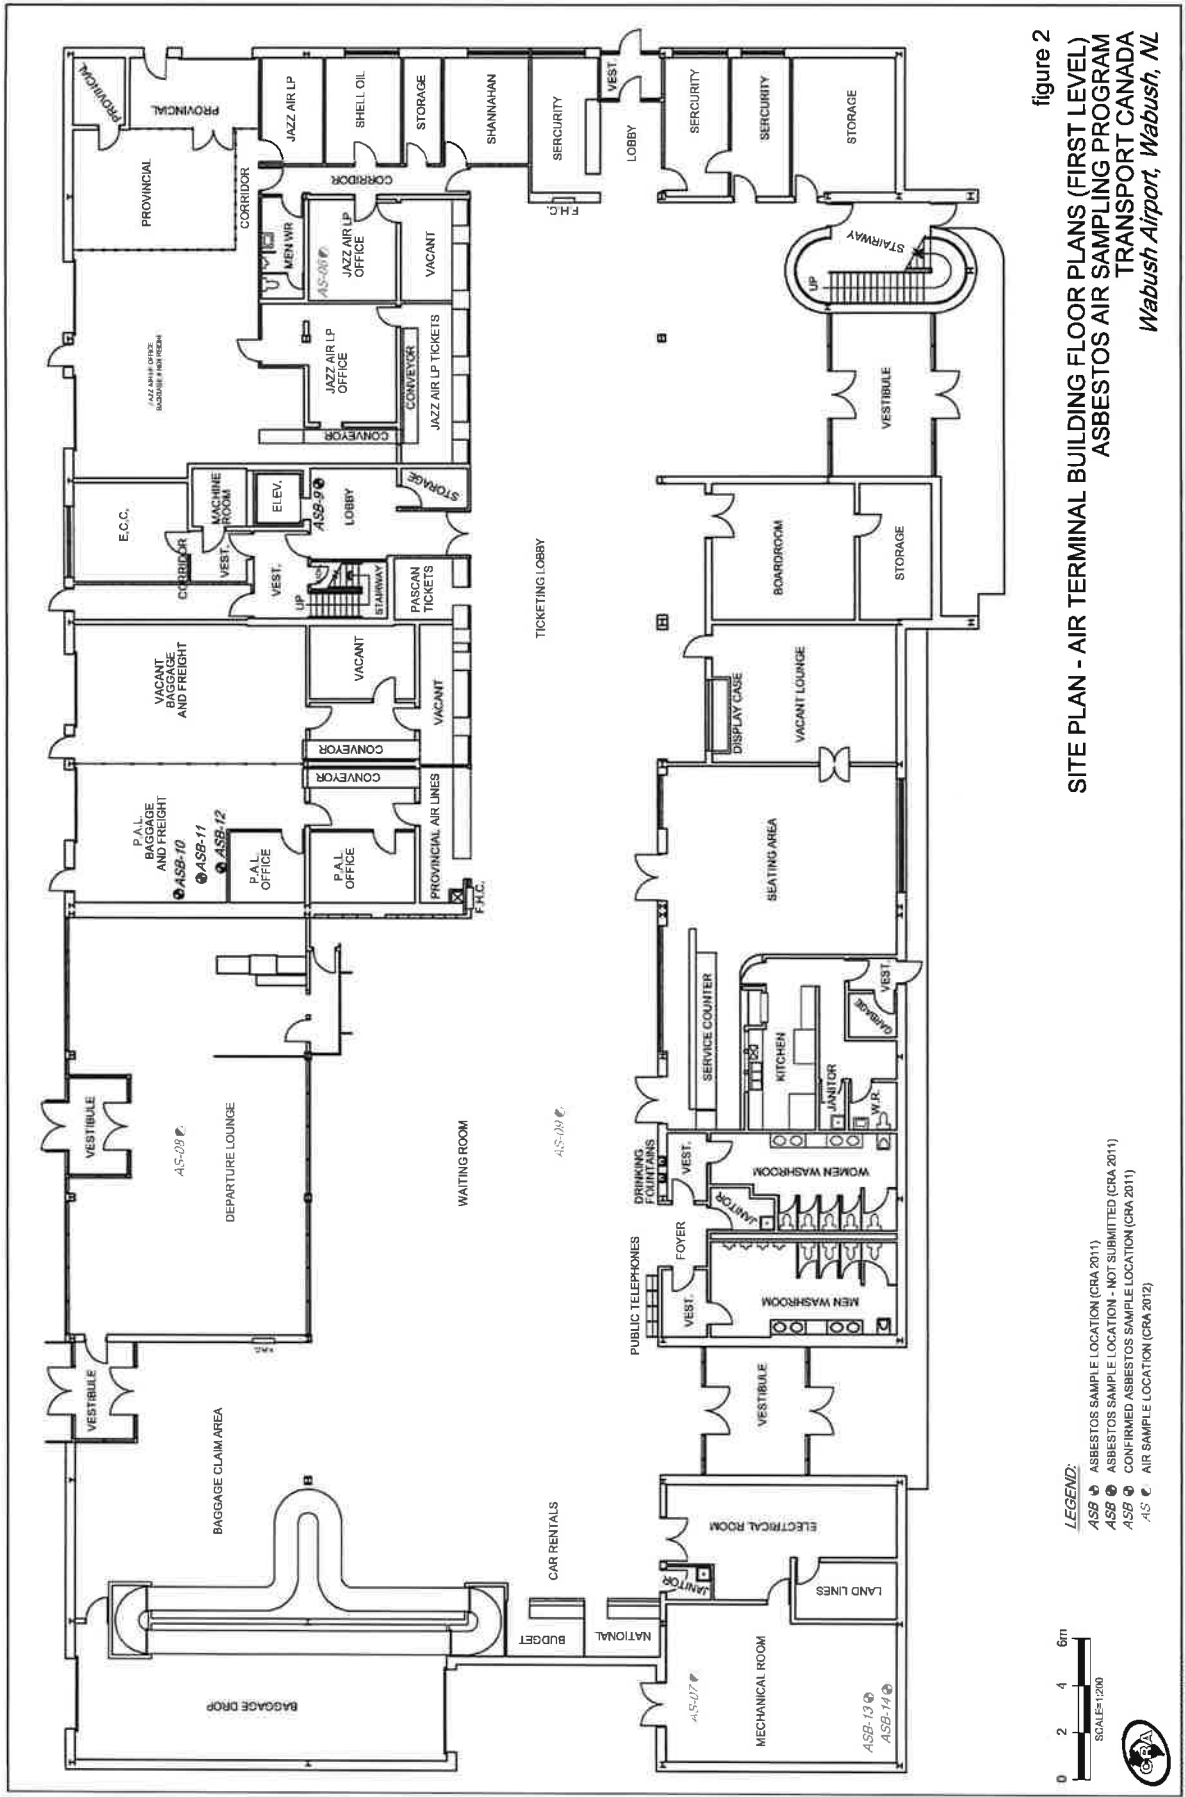
The purpose of the air sampling program was to investigate the potential presence of air borne asbestos fibres throughout the two facility buildings and evaluate potential asbestos inhalation exposure for TC and other airport employees including contractors, maintenance and custodial personnel, and the public. Air sample locations are shown on Figures 2 to 4 of Attachment A.

figure 2
 SITE PLAN - AIR TERMINAL BUILDING FLOOR PLANS (FIRST LEVEL)
 ASBESTOS AIR SAMPLING PROGRAM
 TRANSPORT CANADA
 Wabush Airport, Wabush, NL

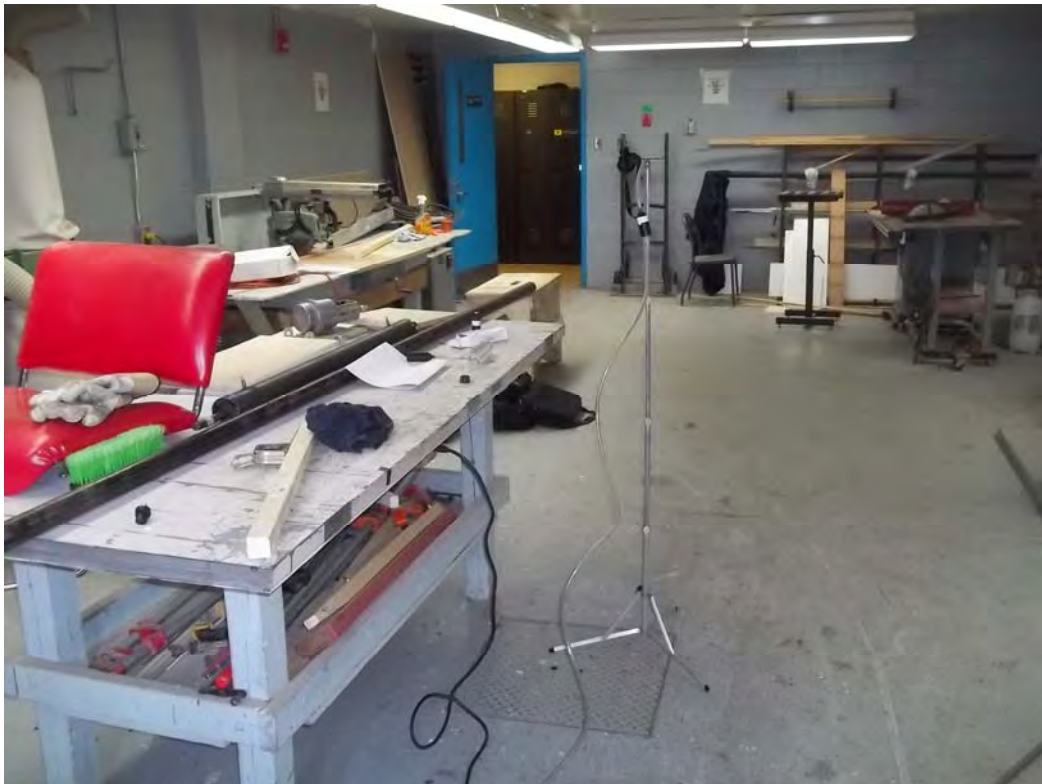
Photo 1: View, showing air sampling set-up at sample location AS-01 (Combined Services Building, 1st level, Trades Workshop).

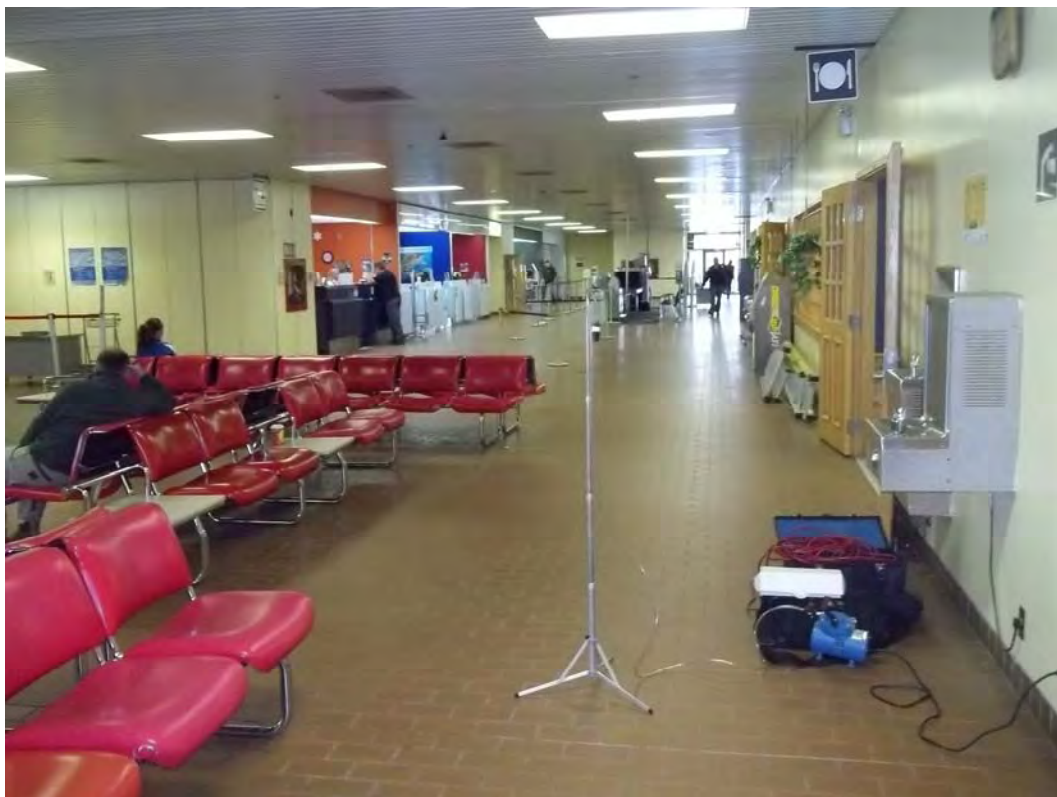
Photo 2: View, showing air sampling set-up at sample location AS-09 (Air Terminal Building, 1st level, Public Waiting Area).
