17. MHK - CELL UNIT

17.1 Building Description

17.2 Survey Findings

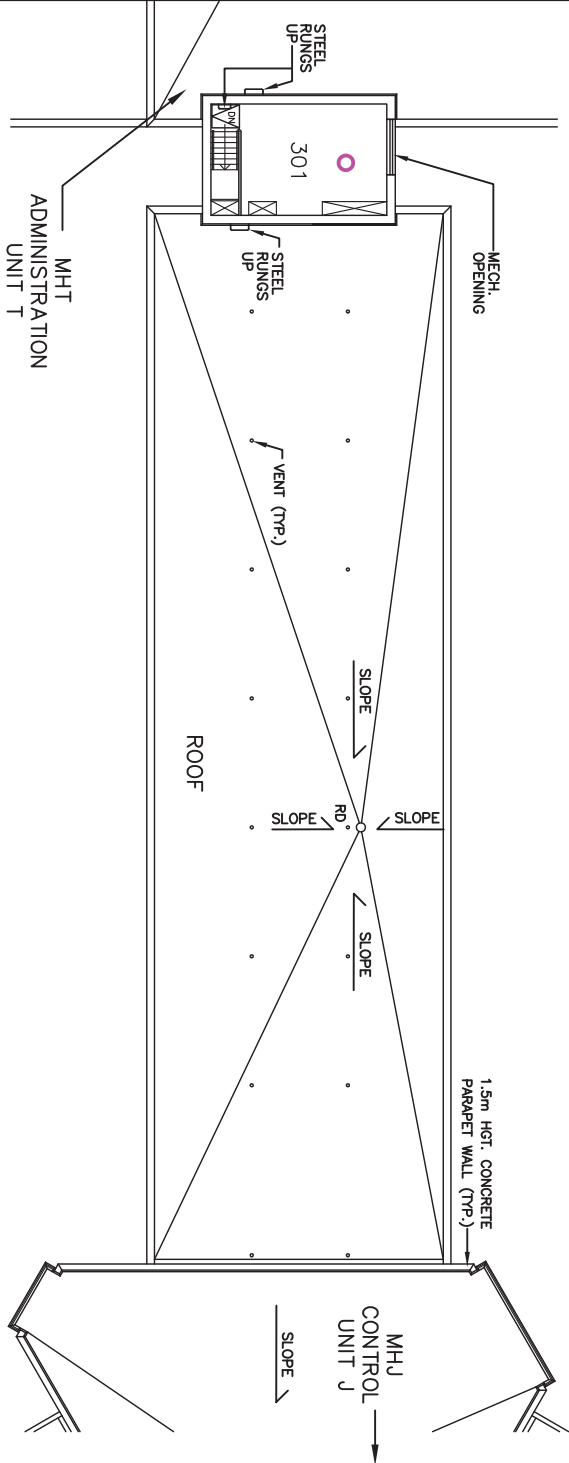
THIRD FLOOR PLAN

- Insulated pipe elbows were observed in room 131 and 301. The insulation around these elbows was previously sampled by THEM (1997) and found to contain up to 60% chrysotile asbestos. A total of 25 ACM insulated elbows were observed.

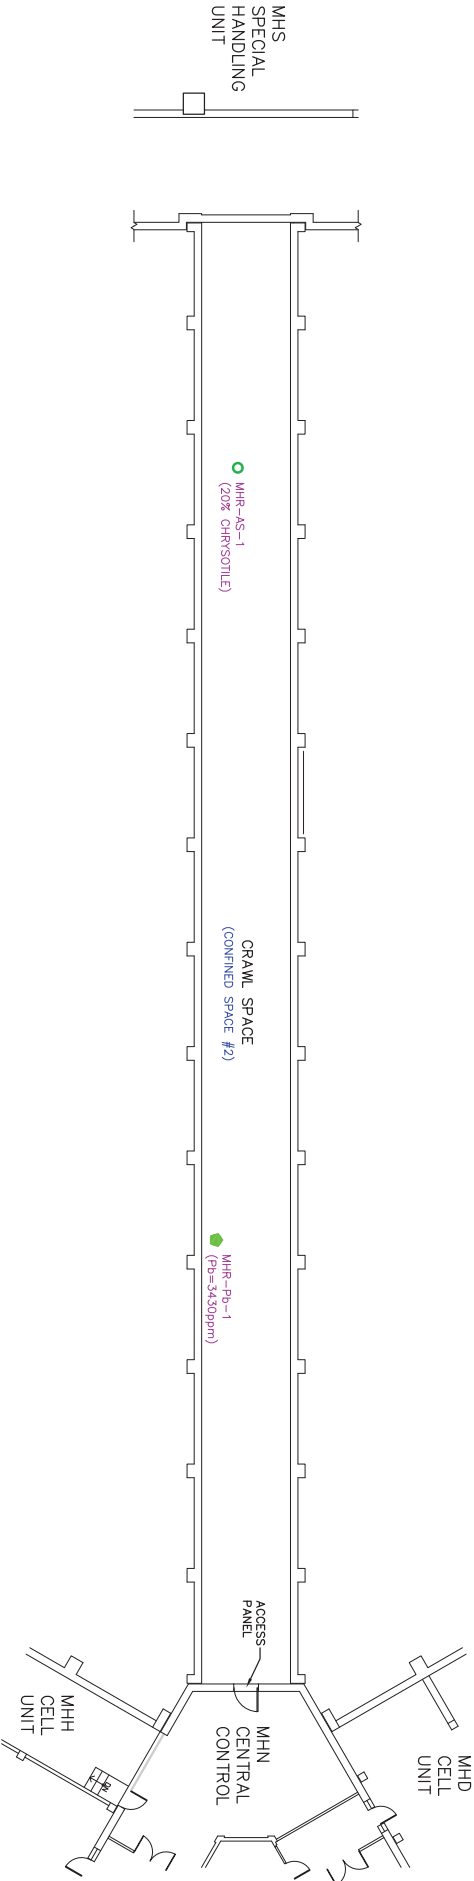
BASEMENT PLAN

- The insulation around pipe elbows in MHR crawlspace contained up to 20 % chrysotile asbestos. A total of 2 ACM containing pipe elbows were observed in the MHR crawlspace.

Sample ID	Room Number	Colour, Location and Description	Condition ¹	Layers Noted ²	Lead Content (ppm)	Estimated Quantity (m ²)
MHR-Pb-1	Crawl Space (Confined Space 2)	Red paint on sprinkler pipe	Fair with flaking	No	3430	11
