**REPORT
TO
PUBLIC WORKS AND GOVERNMENT SERVICES CANADA
DESIGNATED SUBSTANCES AND
HAZARDOUS MATERIALS SURVEY
ADMINISTRATION BUILDING (WW03)
WARKWORTH INSTITUTION
WARKWORTH, ONTARIO
CORRECTIONAL SERVICE OF CANADA
PWGSC PROJECT R.033225.001**

April 2011

Re: **Designated Substances and Hazardous Materials Survey
Administration Building (WW03), Warkworth Institution
Warkworth, Ontario**

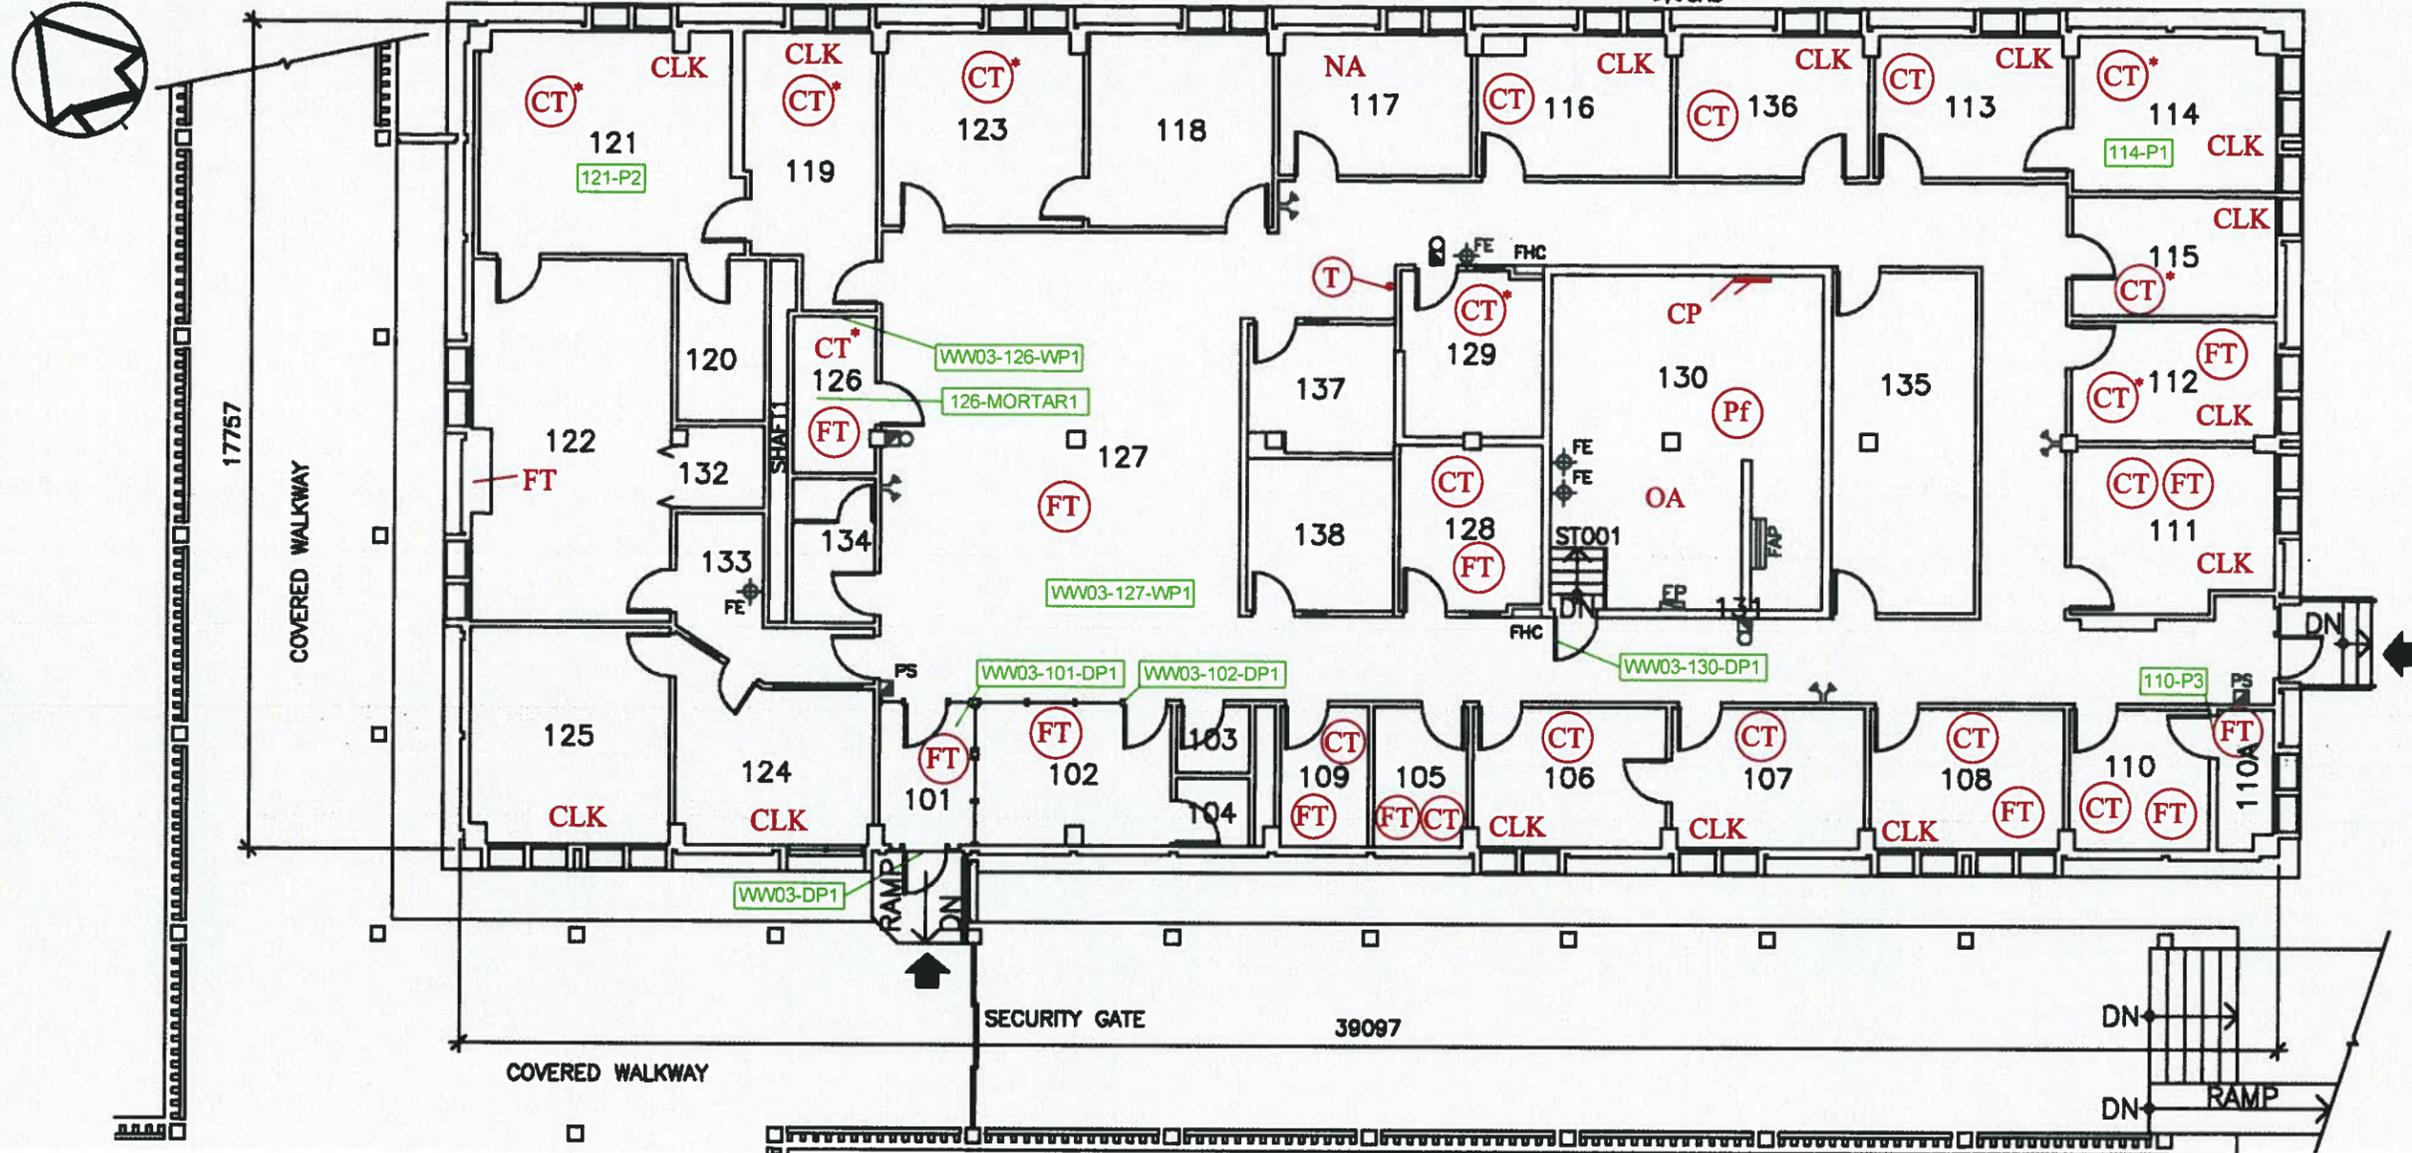
FLOOR PLAN

Asbestos-containing materials found to be present in the Administration Building included 9” and 12”vinyl floor tiles, floor tile mastic, 12” ceiling tiles, caulking on interior window frames, thermal insulation on pipe fittings, isolation sleeve material on fan units and cement ducting.

Lead was detected in two samples of paint chips collected by DCS during the course of the designated substances survey (and in three samples referenced in a previous report by XCG Consultants). All paint applications were noted to be in good condition (i.e. no peeling or deterioration) except for some areas on concrete walls in Rooms 106, 108, 112 and 114.

1. Cleanup the fallen pipe fitting insulation debris present on the floor and other surfaces in Room 130 and remove or repair damaged insulation on two pipe fittings using Type 2 procedures as specified in O.Reg. 278/05.

2. Remove four 12” x 12” asbestos-containing ceiling tiles lying loose on top of the suspended T-bar ceiling tiles in Room 112. Remove one 12” x12” asbestos-containing ceiling tile lying loose on top of the suspended T-bar ceiling tiles and remove two 12” x 12” asbestos-containing ceiling tiles delaminating from the gypsum board substrate in Room 115. Remove three 12” x12” asbestos-containing ceiling tiles lying loose on top of the plaster ceiling in Room 126 accessible through the T-bar ceiling system in Room 119. For all above asbestos removal operations use Type 1 procedures as specified in O.Reg. 278/05.

5. Remove loose and delaminating paint on concrete walls below the windows in Rooms 106, 108, 112 and 114 following procedures outlined in the Ministry of Labour Guideline - *Lead on Construction Projects*. If the removal work is done with non-powered hand tools (other than manual scraping or sanding), or with a power tool in conjunction with an effective dust collection system (i.e., a HEPA air filtration system capable of controlling airborne lead concentration levels to below 0.05 mg/m³), then the work is classified as Type 1. If the removal work involves manual scraping or sanding using non-powered hand tools, then the work is classified as Type 2a. Additional information on the classification of work involving lead is provided in Appendix C, Table C-2.
