Public Works and Government Services Canada

Pacific Agri-Food Research Centre

Hazardous Building Materials Abatement

Project no. R.057604.001
October 2013

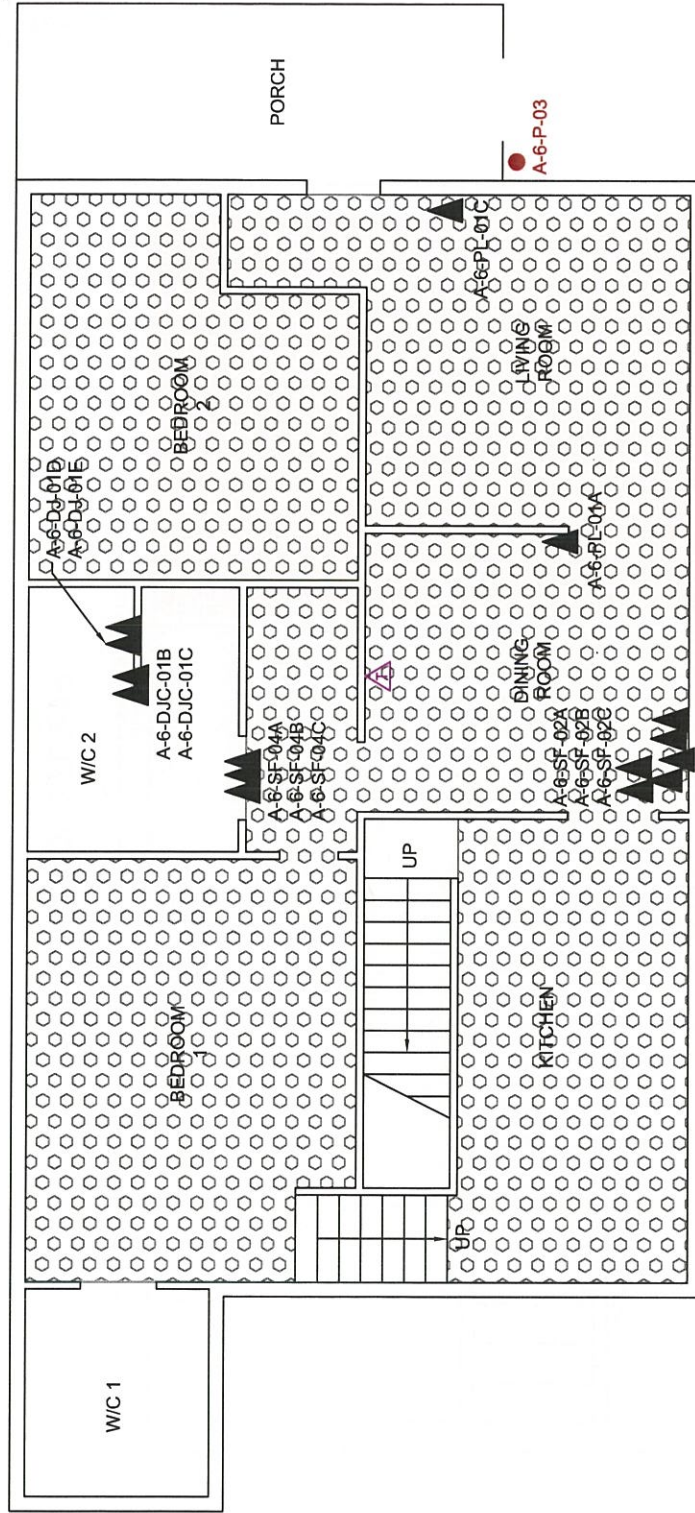
MAIN FLOOR - UPPER LEVEL

- LEGEND**
- BULK SAMPLE
 - PAINT CHIP SAMPLE
 - ASBESTOS-CONTAINING SHEET FLOORING (PRESENT AS A SUB-LAYER OF FLOORING BENEATH EXISTING SHEET FLOORING)
 - MERCURY-CONTAINING THERMOSTAT
