## VOID BACKFILLING WORK SUMMARY

# Giant Mine B1-18 Stope Complex

**Golder Reference Number:** 1314260010-120-R-RevC-1000  
**AECOM Reference Number:** 330-B1-18 Stope-10-RPT-0001-Rev.0\_20140331

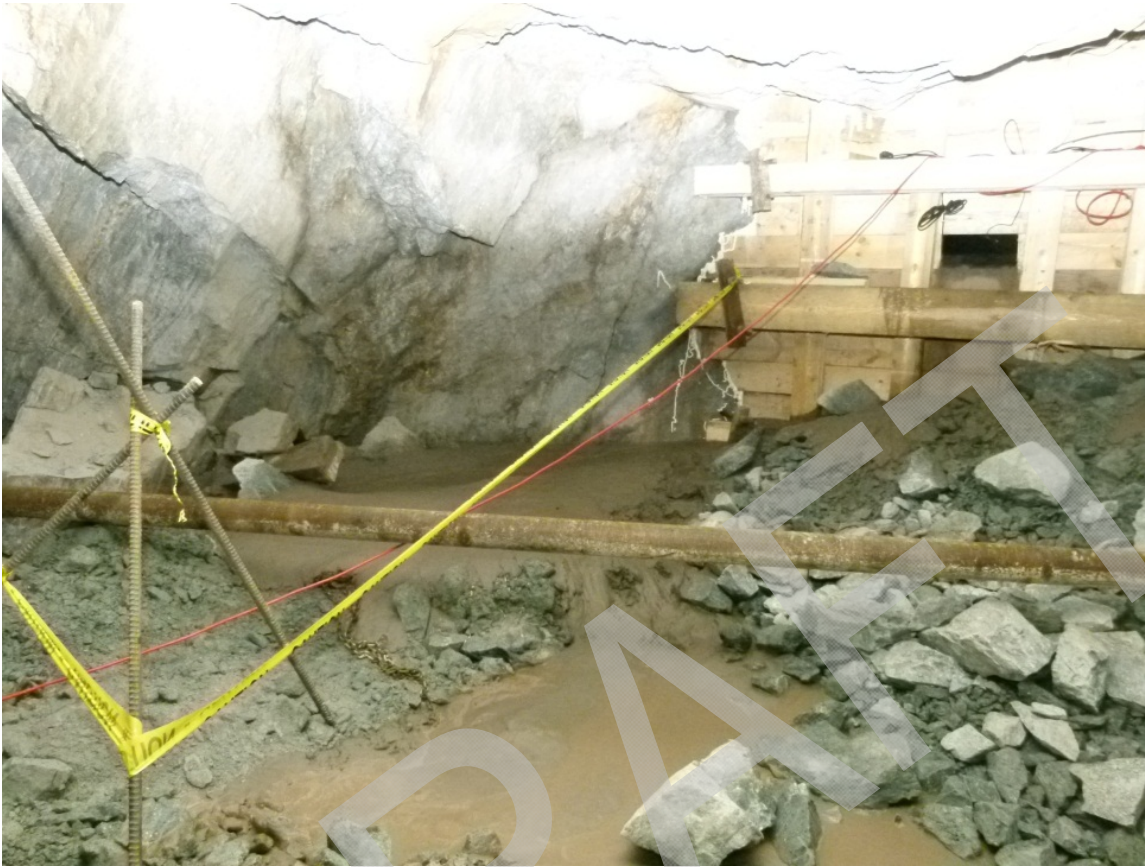
Photograph 3 shows Barricade 1 prior to paste delivery and Photograph 4 shows the area after the paste level had risen to the first spill point. This was noted in the underground cameras. Paste pumping was stopped and personnel re-entered the mine 24 hours later to inspect the barricade. Photograph 5, taken through one of the ports in Barricade 1 shows the flat profile of the paste.

*Photograph 4: Constructed fill fence (barricade 1) showing paste spillage from ports*

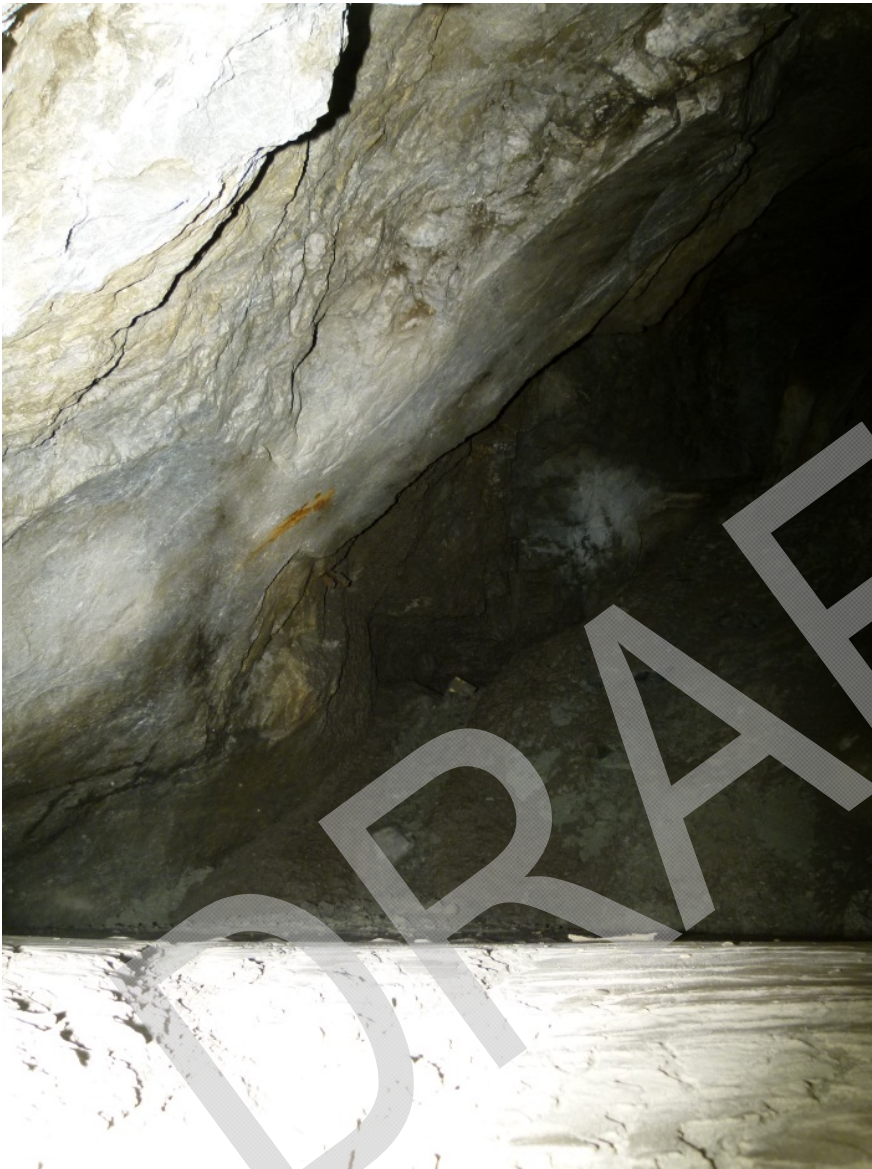
*Photograph 5: Paste behind barricade 2 (taken through ports) showing flat paste profile*

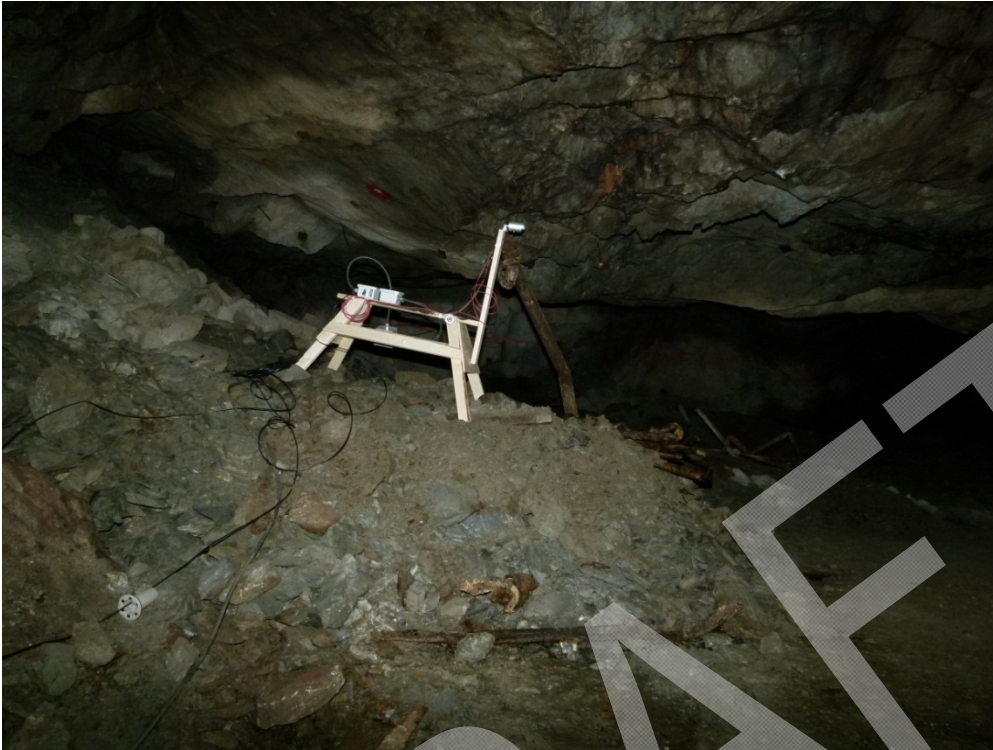
Photograph 6: Saw-Horse mounted camera

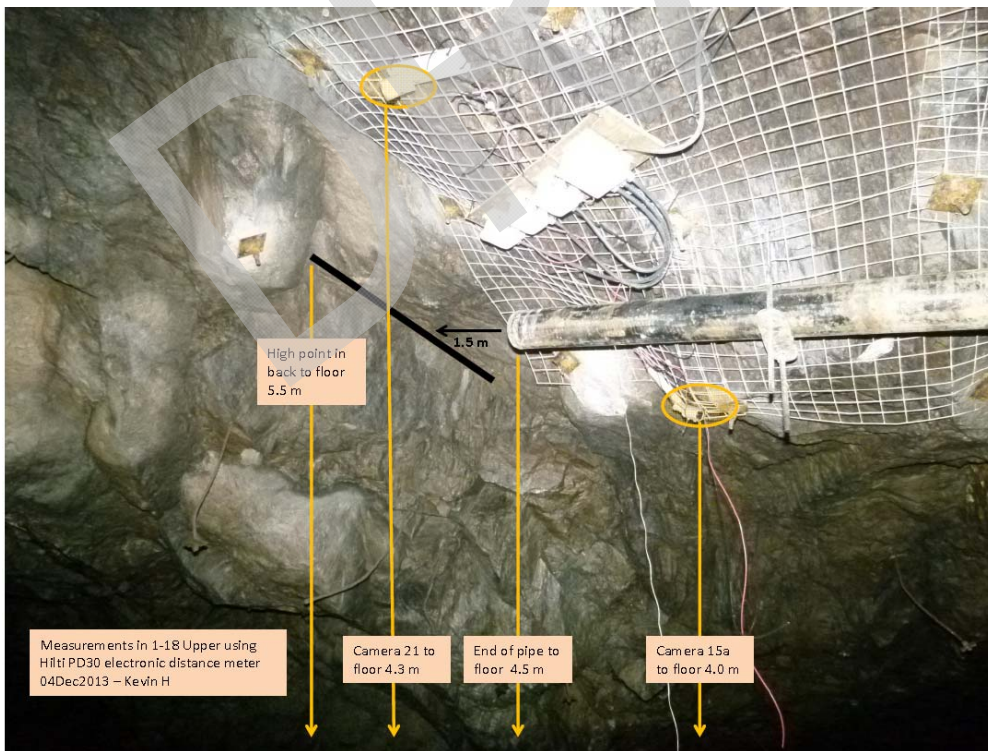
Photograph 7: Cameras fixed to the back in B1-18 Upper, note end of paste delivery slickline

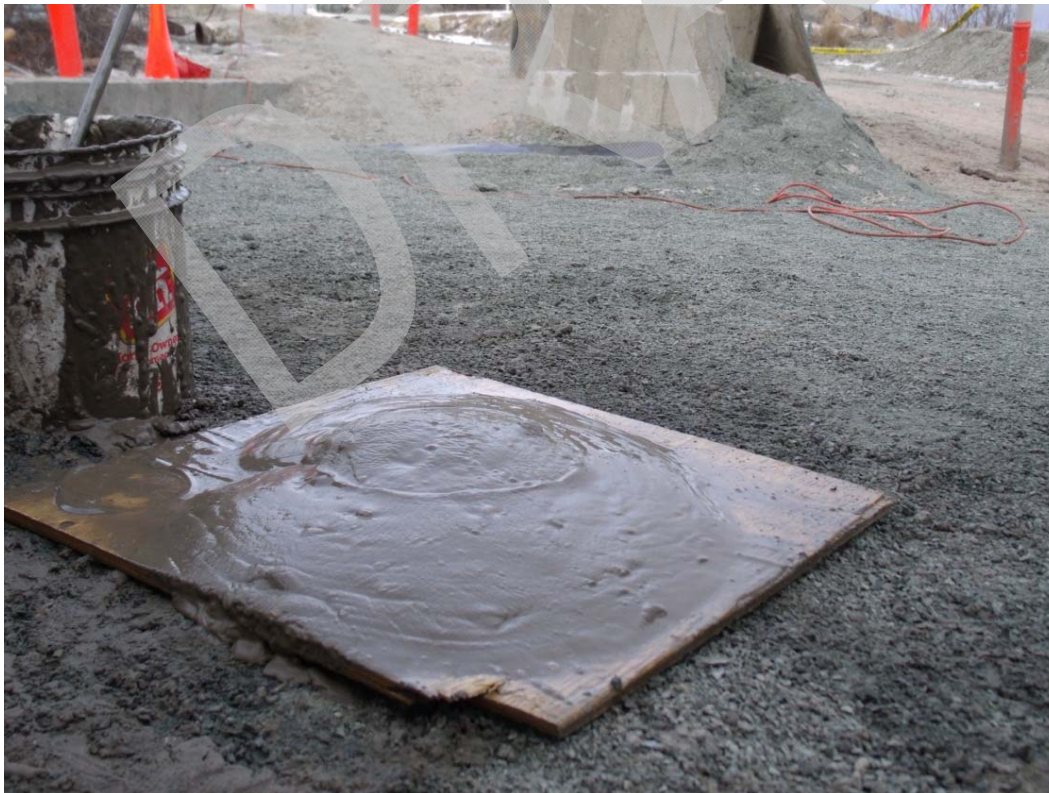
Photograph 9 below shows 10" slump paste material produced at Giant Mine.

Photograph 9: 250 mm (10") slump paste with 2% (by weight) Normal Portland Cement binder

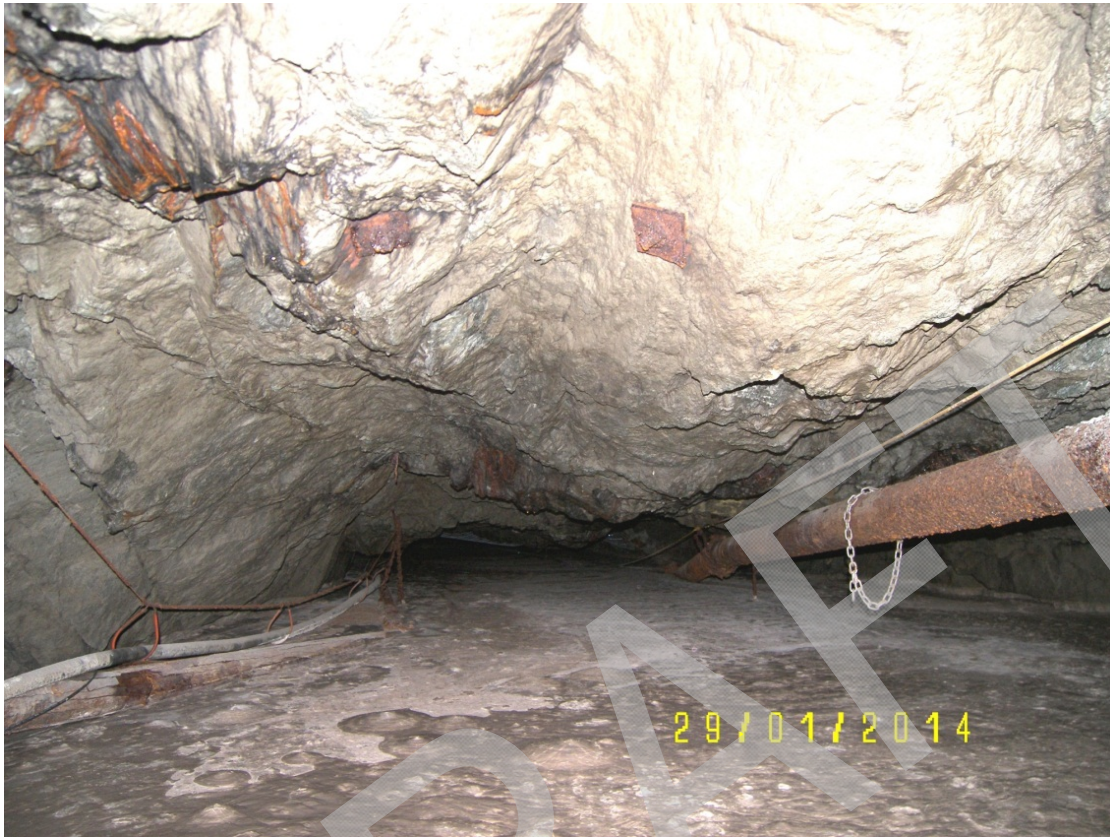
The amount of 250 mm (10") slump material used is important as this paste mix provides a very flat paste profile. This means that as the level of paste in a particular void rises it does so evenly over the area of the void. Since boreholes were generally targeted to intersect the high point of the void once the borehole is full of paste this is a strong indicator of the void being tightly filled. Photographs 10-12 show examples of flat paste profiles in various voids in the B1-18 stope complex.

*Photograph 10: Flat paste profile south of B1-18 EA void*

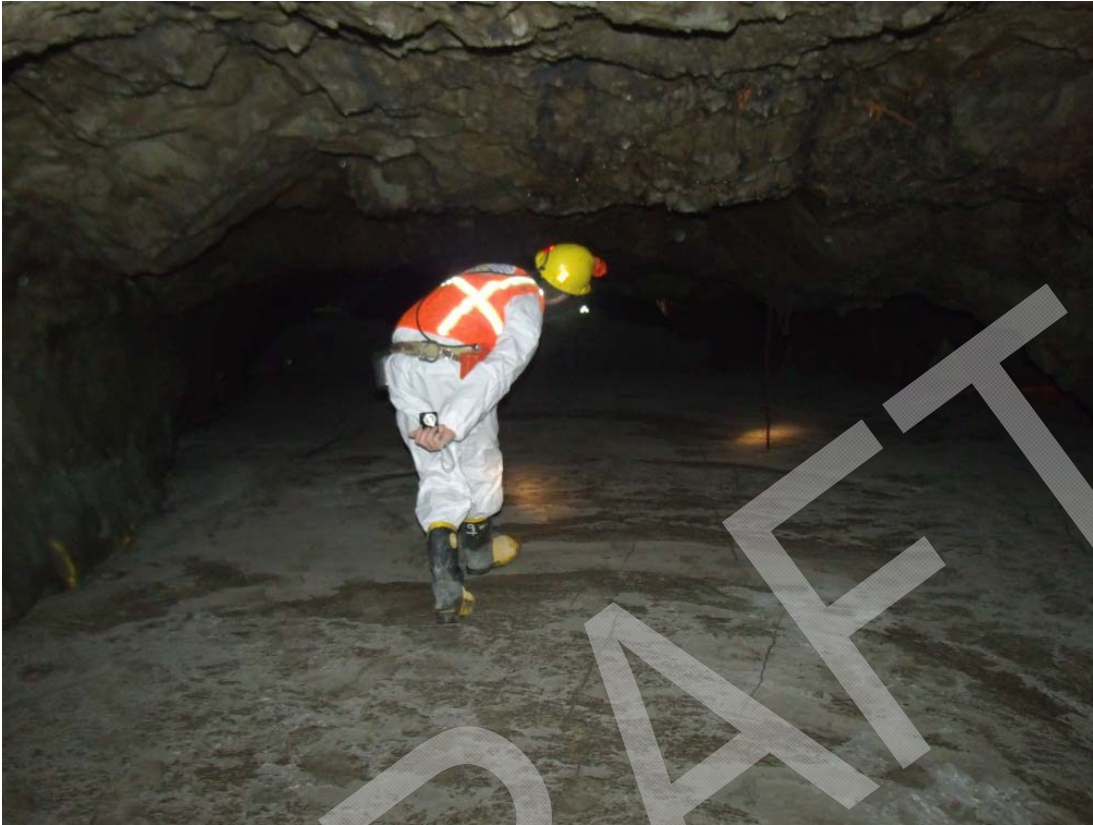
*Photograph 11: Flat paste profile in the North extension of the B1-18 Upper North stope*

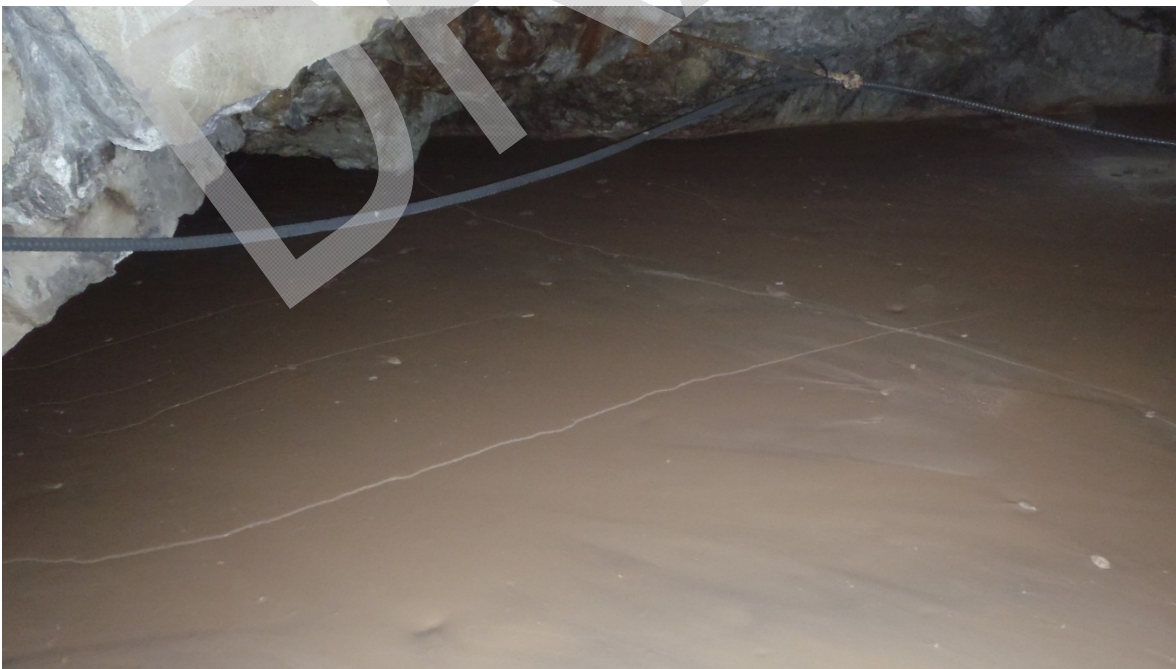
*Photograph 12: Flat paste profile in B1-18 EB void below B1 pit sinkhole*

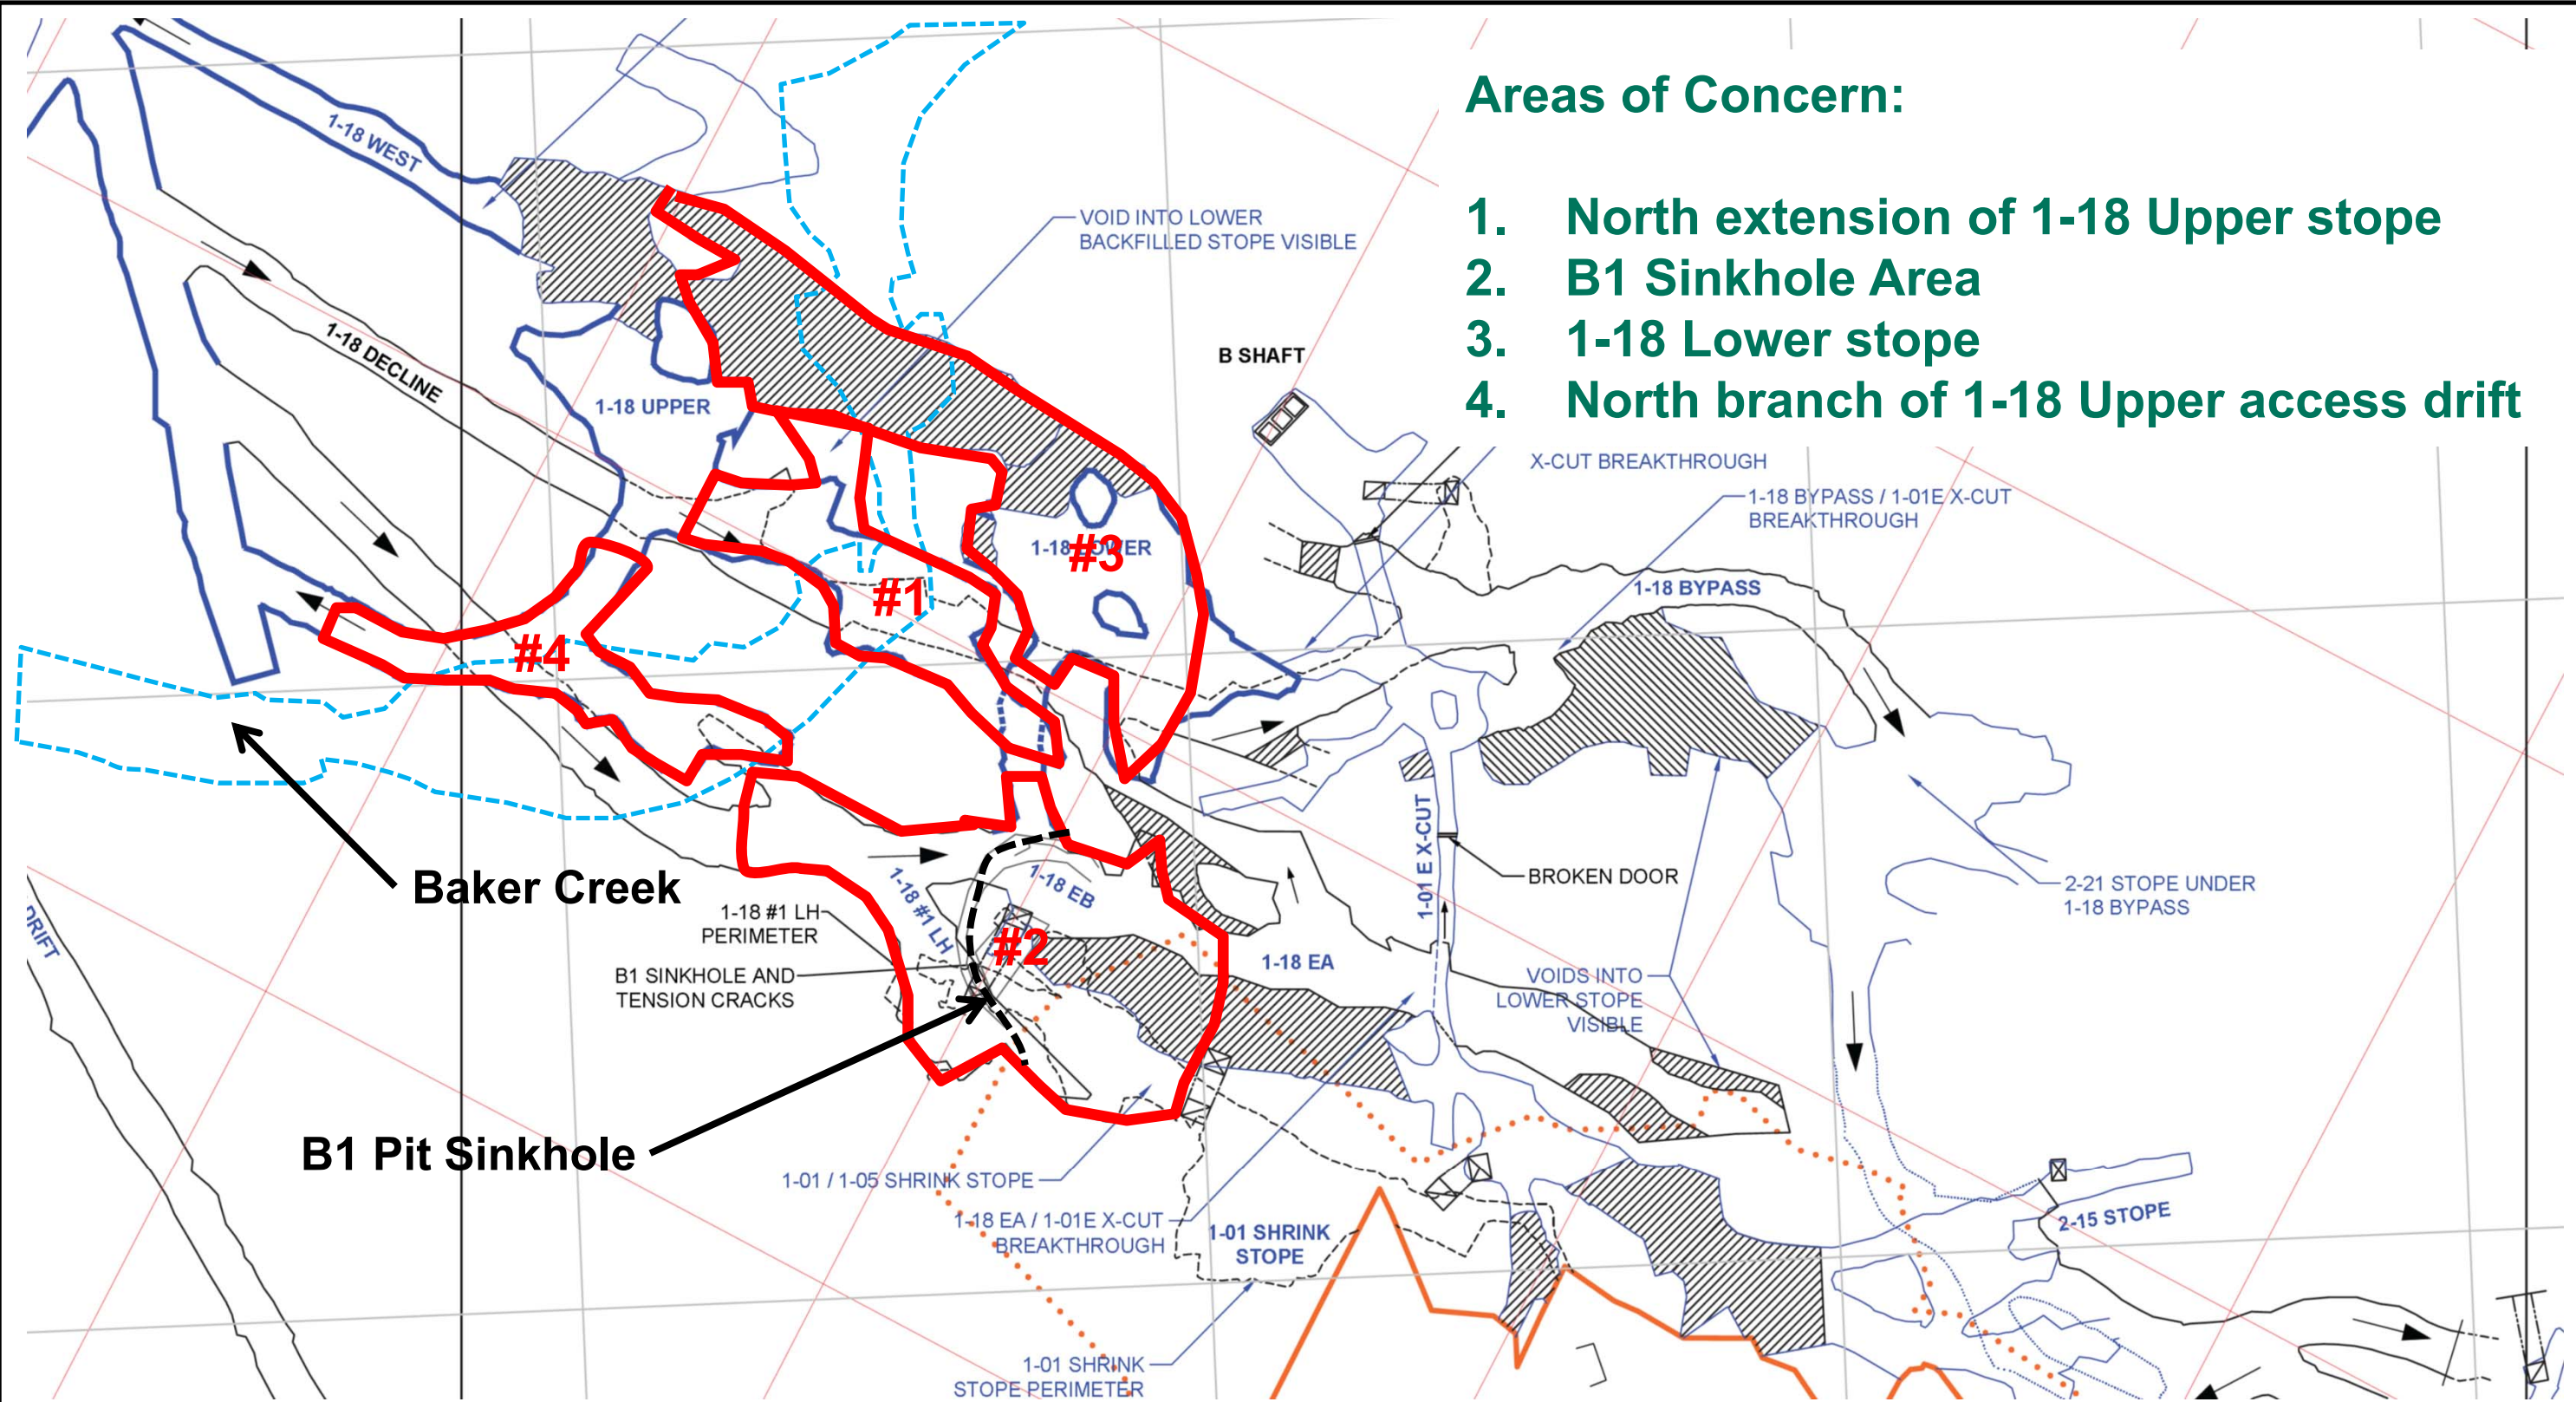
Figure 3

Areas of the B1-18 stope complex previously identified as posing a stability concern included areas of relatively thin crown pillar under Baker Creek and those in proximity to a surface depression (i.e., sinkhole) that had developed on the south rim of the B1 open pit in May of 2012. The four areas of concern are shown on the mine plan in Figure 3. A screen-capture of the digital 3D Mine Model of the area also highlights the four areas of concern on Figure 4. Contours of crown pillar thickness (rock only, no overburden) are shown in Figure 5.

1. North extension of 1-18 Upper stope
2. B1 Sinkhole Area
3. 1-18 Lower stope
4. North branch of 1-18 Upper access drift

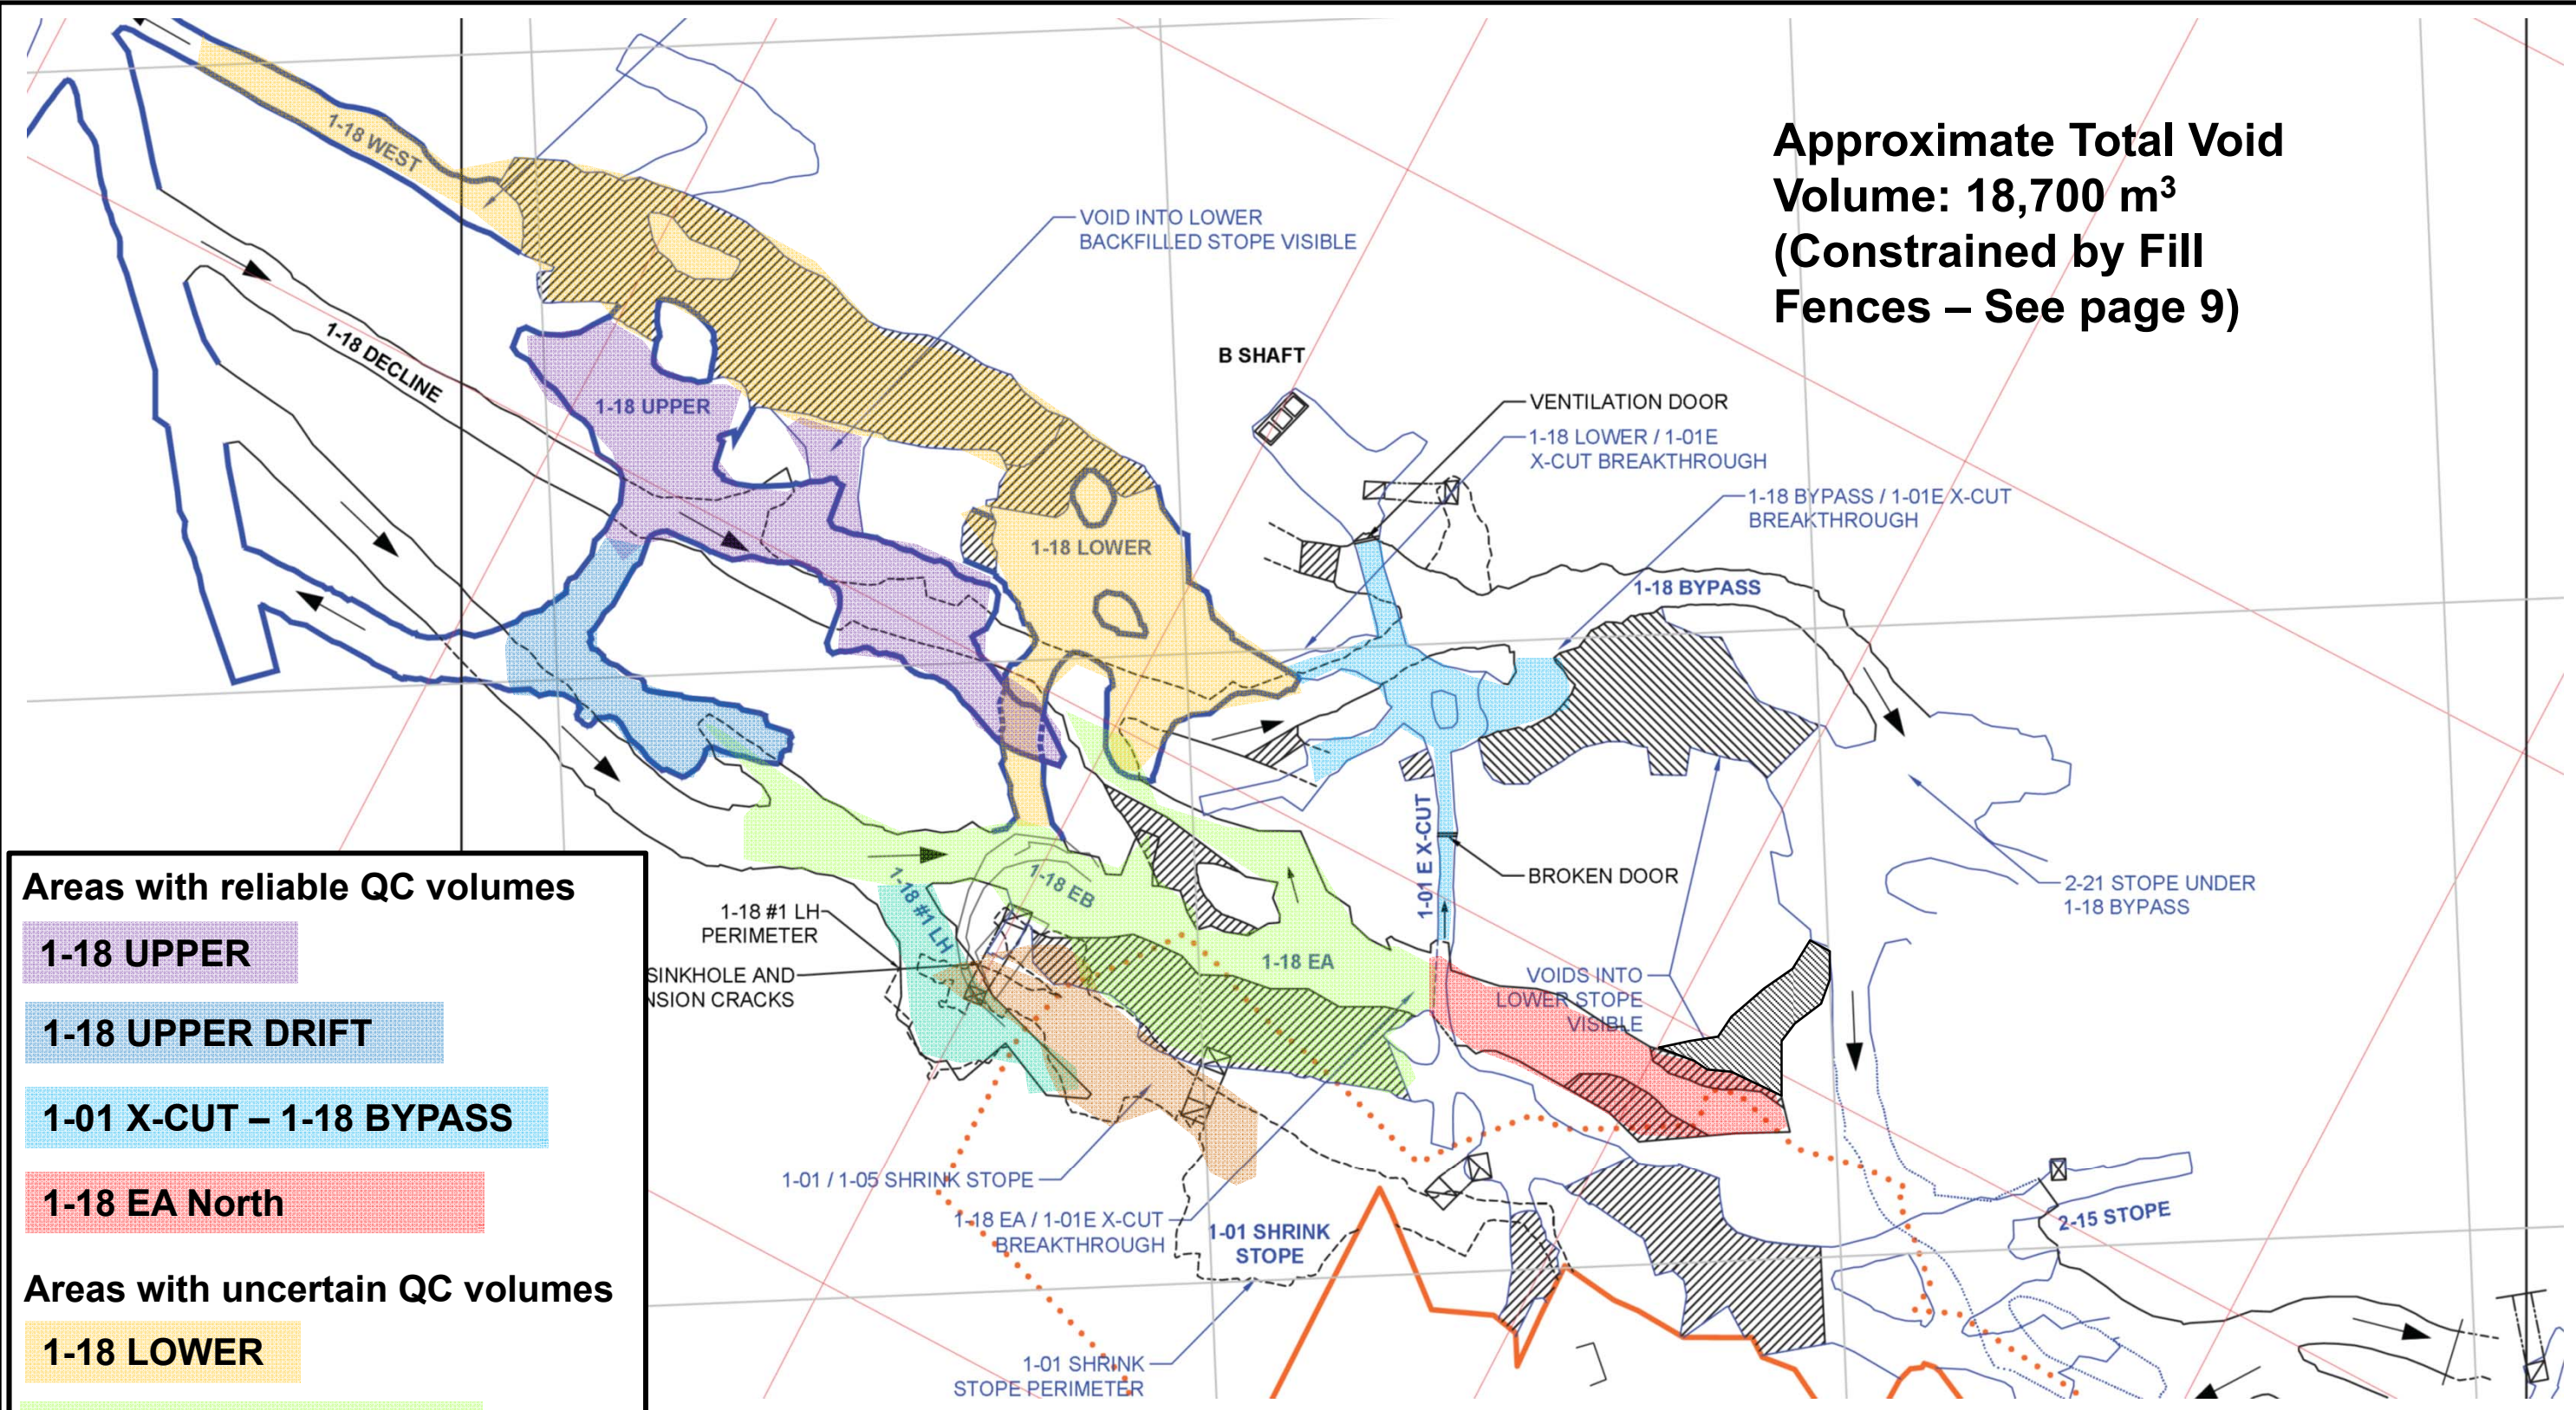
**Figure 6**

Due to the interconnected nature of the underground voids in the area it was known at the start of the work that some additional backfill volume was going to be required to fill the target areas. Due to the lack of safe access for inspection and the presence of partially backfilled (i.e., leaky) voids the volume was poorly constrained but was estimated to be approximately up to 22,000 m<sup>3</sup>. Later surveying revealed that the early volume estimates were high and the void volume of various stope in the area shown in Figure 6, was approximately 19,000 m<sup>3</sup>.

Connections between voids that were partially backfilled with waste rock were anticipated to exhibit leakage and in some cases additional boreholes were drilled close to these areas (e.g., north end of B1-18 EA stope void as seen in Figure 6). The strategy was to inject high cement, moderate slump (4 to 6 inch) material that in some cases contained aggregate to try and plug the leaks.

**Approximate Total Void  
Volume: 18,700 m<sup>3</sup>  
(Constrained by Fill  
Fences – See page 9)**

**Partially backfilled connections between voids, potential leakage areas.**

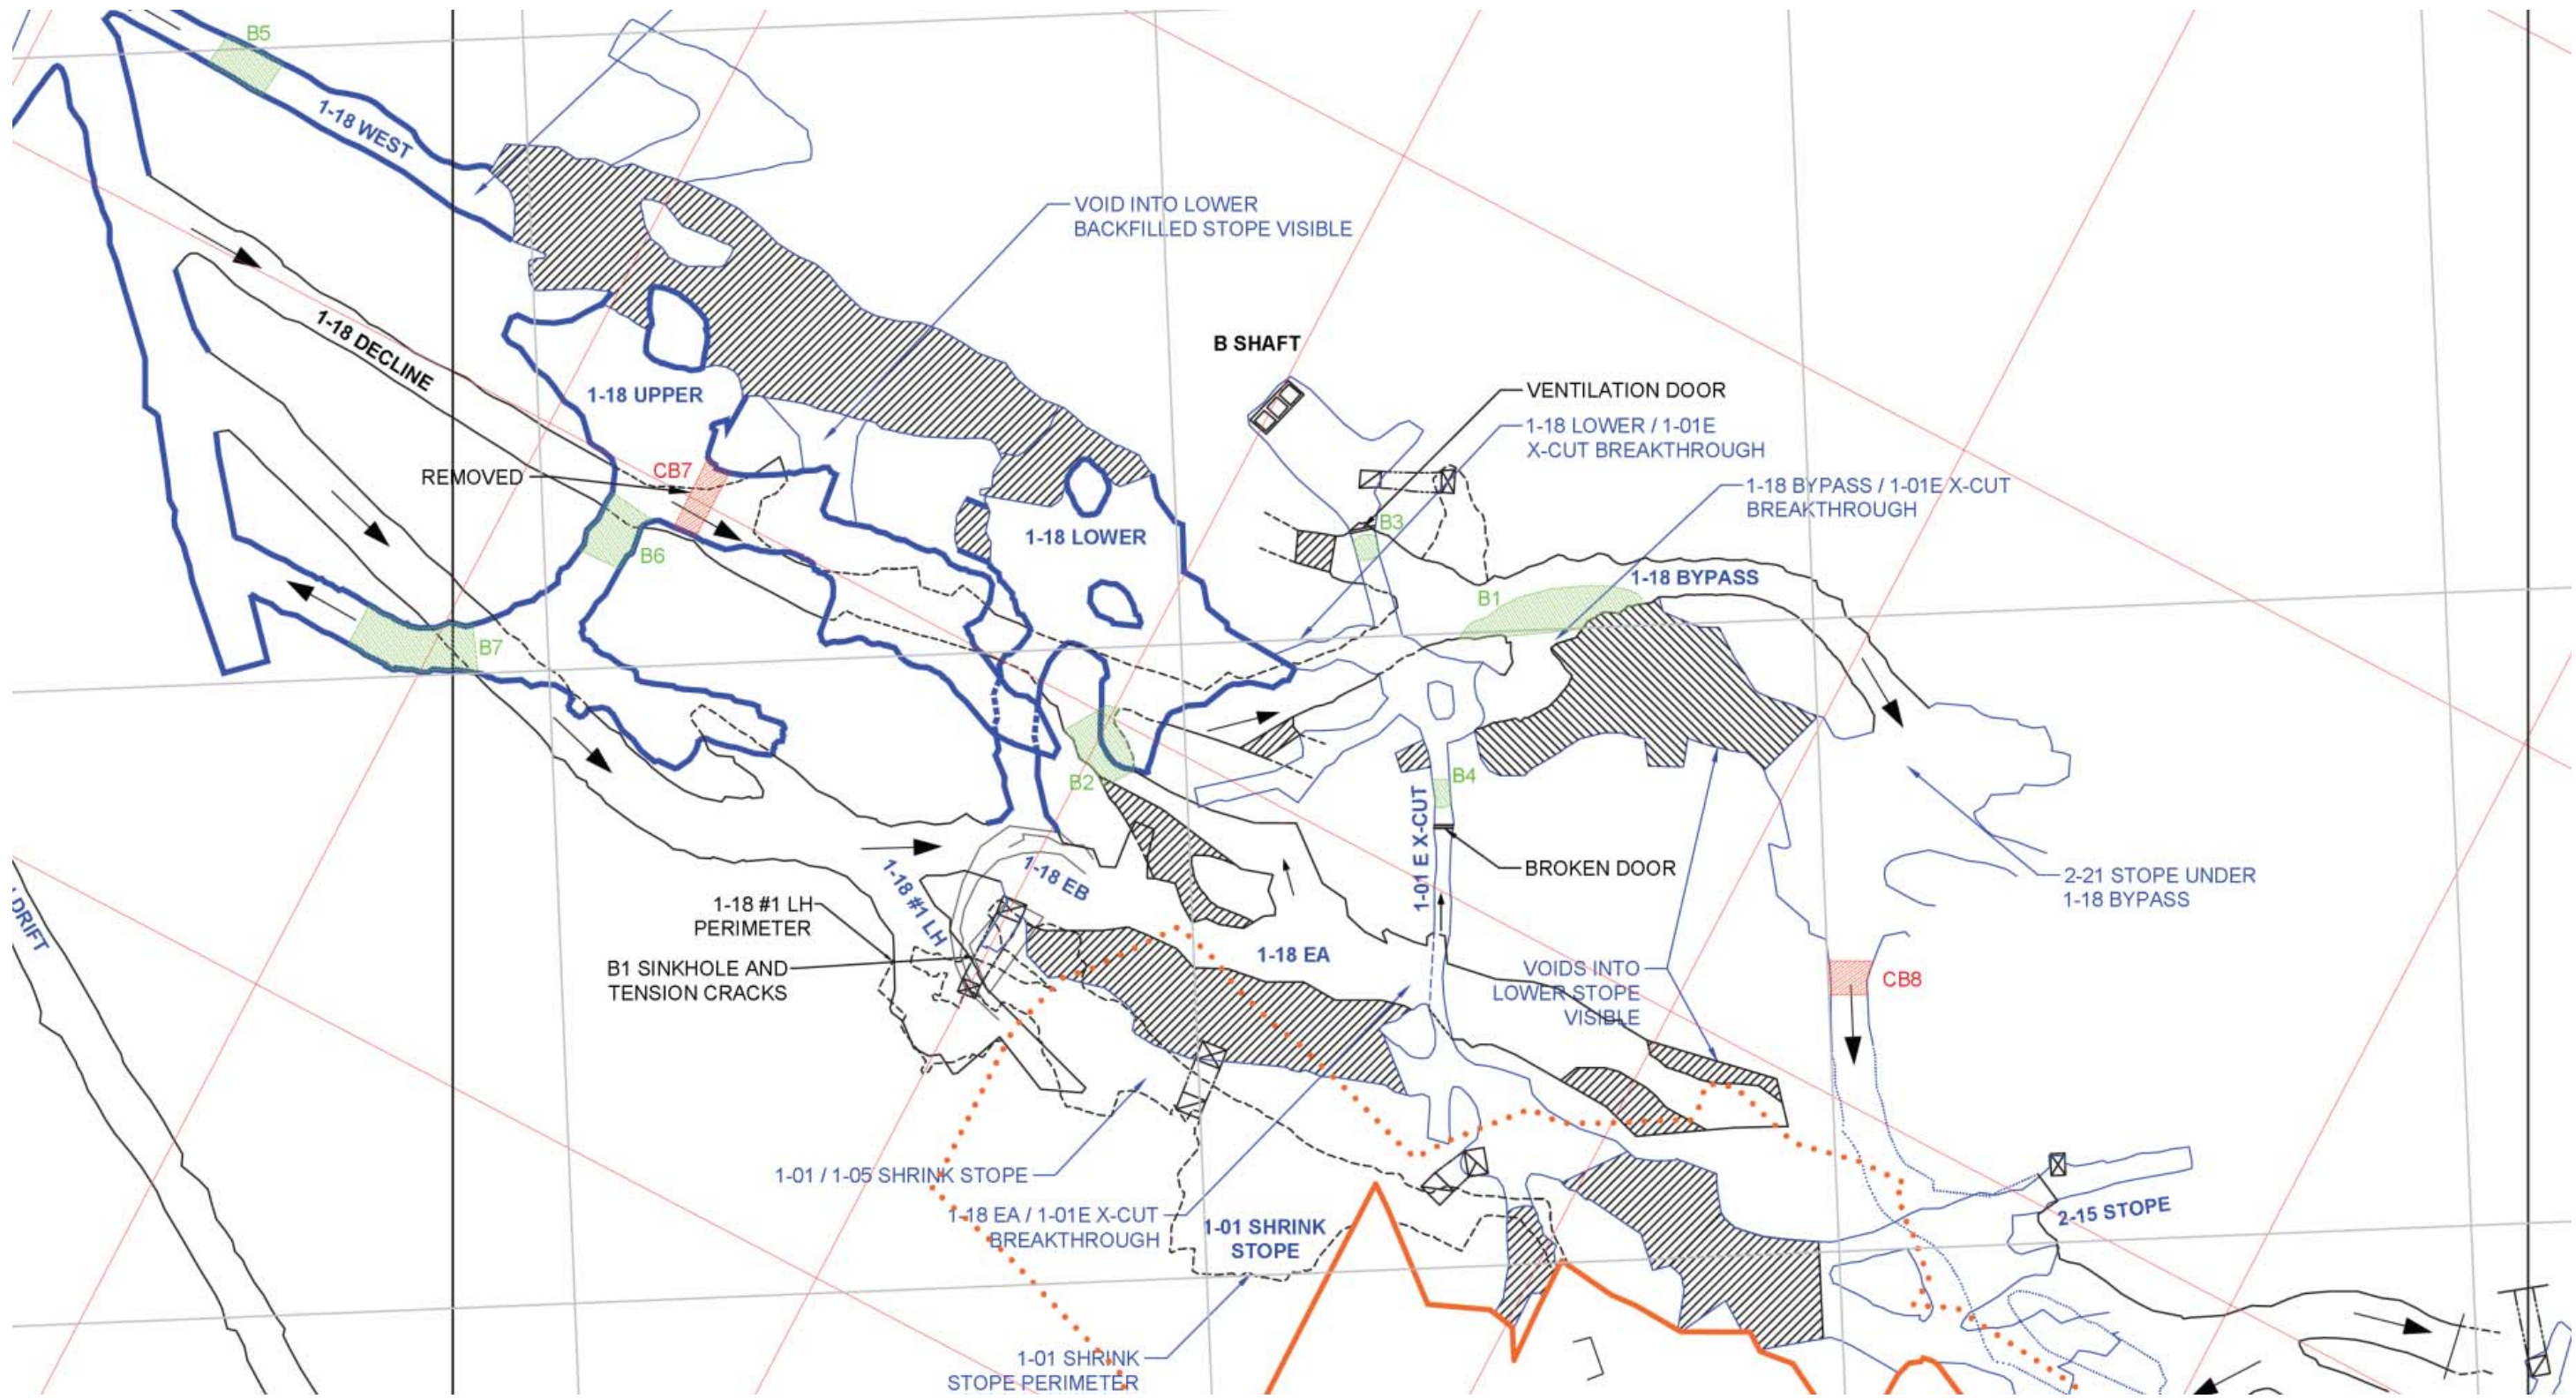
**Figure 8**

Paste barricades constructed to contain the paste are shown in Figure 8 in green. Contingency paste barricades required for scheduling reasons or to contain paste in areas where unexpected leakage occurred are noted in Figure 8 in red. Available photographs of the paste barricades are included in Figure 9.

**Fill fence (barricade) location and approximate shape**

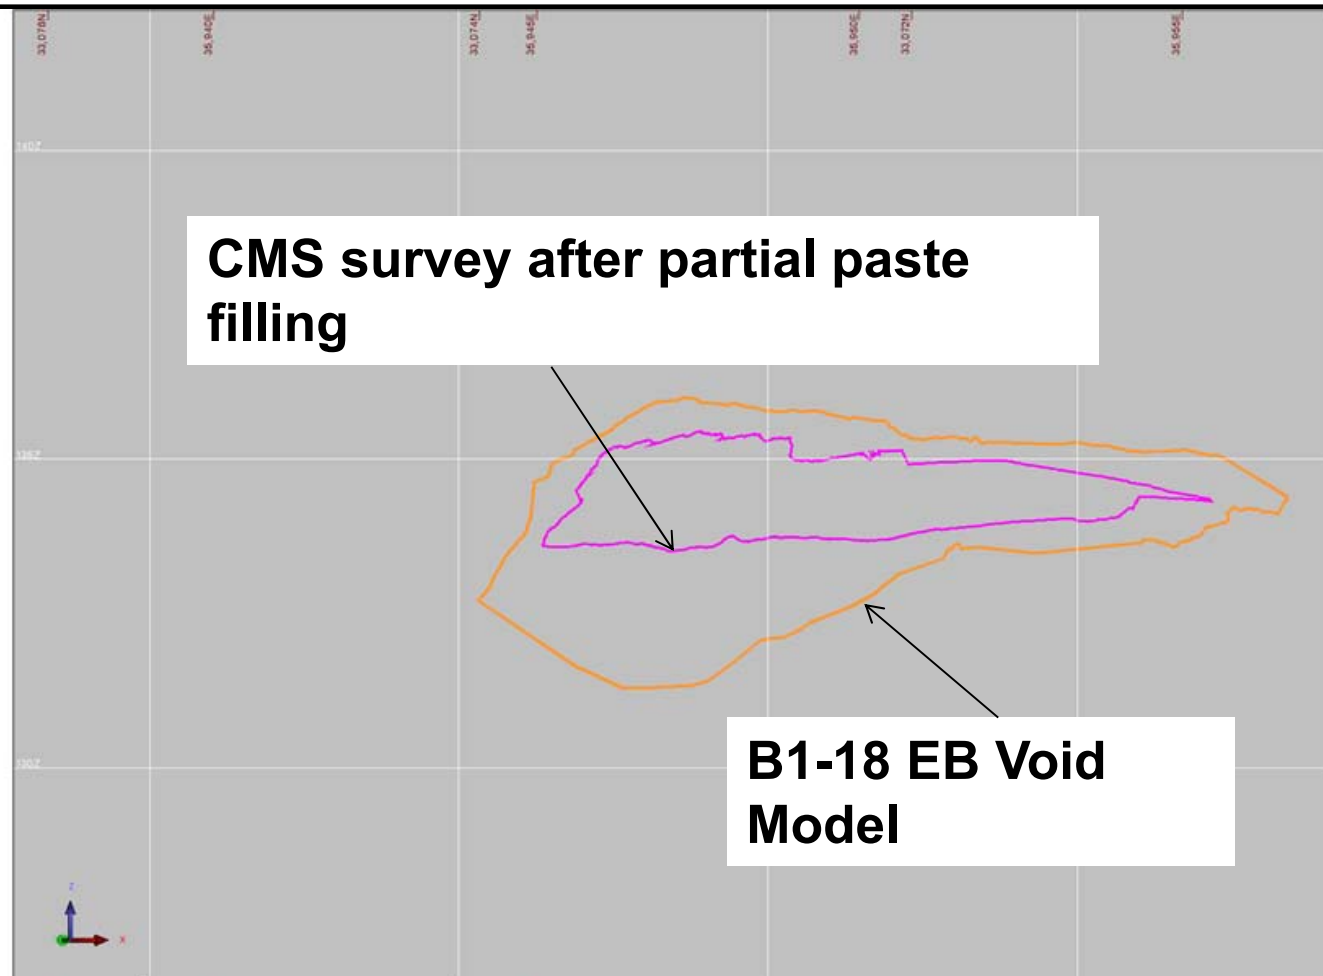
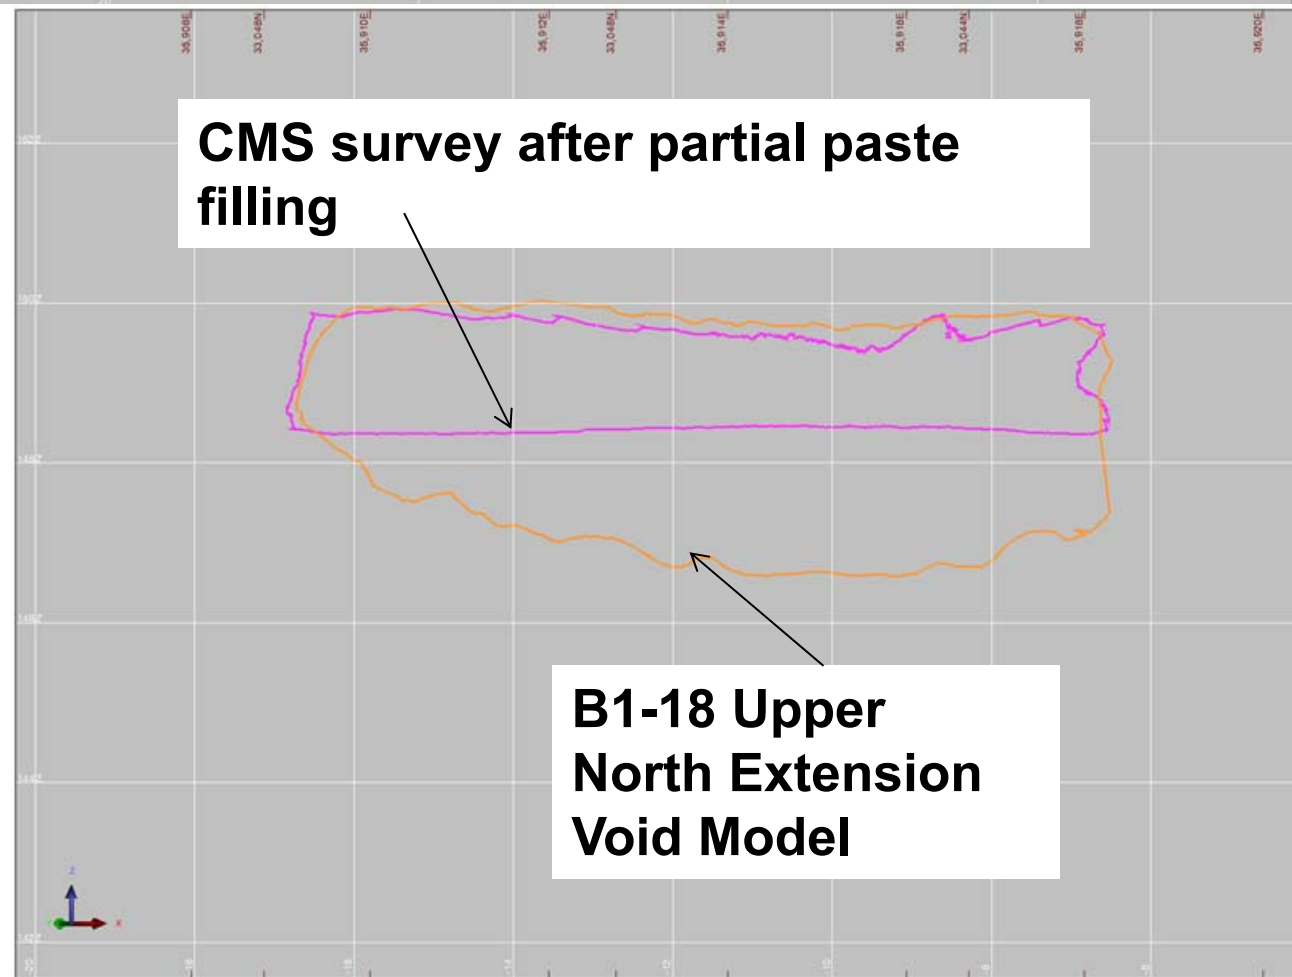
**Figure 12**

Additional evidence of the relatively flat profile of the paste includes laser cavity monitoring scans carried out prior to backfilling, and after some paste had been pumped into the void. Figure 12 shows laser scans carried out remotely through paste delivery boreholes after paste delivery to underground voids. The flat paste profile is evident.
