## VOID BACKFILLING WORK SUMMARY

# Giant Mine B1-18 Stope Complex

**Golder Reference Number:** 1314260010-120-R-RevC-1000  
**AECOM Reference Number:** 330-B1-18 Stope-10-RPT-0001-Rev.0\_20140331

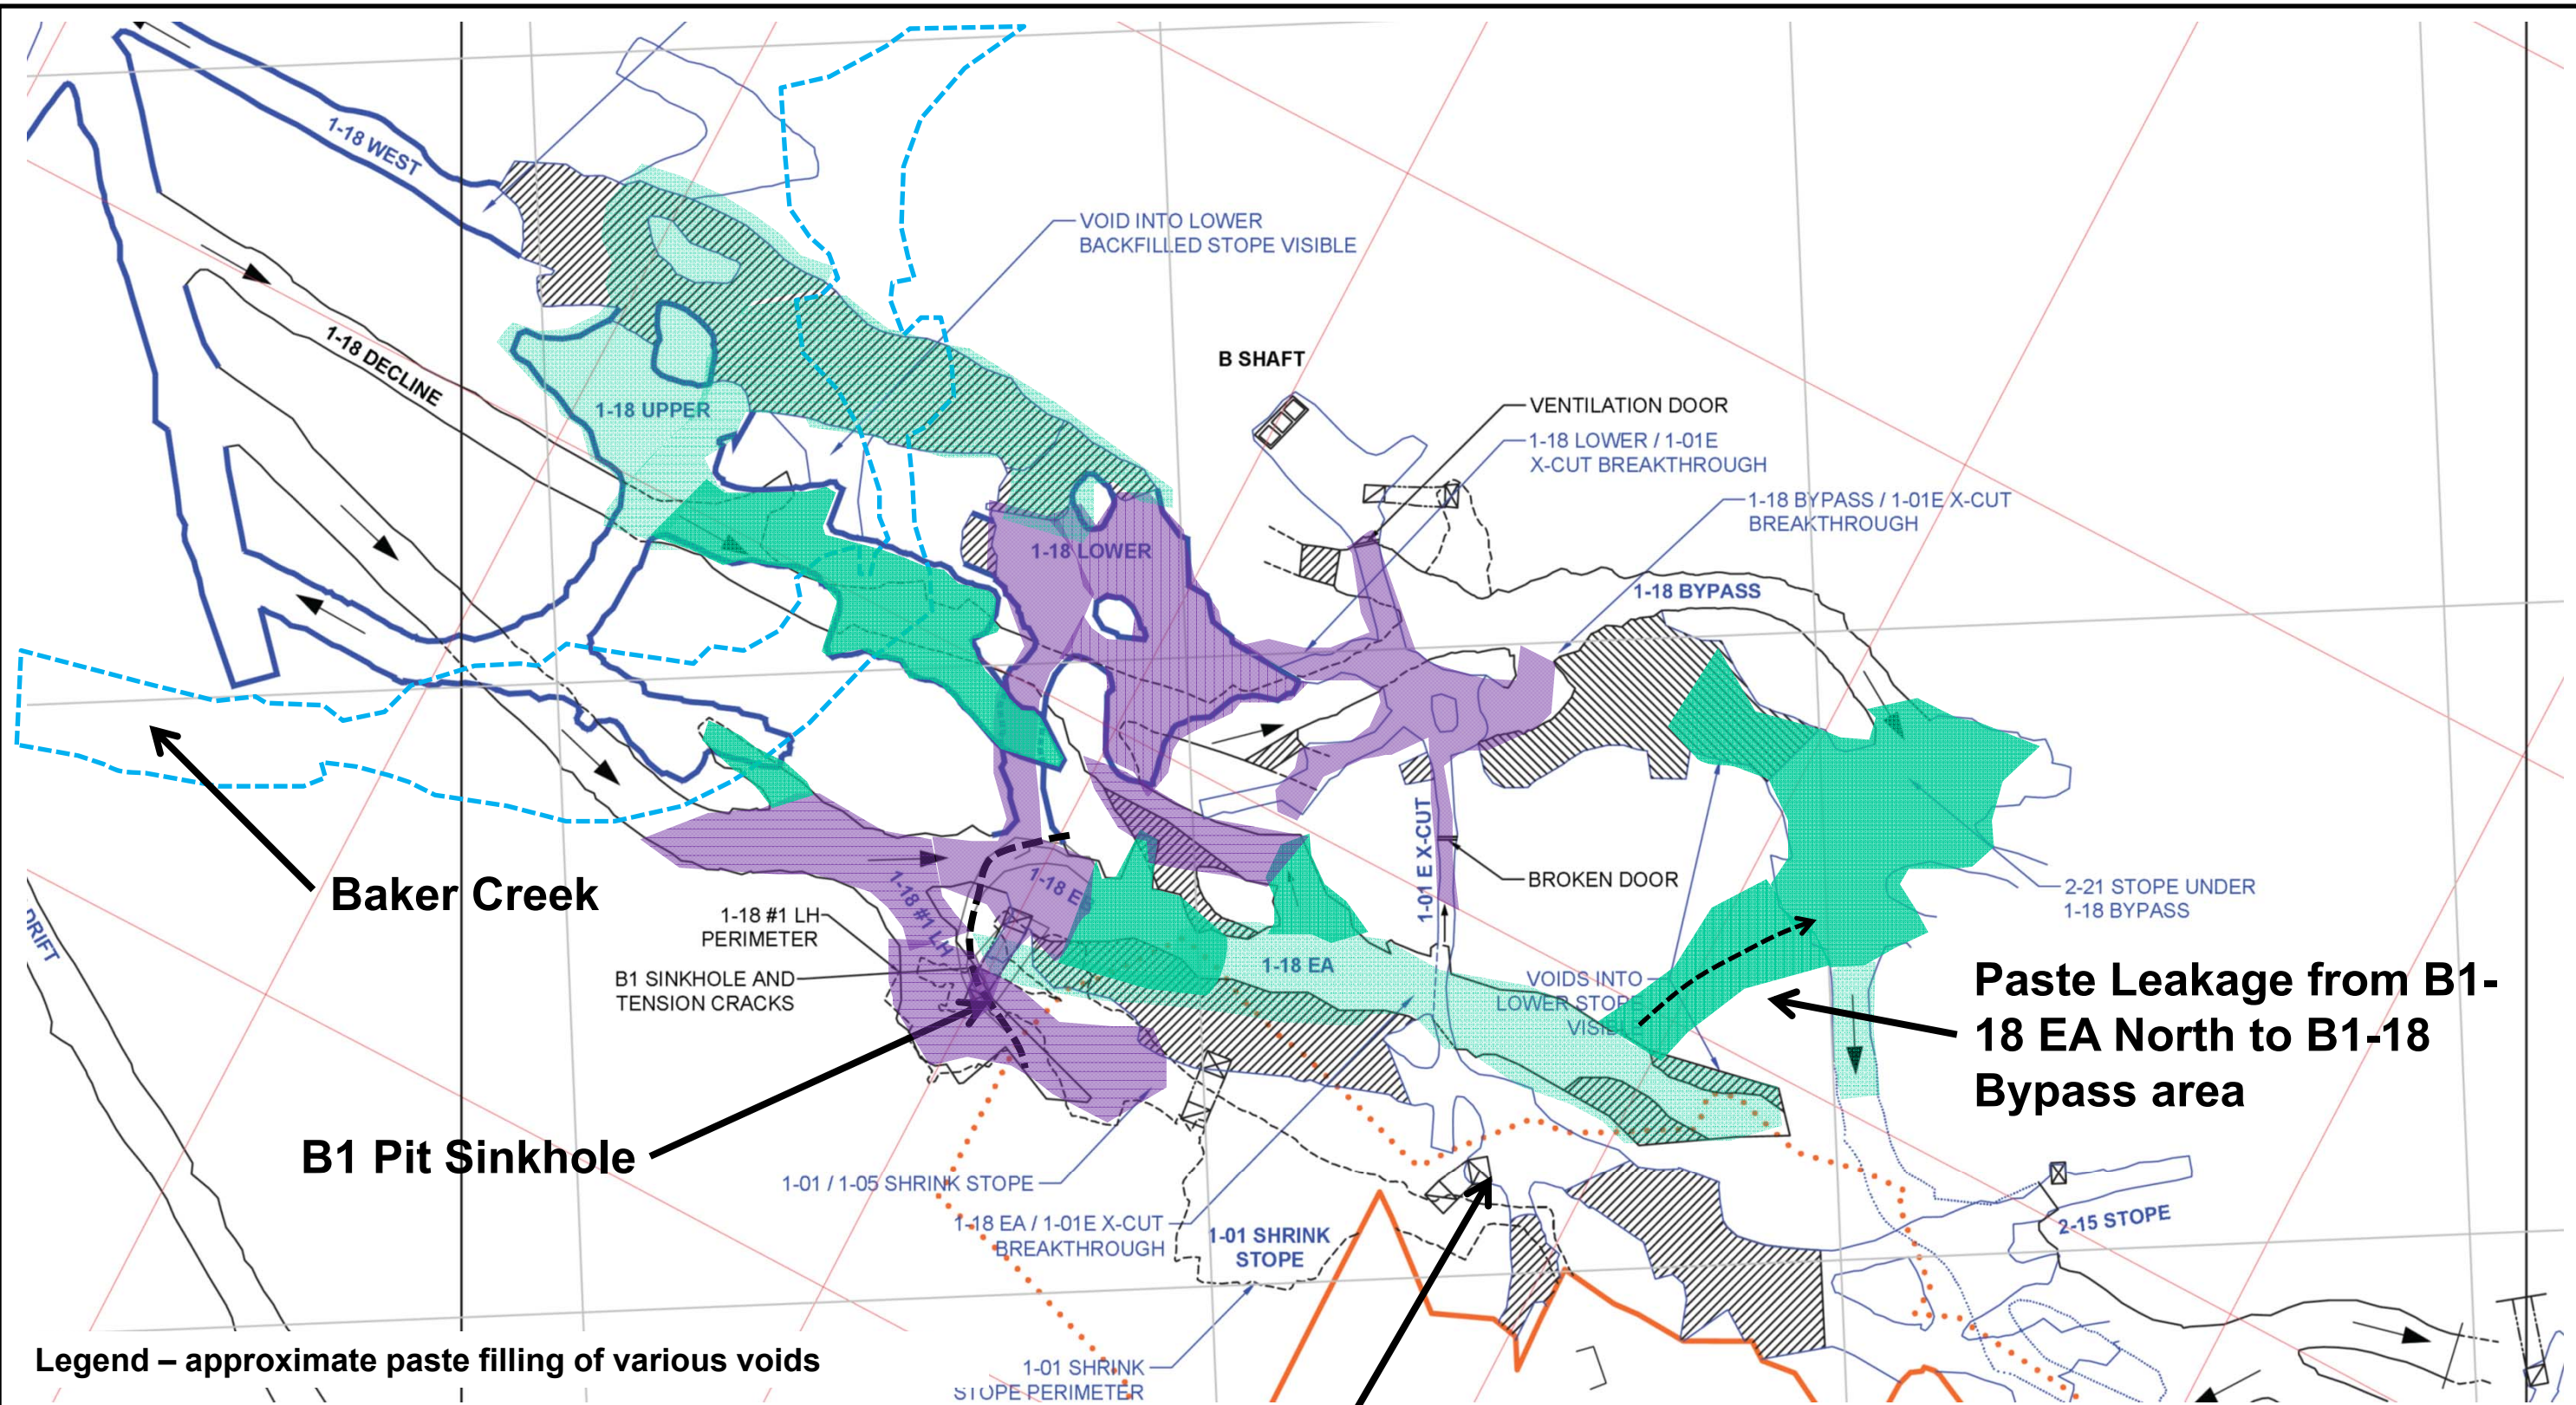
Figure 14

A qualitative assessment of the level of backfill in the various voids in the B1-18 stope complex is summarised in Figure 14. Specific information regarding the level and profile of paste backfill in the four critical areas shown in Figures 3, 4, and 5 is outlined in this section. Should some rock crown failure, cracking, or block movement occur in one of these four areas under Baker Creek water could enter the mine at an unknown flow rate. These areas are:

Legend – approximate paste filling of various voids

- Paste fill on floor
- Paste close to back
- Paste relatively tight to back

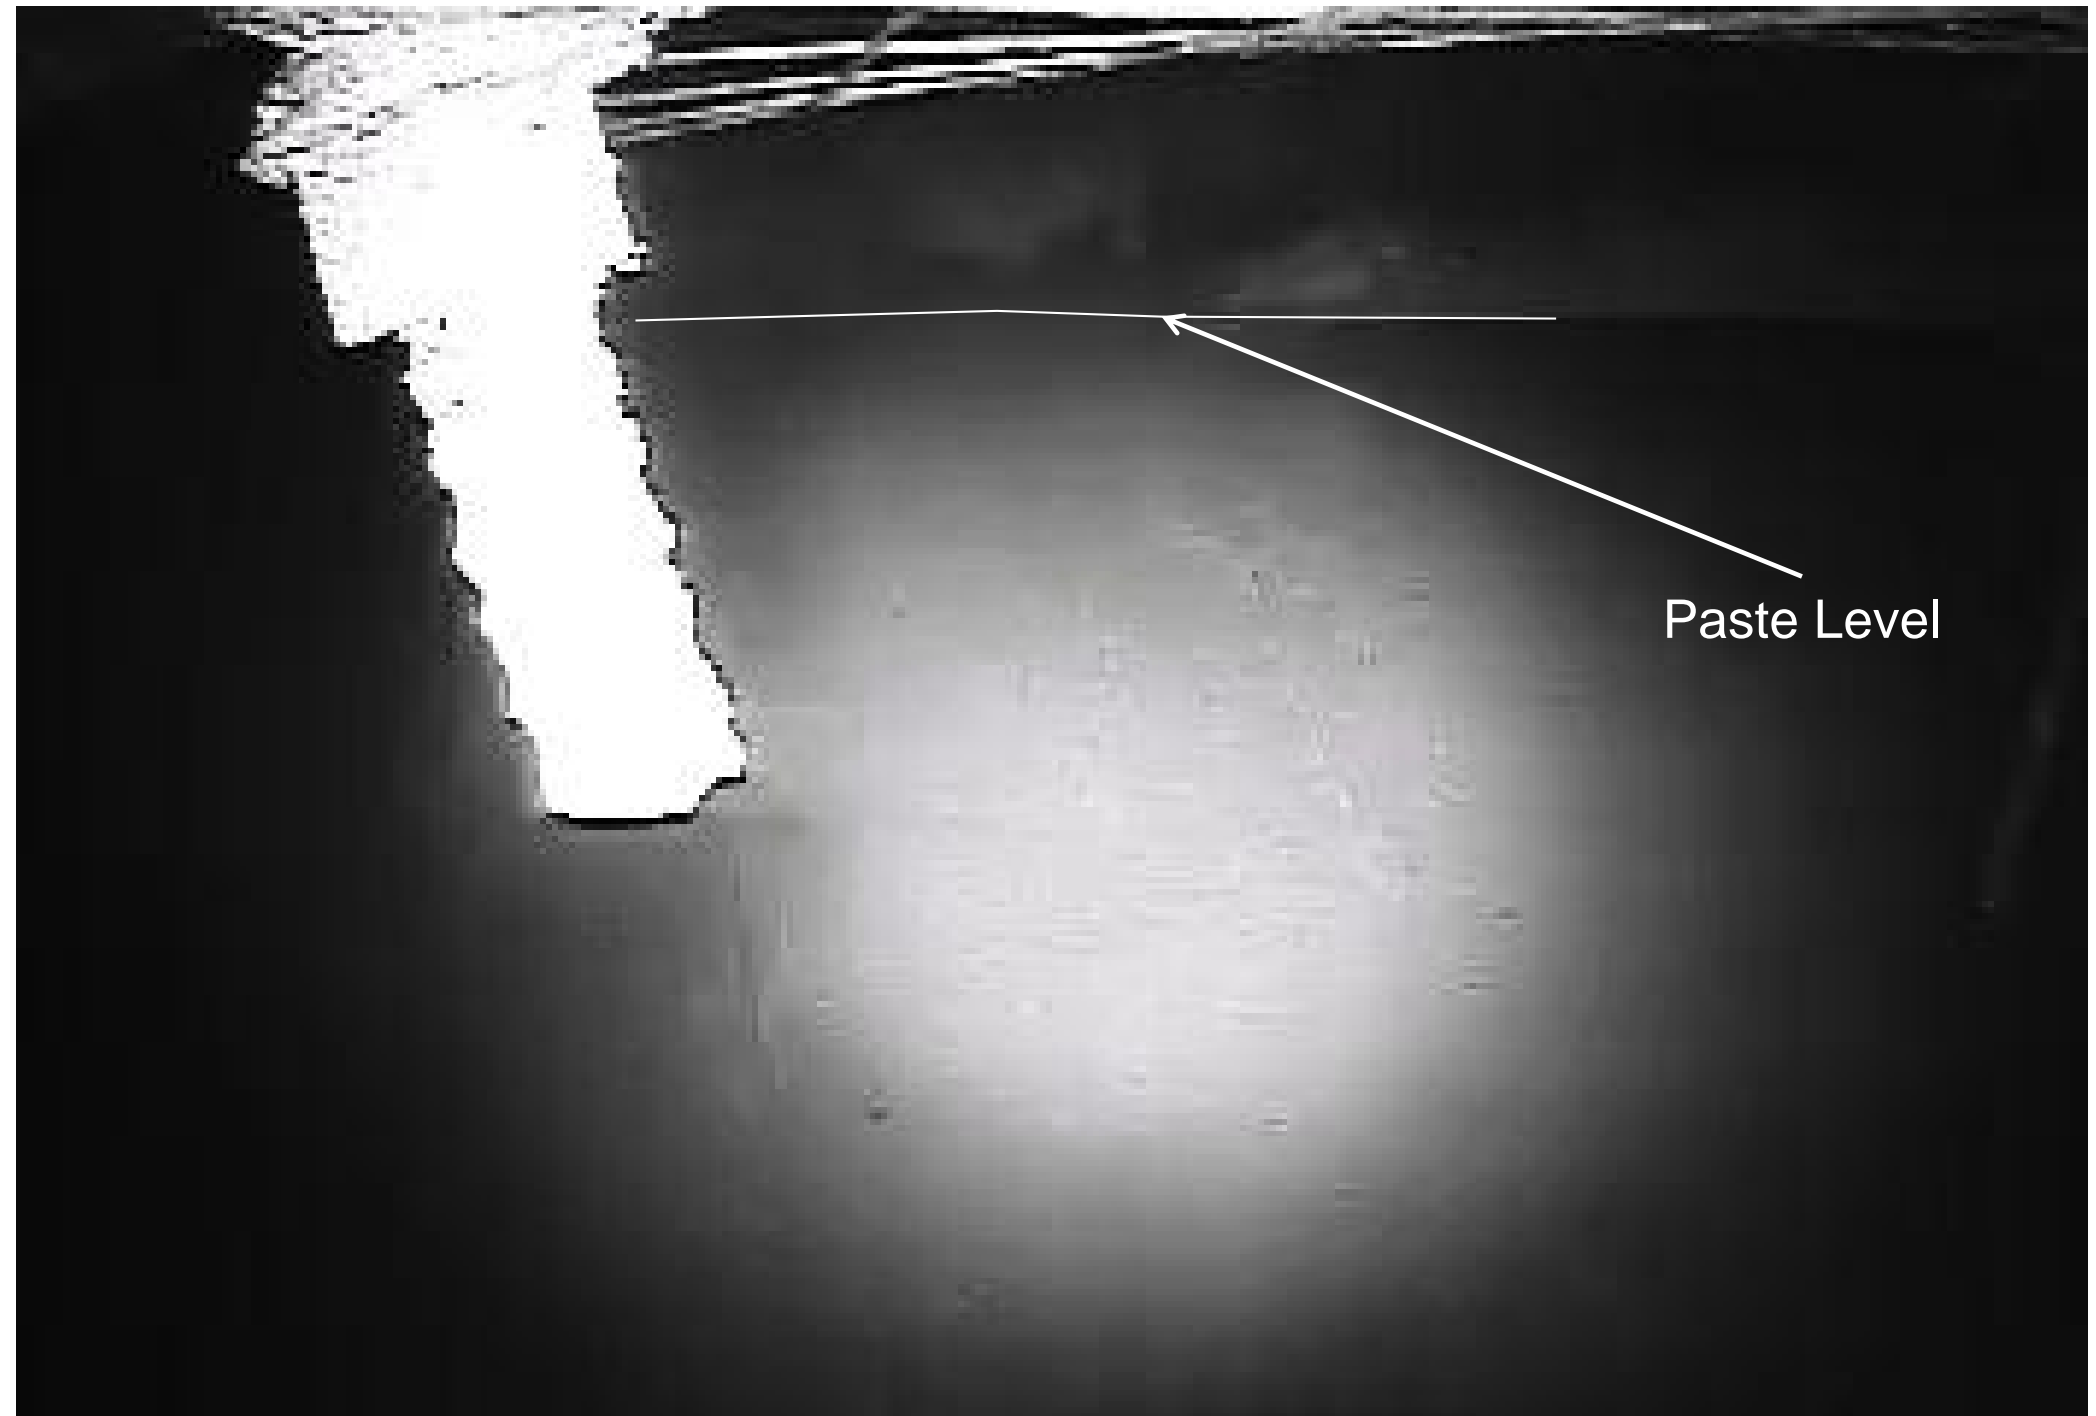
- Camera 15a shows paste choking off the brow at top of Barricade 6.
- With the low slump paste pumped into Deliv\_118\_15 the flat level of the paste at the brow at barricade 6 shows that the finger of the 118 upper is full to approximately 1.4m from the back.

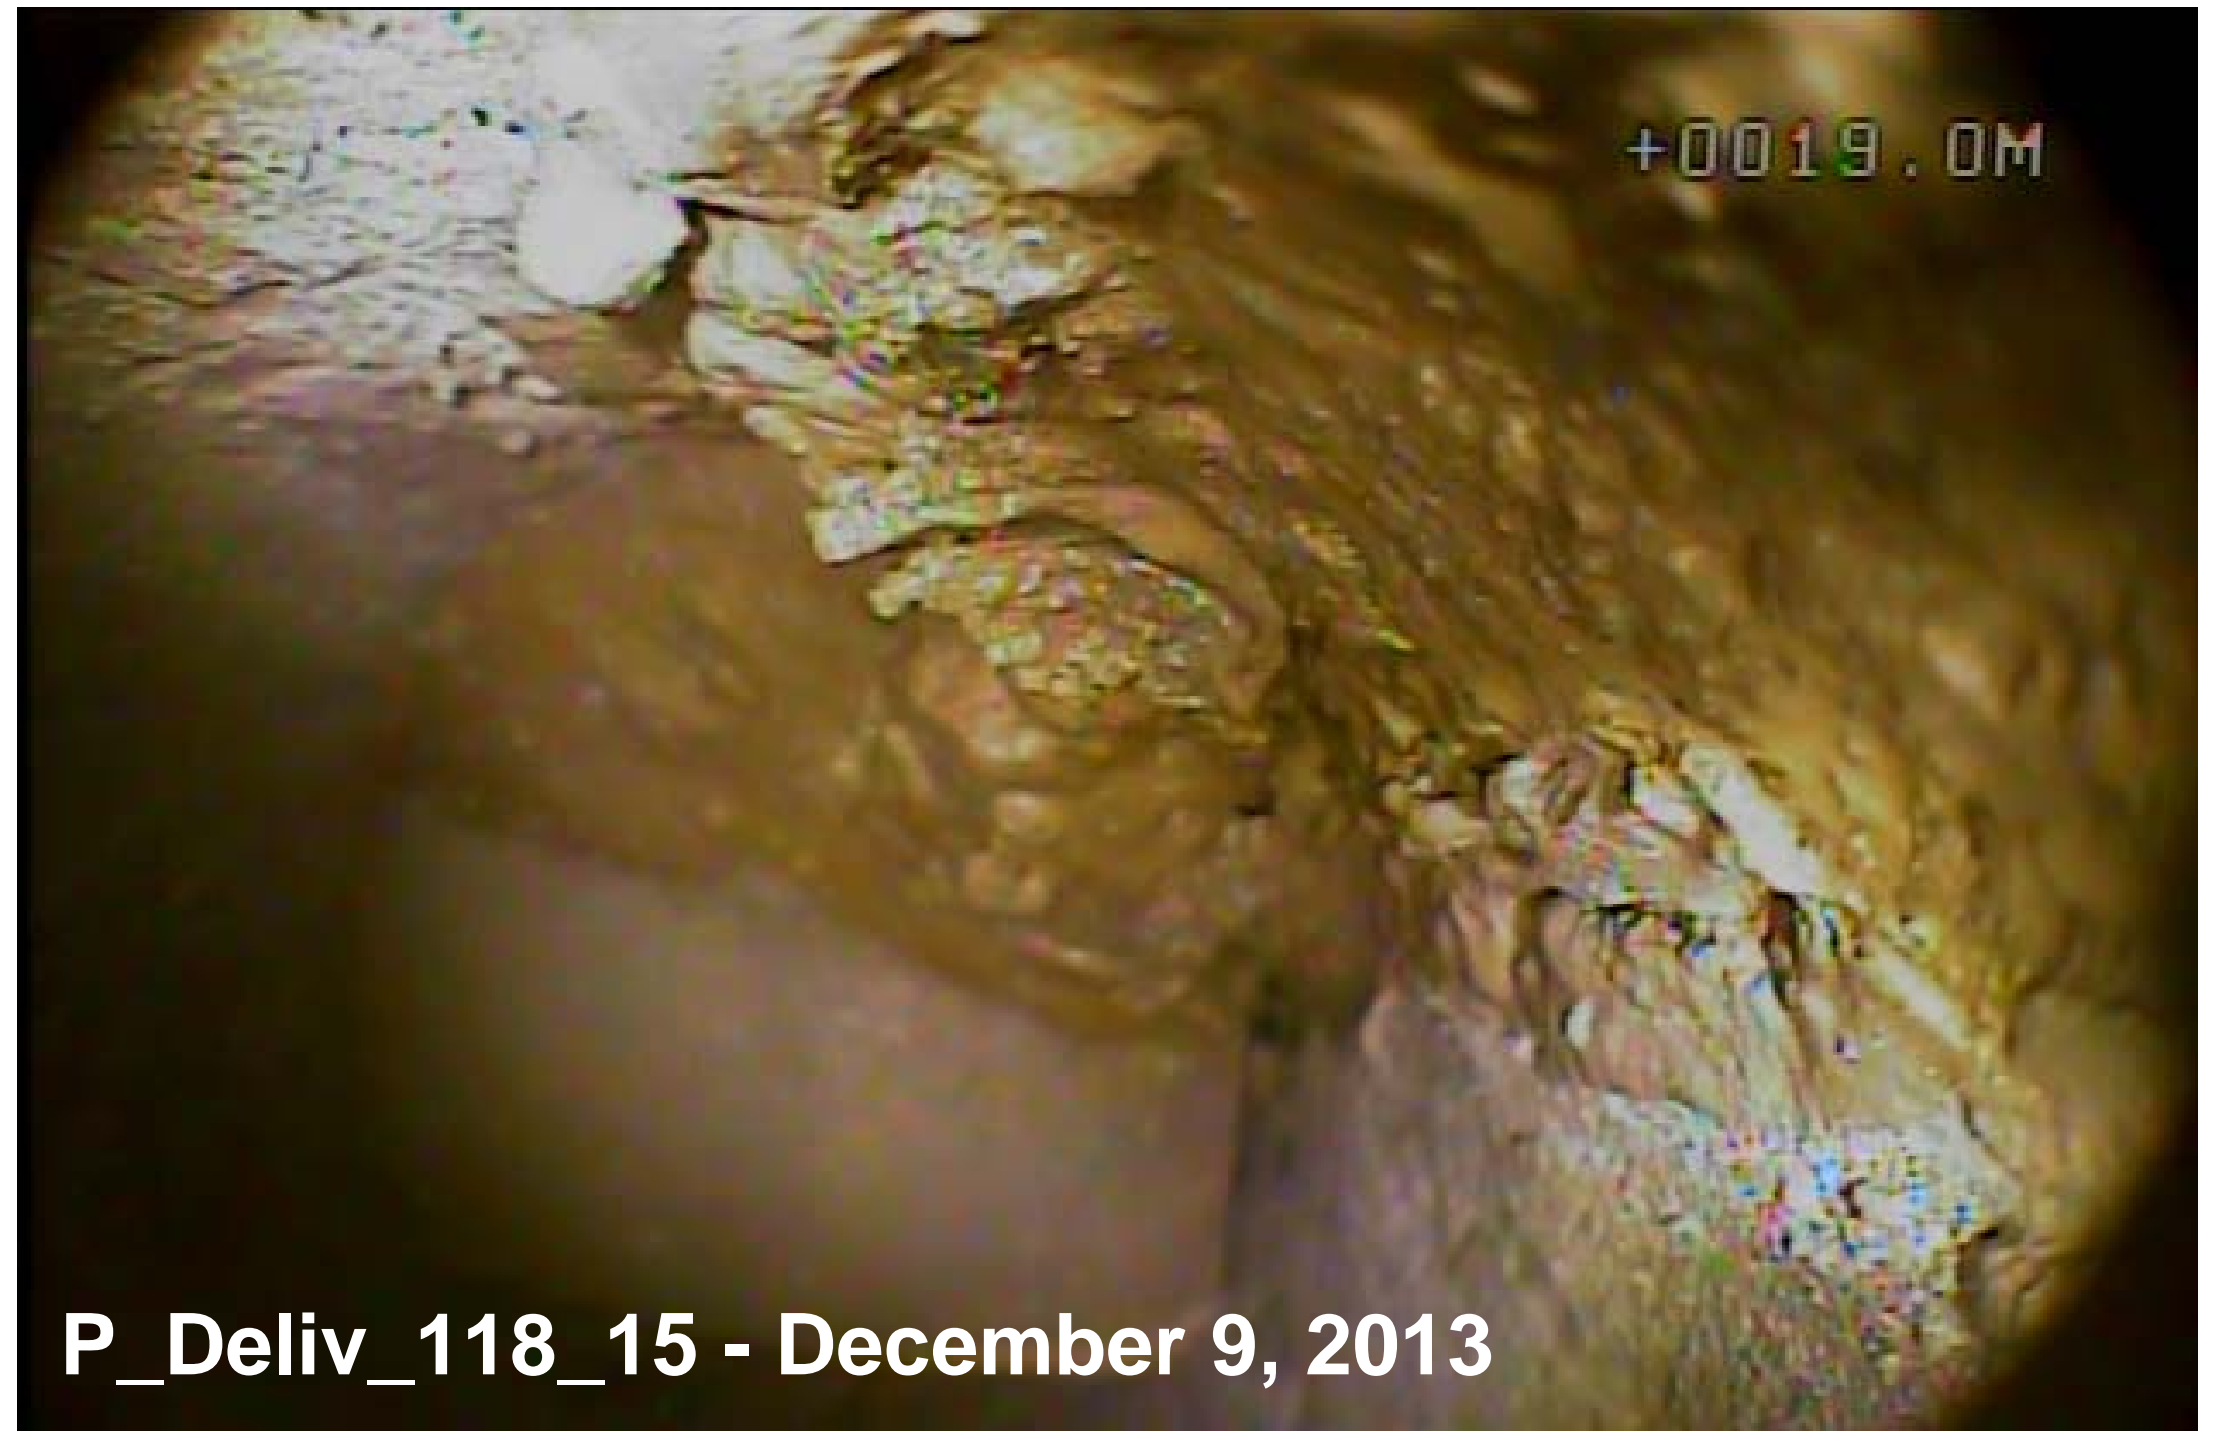
- Borehole video screenshot showing a pig at 19.0 m depth in hole Deliv\_118\_15.
- No further Paste pours were made into this hole.

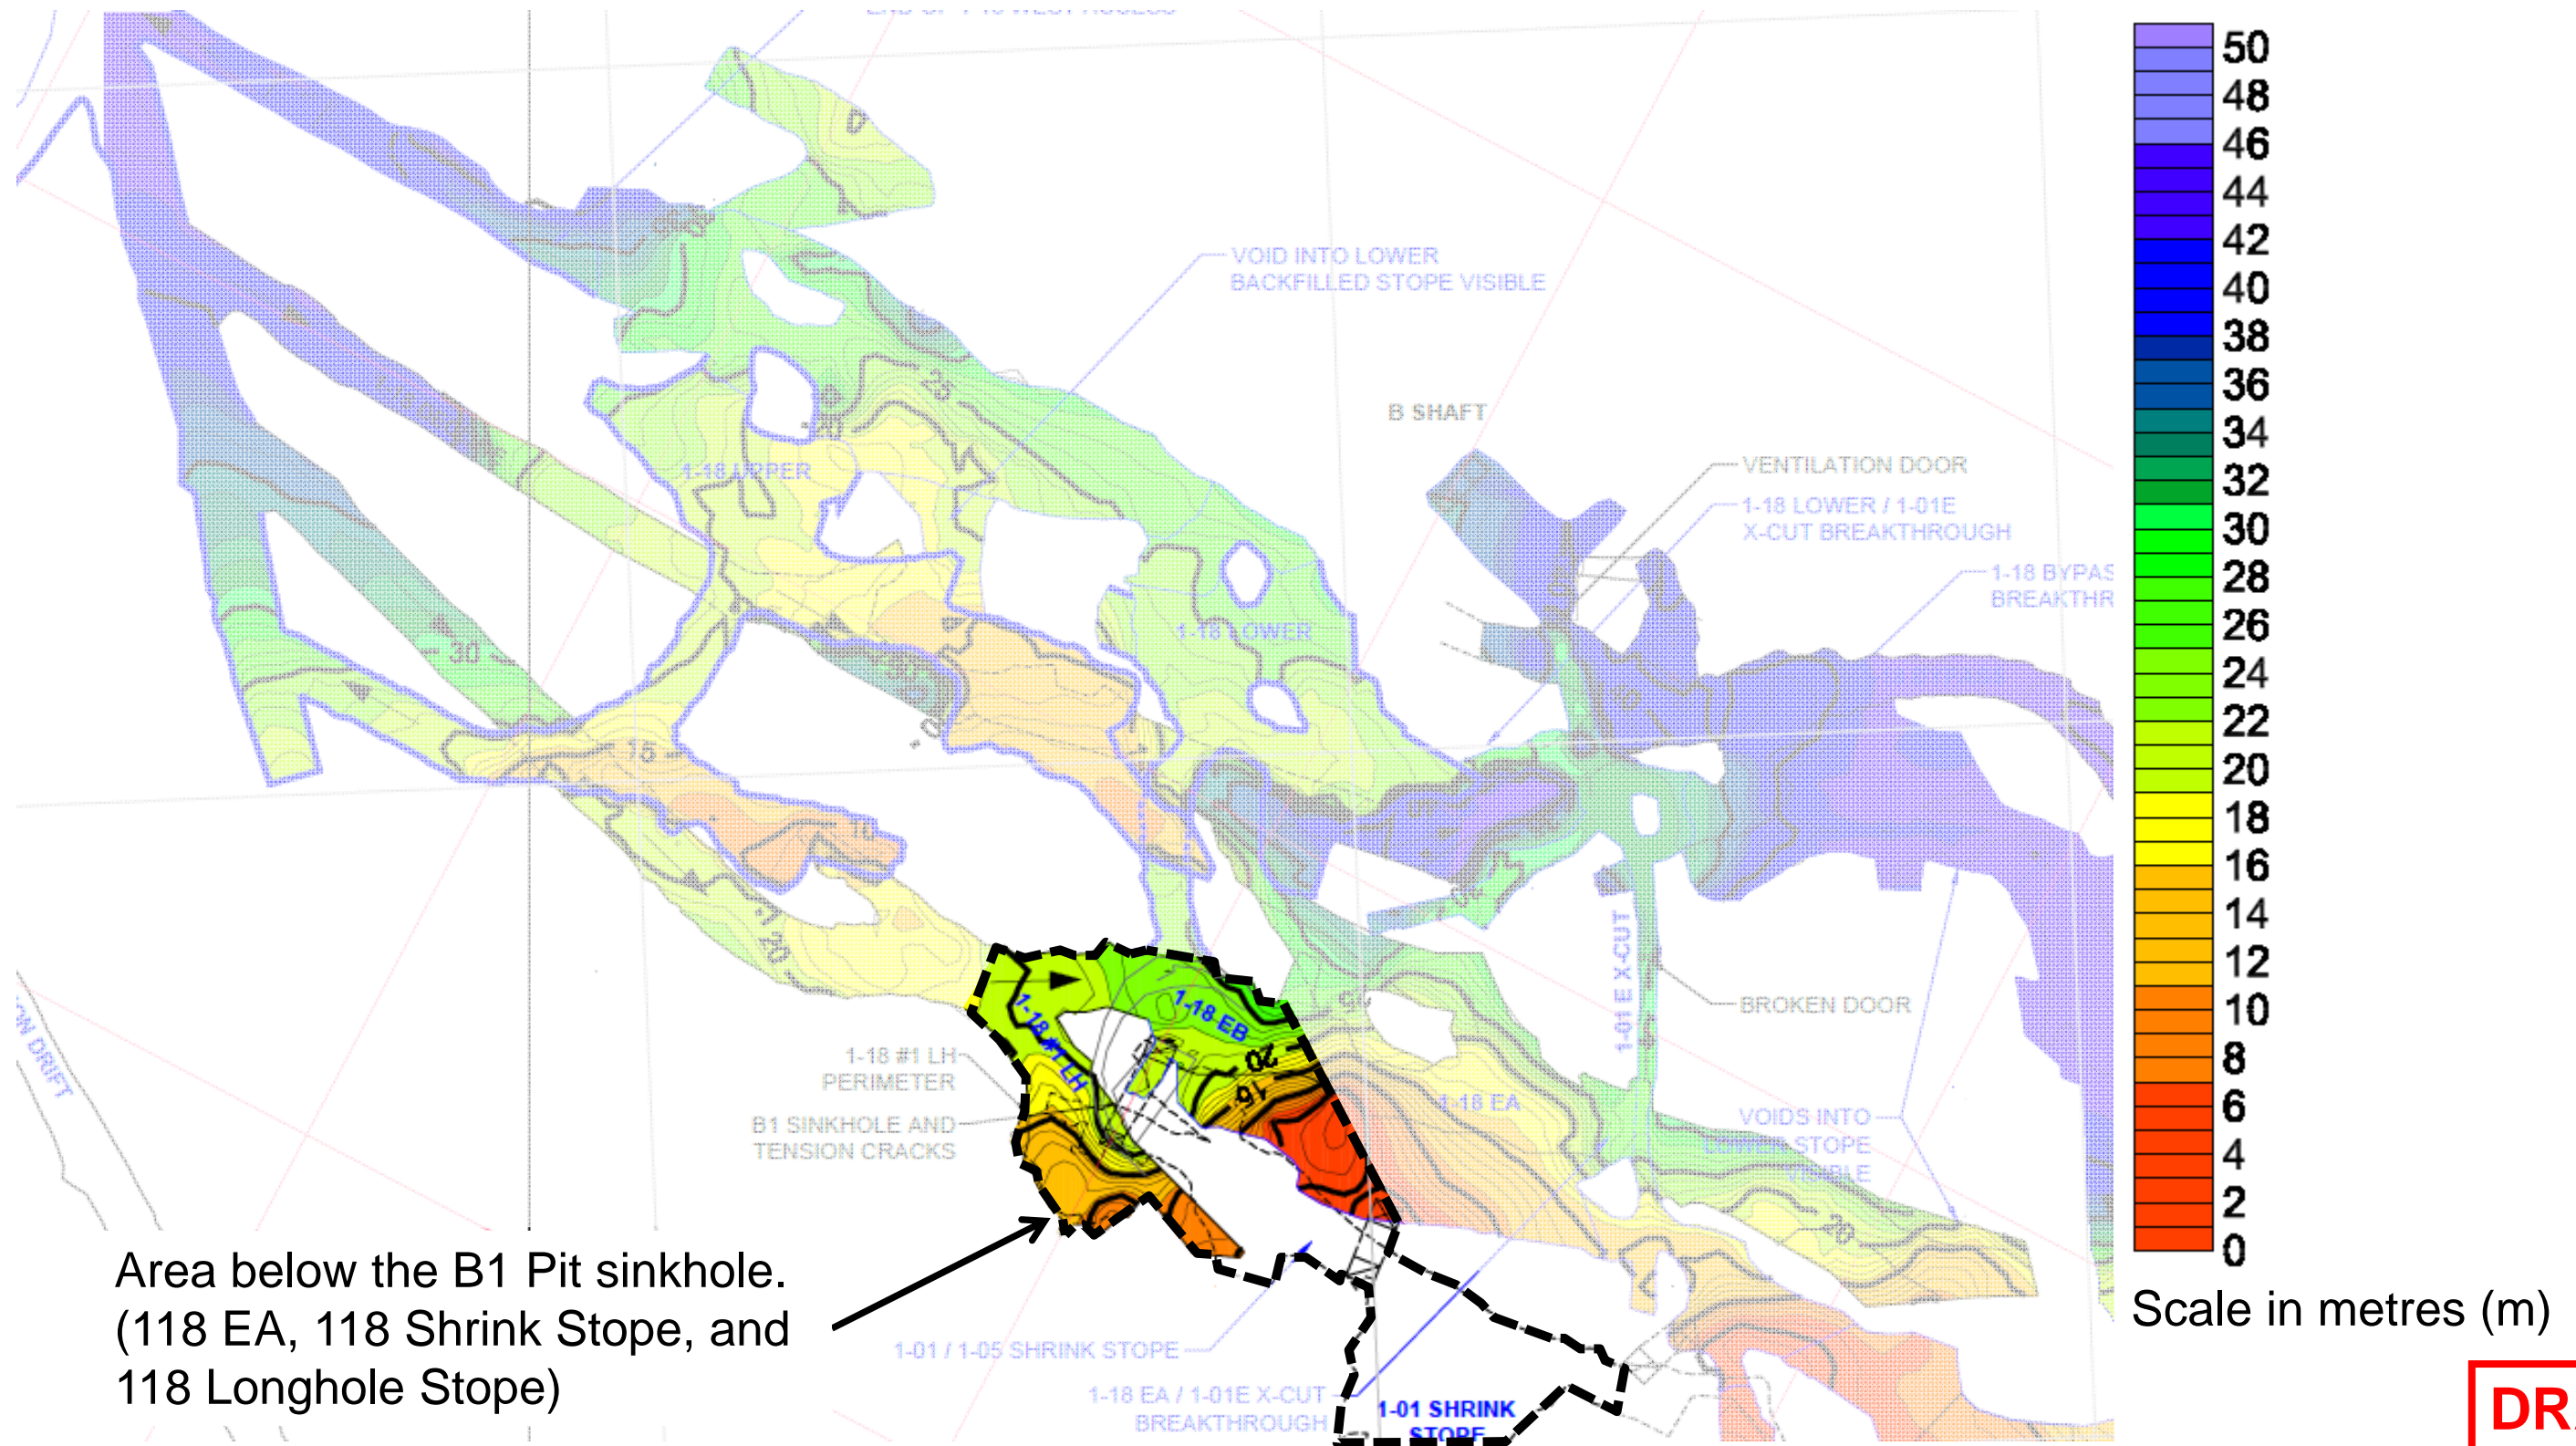
PROJECT		PWGSC	
GIANT MINE INTERIM U/G STABILIZATION PROJECT			
YELLOWKNIFE, NWT			
TITLE		Crown pillar thickness Below B1 Pit Sinkhole	
PROJECT No.	10-1426-0010	PHASE No.	1000
DESIGN	DTK 24SEP13	SCALE	N.T.S. REV. A
CADD	DTK/FM 04OCT13	Page 9	
CHECK	DTK/FM 29OCT13		
REVIEW

Area below the B1 Pit sinkhole.  
(118 EA, 118 Shrink Stope, and  
118 Longhole Stope)

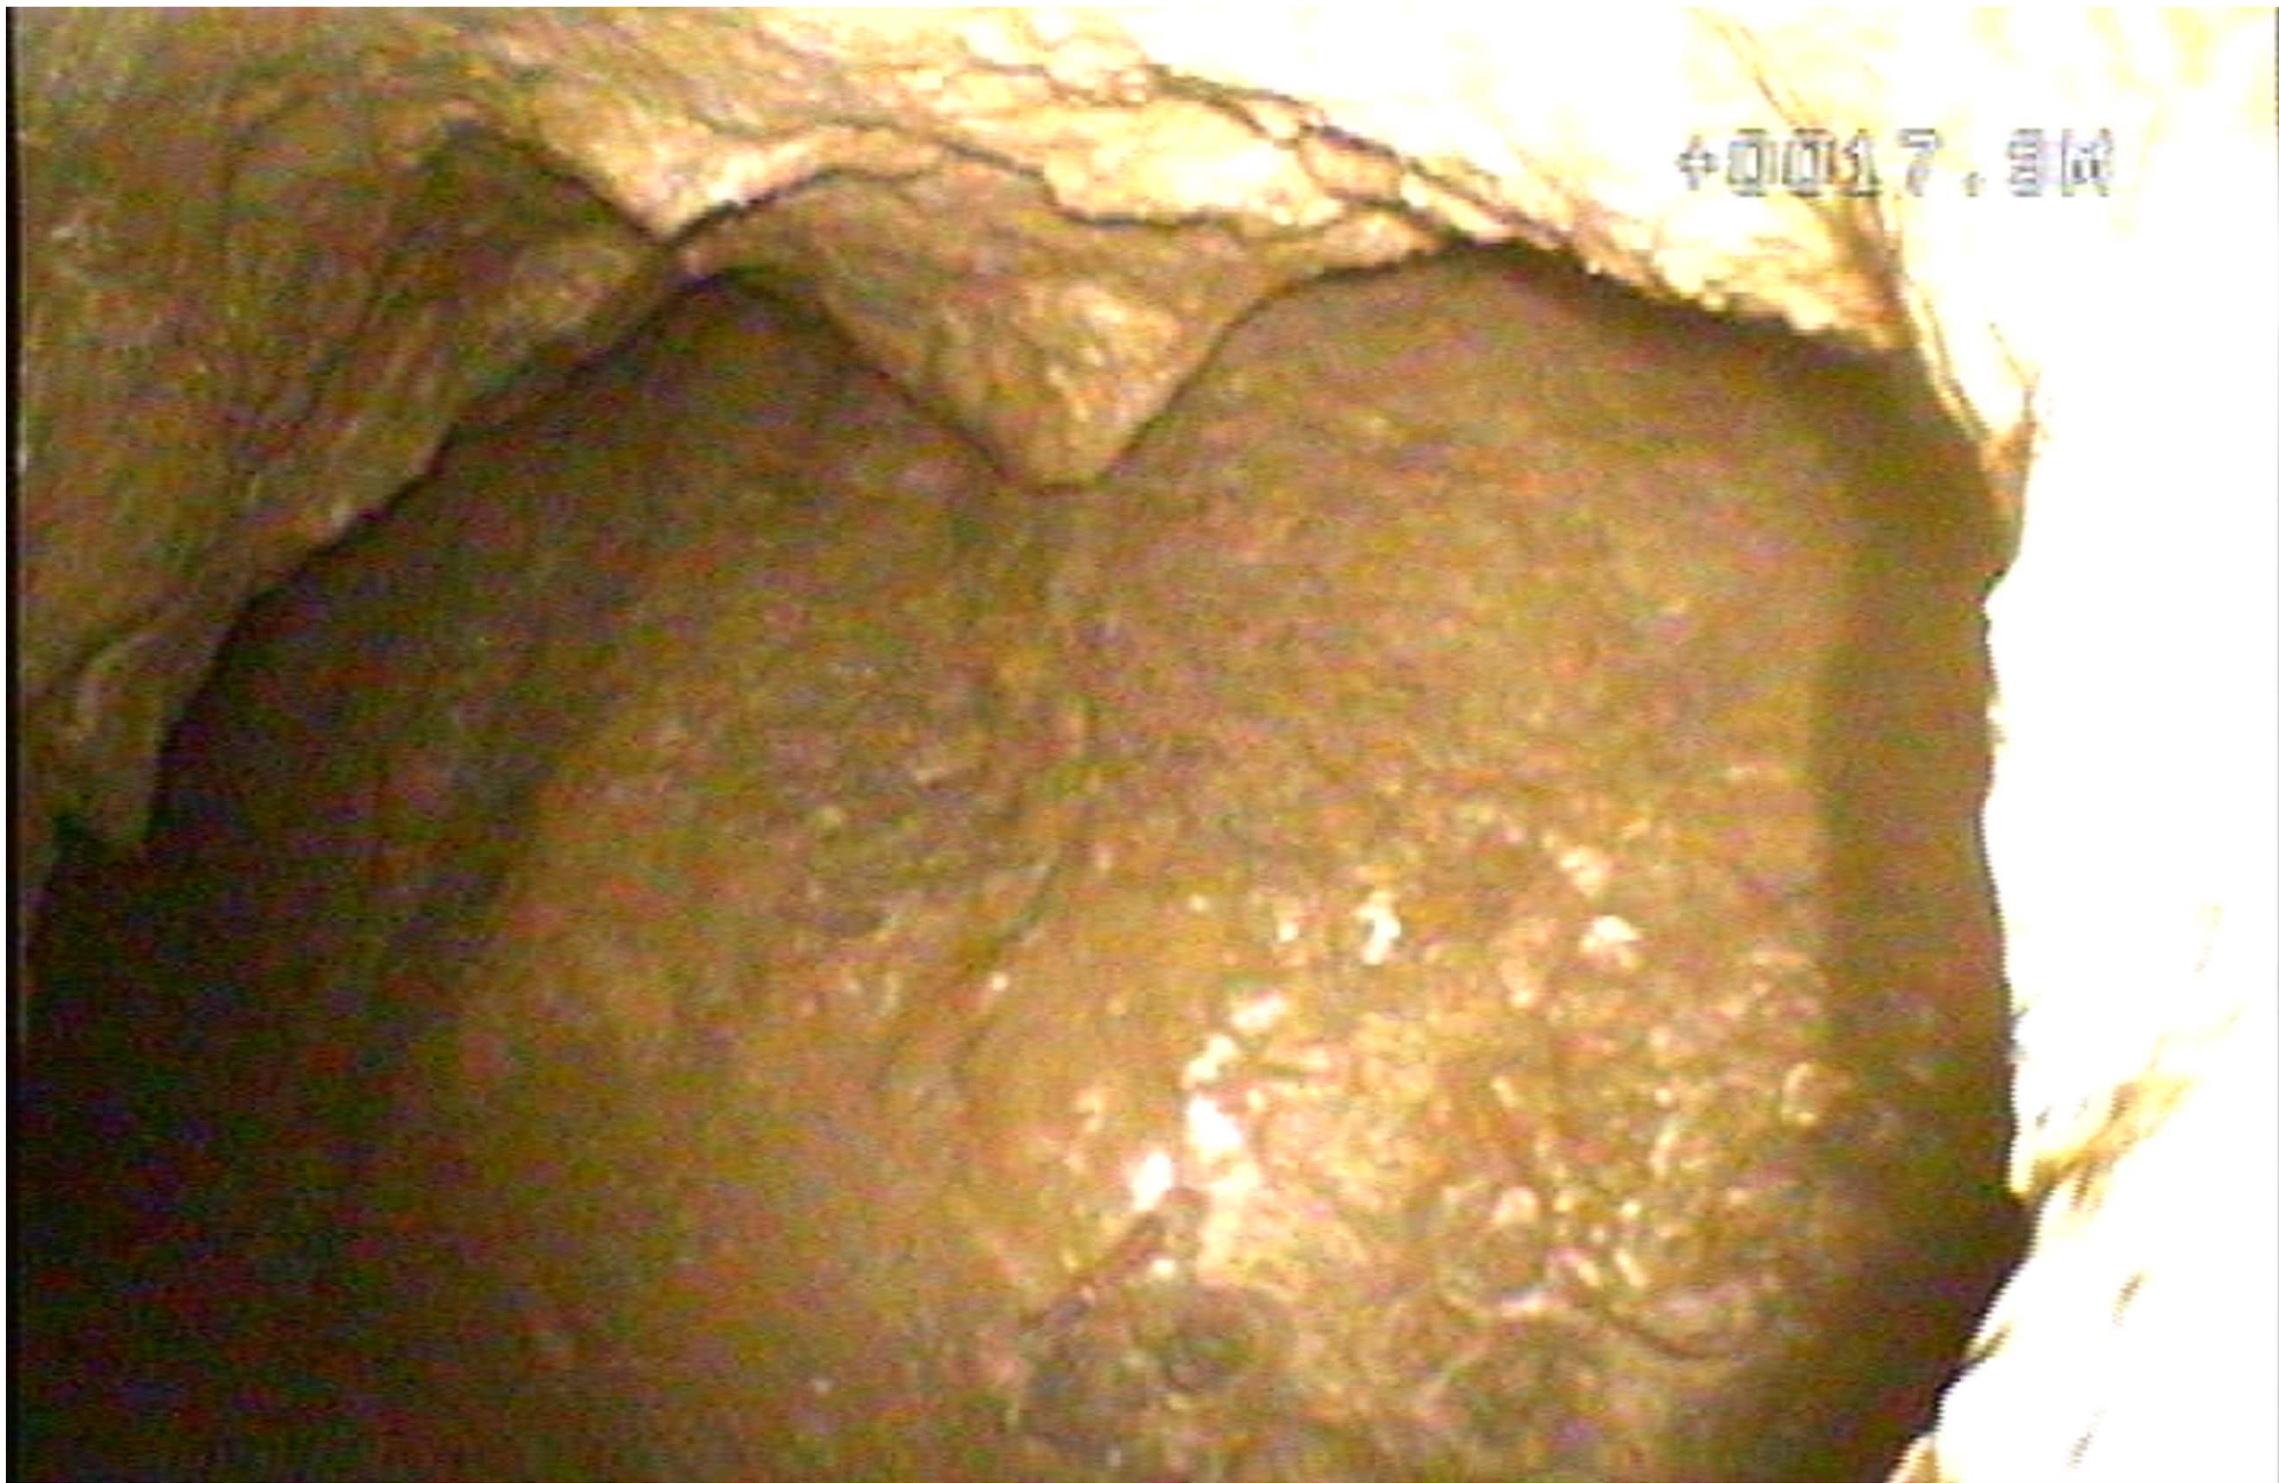
- Paste backed up to 17.5m depth into the drillhole due to pouring on the 14<sup>th</sup> of November
- Shows that the area below the sinkhole is full as the paste rose in drillholes  
OBS\_118\_06,  
Deliv\_118\_02, and  
BKGT\_12\_14 rather than escaping underground.

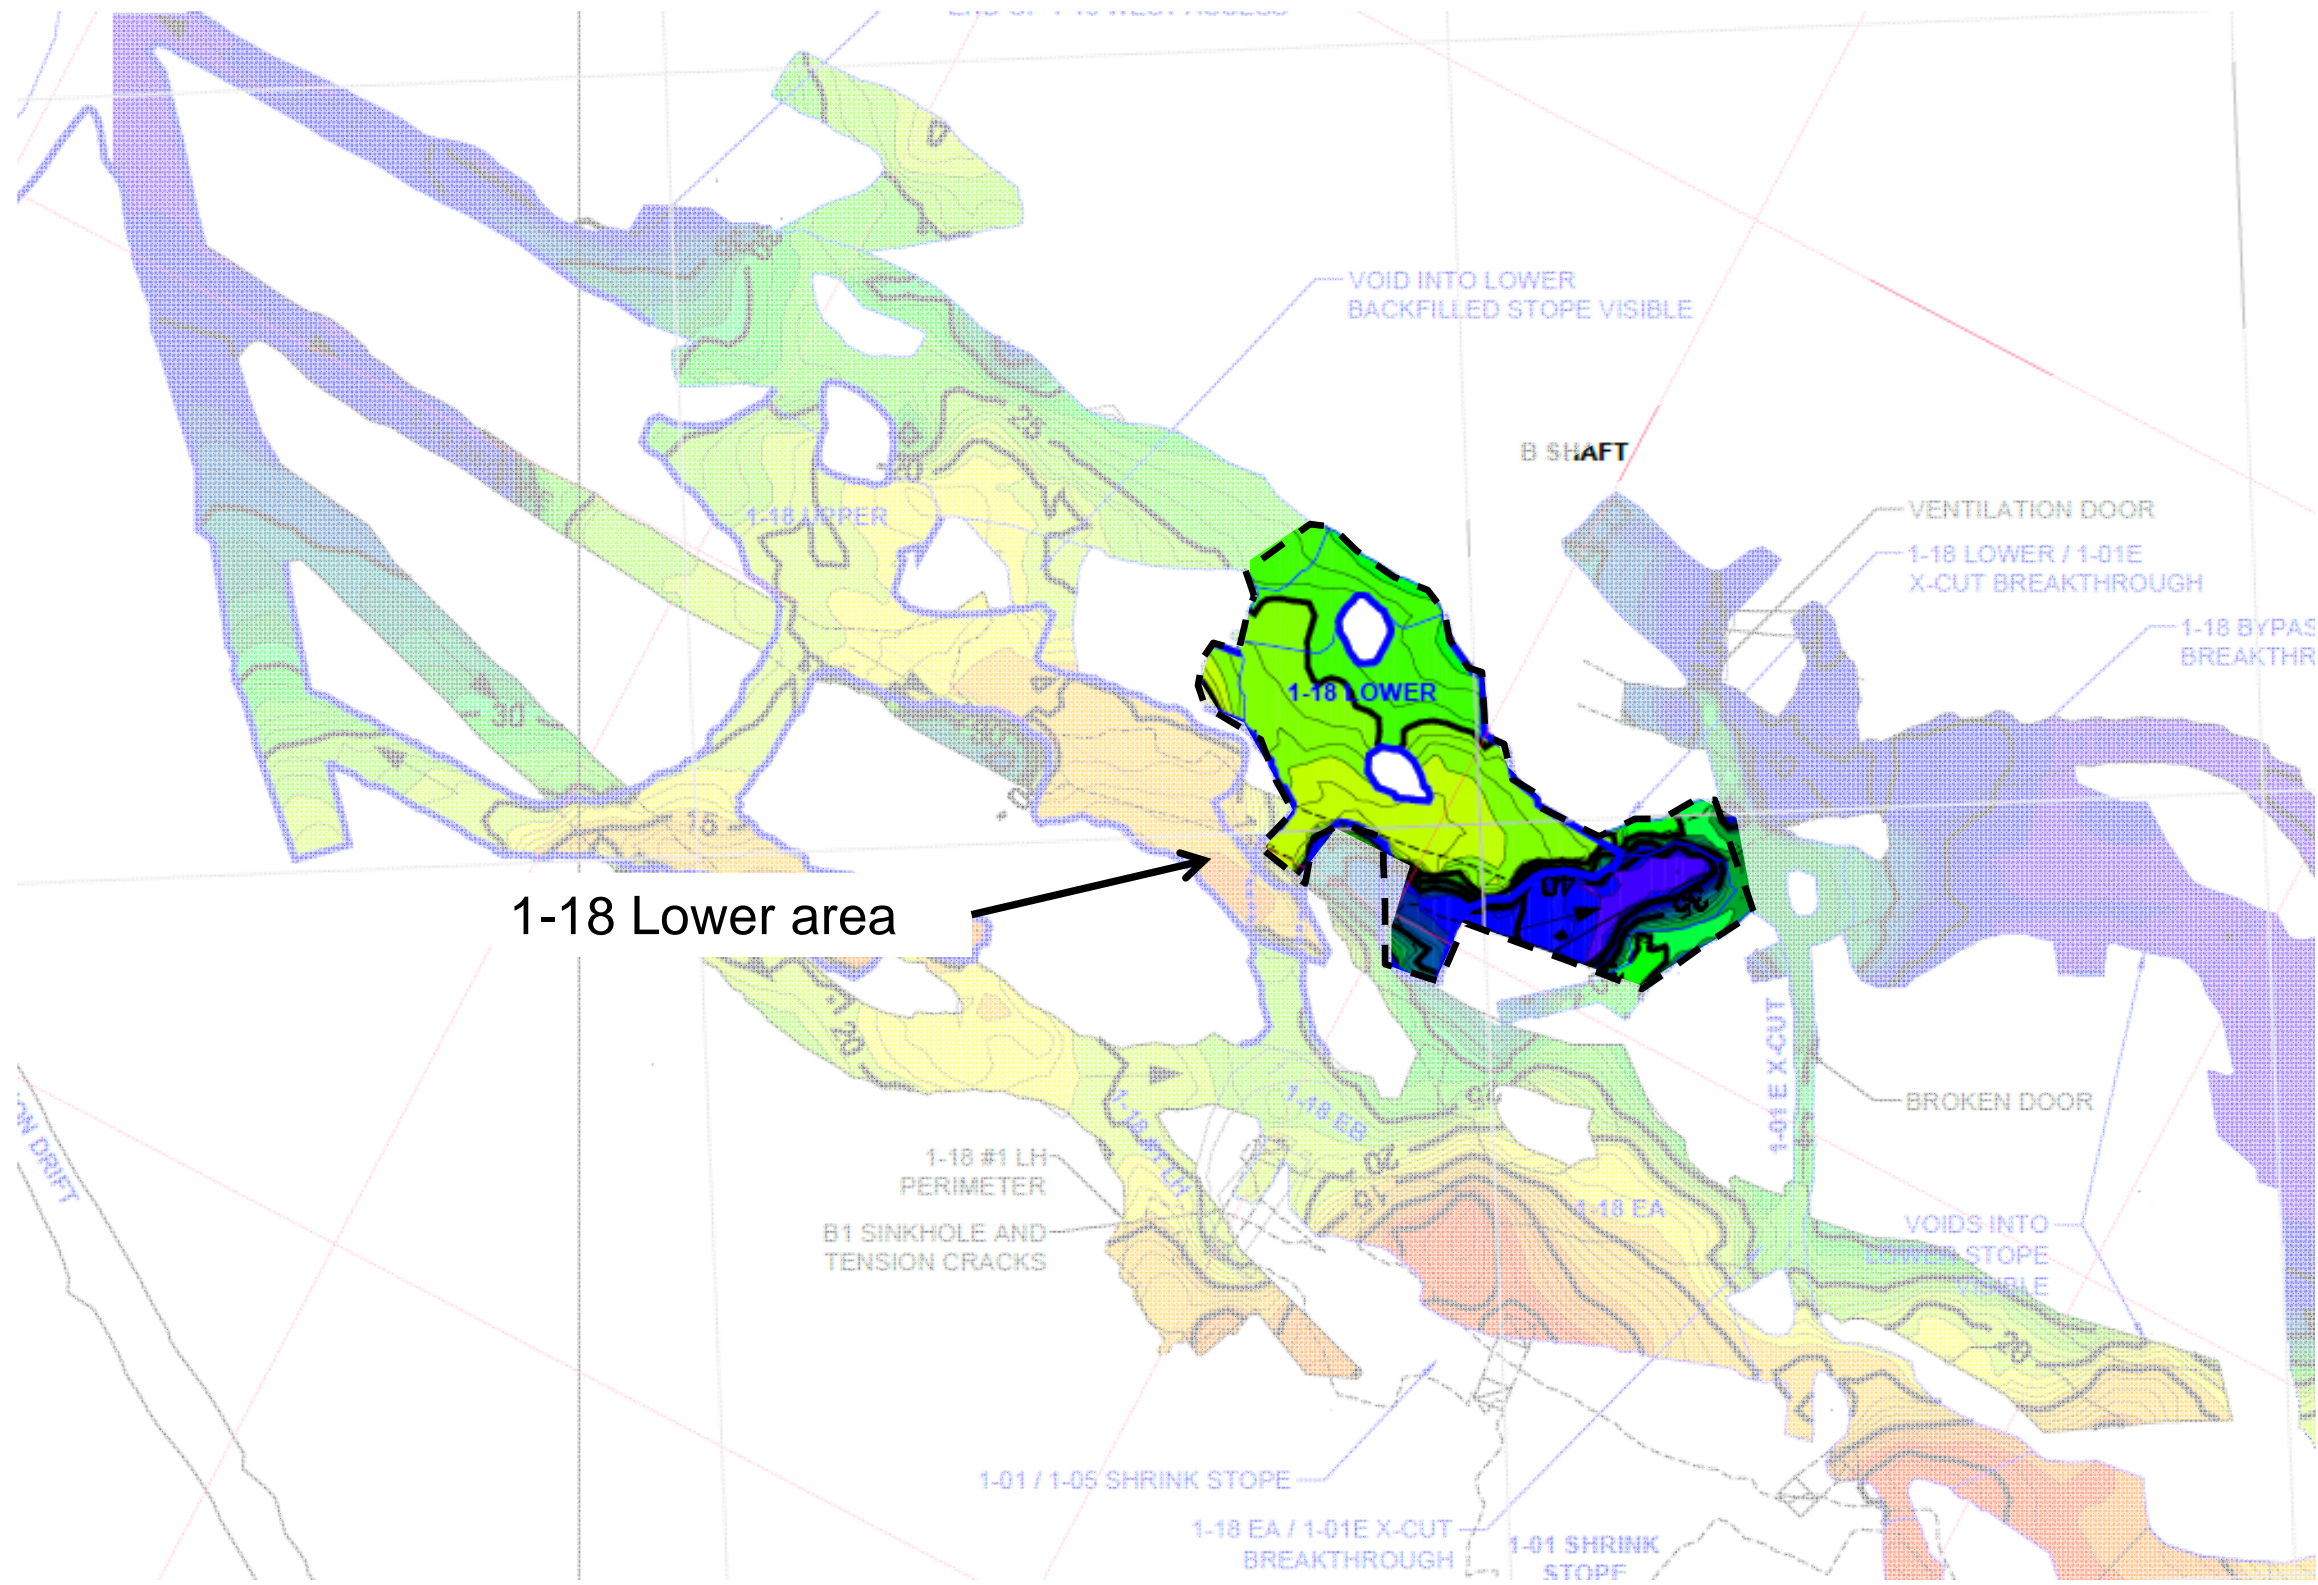
1-18 Lower area

PROJECT		PWGSC	
GIANT MINE INTERIM U/G STABILIZATION PROJECT			
YELLOWKNIFE, NWT			
TITLE		Crown pillar thickness	
		Above 1-18 Lower	
PROJECT No. 10-1426-0010		PHASE No. 1000	
DESIGN	DTK	24SEP13	SCALE N.T.S. REV. A
CADD	DTK/FM	04OCT13	
CHECK	DTK/FM	29OCT13	
REVIEW
