## VOID BACKFILLING WORK SUMMARY

# Giant Mine B1-18 Stope Complex

**Golder Reference Number:** 1314260010-120-R-RevC-1000  
**AECOM Reference Number:** 330-B1-18 Stope-10-RPT-0001-Rev.0\_20140331

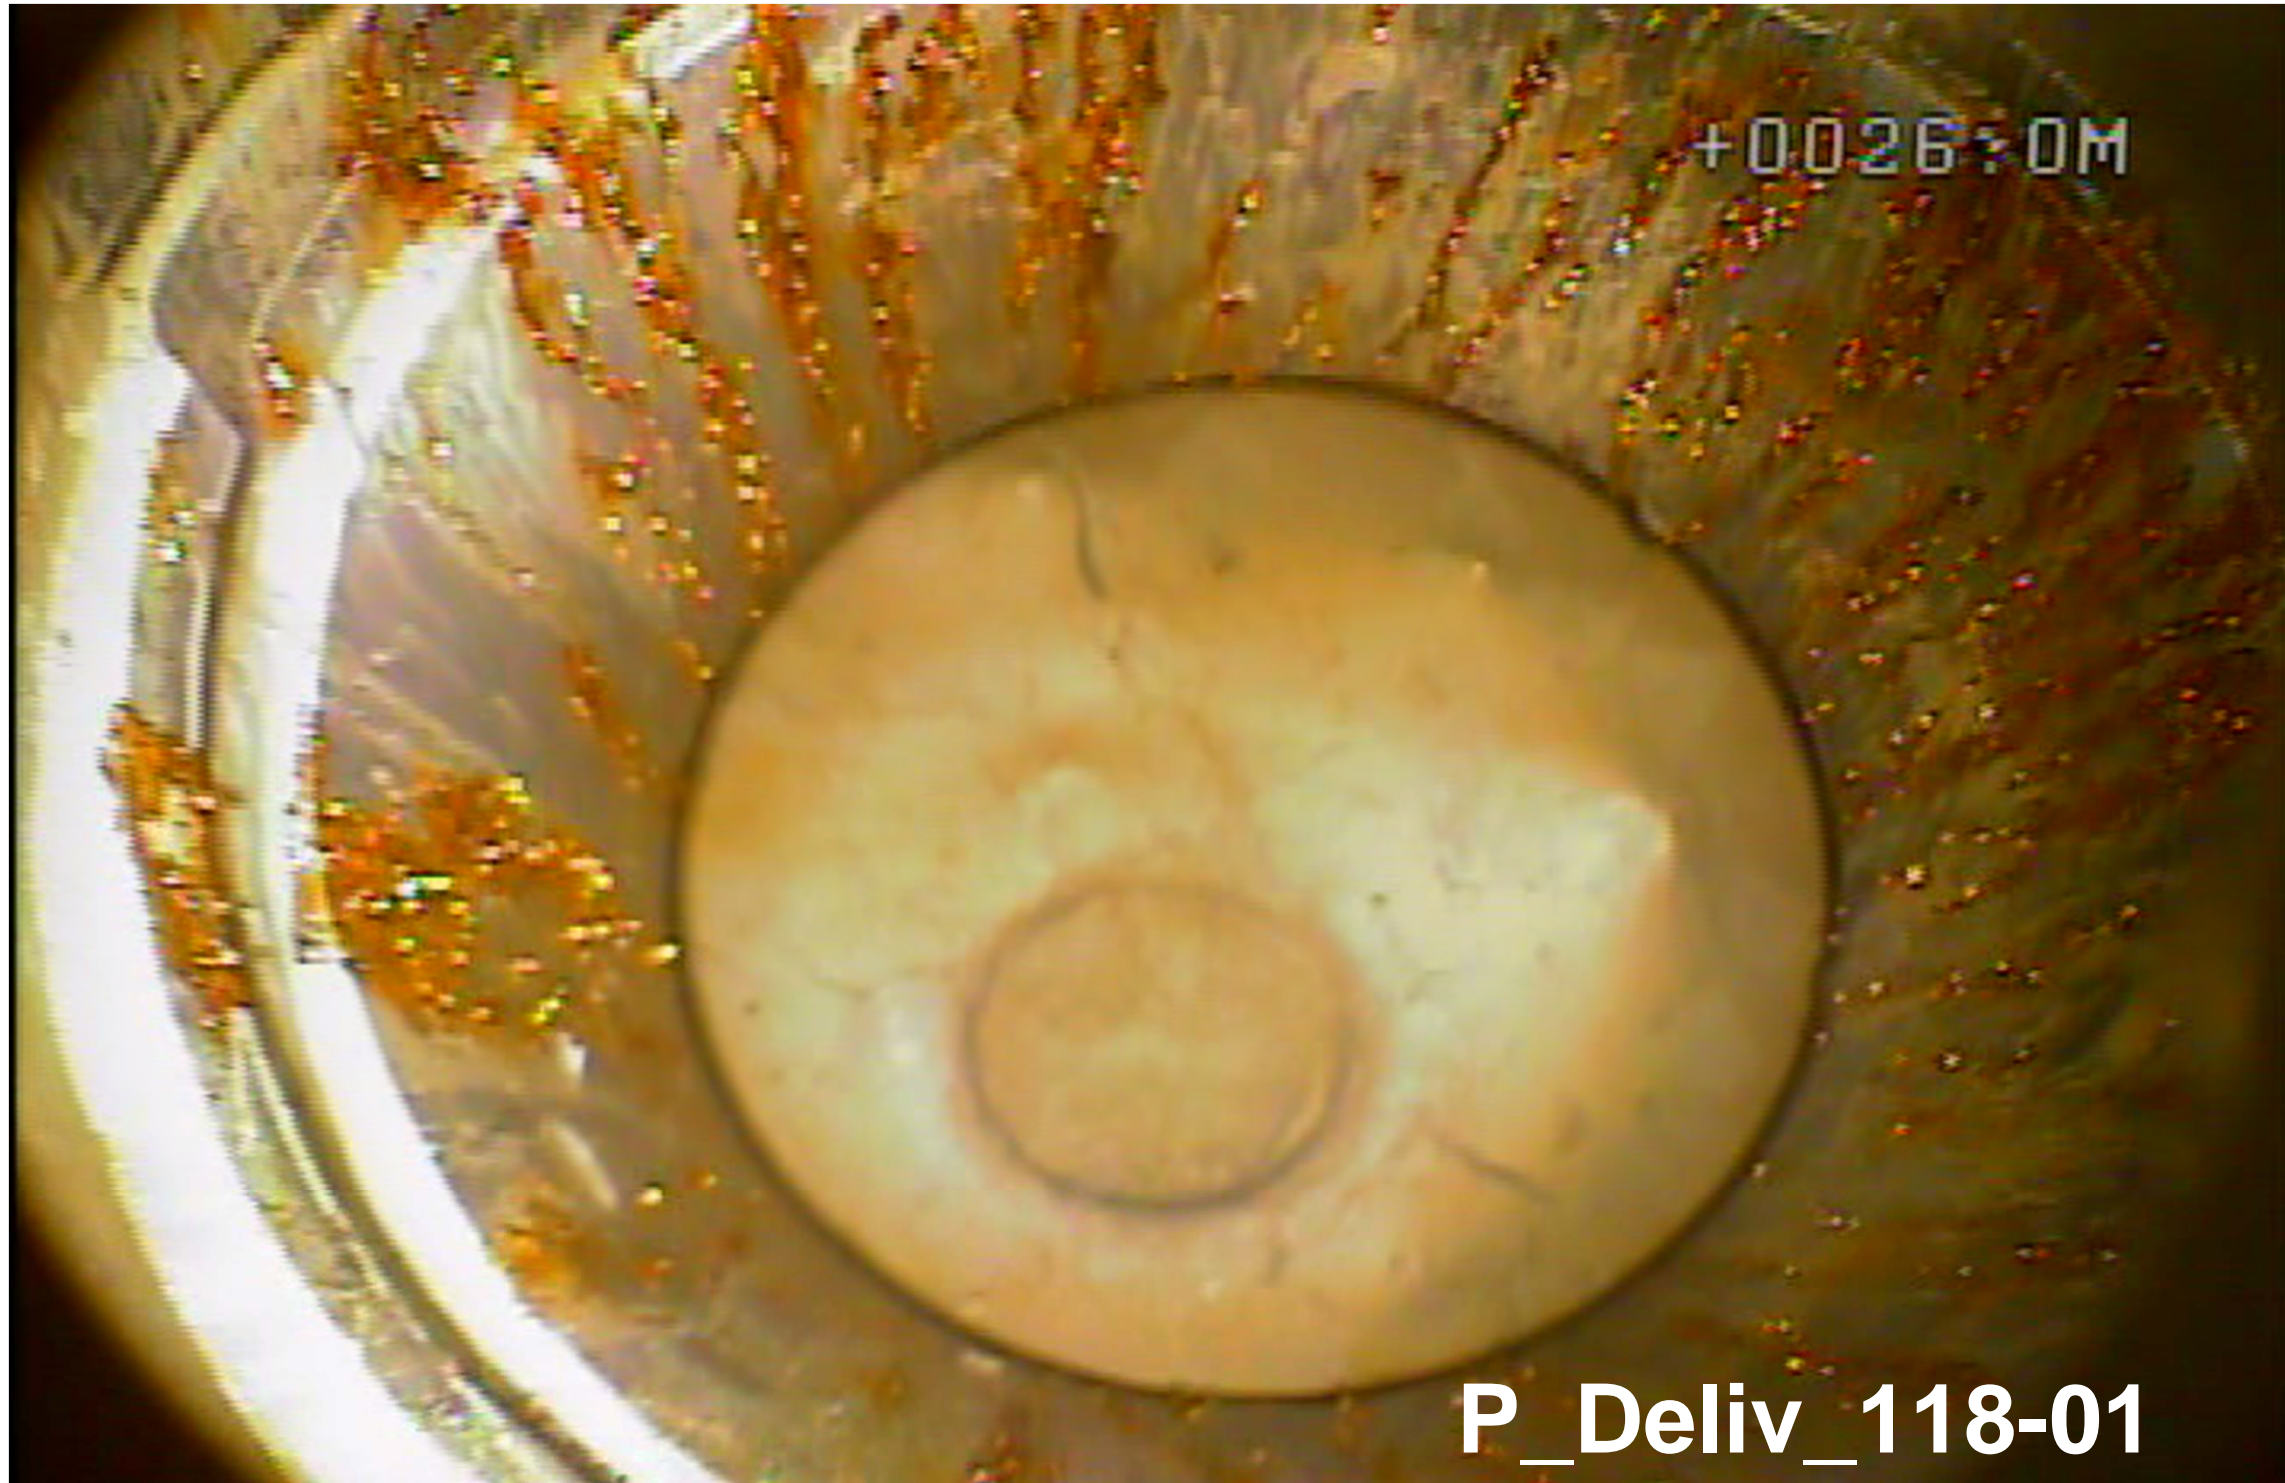
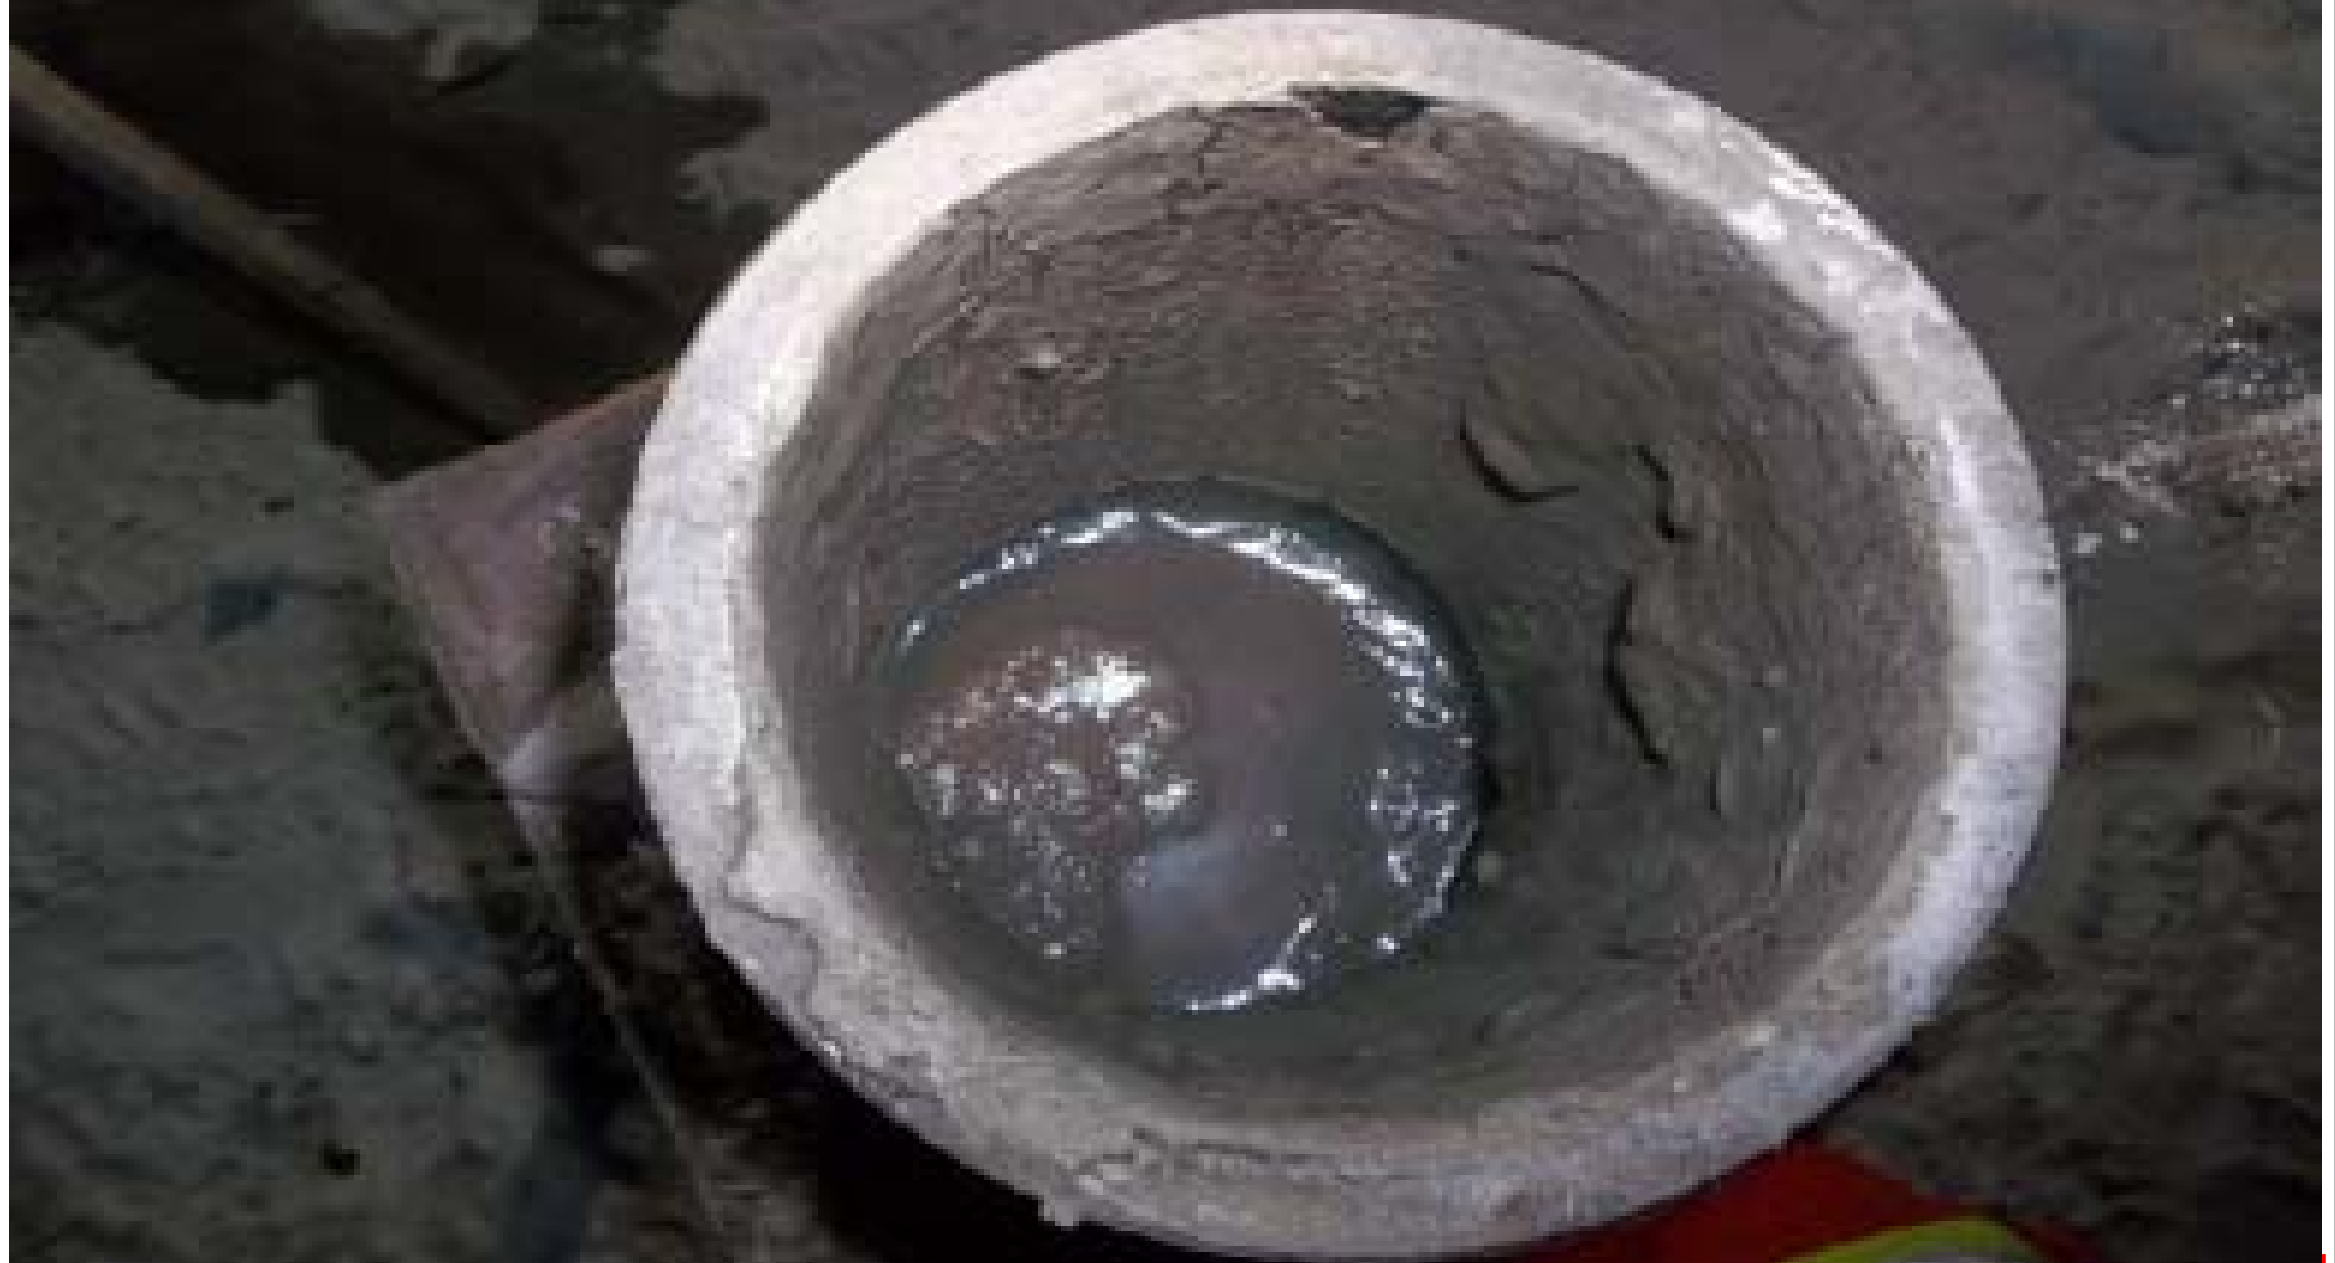
**P\_Deliv\_118-01**

PROJECT		PWGSC					
GIANT MINE INTERIM U/G STABILIZATION PROJECT							
YELLOWKNIFE, NWT							
TITLE		P_Deliv_118_01					
		Paste Delivery Hole full					
 	PROJECT No.	10-1426-0010	PHASE No.	1000			
	DESIGN	DTK	24SEP13	SCALE	N.T.S.	REV.	A
	CADD	DTK/FM	04OCT13				
	CHECK	DTK/FM	29OCT13				
	REVIEW

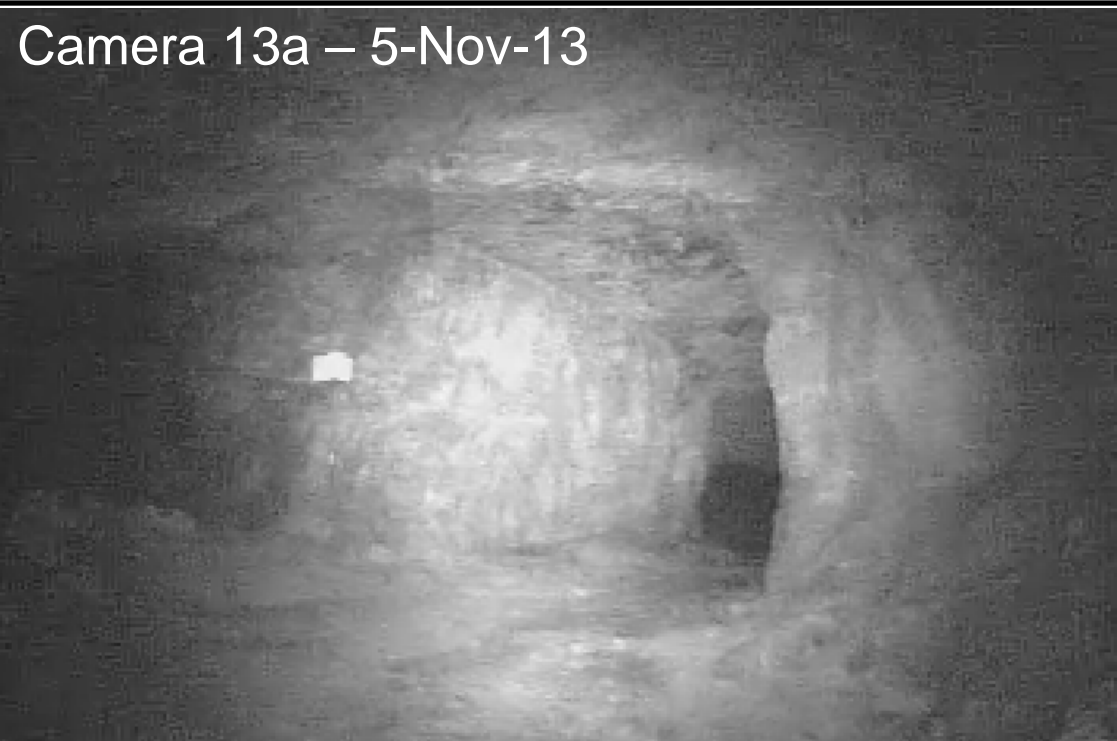
Camera 13a – 5-Nov-13

- Camera 13a is looking at the 1-18 Lower access
- Camera 13b is looking into the back of the inaccessible area in the 1-18 Lower. 13b is installed in the back.
