Title - Sujet SWING BRIDGE REPLACEMENT	
Solicitation No. - N° de l'invitation EB144-150508/A	Amendment No. - N° modif. 002
Client Reference No. - N° de référence du client EB144-15-0508	Date 2014-09-17
GETS Reference No. - N° de référence de SEAG PW-\$PWA-115-5118	
File No. - N° de dossier PWA-4-72016 (115)	CCC No./N° CCC - FMS No./N° VME
Solicitation Closes - L'invitation prend fin at - à 02:00 PM on - le 2014-10-06	Time Zone Fuseau horaire Atlantic Daylight Saving Time ADT
F.O.B. - F.A.B. Plant-Usine: <input type="checkbox"/> Destination: <input checked="" type="checkbox"/> Other-Autre: <input type="checkbox"/>	
Address Enquiries to: - Adresser toutes questions à: Allen (PWA), Tanya	Buyer Id - Id de l'acheteur pwa115
Telephone No. - N° de téléphone (902) 496-5142 ()	FAX No. - N° de FAX (902) 496-5016
Destination - of Goods, Services, and Construction: Destination - des biens, services et construction:

ST. PETERS CANAL SWING BRIDGE
CAPE BRETON ISLAND

Mechanical and Electrical Inspection

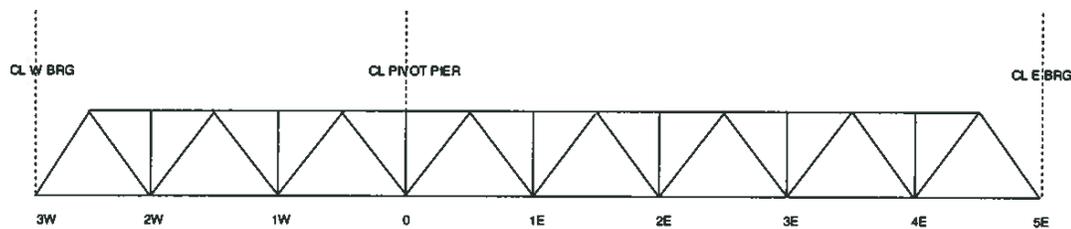
Figure 1- Node Identification

For the purpose of this report, the bridge is considered to be oriented in an east-west direction (east is towards Sydney). The location of the bridge is shown on the Key Plan in Appendix A. The stringers (S) are numbered from S1 to S8 from north to south, except between nodes 2W and 3W (counter weight span), where there are only 6 stringers (numbered S1 to S6 from north to south). The node numbers for the purpose of reference are shown in the following Figure 1 and are adopted from previous reports and drawings.

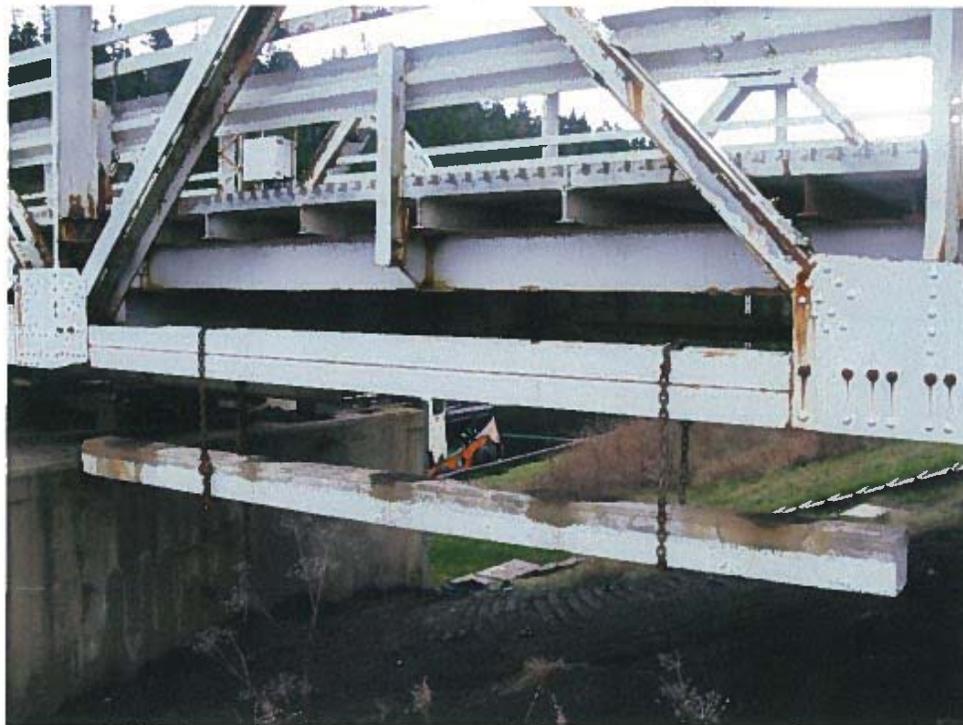
In order to carry out the inspection of the bottom chord along the north truss, the concrete counter weights attached to the bottom chord were lowered (as shown in Photograph 8). This enabled MRC to inspect the condition of the bottom chord.

Photograph 8 – Lowering of concrete counter weights along north truss (typ.).

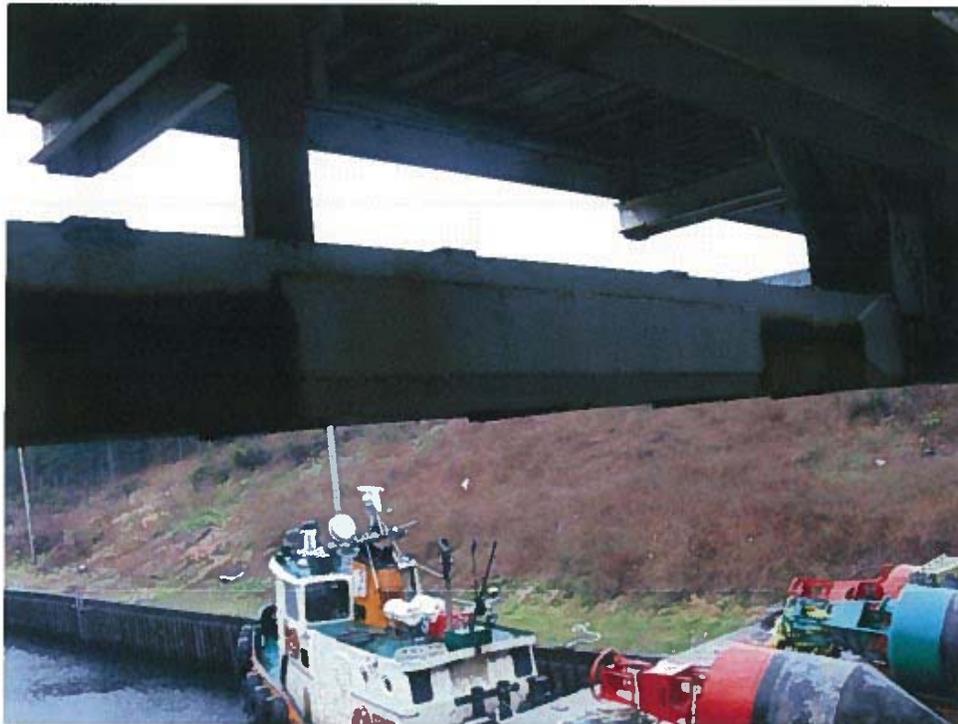
Numerous reinforcements have previously been completed to the north truss components by welding as shown in Photographs 18 and 19. Dynamically loaded structures such as bridges are subjected to variations in forces in the members. Movable bridges are even more unique with stress reversals in many members at some point during the movement of the bridge. Welded repair/reinforcement is generally not desirable in the tension zone, due to fatigue.

As with the north truss a number of reinforcements have been completed to the south truss components by welding. This is shown in Photographs 26 and 27.

Photograph 26 – Welded reinforcement along south truss (between panel points 4E and 5E).

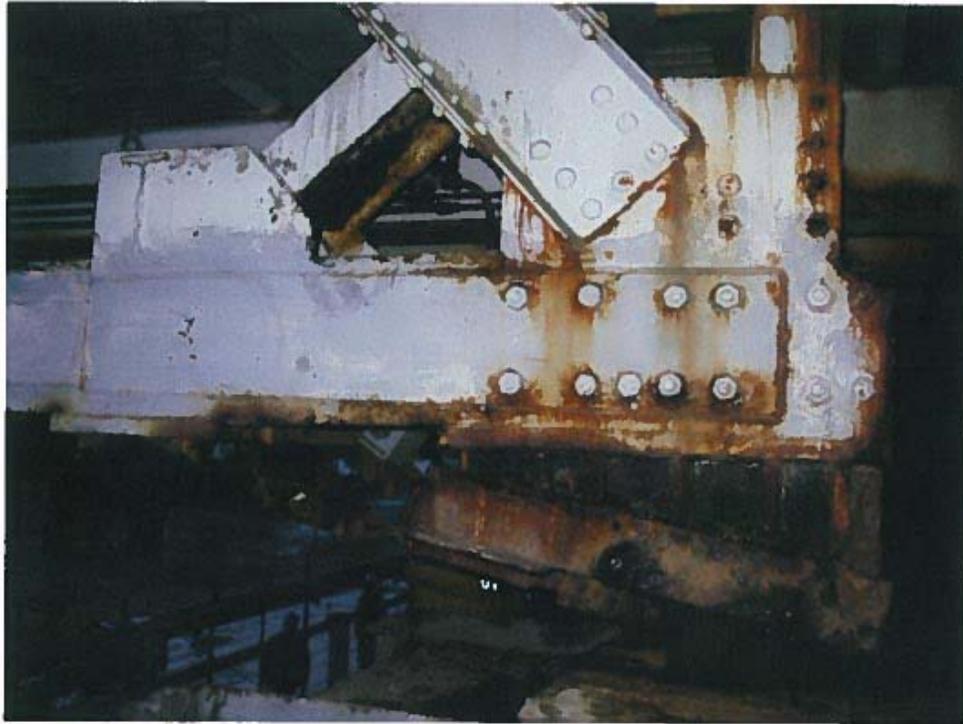
Photograph 27 – Welded reinforcement along south truss at the nose.

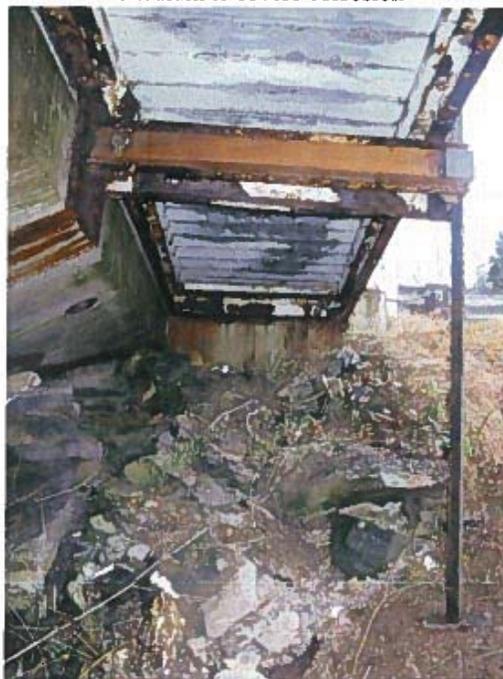
The sidewalk structural steel at the east abutment was noted to be in poor condition with medium to severe corrosion as shown in Photographs 36 and 37. The transverse and the longitudinal steel channels supporting the timber sidewalk have perforations and section loss. At one transverse support location it was noted that a hollow structural section (HSS) was welded to the existing steel anchorage as shown in Photograph 38 and 39. The HSS is supported by a column on the existing ground.

Photograph 38 – Welded reinforcement to existing transverse steel member at the sidewalk near the east abutment.

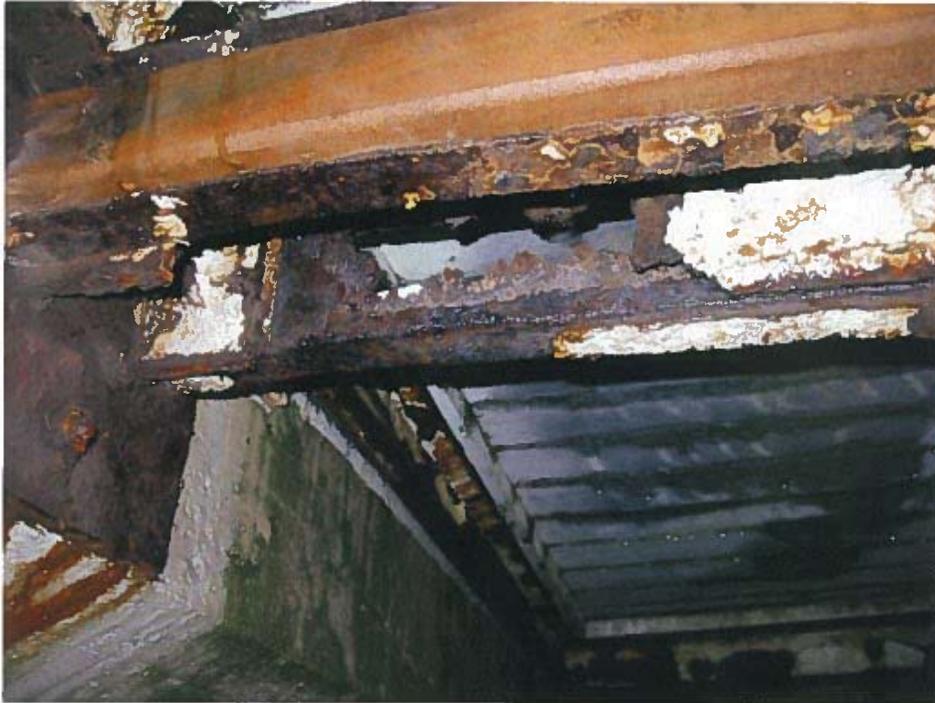
Photograph 39 – Welded reinforcement to existing transverse steel member at east app. sidewalk.
Note: perforation and section loss at existing steel member

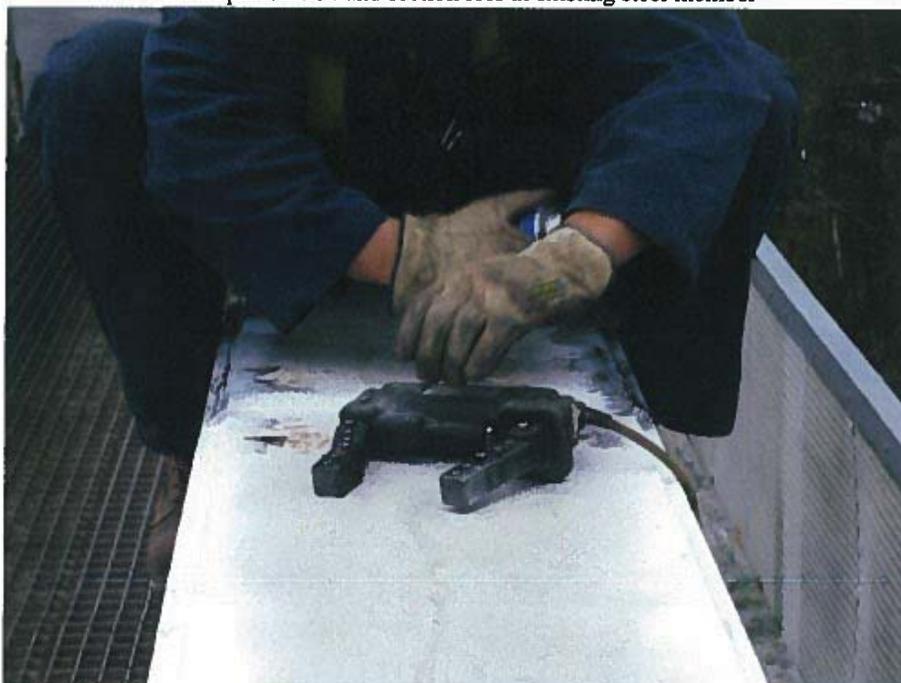
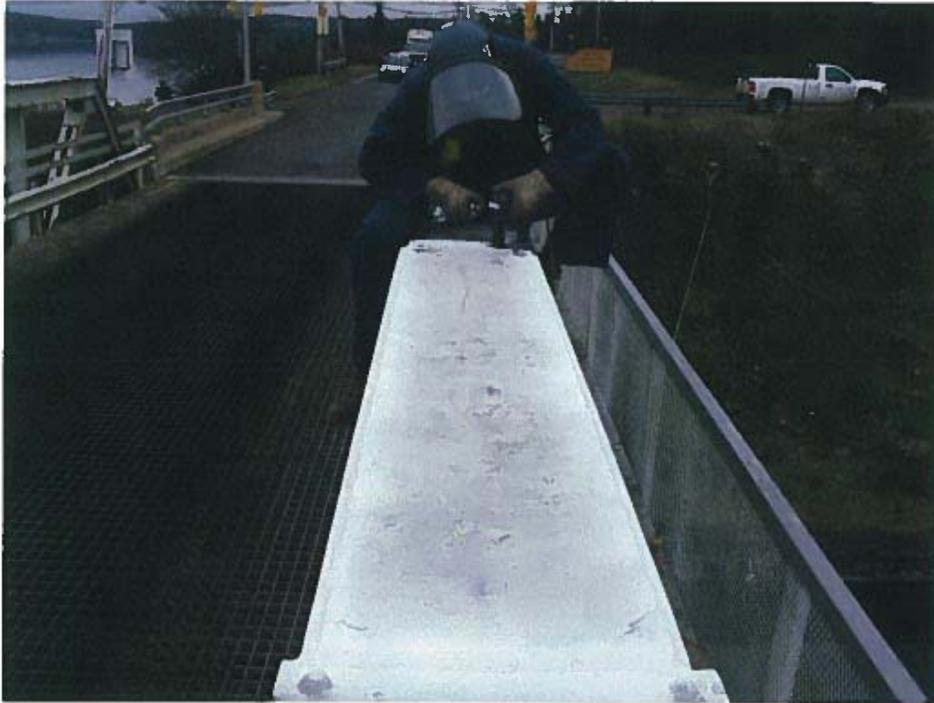
The magnetic particle testing of the welded reinforcements for the south truss top chord between panel points 2W to 3W and 1E to 3E did not indicate any cracks in the welds. Similarly, the welded reinforcements at diagonal members between panel points 2E and 3E at the south truss top chord did not indicate any cracks in the welds when tested for magnetic particle testing. Photographs 40, 41 and 42 show the magnetic particle testing of the welded reinforcements at the south truss top chord and diagonal members.

Photograph 40 – Magnetic particle testing of welded reinforcement at south truss top chord between
panel points 1E and 3E

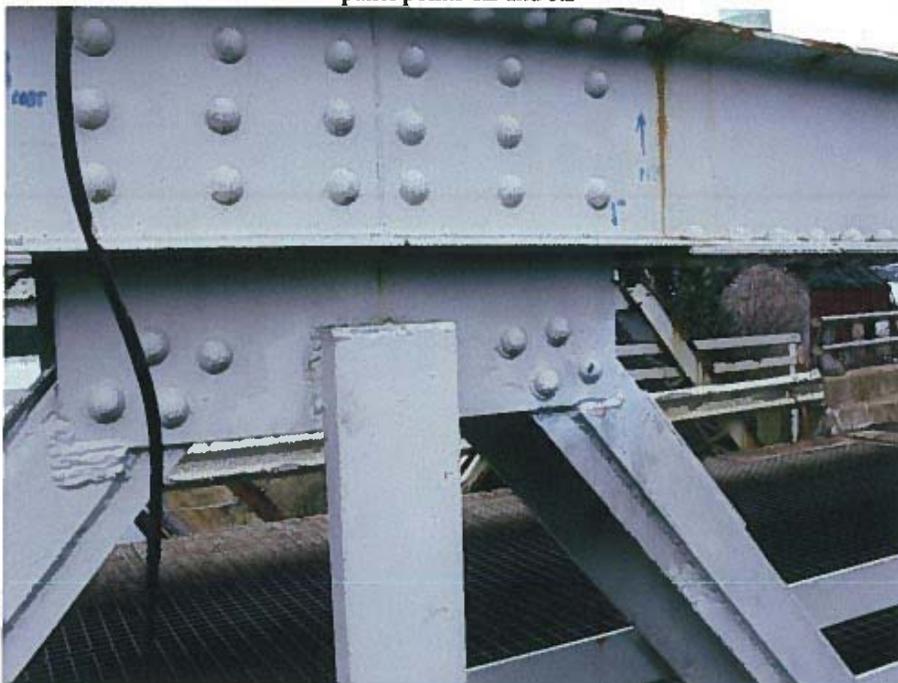
Photograph 42 – Magnetic particle testing of welded connection at the top truss diagonal member.

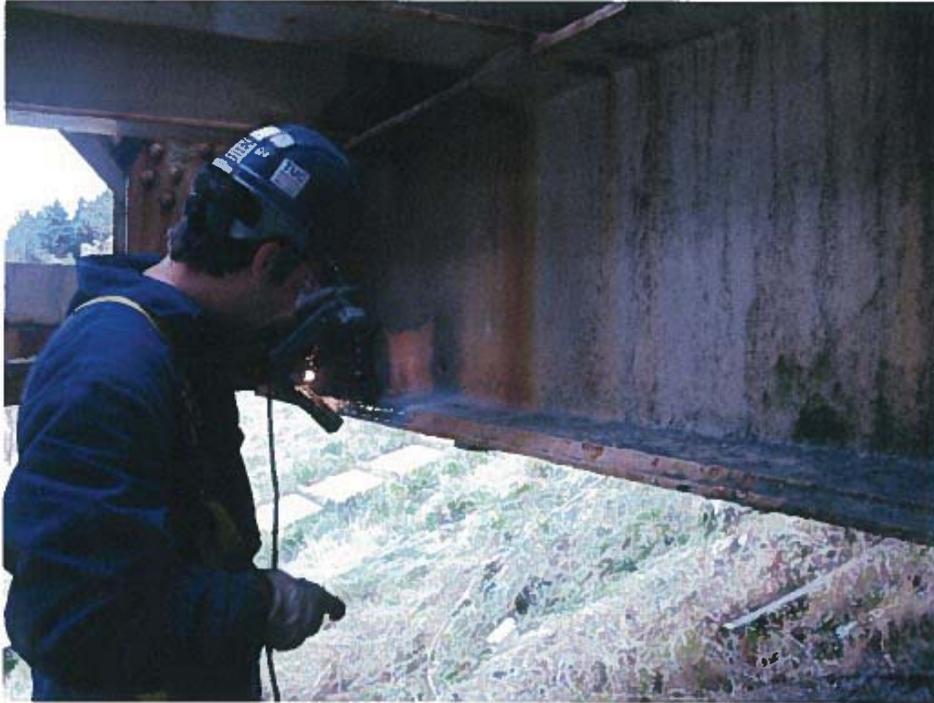
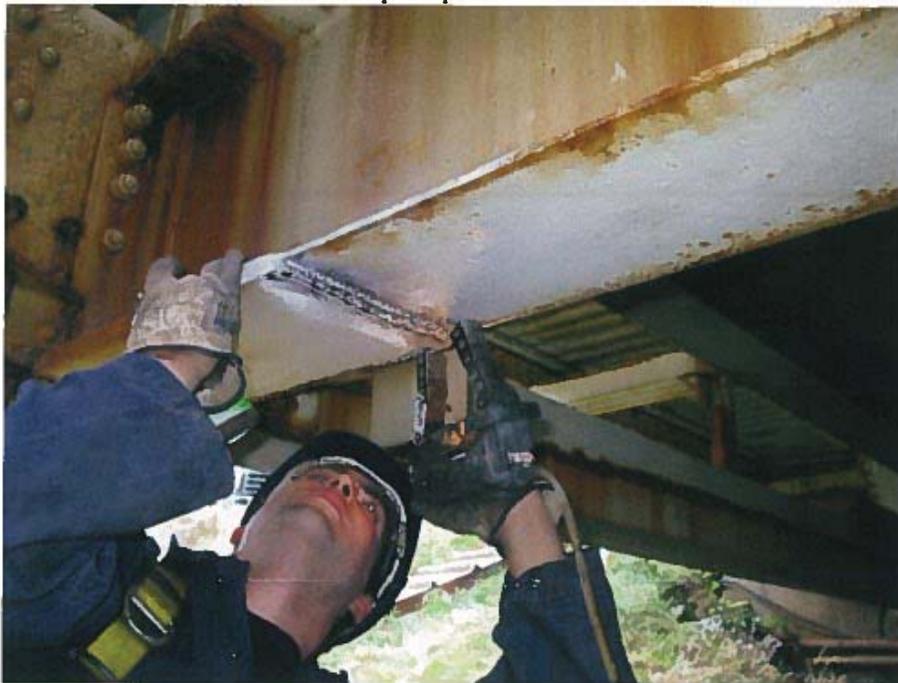
Photograph 45 – Magnetic particle testing of welded reinforcement at bottom flange of floor beam at panel point 2W

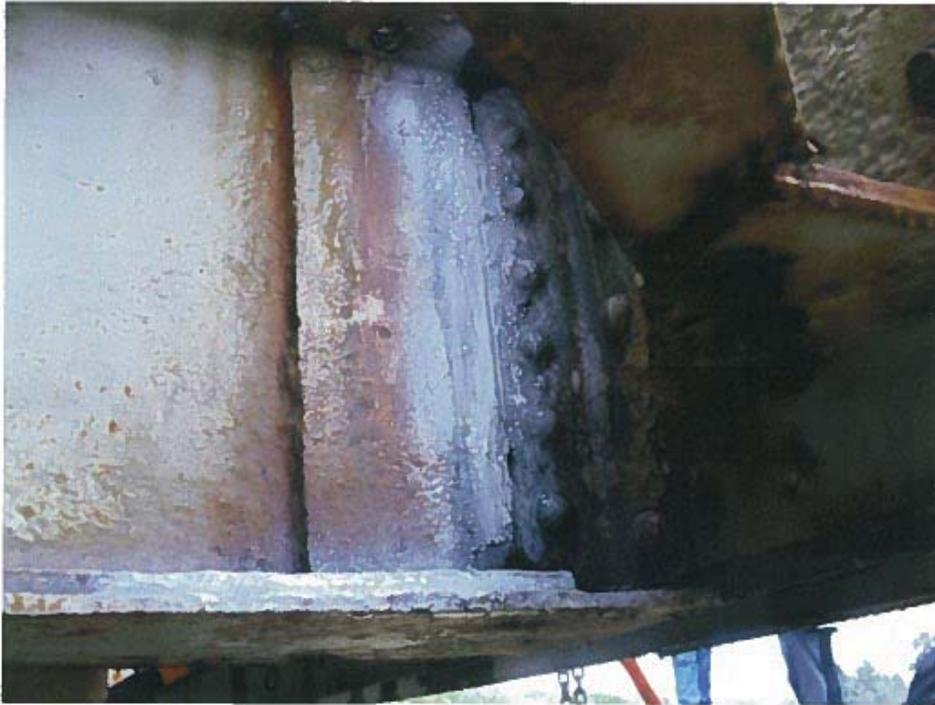
Photograph 47 – Magnetic particle testing of welded reinforcement at the web of the floor beam to the connection angle at panel point 2W.

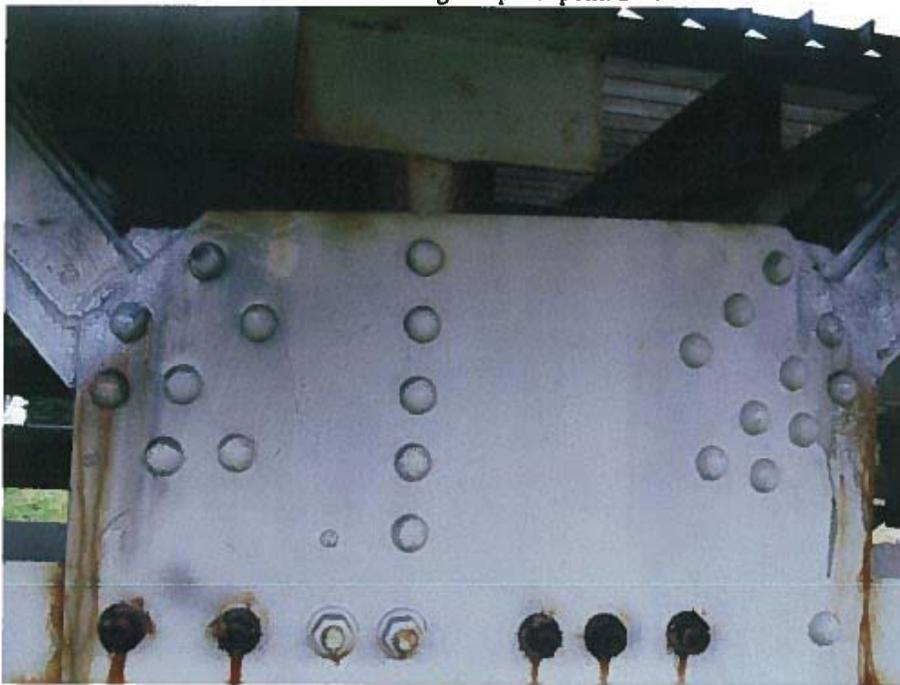
Photograph 48 – Magnetic particle testing of welded reinforcement at the diagonal members at panel point 2W.

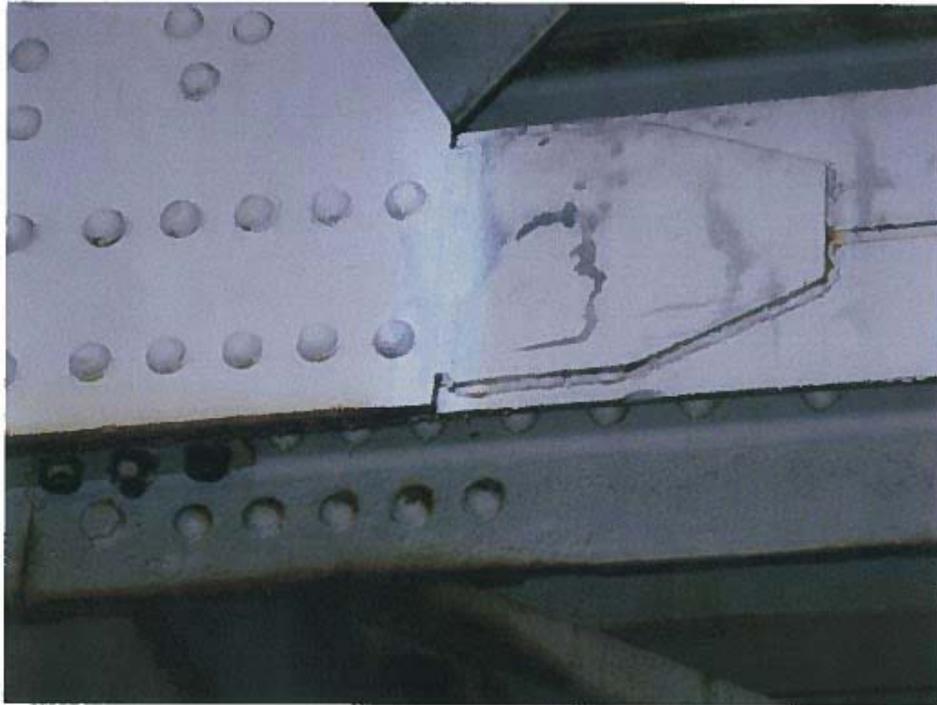
Photograph 49 – Magnetic particle testing of welded reinforcement at panel point 2E south truss bottom chord.

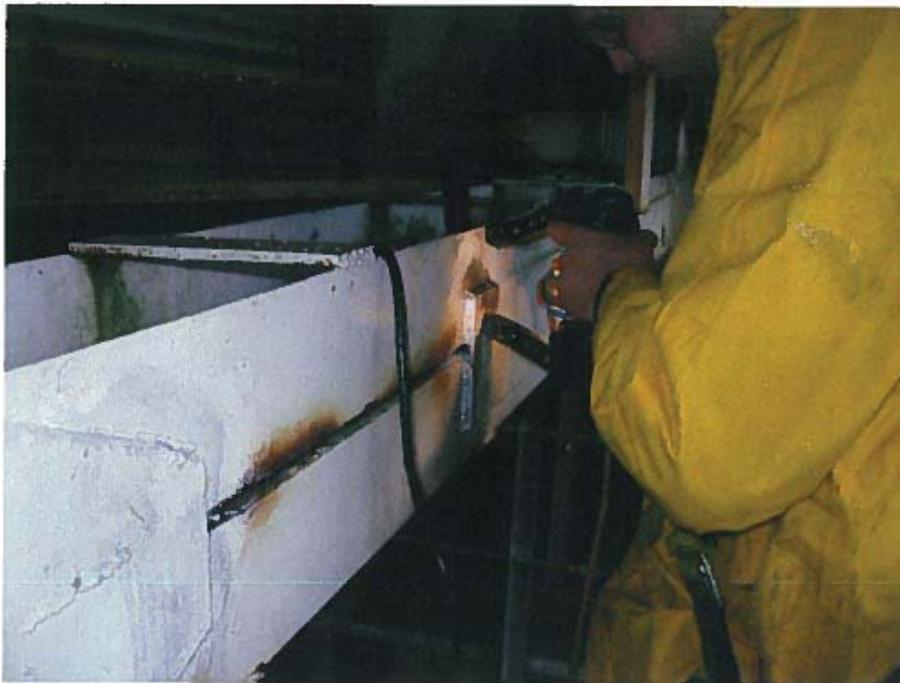
Photograph 50 – Magnetic particle testing of welded reinforcement at south truss bottom chord between panel points 4E and 5E.

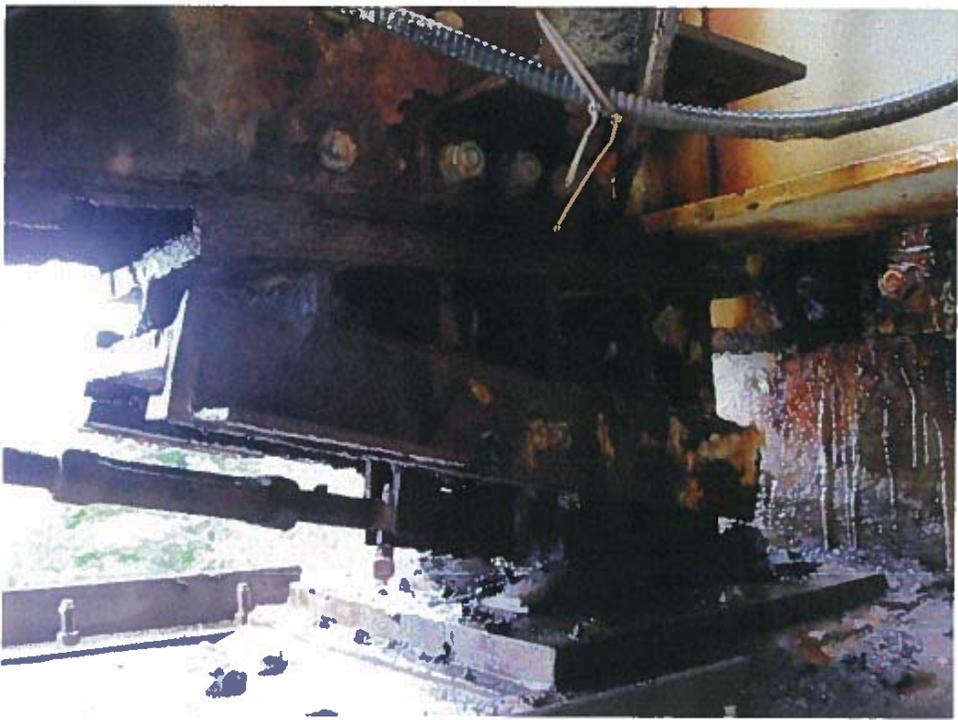
Photograph 2 – North east wedge, note locating feature in wedge and wedge receiver.

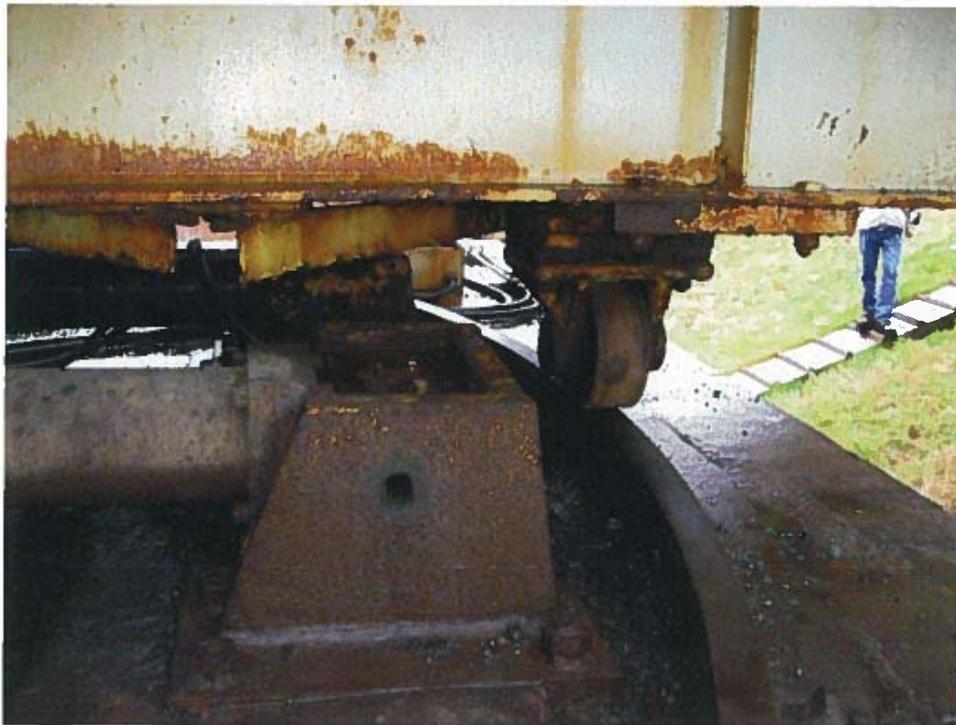
Photograph 12 – East bogey wheel, note number of shims

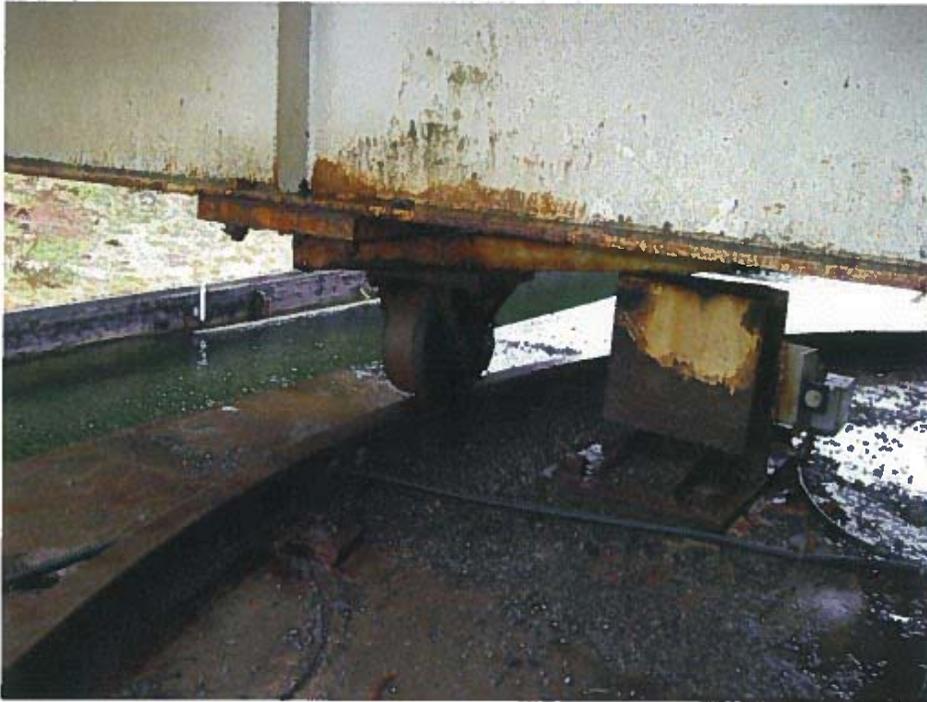
Photograph 13 – Bridge open end stop, note that rubber pad is sandwiched in between steel plates
