Pavement Management Update

# National Parks in Eastern Canada 2010/2011

Dr. D.R. MacLeod P.Eng.

September 2011

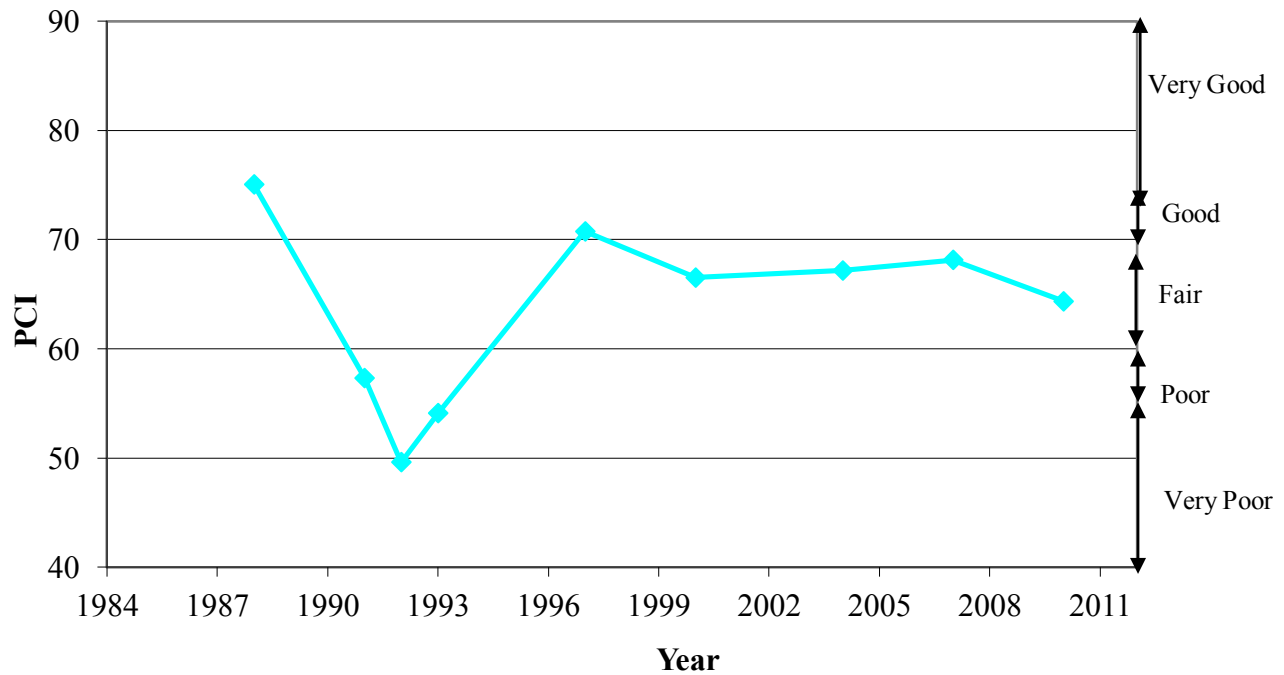
**Figure 2- Condition (PCI) of TCH Terra Nova National Park**

Severe raveling was noted between km 1.9 and 2.7 and moderate raveling in the rest of the section between km 0 and 12.4. The field recommendation for km 0 to 12.4 was for a micro-surface to arrest deterioration due to raveling and correct the rutting as the ridescore on these sections was still adequate. During the early winter of 2010/11, this section of highway began to deteriorate quite rapidly due to disintegration of the mix. This section needs a further detailed study to develop a rehabilitation strategy.

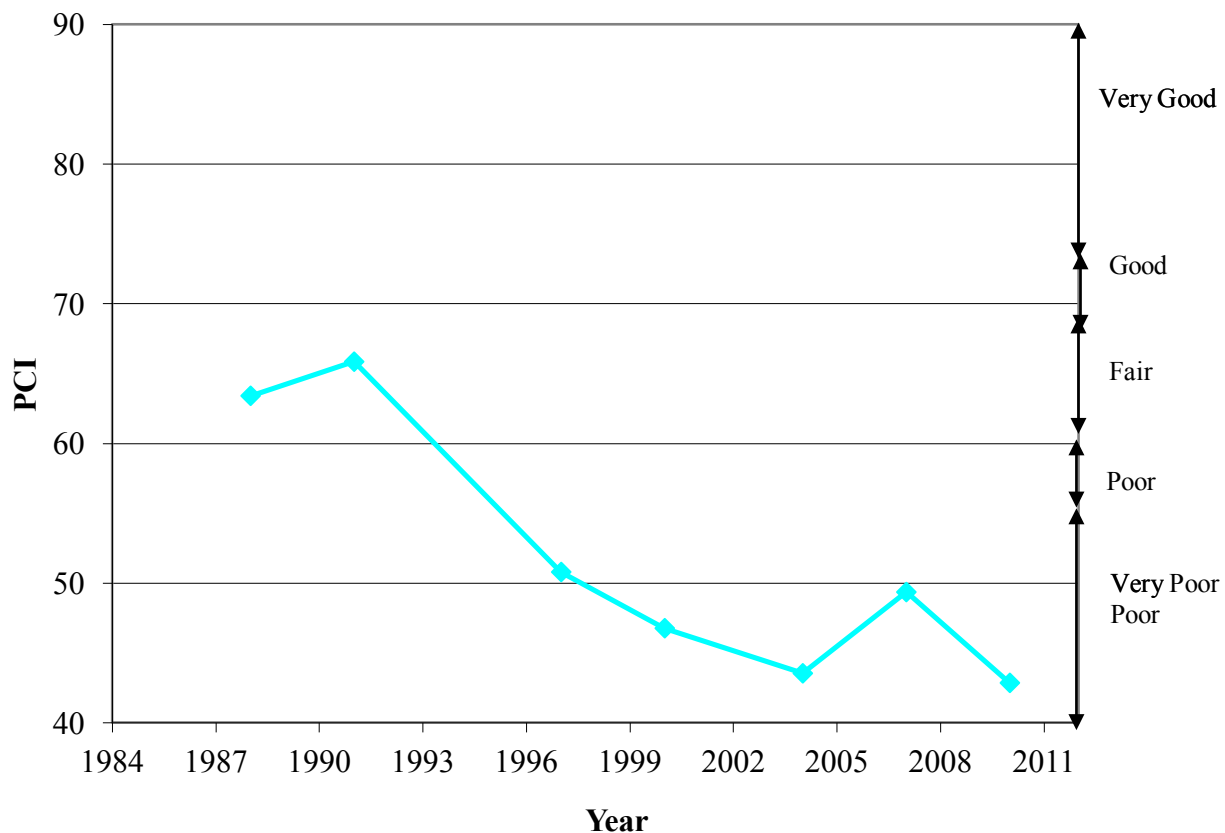
**Figure 4 - Condition (PCI) of Eastport Road, Terra Nova National Park**

This Highway was rated in two sections for a total of 8.16 kilometres. This road is in very poor condition. The ridescores for both sections were low (4 and 4.5) and there was some rutting and wheel track alligator cracking. As far as rehabilitation is concerned some sections could just be overlaid while other sections should be excavated and repaired before paving. This section has numerous frost heaves which makes the winter ridescore even worse. For planning and budgetary purposes the field recommendation for this section is major rehabilitation in less than 2 years.

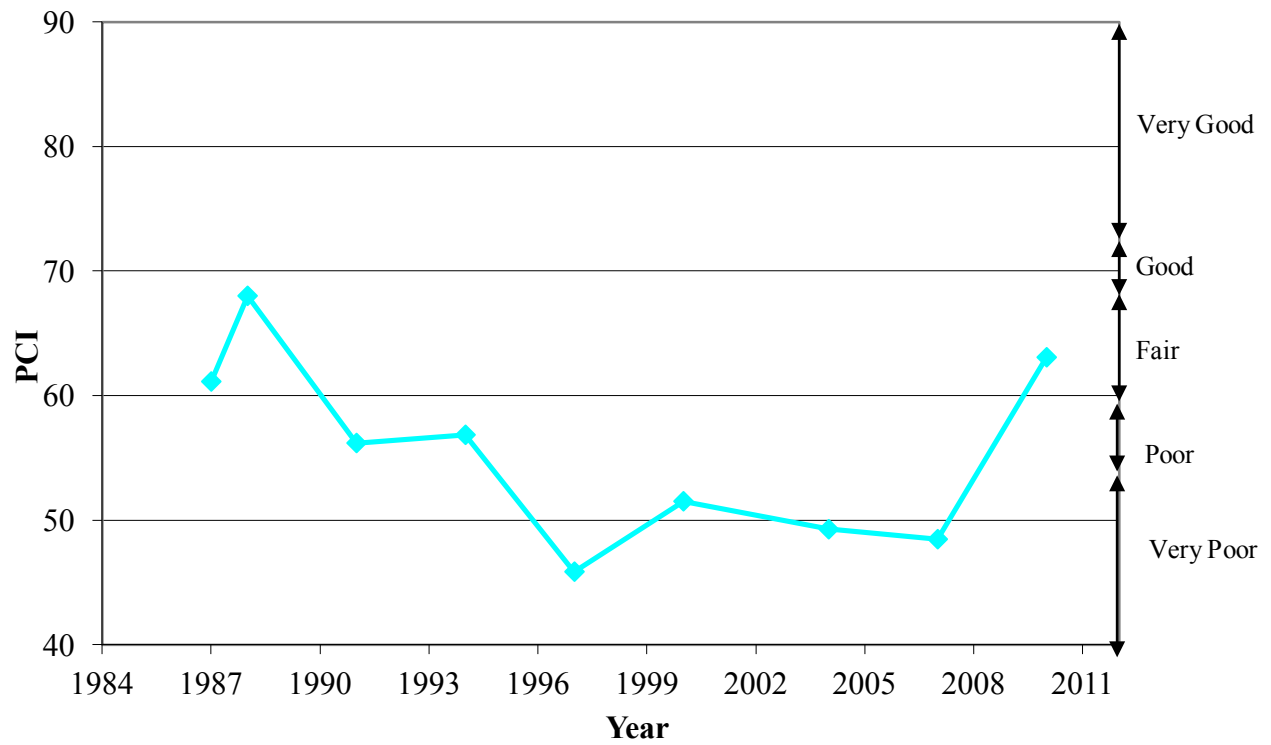
**Figure 5- Condition (PCI) of Hwy 114, Fundy National Park**

This section has been reconstructed in 2009 and no further rehabilitation work is foreseen

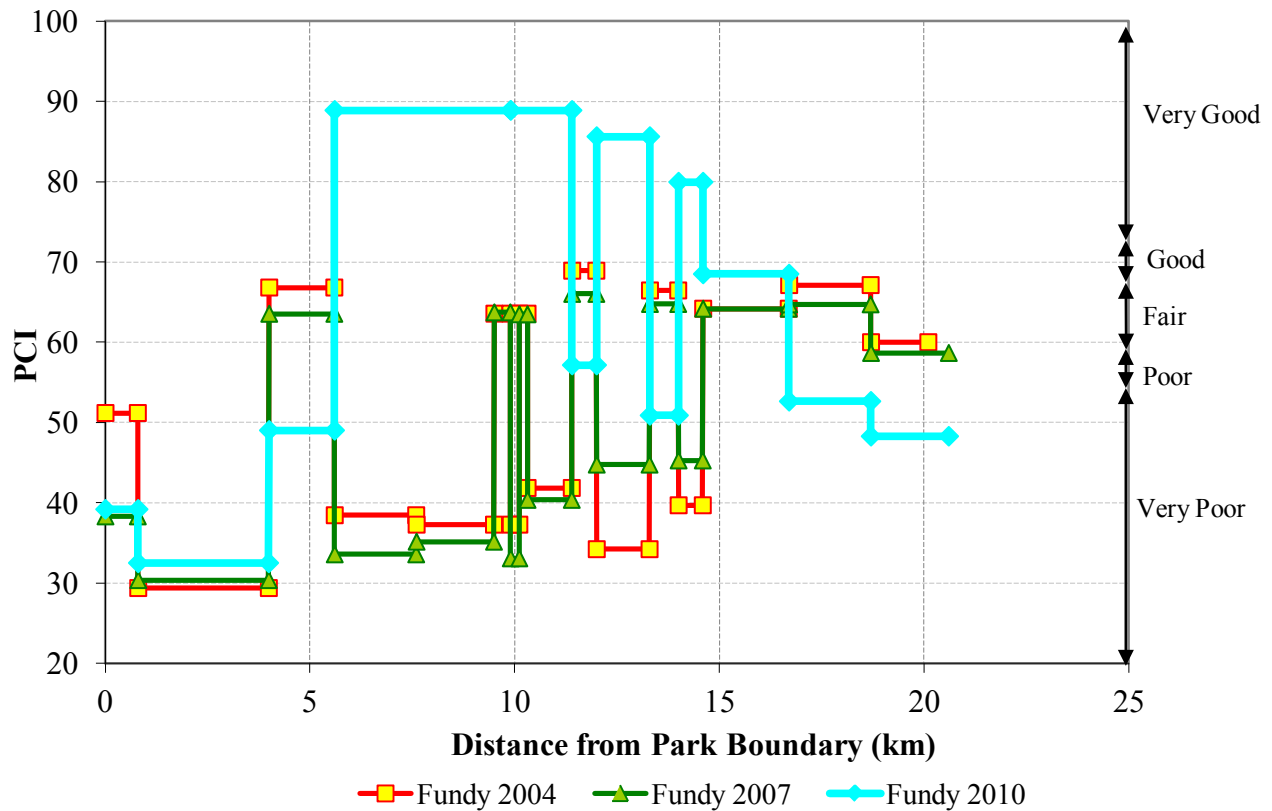
**Figure 6- Hwy 114, Fundy National Park  
( km 0 is at Alma Park Boundary)**

This is a 14 year old pavement with a significant amount of moderate cracking but the ride score is still adequate. Routine maintenance or a chip seal to seal some of the cracks could be considered.

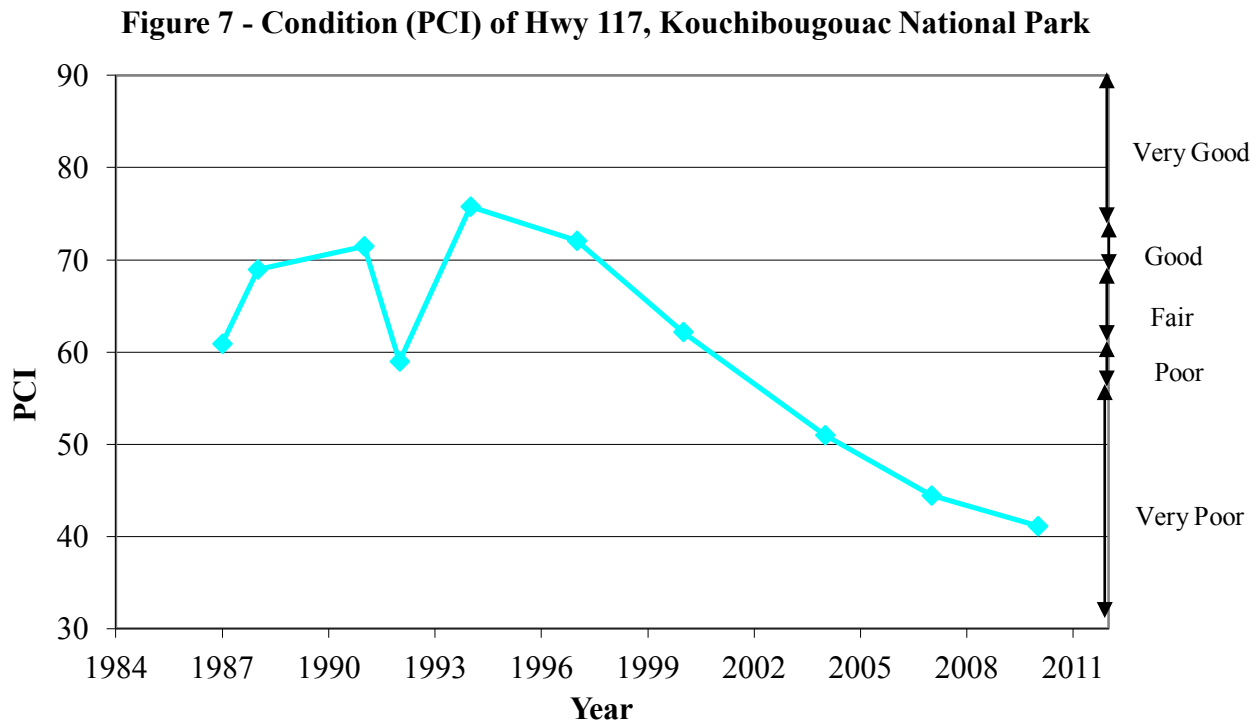
Highway 117 in Kouchibouguac National Park was rated in three sections for a total of 23.7 kilometres. The entire highway is in very poor condition.

Highway 117 in Kouchibouguac National Park had a significant improvement in PCI from 1992 to 1994 but has been on the decline since that time with a PCI of 41.1 in 2010. (Figure 7)

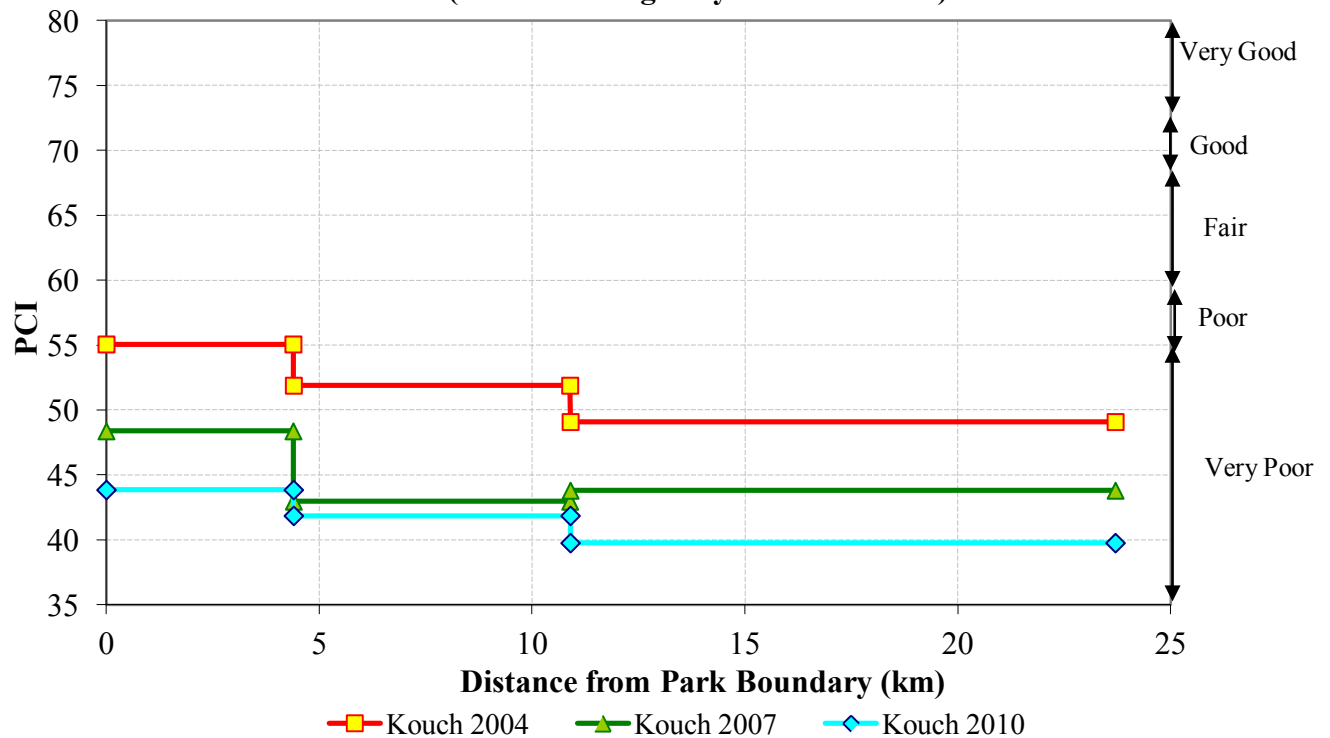
**Figure 8- Hwy 117, Kouchibougouac National Park  
( km 0 is at Highway 11 Intersection)**

Severe bleeding, severe rutting and severe wheel track cracking are the major distresses in this section as they exceed the maximum values for safety criteria. The main resurfacing issue is due to the severity of the rutting distresses. In addition, the gravel shoulders should be raised, as there is a significant drop-off at the pavement edge. The field recommendation for this section is resurface in less than two years.

There is a sharp drop off from the edge of the pavement which is safety concern and as a result of this large drop to the gravel shoulder from the pavement. There is some edge cracking occurring due to lack of support of the pavement edge. Rutting and wheel track alligator cracking in this section are severe and extensive leading to the field recommendation of major rehabilitation within 2 years.

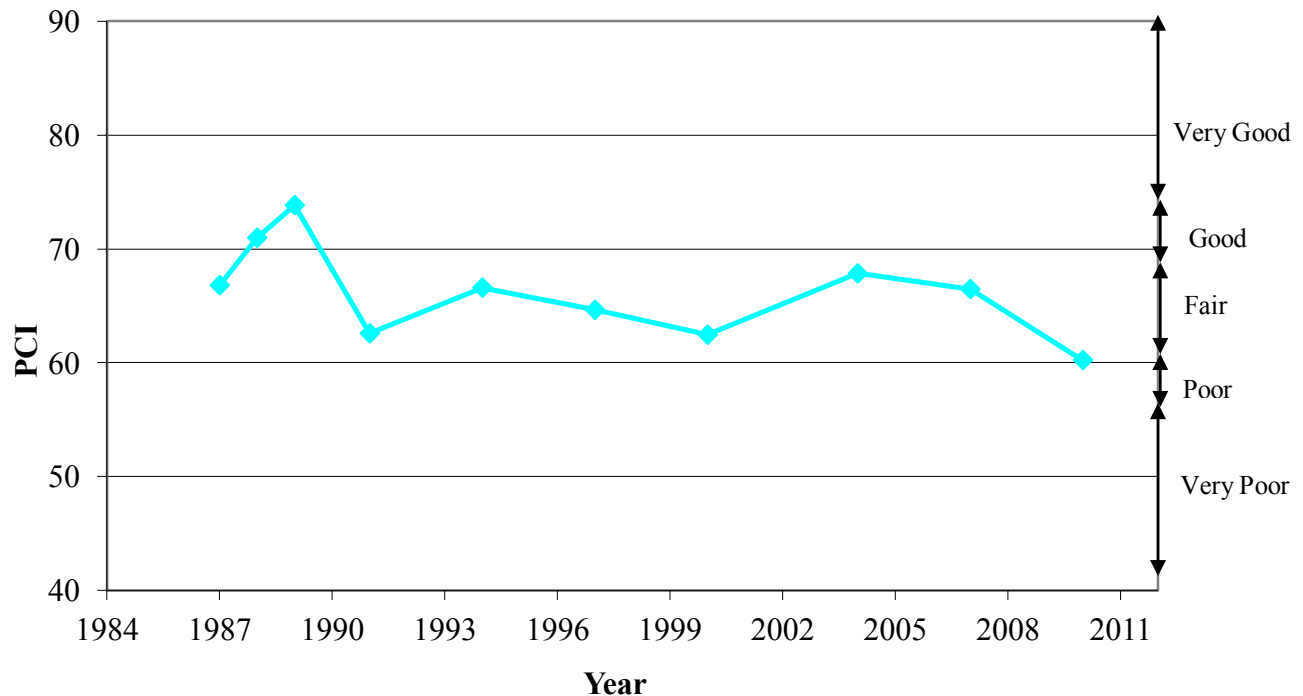
**Figure 9 - Condition (PCI) of Hwy 430 , Gros Morne National Park**

This highway (Figure 9) has maintained a PCI above 60 from 1991 to 2000 with an improvement PCI in 2004. A paving project in 2004 resulted in a noticeable improvement in PCI in 2004. (Figures 9 and 10)

This highway has deteriorated significantly since 2007 as the PCI has dropped from 66.5 to 60.2. The main reasons for this decrease was significant increase in wheel track and centreline cracking and severe meander cracking and a resulting decrease in the ride score.

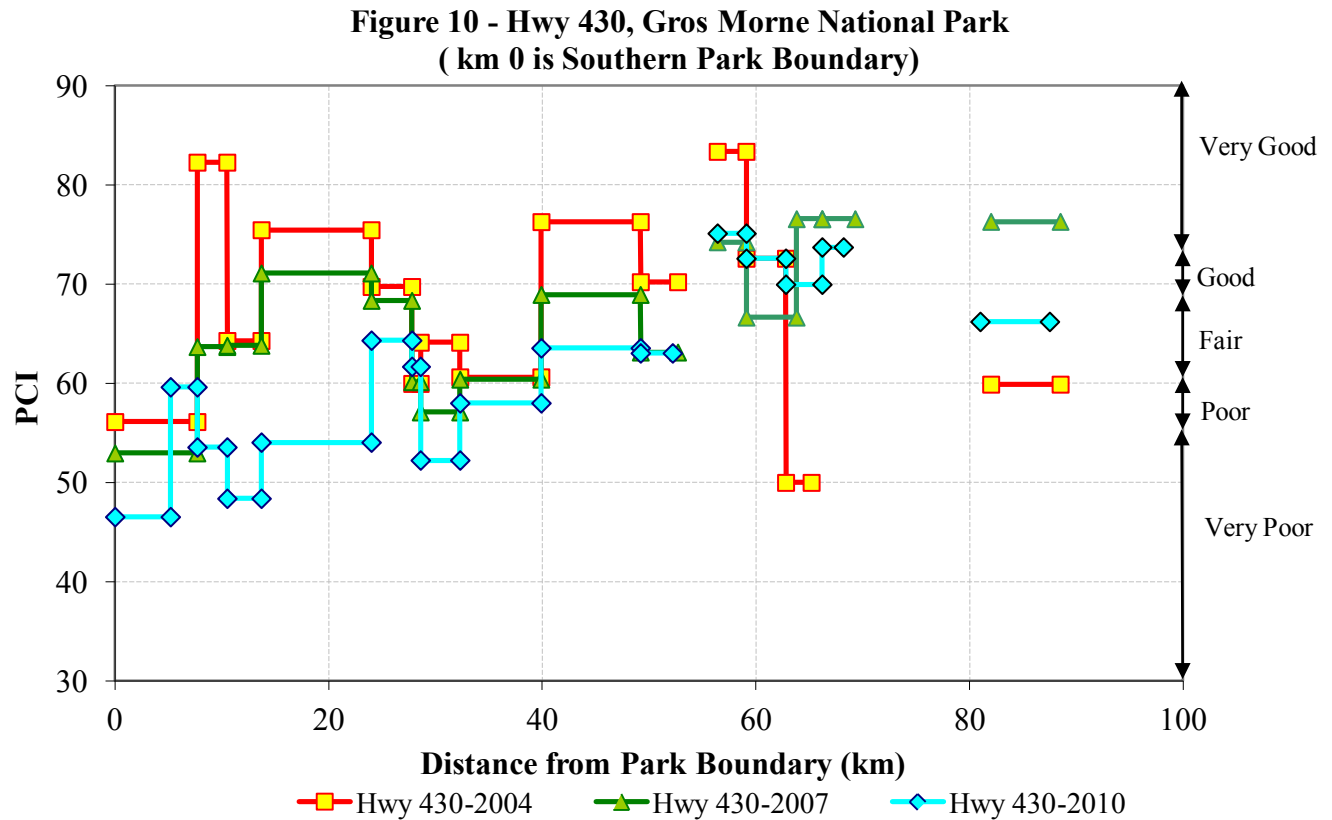
With the exception of km 10.5 to 13.5 these pavements are 6 to 7 years old. The section between km 10.5 and 13.5 has some severe ravelling and severe wheel track cracking, however the ride score is acceptable (5.25) and should be programmed for rehabilitation within the next three years. The remaining pavements in this section are in fair condition with a few severe ravelled sections and a few severe cracks but with good ridescores and with increased maintenance should not

This section has a few severe distortions, intermittent severe wheel track cracking, and requires significant repairs or rehabilitation.

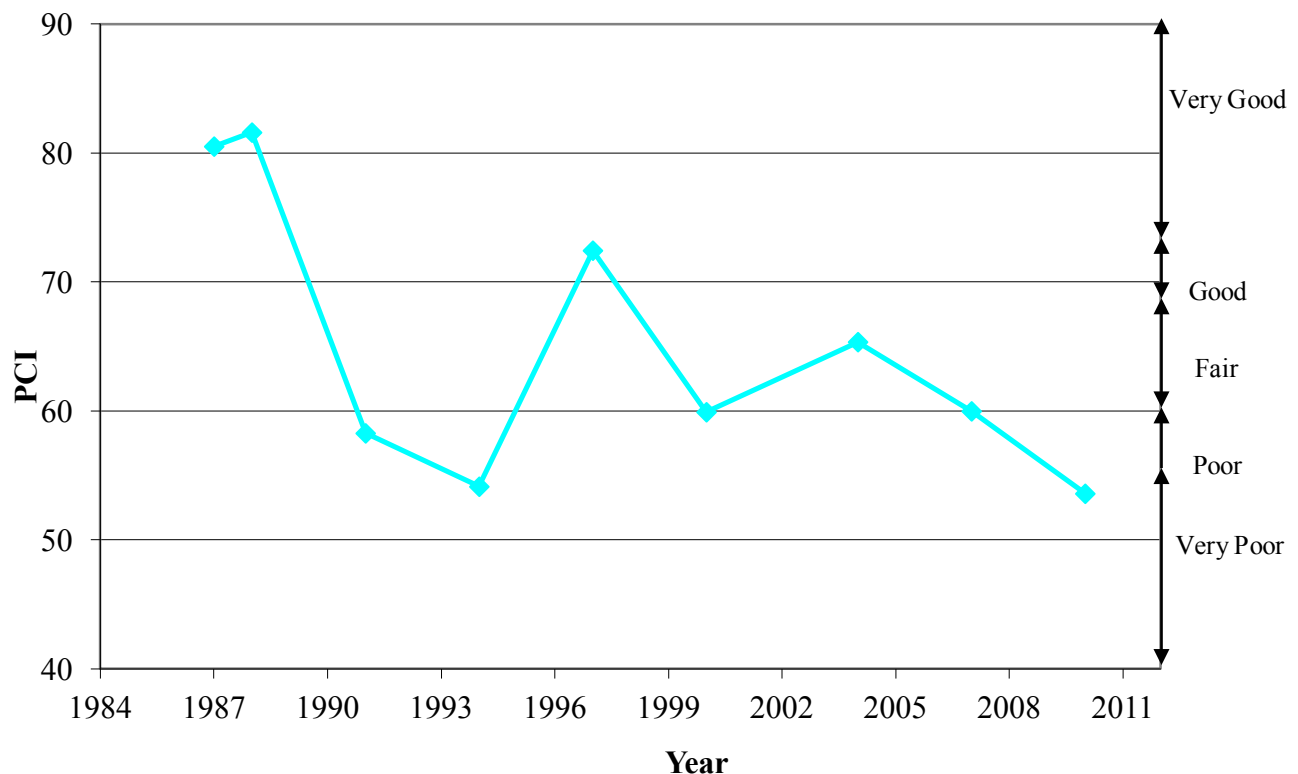
**Figure 11- Condition (PCI) of Hwy 431, Gros Morne National Park**

Highway 431 in Gros Morne National Park was rated in 4 sections for a total of 28.3 kms and overall is in poor condition. (Figures 11 and 12). Approximately, 60% in fair condition, and 40% in very poor condition. There was an improvement in 2004 due to new pavement on several sections of the highway but the PCI has decreased to 53.5 in 2010.

This seven year old pavement is showing extensive ravelling damage. The ravelling should be repaired as a priority with a micro-surface or chipseal

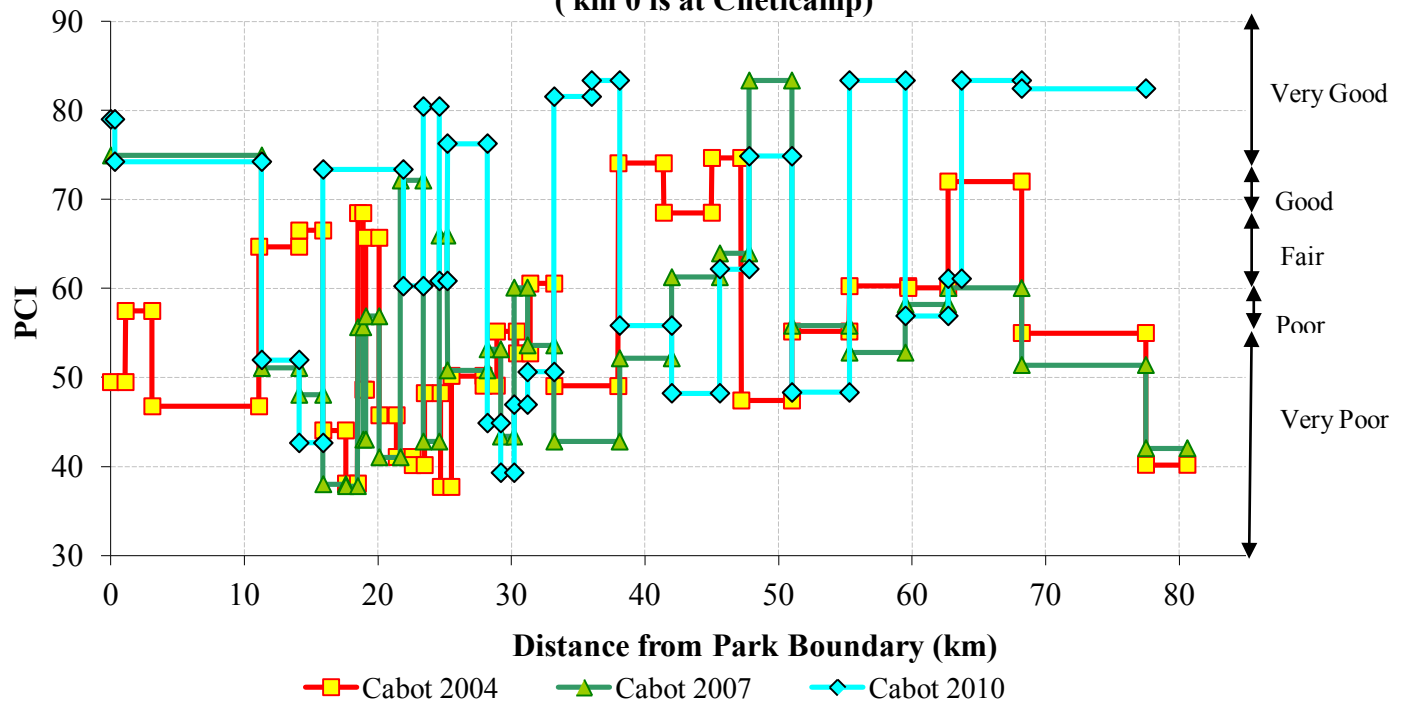
**Figure 14 - Cabot Trail, Cape Breton Highlands National Park  
( km 0 is at Cheticamp)**

This section is in very poor condition ravelling, some rutting, wheel track alligator cracking and poor ride quality are the major distresses in these sections. The field recommendation for this section is a major rehabilitation in less than 2 years.

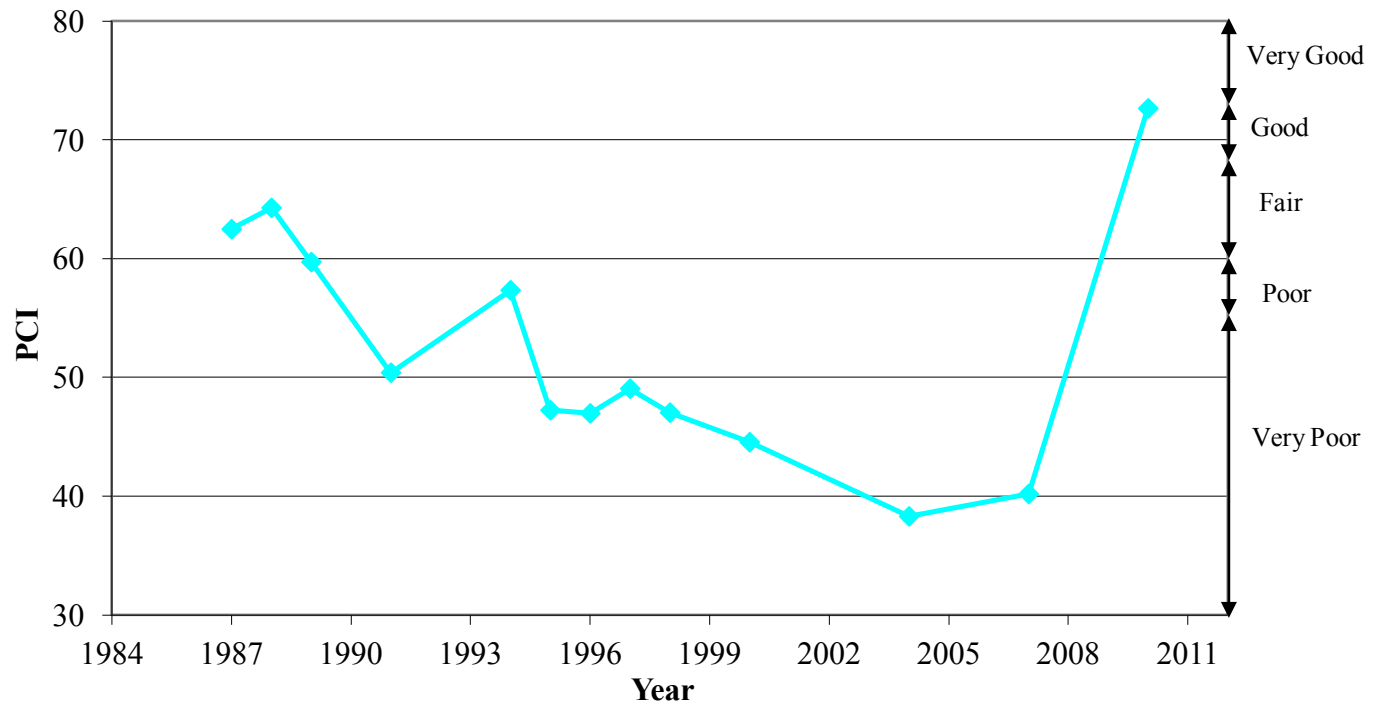
**Figure 15 - Condition (PCI) of The Gulf Shore Road, PEI National Park**

The Gulf Shore Road in Prince Edward Island National Park was rated in 10 sections for a total of 26.4 kilometres. Approximately 60% of the pavements are in good or very good condition, 20% in fair condition and 20% in very poor condition. See figures 15 and 16 for a graphical representation of the pavement condition.

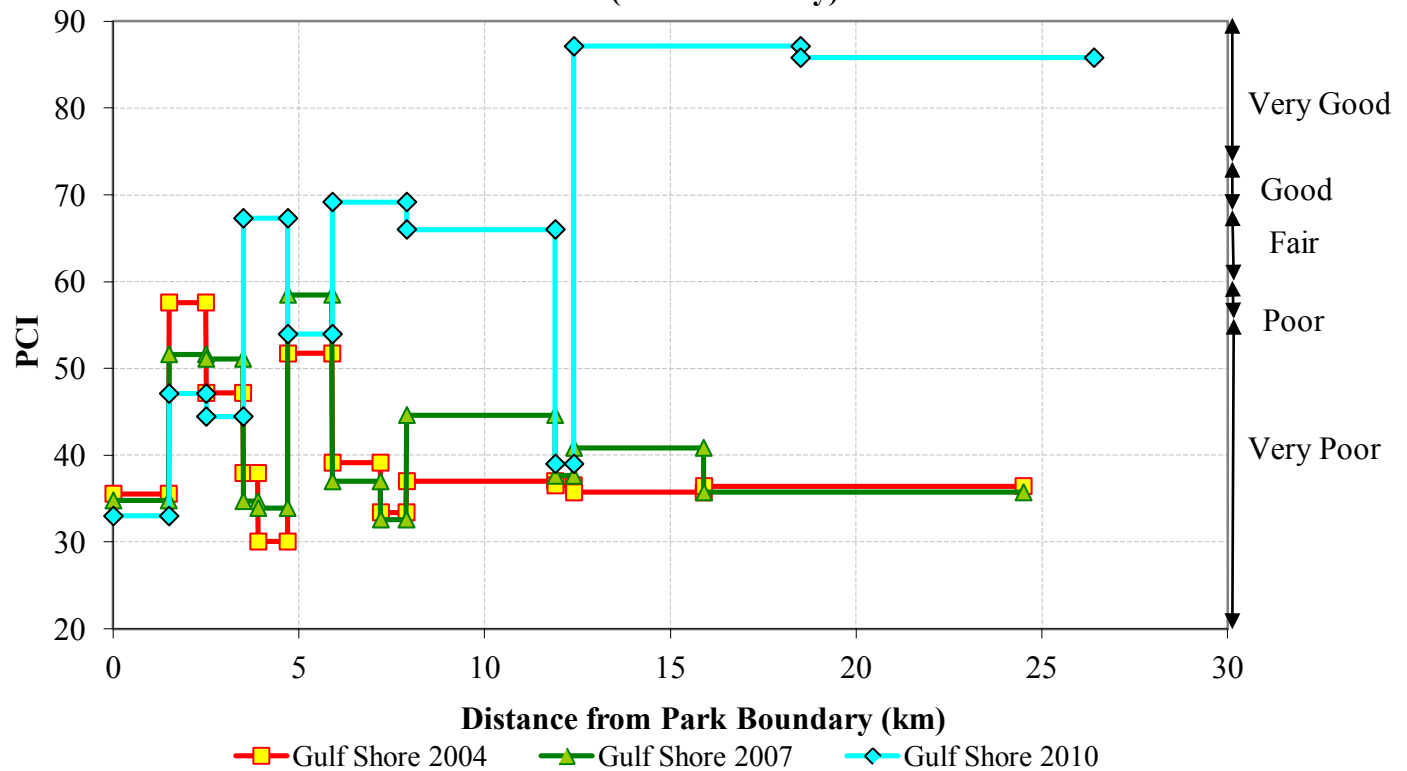
**Figure 16 - Gulf Shore Road, PEI National Park  
( km 0 is Dalvay)**

Ravelling, rutting, wheel track cracking transverse alligator and meander cracks and poor ride scores are a concern in all these sections. The field recommendation for these sections is major rehabilitation within two years.

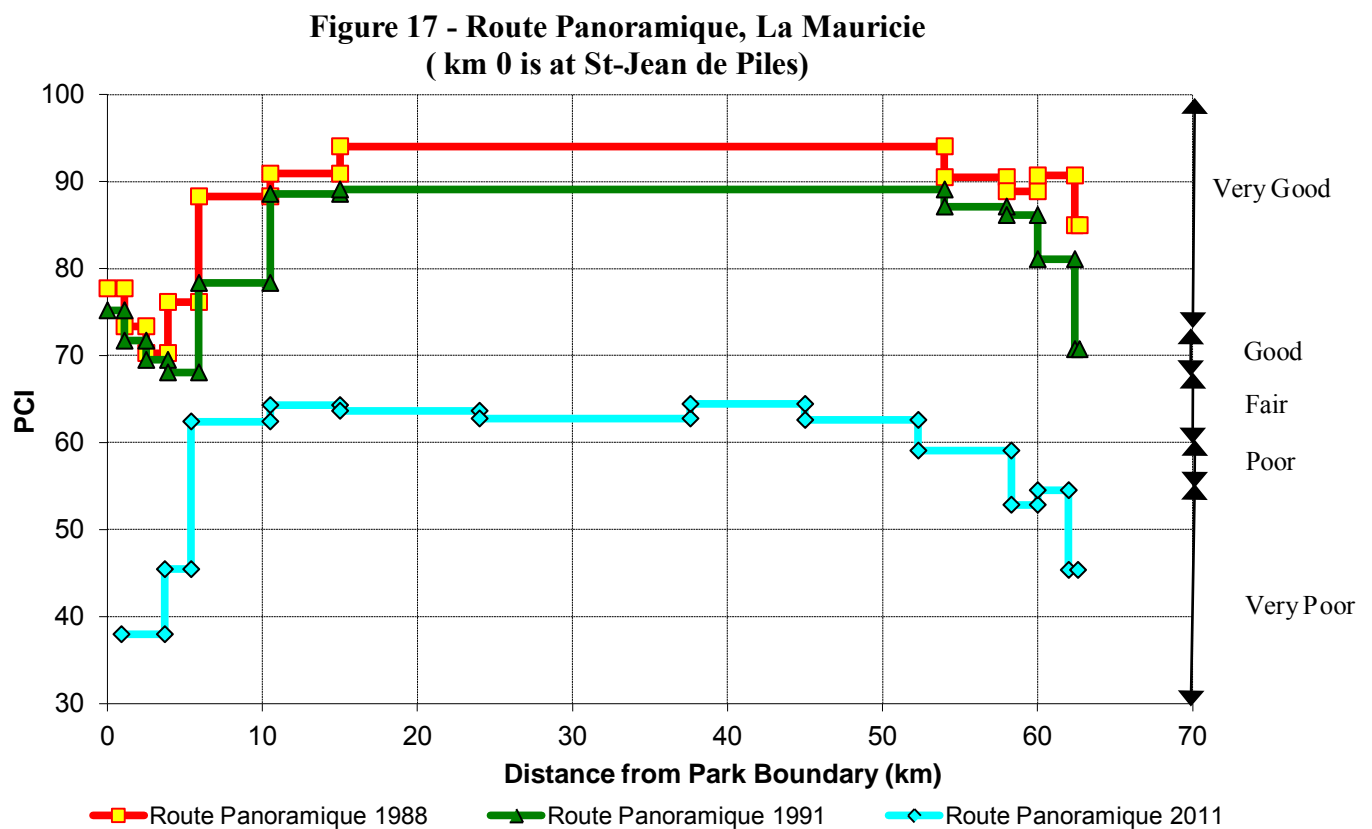
The Route Panoramique in La Mauricie National Park was rated in 13 sections for a total of 62.6 kilometres. Approximately 75% of the pavements are in fair condition, 10% in poor condition and 15% in very poor condition. Figure 17 is a graphical representation of the pavement condition.

Very severe rutting and single and alligator wheel cracking characterize this section indicating that the pavement needs to be strengthened. There are also moderate transverse, centerline, longitudinal and block cracking throughout. These conditions have resulted in a poor ride score. Given the extent and severity of these distresses, a simple overlay will not correct these problems and a more extensive rehabilitation strategy that will strengthen the pavement is required.

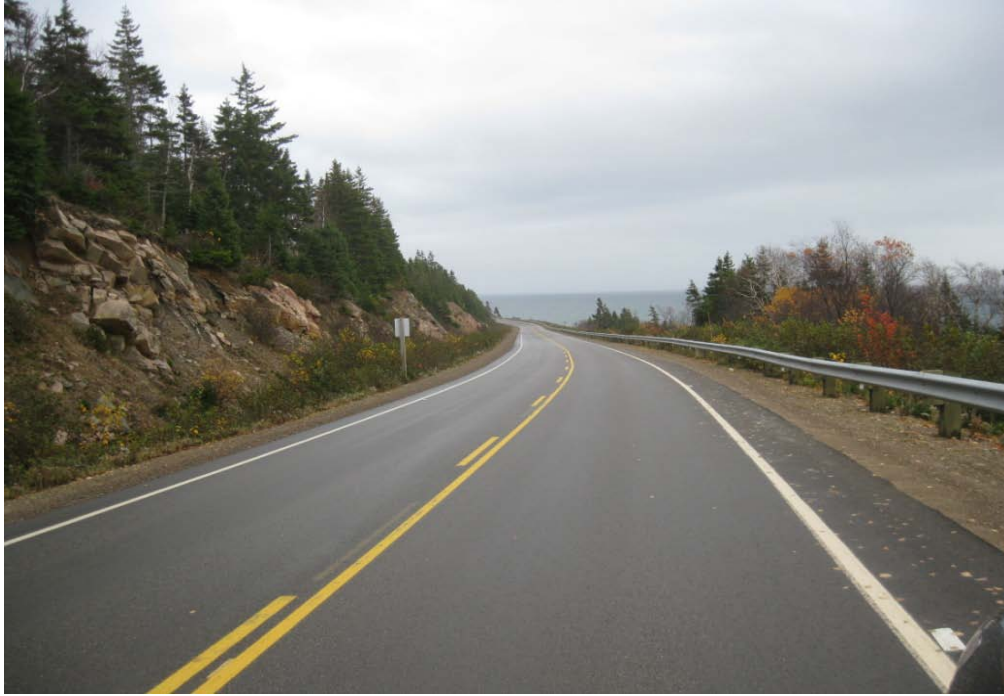
Photo D14: Very Severe Alligator Wheel Track Cracks – Fort Louisbourg

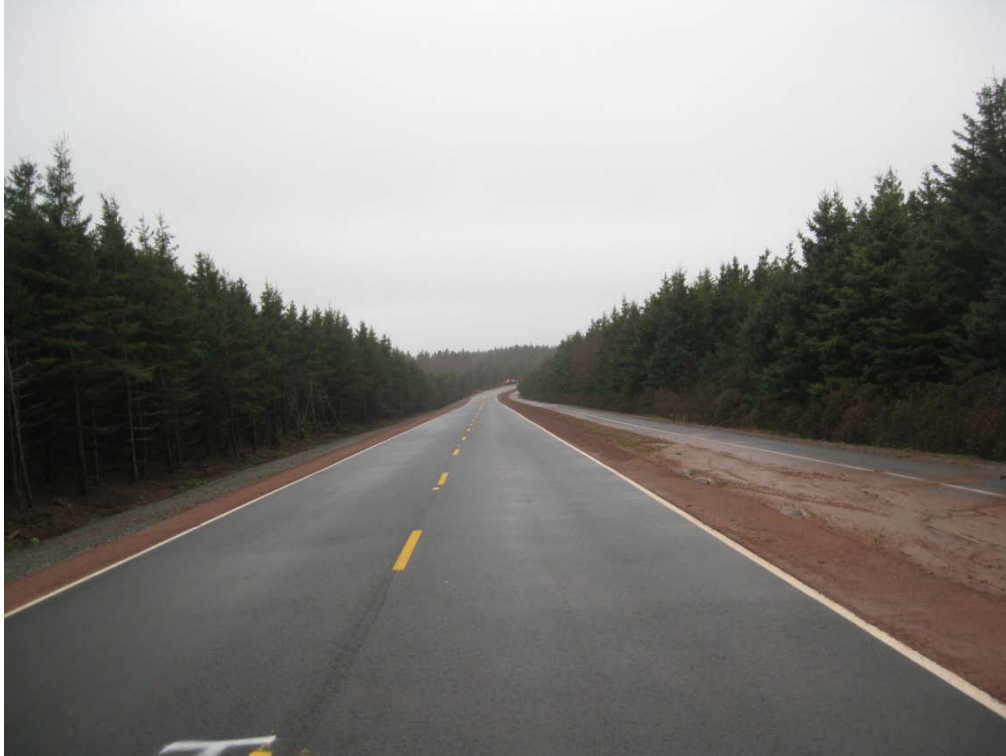
Photo D18: Very Severe Rutting – PEI National Park

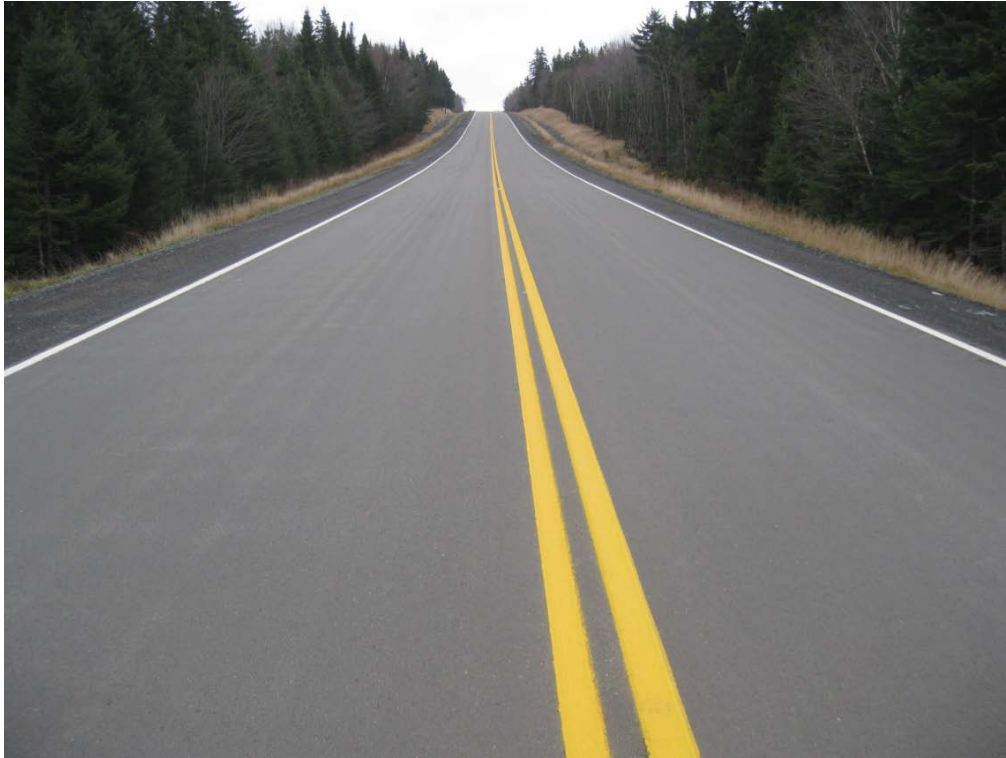
Photo D20: Severe Edge Cracking, Severe Transverse Alligator Cracking – Fundy National Park

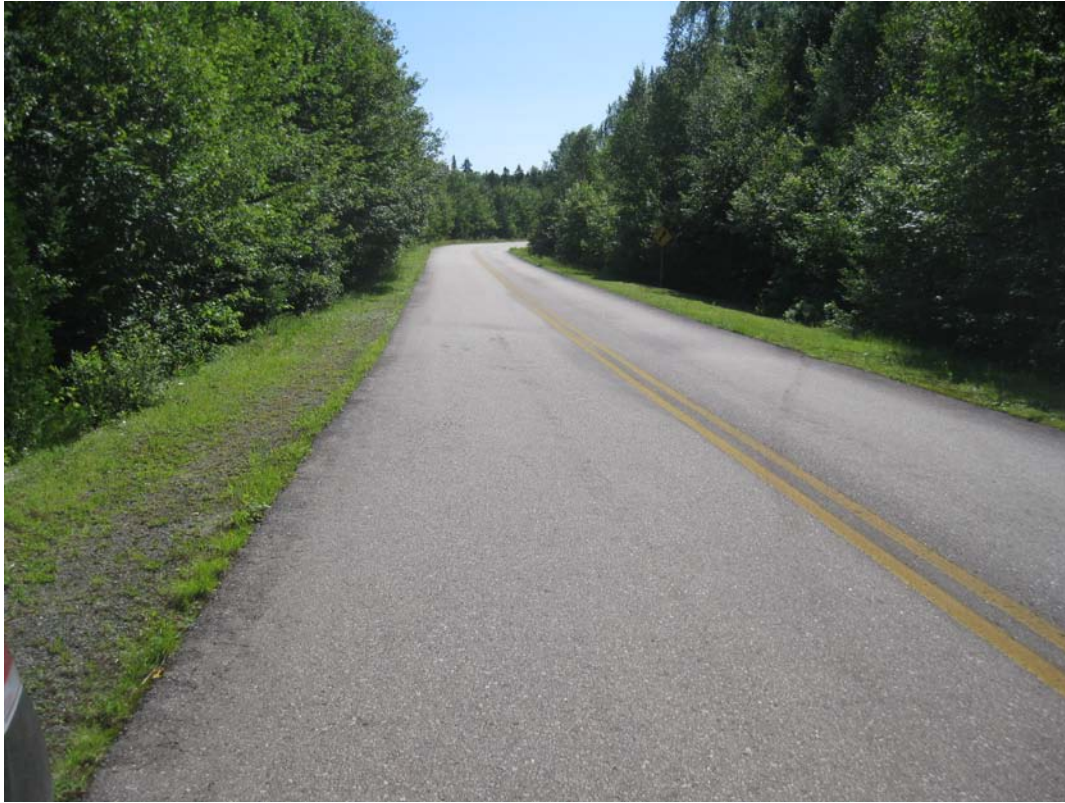
Photo D32: Very Severe Rutting and Alligator Wheel Track Cracking Km 2, La Mauricie National Park
