<b>Title - Sujet</b> Mise Hors Service et Démolition de	
<b>Solicitation No. - N° de l'invitation</b> EJ192-150405/A	<b>Amendment No. - N° modif.</b> 002
<b>Client Reference No. - N° de référence du client</b> 20150405	<b>Date</b> 2014-09-25
<b>GETS Reference No. - N° de référence de SEAG</b> PW-\$\$\$FG-353-65646	
<b>File No. - N° de dossier</b> fg353.EJ192-150405	<b>CCC No./N° CCC - FMS No./N° VME</b>
<b>Solicitation Closes - L'invitation prend fin</b> <b>at - à 02:00 PM</b> <b>on - le 2014-09-30</b>	
<b>F.O.B. - F.A.B.</b> <b>Plant-Usine:</b> <input type="checkbox"/> <b>Destination:</b> <input checked="" type="checkbox"/> <b>Other-Autre:</b> <input type="checkbox"/>	
<b>Address Enquiries to: - Adresser toutes questions à:</b> Searchwell, Suzette	<b>Buyer Id - Id de l'acheteur</b> fg353
<b>Telephone No. - N° de téléphone</b> (819) 956-6645 ( )	<b>FAX No. - N° de FAX</b> (819) 956-8335
<b>Destination - of Goods, Services, and Construction:</b> <b>Destination - des biens, services et construction:</b> Agriculture Canada Ferme Expérimentale Central 78 Promenade Prince of Wales Ottawa, Ontario

**ADDENDA NO. 02**

# Designated Substances Survey for the Central Experimental Farm Centr

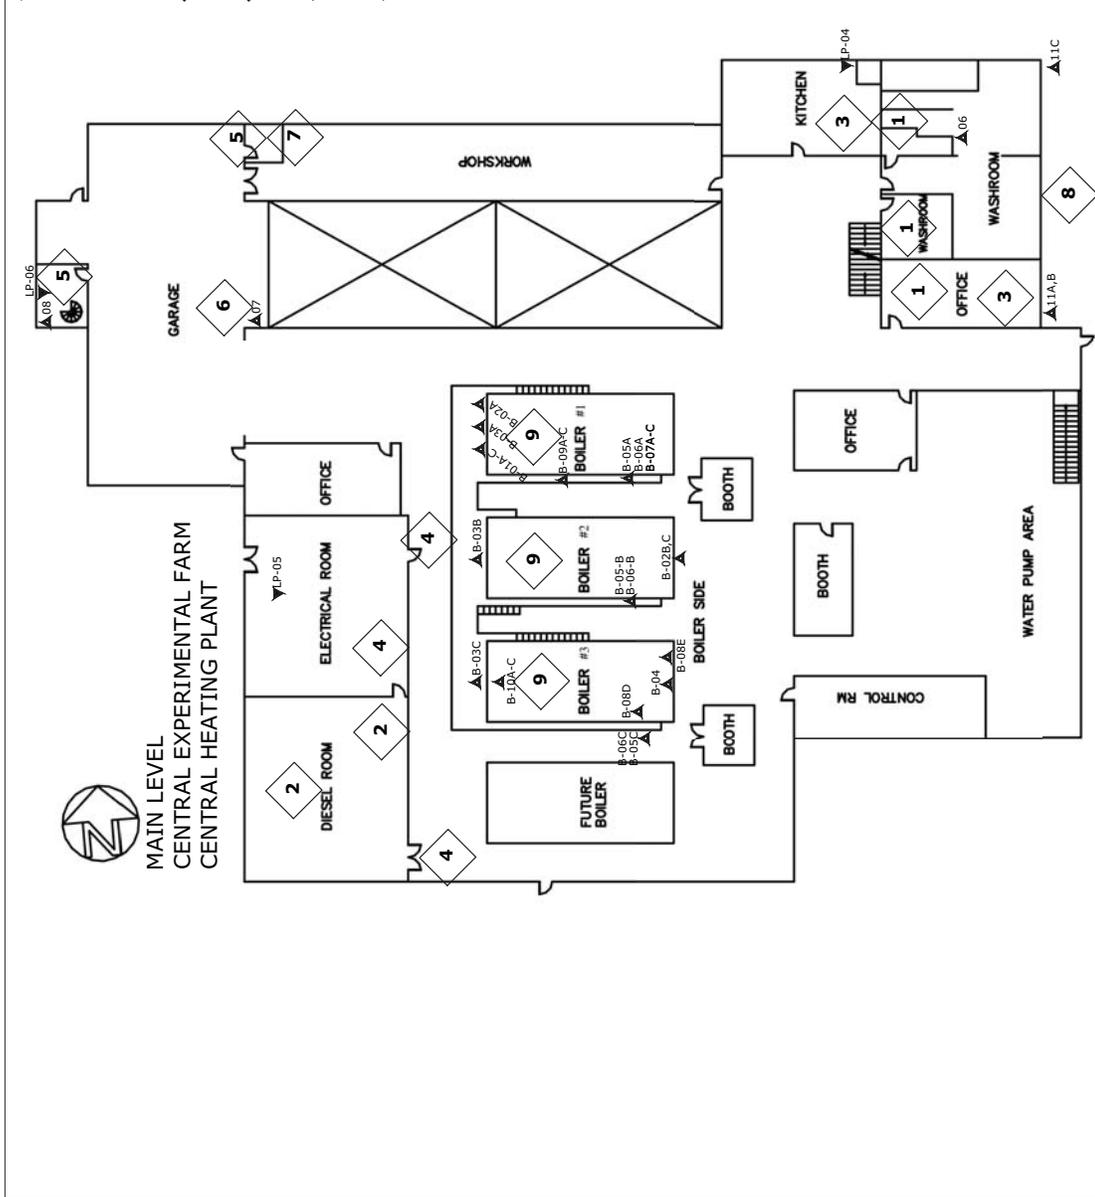
**MAIN LEVEL**  
**CENTRAL EXPERIMENTAL FARM**  
**CENTRAL HEATING PLANT**

- ◆ 4 ASBESTOS CONTAINING FIRE DOOR
- ◆ 5 ASBESTOS CONTAINING TRANSITE PANEL
- ◆ 6 ASBESTOS CONTAINING DRAIN PIPE JOINT CAULKING
- ◆ 7 SUSPECT ASBESTOS CONTAINING LIGHT HEAT SHIELDING
- ◆ 8 ASBESTOS CONTAINING EXTERIOR WHITE CAULKING.
- ◆ 9 ASBESTOS CONTAINING BOILER MATERIALS
