## 4.0 TRAMWAY STORAGE SHED

**Project:** DEMOLITION HAZARDOUS BUILDING MATERIALS  
ASSESSMENT AND INVENTORY,  
BACALHAO ISLAND LIGHTSTATION  
BACALHAO ISLAND, NL

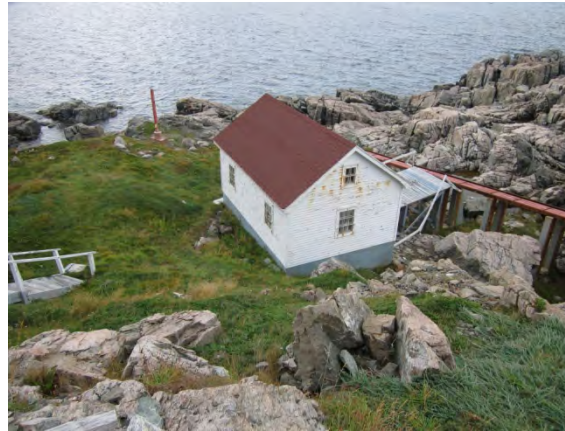
Photo 1: View of the south side of the tramway storage shed.

The condition of the paint visible on the exterior of the tramway storage shed varied from fair to poor condition. Peeling and flaking paint was observed on the exterior siding and foundation of the tramway storage shed (refer to Photos 1, 10, 12 and 13, Appendix B4).

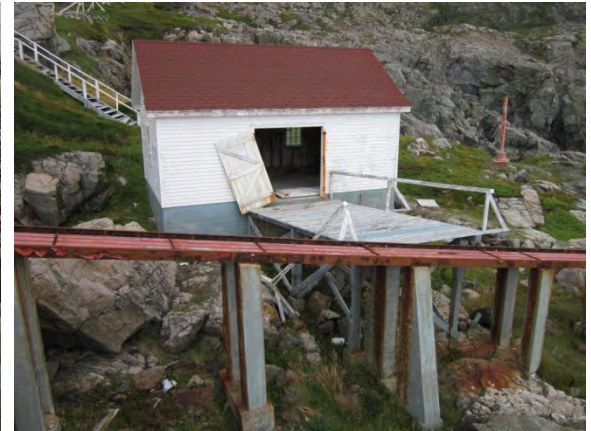
Photo 2: View of the north and east sides of the tramway storage shed.

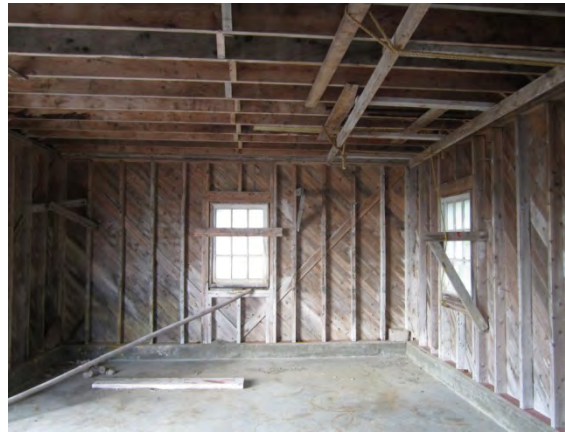
Various items were observed in the attic of the tramway storage shed, including but not limited to, canvas sails and rope, cardboard boxes, and various pieces of wood and metal; there also appeared to be an old electrical motor or generator in the attic (refer to Photo 4, Appendix B4).

Photo 4: View of attic in tramway storage shed.
