**Iqaluit, Nunavut  
DFO Bunkhouse Building 1074,  
Hazardous Material Abatement  
Solicitation # E0208-151273/A**

# HAZARDOUS MATERIALS ABATEMENT

**Final – Designated Substances Survey, Bunkhouse Building –  
Department of Fisheries and Ocean, Iqaluit, Nunavut**

June 26, 2012

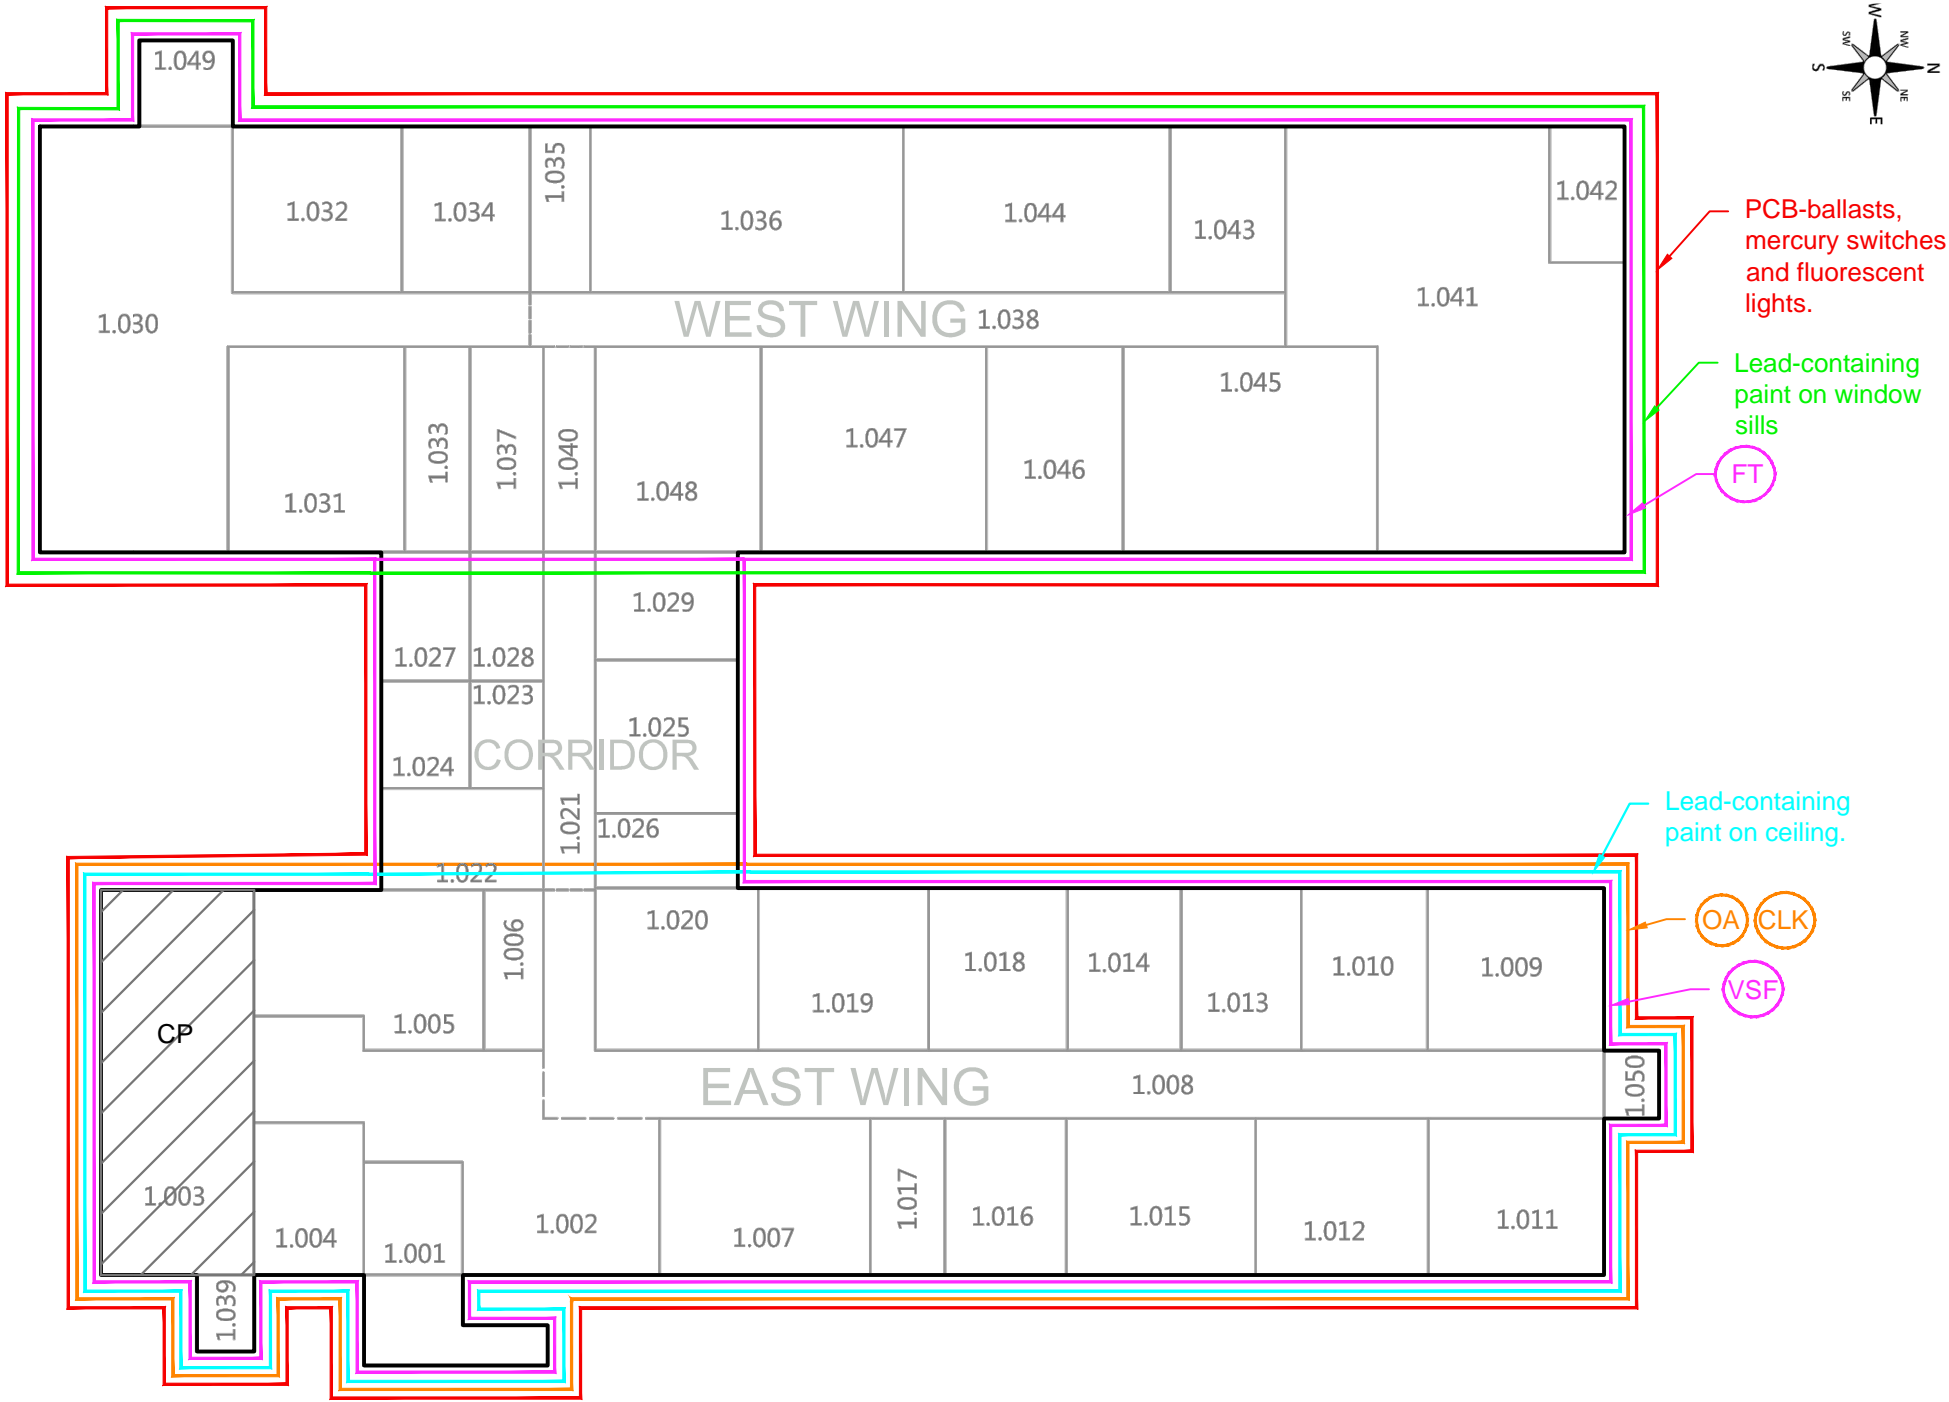
LOCATIONS OF  
HAZARDOUS MATERIALS

- OA ASBESTOS ROOFING MATERIALS
- CLK ASBESTOS WINDOW CAULKING
- FT ASBESTOS FLOORING
- VSF ASBESTOS VINYL SHEET FLOORING
- CP ASBESTOS CEMENT PRODUCT
- THROUGHOUT FUNCTIONAL AREA
- 1.025 ROOM LOCATION NUMBER

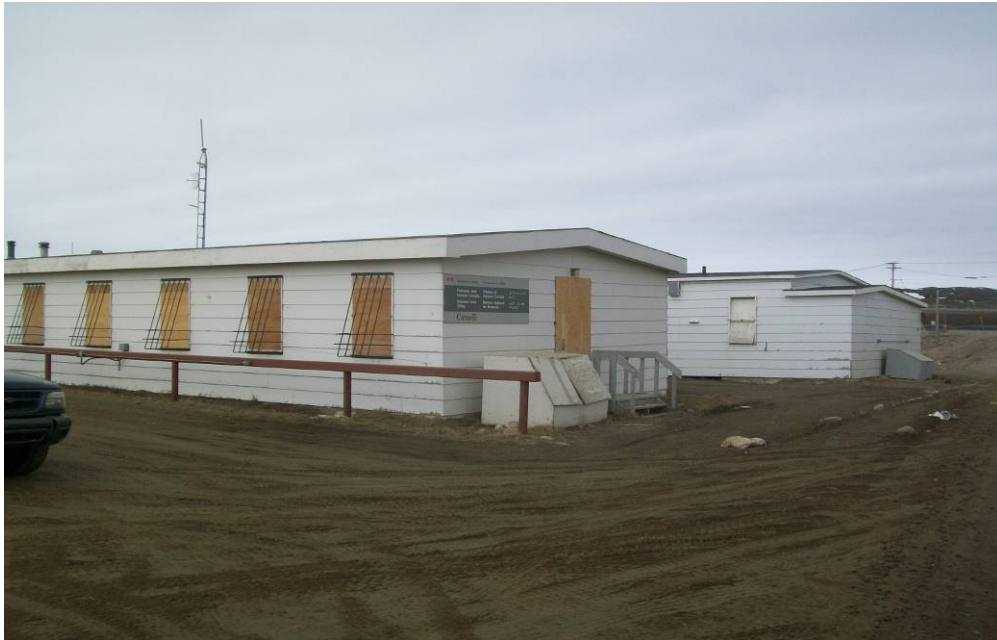
**Photograph 1:** View of vacant CFO Bunkhouse building, Iqaluit, Nunavut.
