ENVIRONMENT CANADA MAINTENANCE INSPECTION

24m (79 ft) KNOCK-DOWN SELF-SUPPORT TOWER

XNC Chipman, NB

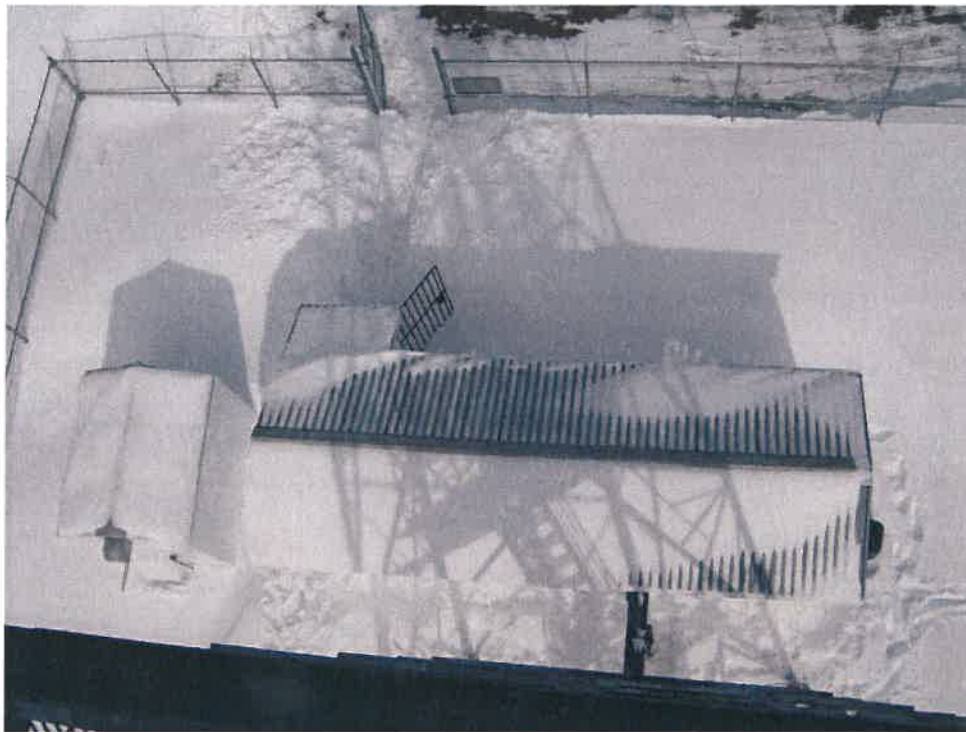
Photo #8: Site Buildings

- A. General:** The compound was snow covered but appeared clear of brush and debris. See Appendix A, Photos #1, #6, and #8.
- B. Access:** The tower access road was snow covered at the time of inspection but appeared satisfactory. The site parking was clear and appeared satisfactory.
- C. Fencing:** The fence appears satisfactory. See Appendix A, Photos #1, and #8.
- The fence had the barbed wire removed.
- There is no grounding installed on fence post.
- There is no grounding installed on the fence gates.
- D. Security:** There was a anti-climb gate installed at the base of the access stairs to the tower. Gate was not locked and was ineffective to prevent entry. See Appendix A, Photo # 9.
- E. Due Diligence:** There is no site warning signage installed on tower compound, or fence. Warning sign on building door and gate at base of tower are satisfactory.
