ENVIRONMENT CANADA MAINTENANCE INSPECTION

18m (60 ft) KNOCK-DOWN SELF-SUPPORT TOWER

XMB Marion Bridge, NS

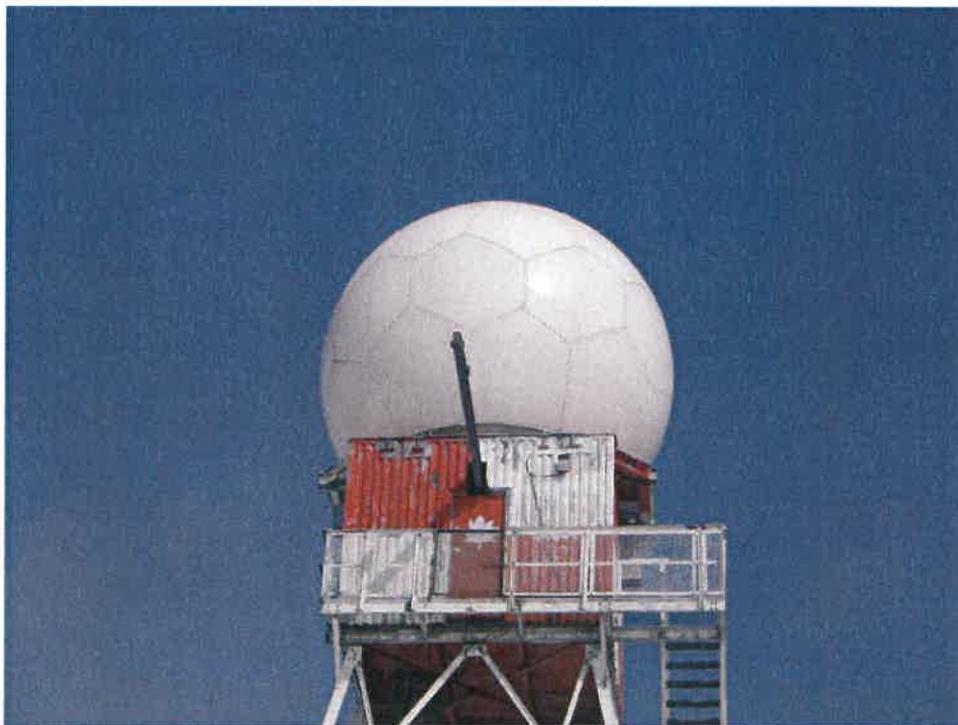
Photo #3: Building and Radome

A. Antennas: The 5.5m radome appears satisfactory. See Appendix A, Photo #3.

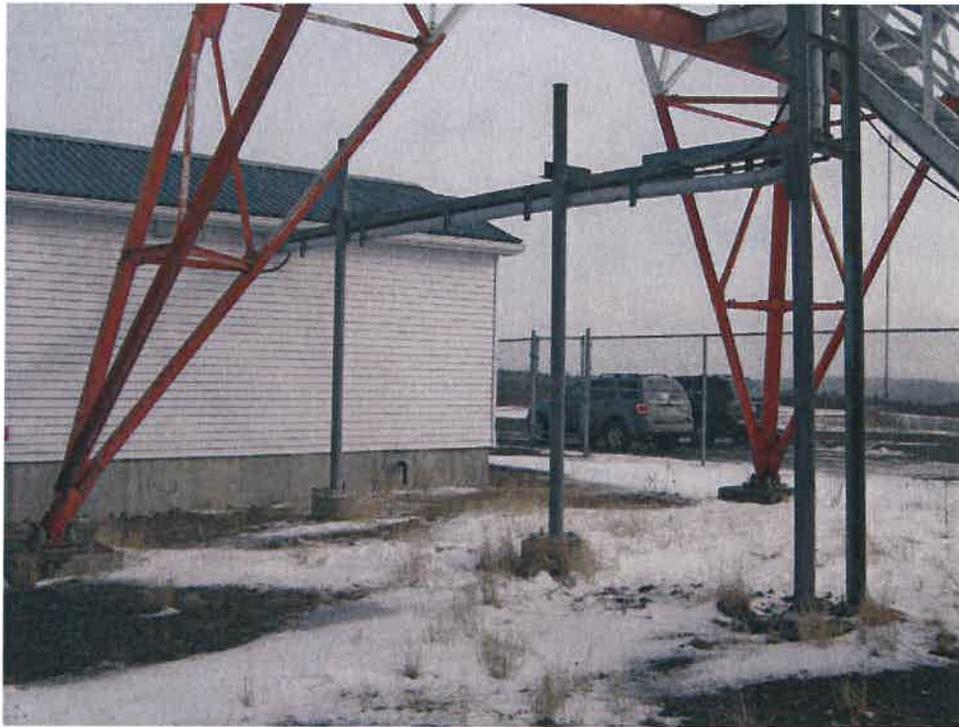
Photo #6: Waveguide Bridge

A. Waveguide Bridge: The waveguide bridge appears satisfactory. See Appendix A, Photo #6.

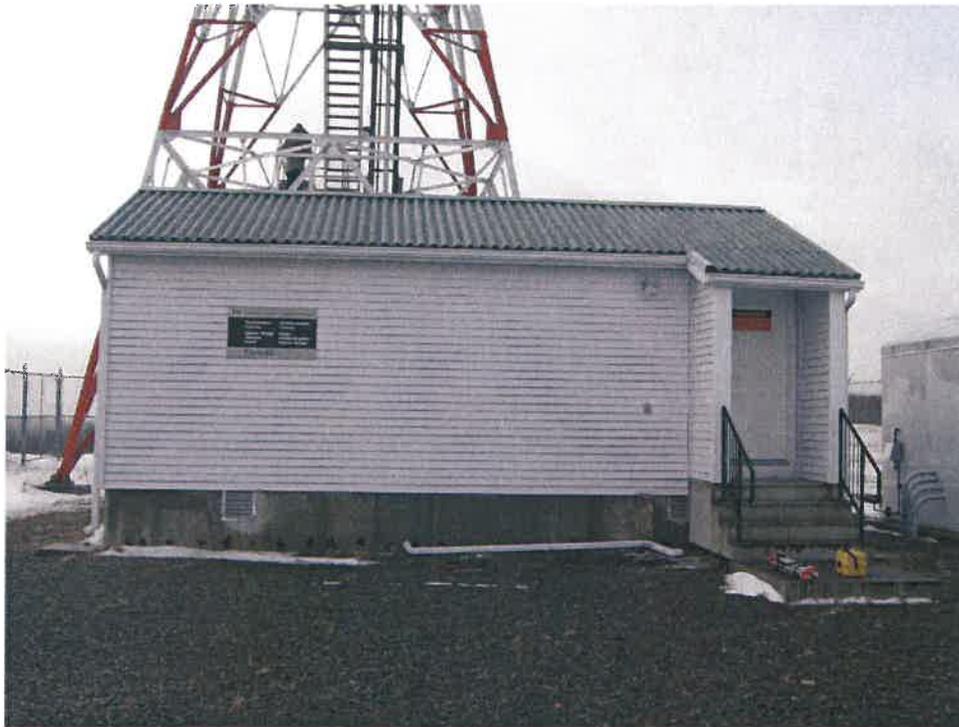
Photo #8: Site Buildings

- A. General:** The compound was clear of brush and debris. See Appendix A, Photo #6, #8, #9, and #10.
- B. Access:** The tower access road was snow covered at the time of inspection but appeared satisfactory. The site parking was clear and appeared satisfactory. See Appendix A, Photo #1.

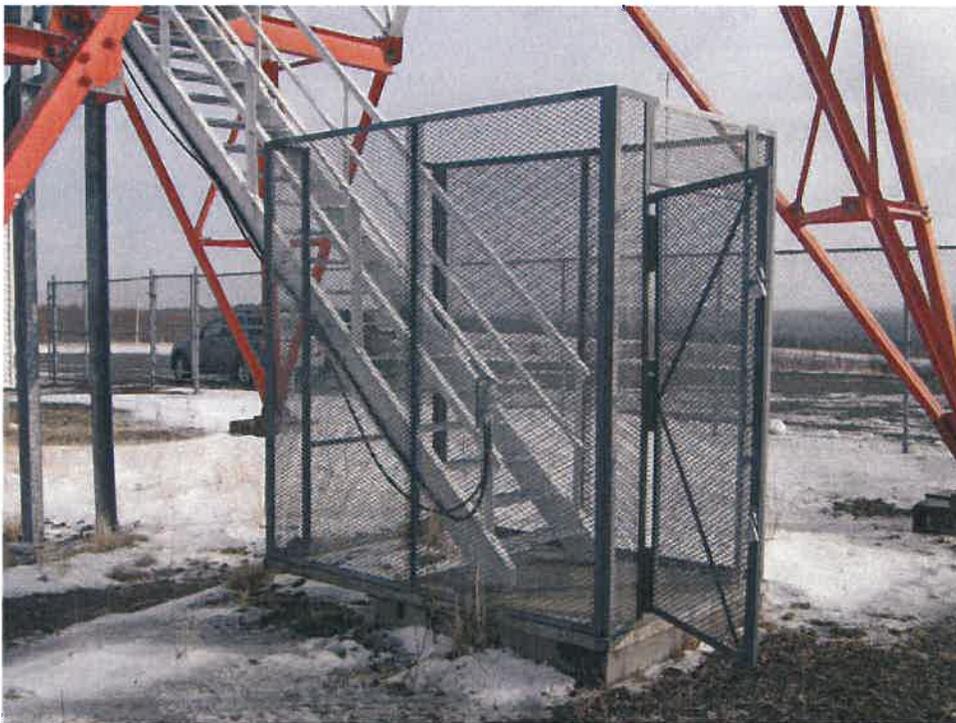
Photo #9: Anti-Climb

- There is no grounding installed on the fence gates.
- D. Security:** The anti-climb installed at the base of the tower appears satisfactory. See Appendix A, Photo #9.
