“Draft” Interim Report

**Cursory Structural Review of Province House
Charlottetown, PEI**

**Parks Canada
Historic Properties
1869 Upper Water Street
Halifax, NS
B3J 1S9**

**J.W. Cowie Engineering Limited
1046 Barrington Street, Suite#200
Halifax, Nova Scotia
B3H 2R1**

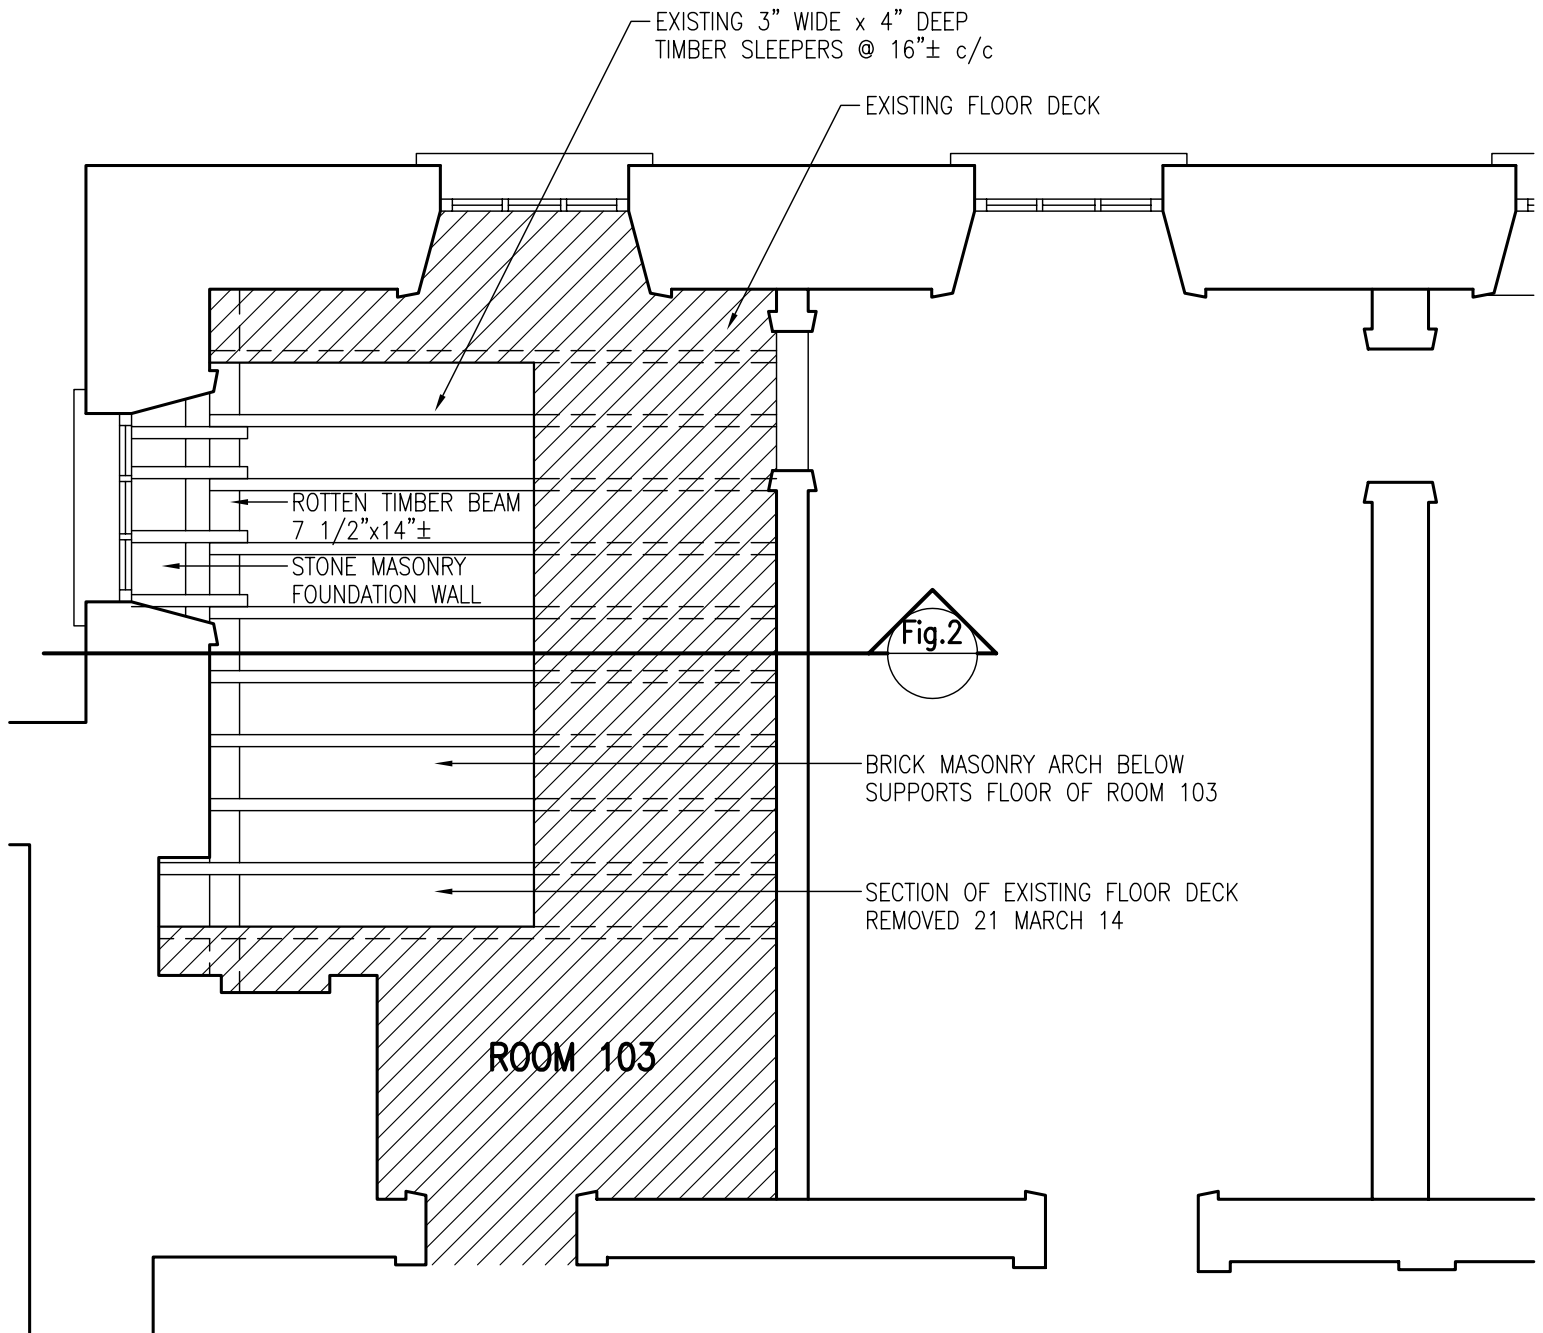
Figure 1
PLAN – EXISTING
SPEAKER'S OFFICE FLOOR (ROOM 103)

Removal of the floor deck exposed the original East/West spanning 3 in. wide x 4 in. deep timber "sleepers" located at approximately 16 in. centre to centre. (Refer to Figure 1 "Plan – Existing Speaker's Office Floor (Room 103), Appendix "A", Volume I and Photograph RS-1, Appendix "B", Volume II).

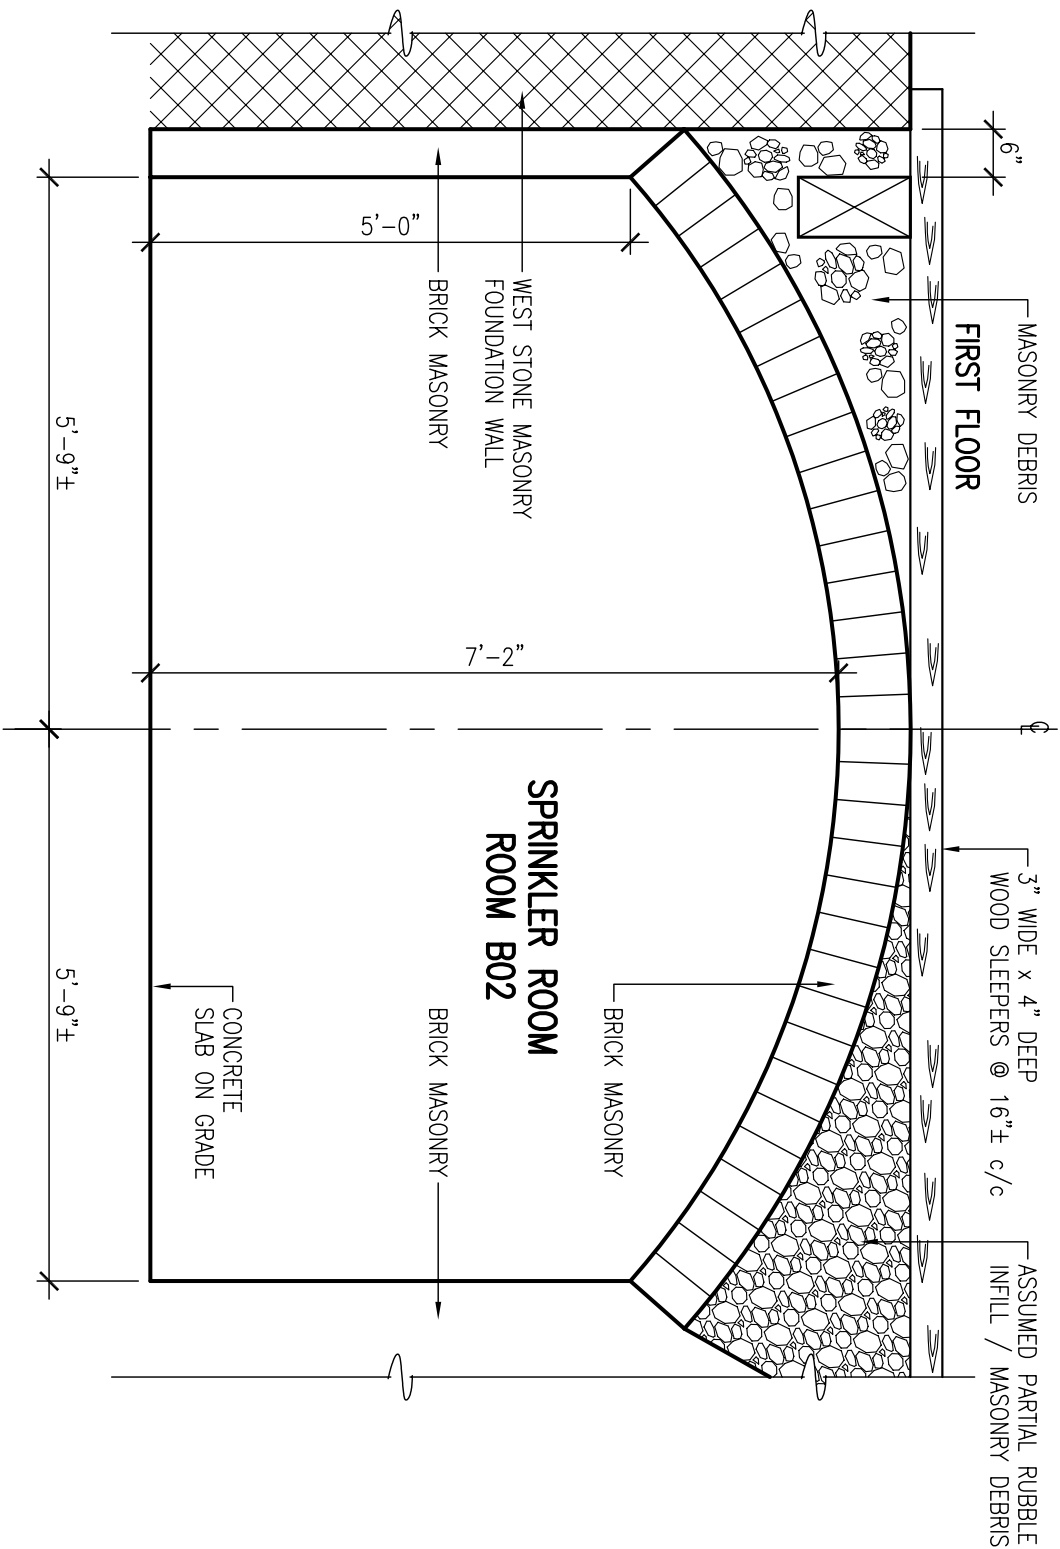
Figure 2
EXISTING SECTION THROUGH SPEAKER'S OFFICE FLOOR
INCLUDING SUPPORTING ARCH ROOF OF BRICK MASONRY VAULT BELOW
(SPRINKLER ROOM)

The East end of the timber "sleepers" are supported on the top of the brick masonry arch of the vault below. (Sprinkler Room/Room B02). (Refer to Figure 2 "Existing Section Through Speaker's Office Floor Including Supporting Arched Roof of Brick Masonry Vault Below (Sprinkler Room), Appendix "A", Volume I and Photograph RS-2, Appendix "B", Volume II).

The West end of the timber "sleepers" are supported on top of **a** North/South spanning 7 $\frac{1}{2}$ in. x 14 in. deep timber beam located adjacent to the West stone masonry foundation wall of the building. (Refer to Figure 2, Appendix "A" and Photographs; RS-19 to RS-21, Appendix "B", Volume II).

The arch shape roof (depressed arch/segmental arch) of the clay brick masonry vault located below the Speaker's Office supports the floor of the Speaker's Office. (Room 103). The vault is located in the basement and serves as the Sprinkler Room (Room B02). (Refer to Figure 2, Appendix "A").

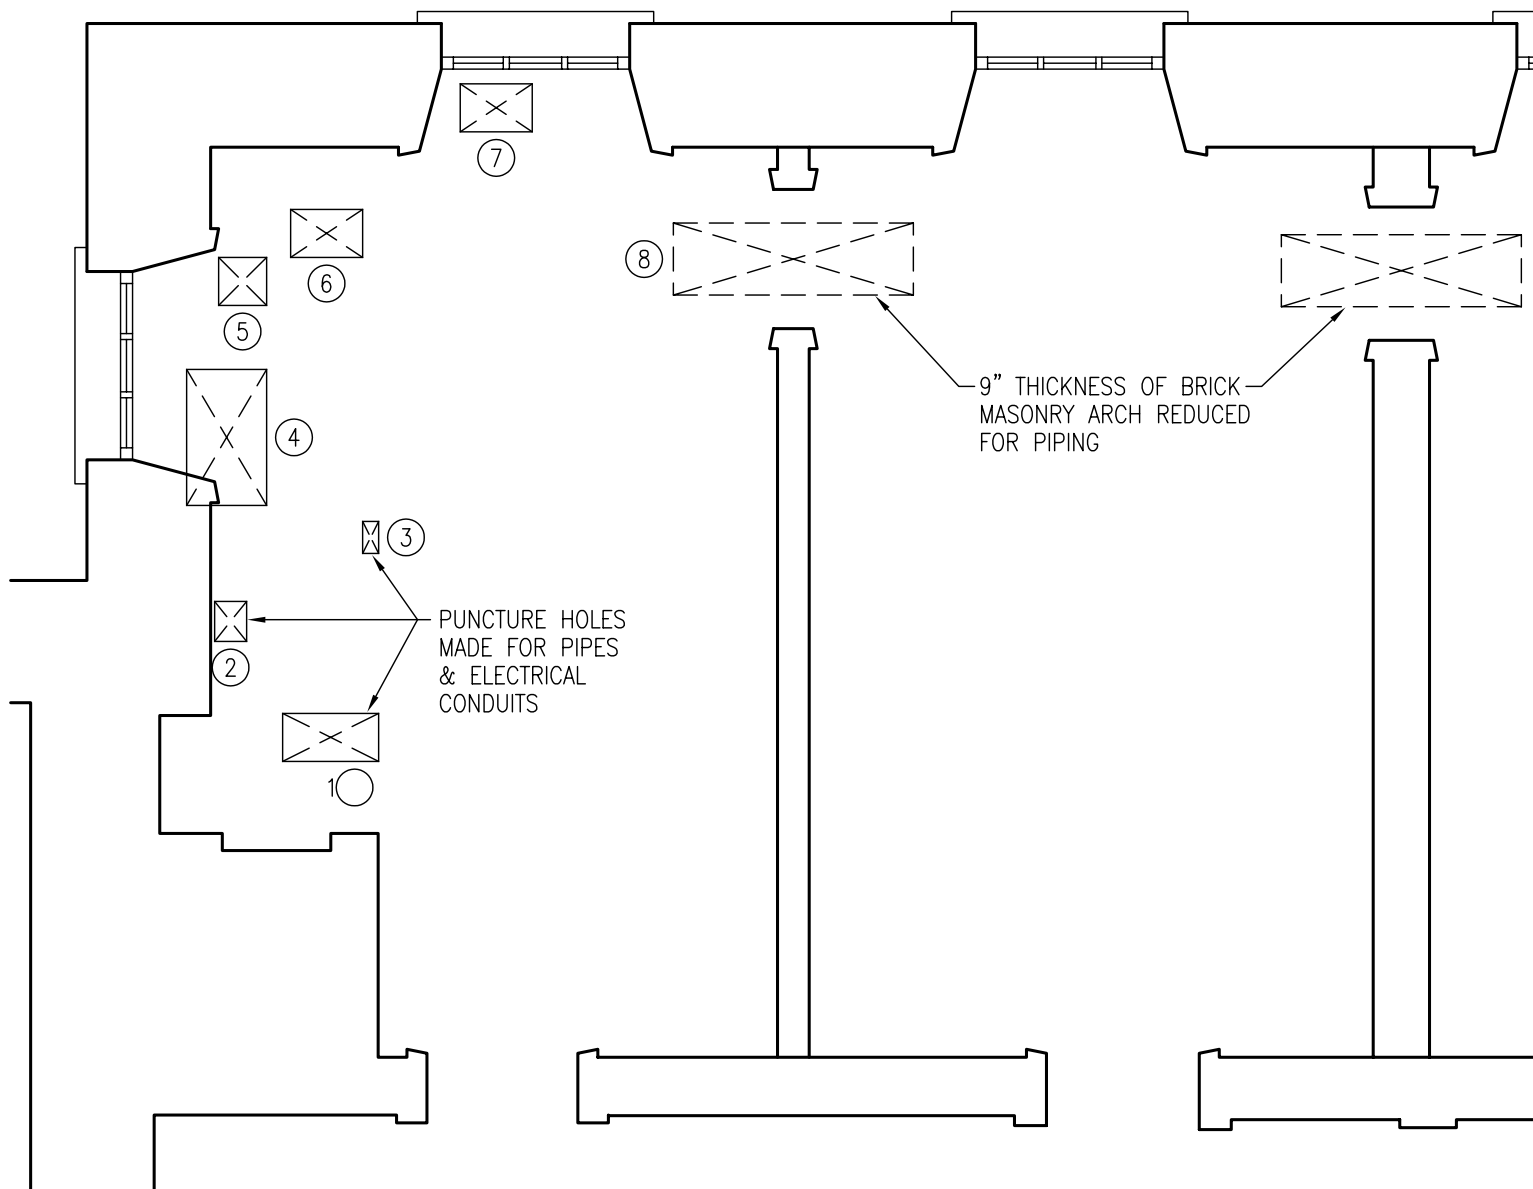
Figure 5
PLAN – LOCATION OF PUNCTURE HOLES
IN BRICK MASONRY ARCH SUPPORTING
THE SPEAKER'S OFFICE FLOOR

The West side of the arch roof of the vault has been severely weakened by the presence of six puncture holes. The location and size of the punched holes can be found in Figure 5, "Plan – Location of Puncture Holes in Brick Masonry Arch Supporting the Speaker's Office Floor" found in Volume I. Photographs were taken of the holes. (Refer to Photographs; RS-6 to RS-12, RS-16 to RS-18, Appendix "B", Volume II).

A hole (Hole 7) also exists in the brick masonry arch adjacent to and below the North window. (Refer to Figure 5, Appendix "A", Volume I and Photograph RS-37, Appendix "B", Volume II).

A horizontal slot (pipe chase) exists near the East base of the brick masonry arch adjacent to the North end of the brick masonry vault. The slot extends through the base of the brick masonry arch to Room B03. The slot is indicated as Hole Location 8 in Figure 5, Appendix "A", Volume I. (Also refer to Photographs; RS-38 and RS-39, Appendix "B", Volume II). It would appear the pipe chase existed at the time of initial construction.

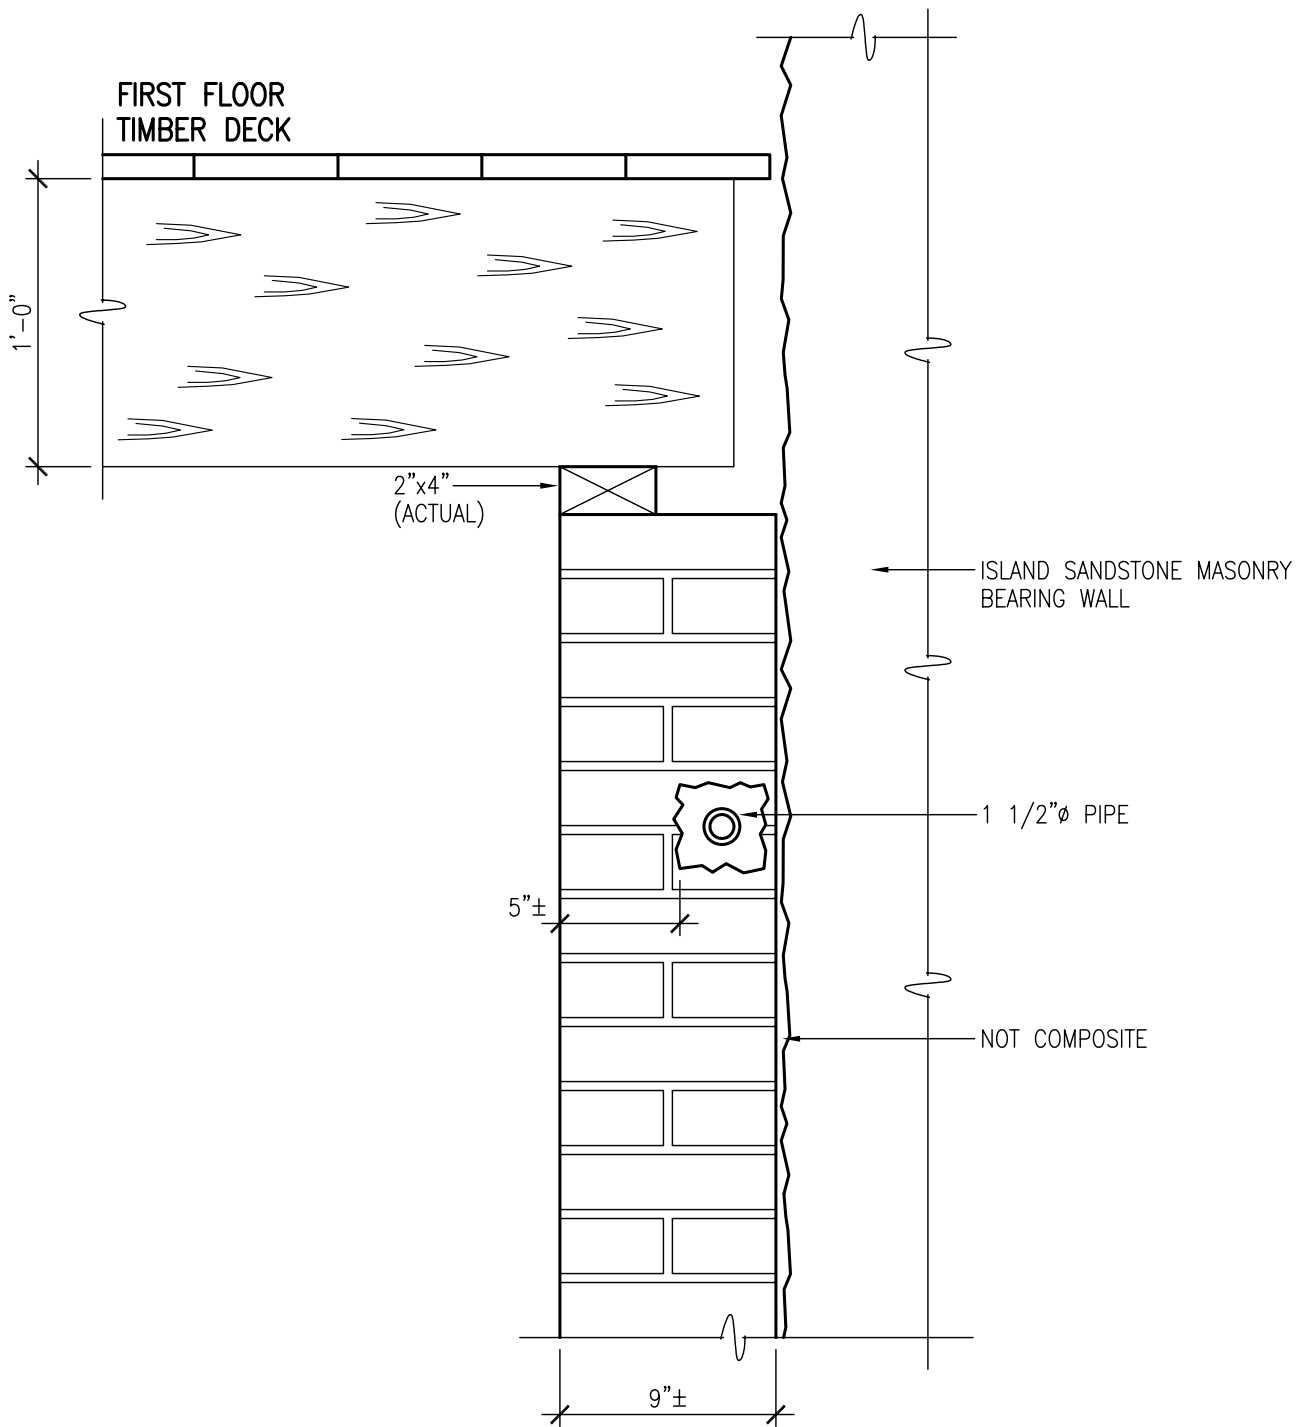
Figure 10
SECTION VIEWING SOUTH,
BRICK MASONRY COLUMN 2c,
BASEMENT ROOM B14

The brick masonry column supports an East/West spanning timber beam. The timber beam is bearing on a 2 in. x 4 in. (actual) member placed along the East top edge of the column. (Refer to Figure 10, Appendix "A", Volume I). The centerline of the North/South spanning timber beam is located approximately 6 in. from the North face of the column. The beam reaction therefore has an eccentricity of approximately 2 ¾ in. from centerline of the North/South dimension of the column and approximately 3 ½ in. eccentricity from the centerline of the column in the East/West direction.

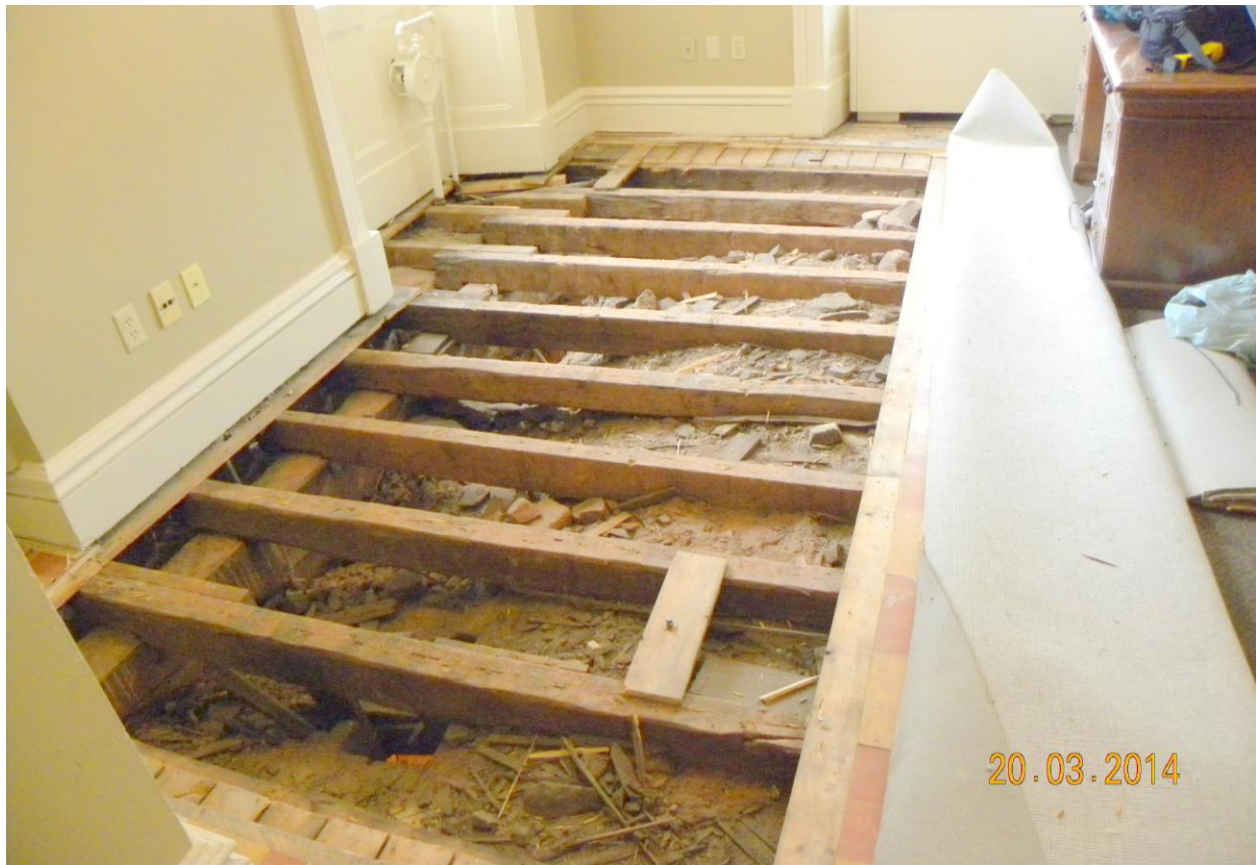
PHOTOGRAPH SR-1:

Speaker's Office (Room 103) viewing North. The carpet was rolled back and the 1980's timber floor deck removed exposing the original East/West spanning timber "sleepers". The East end of the "sleepers" are supported on the top of the arch shaped roof of the brick masonry vault housing the Sprinkler Room below. (Basement Room B02).

The West end of the "sleepers" are supported by a deteriorated 7 ½ in. x 14 in. timber beam spanning North/South. Debris (clay bricks, sections of stone and sand) were found randomly placed between the "sleepers" on top of various areas of the brick masonry vault.

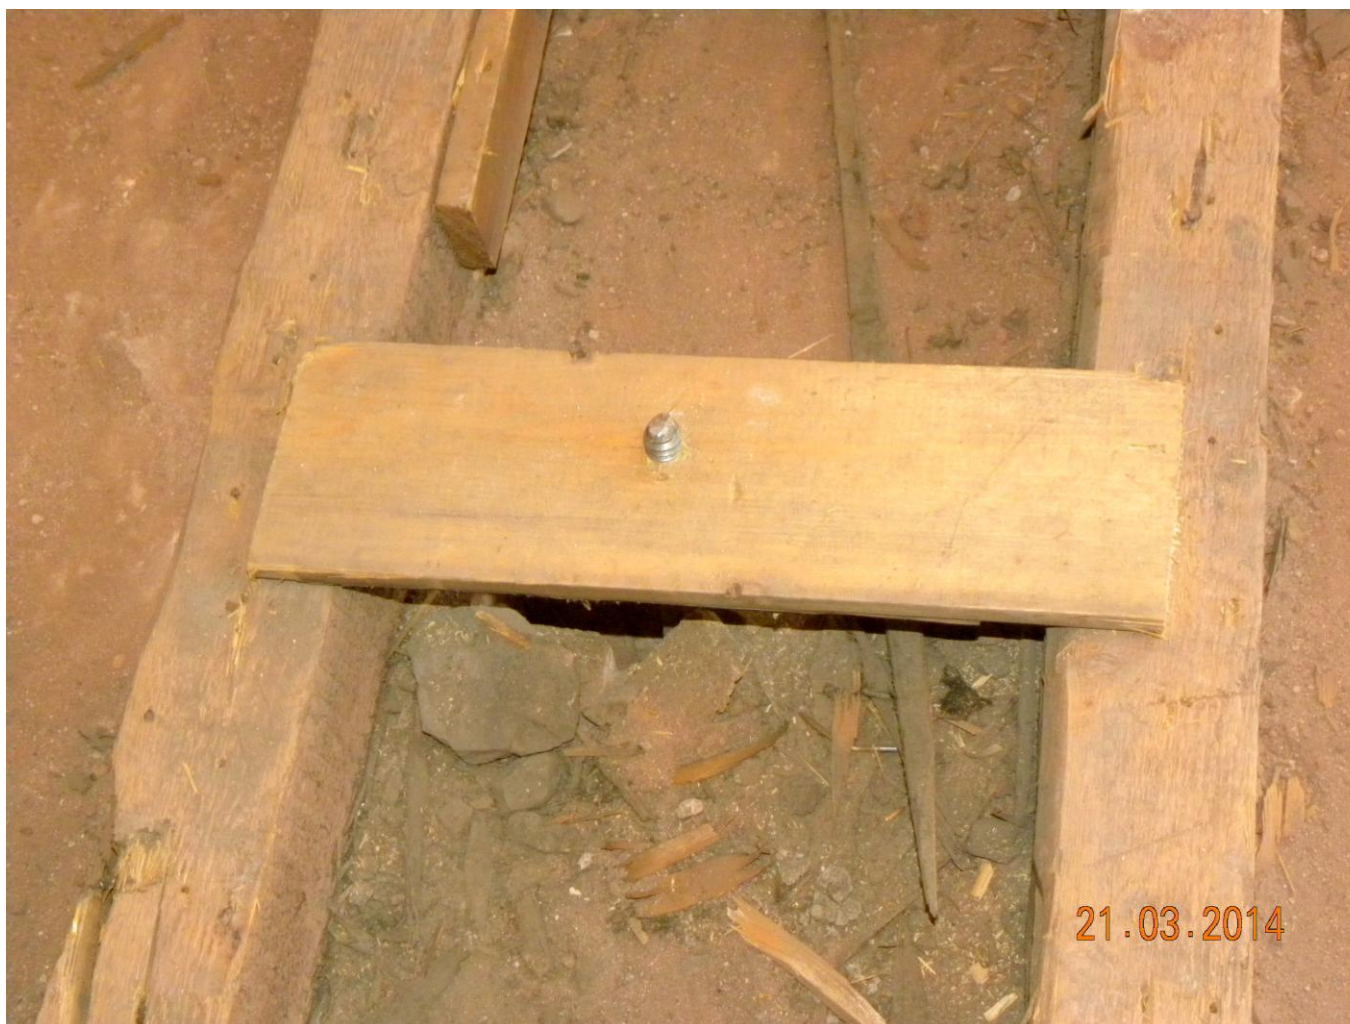
PHOTOGRAPH SR-3:

The screw end of a steel rod of a pipe hanger screwed through the $\frac{3}{4}$ in. thick floor boards for support of the main water supply pipe within the Sprinkler Room below. The upper $\frac{3}{4}$ in. layer of the floor boards was removed.

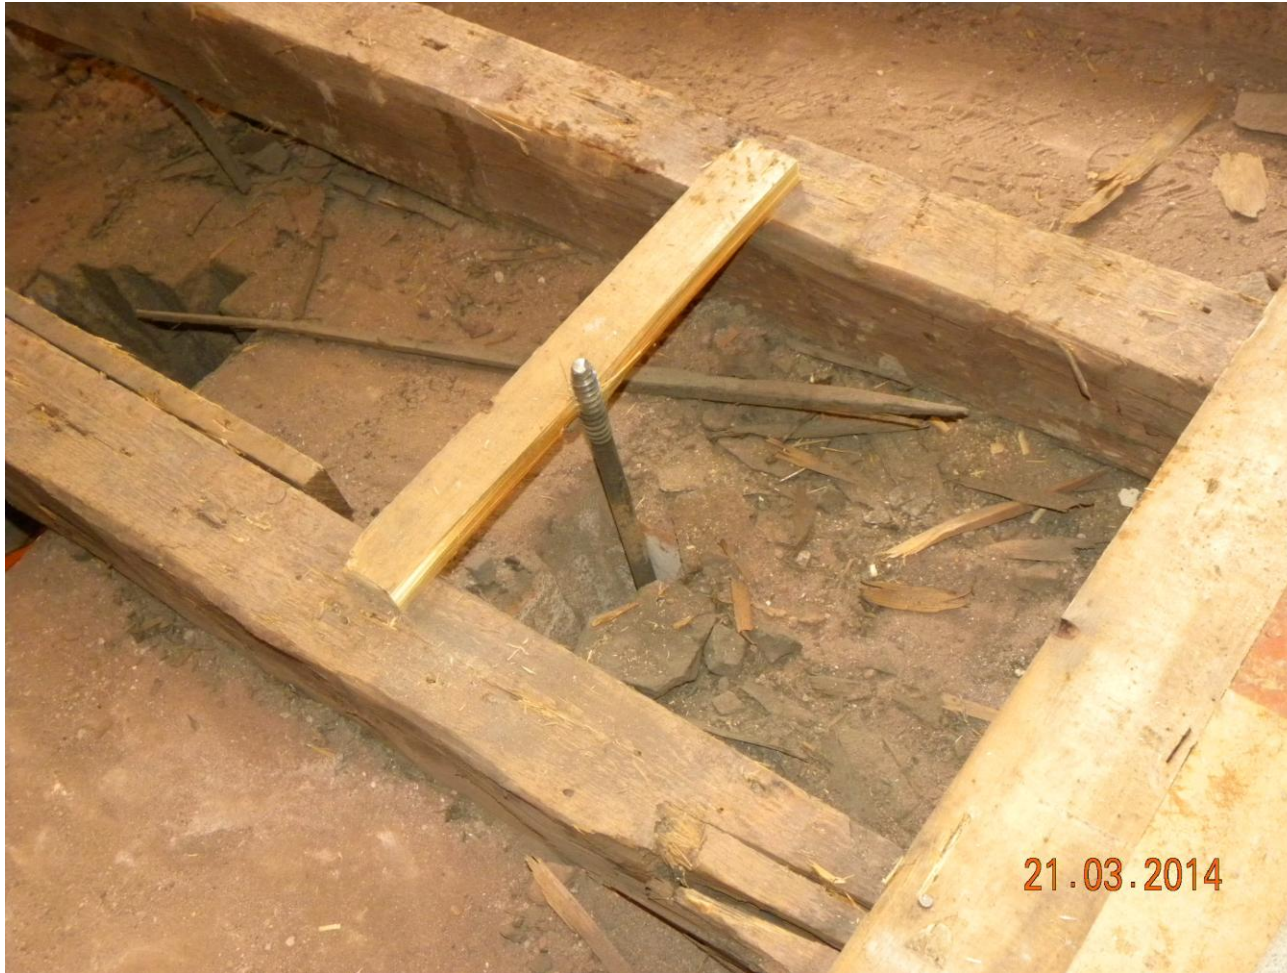
PHOTOGRAPH SR-4:

The $\frac{3}{4}$ in. floor board shown in Photograph SR-3 was split at the time of the installation of pipe hanger. As a safety precaution, the main water supply pipe to the Sprinkler Room was temporarily supported from the floor of the Sprinkler Room. (Refer to Photograph SR-32, Appendix "B", Volume II).

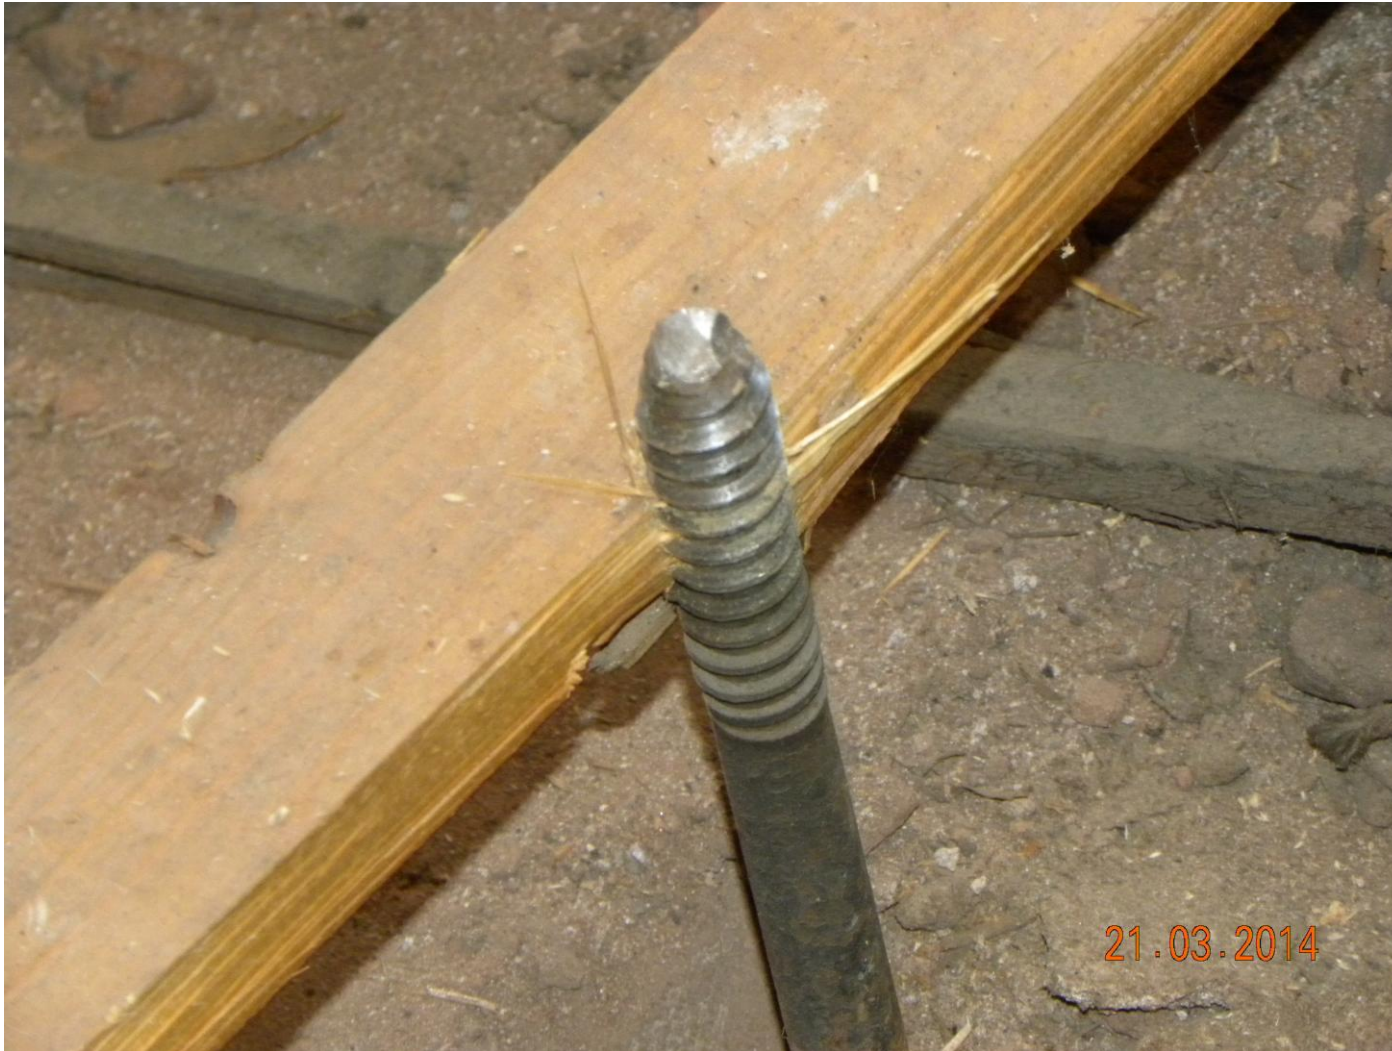
PHOTOGRAPH SR-5:

Shows the threaded end of the steel rod pipe hanger shown in Photographs; SR-3 and SR-4, Appendix "B", Volume II.

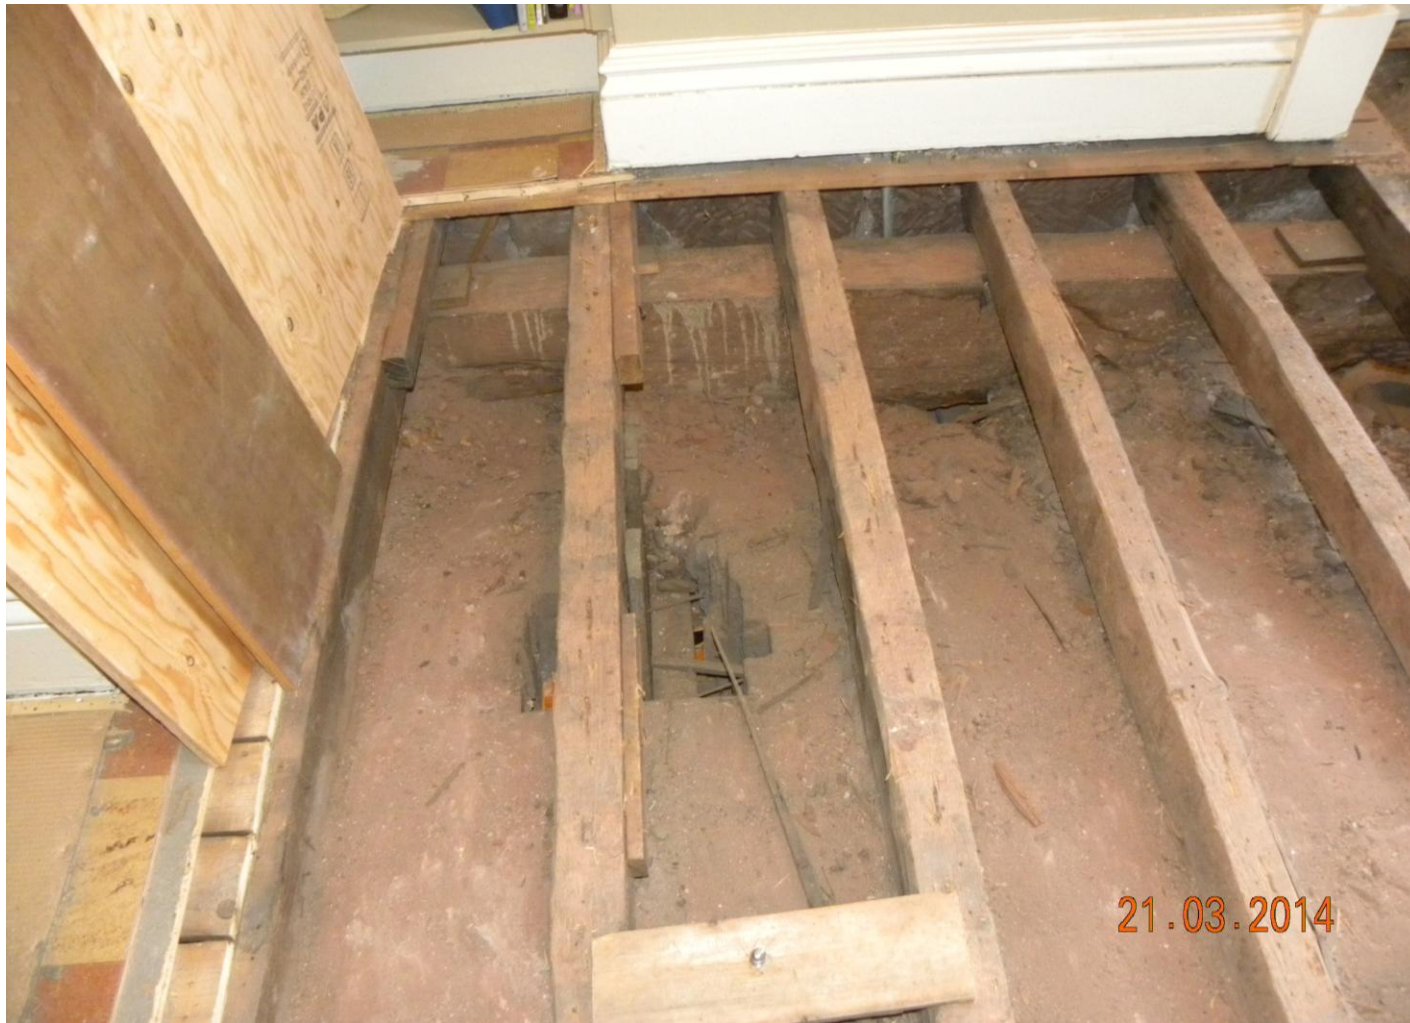
PHOTOGRAPH SR-6:

The Southwest area of the floor of the Speaker's Office. Shows a hole approximately 1 ft. wide x 2 ft. long made within the brick masonry arch roof of the vault housing the Sprinkler Room below. (Refer to Figure 5 (Hole1), Appendix "A", Volume I).

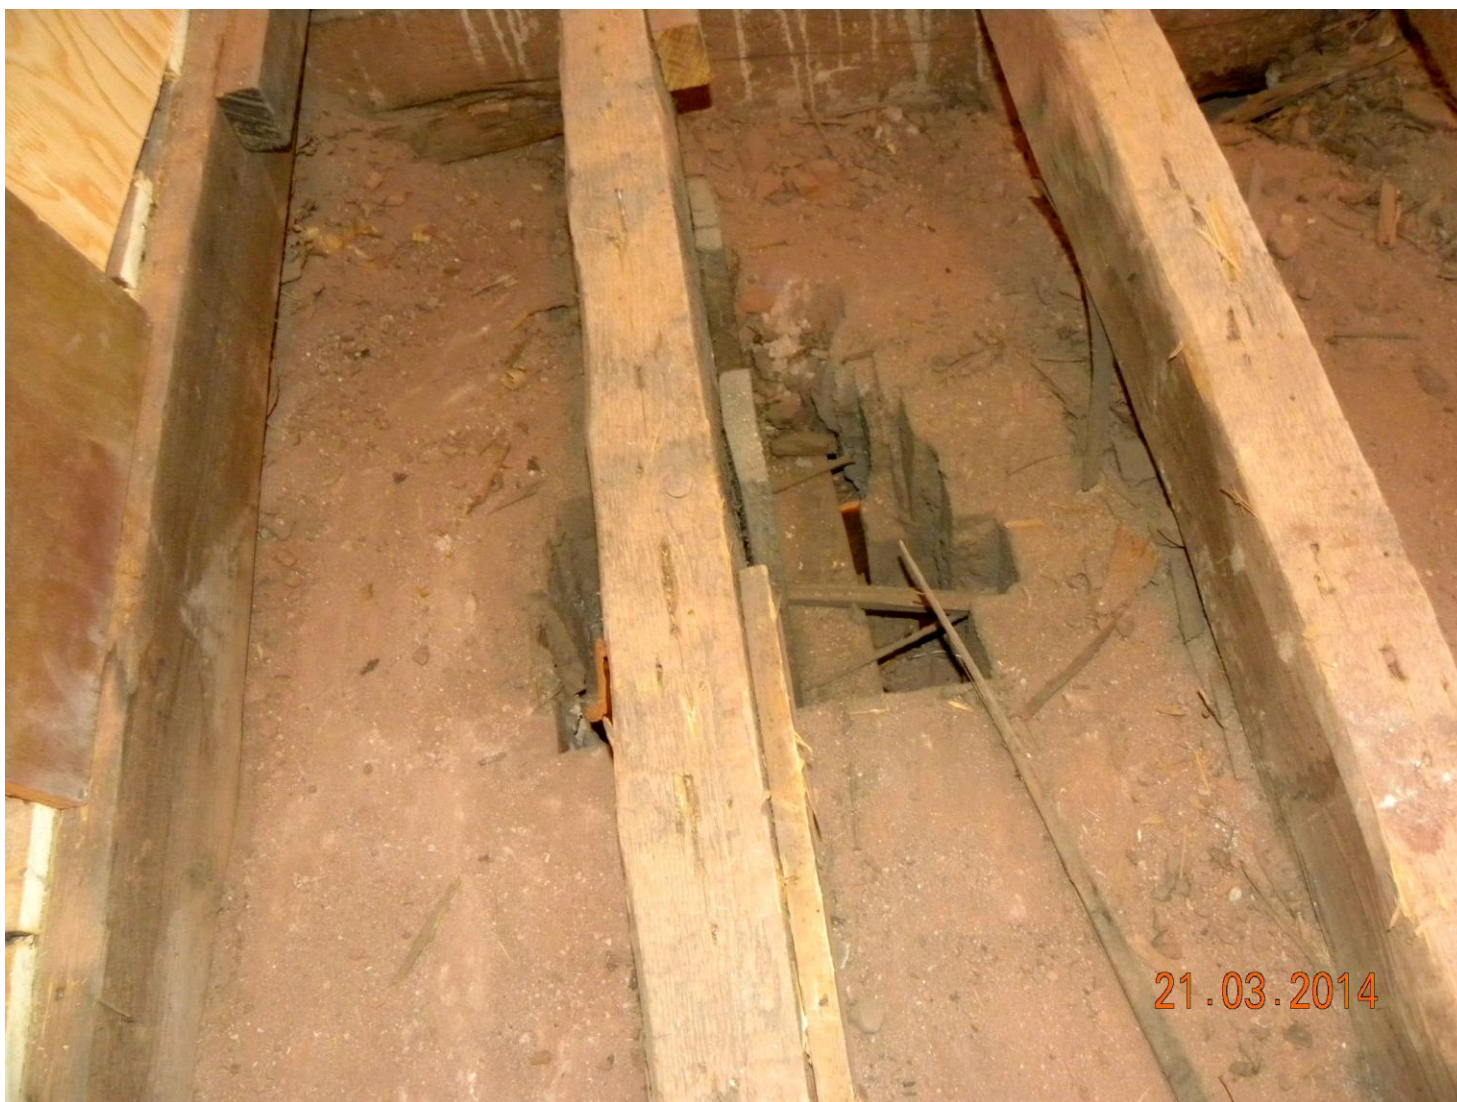
PHOTOGRAPH SR-7:

Close-up view of Photograph SR-6, (Hole 1), Appendix "B", Volume II.

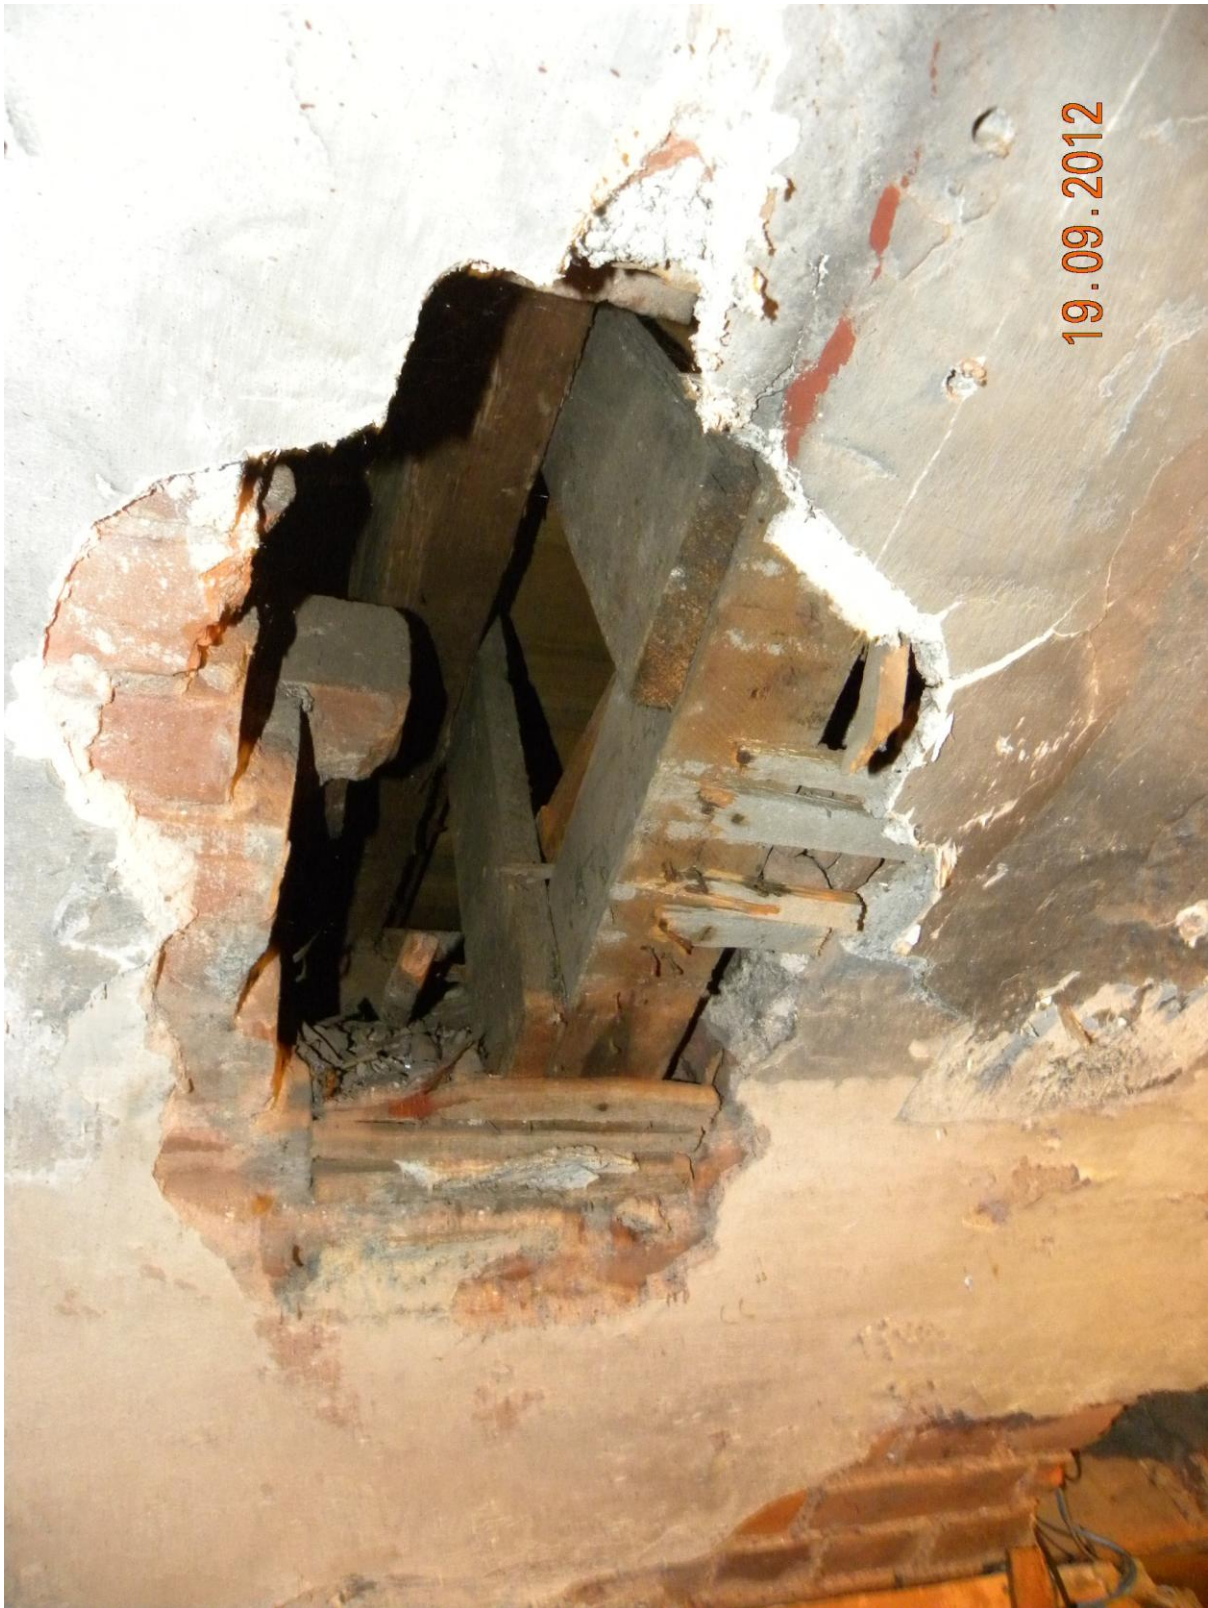
PHOTOGRAPH SR-8:

Close-up view of Photograph SR-6 (Hole 1), from below within the Sprinkler Room. (Refer to Appendix "B", Volume II).

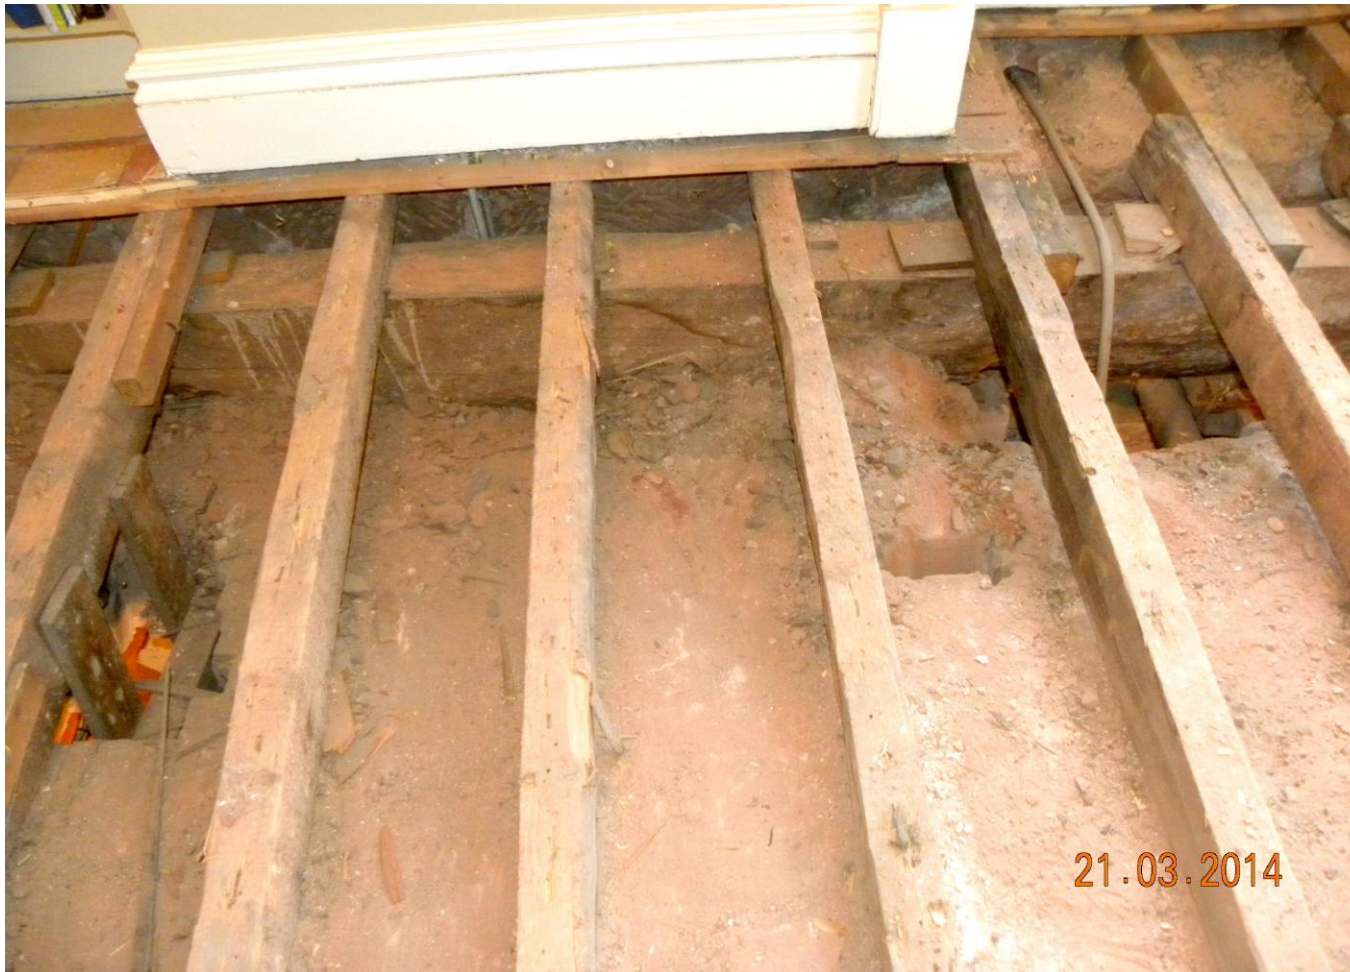
PHOTOGRAPH SR-9:

East/West spanning timber "sleepers" located at approximately 16 in. centre to centre with their West end bearing on top of the 7 ½ in. wide x 14 in. deep North/South spanning timber beam. Also shows Holes; 1 to 4 within the brick masonry arch. (Refer to Figure 5, Appendix A, Volume I).

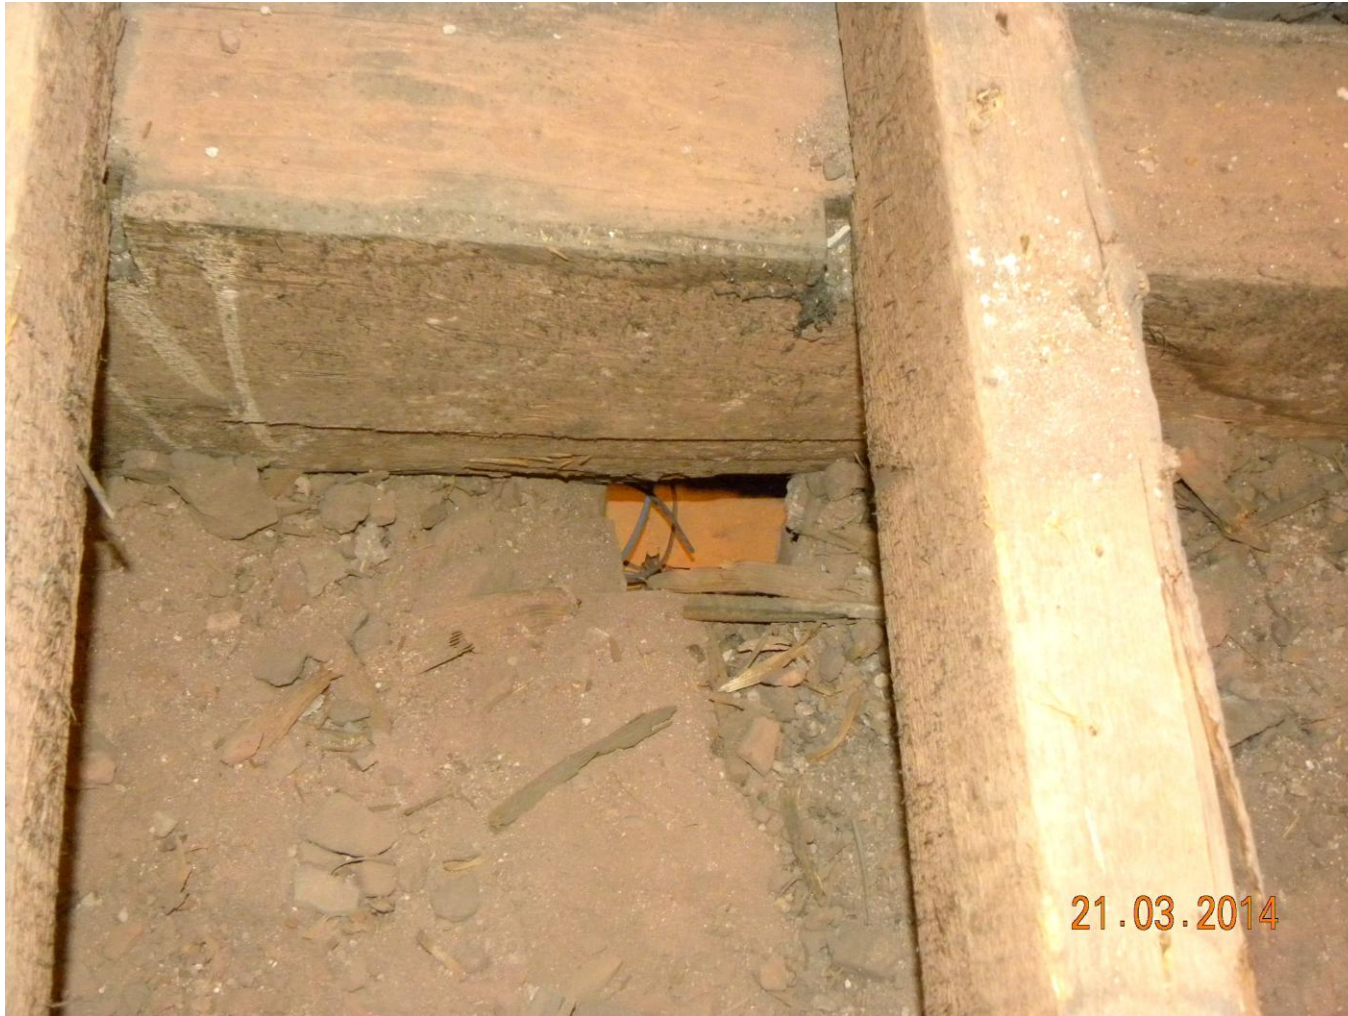
PHOTOGRAPH SR-10:

Close-up view of a 8 in. x 10 in. hole within the brick masonry arch roof of the vault below. (Refer to Figure 5 (Hole 2), Appendix "A", Volume I. The hole is approximately 8 in. x 10 in.).
