“Draft” Interim Report

**Cursory Structural Review of Province House
Charlottetown, PEI**

**Parks Canada
Historic Properties
1869 Upper Water Street
Halifax, NS
B3J 1S9**

**J.W. Cowie Engineering Limited
1046 Barrington Street, Suite#200
Halifax, Nova Scotia
B3H 2R1**

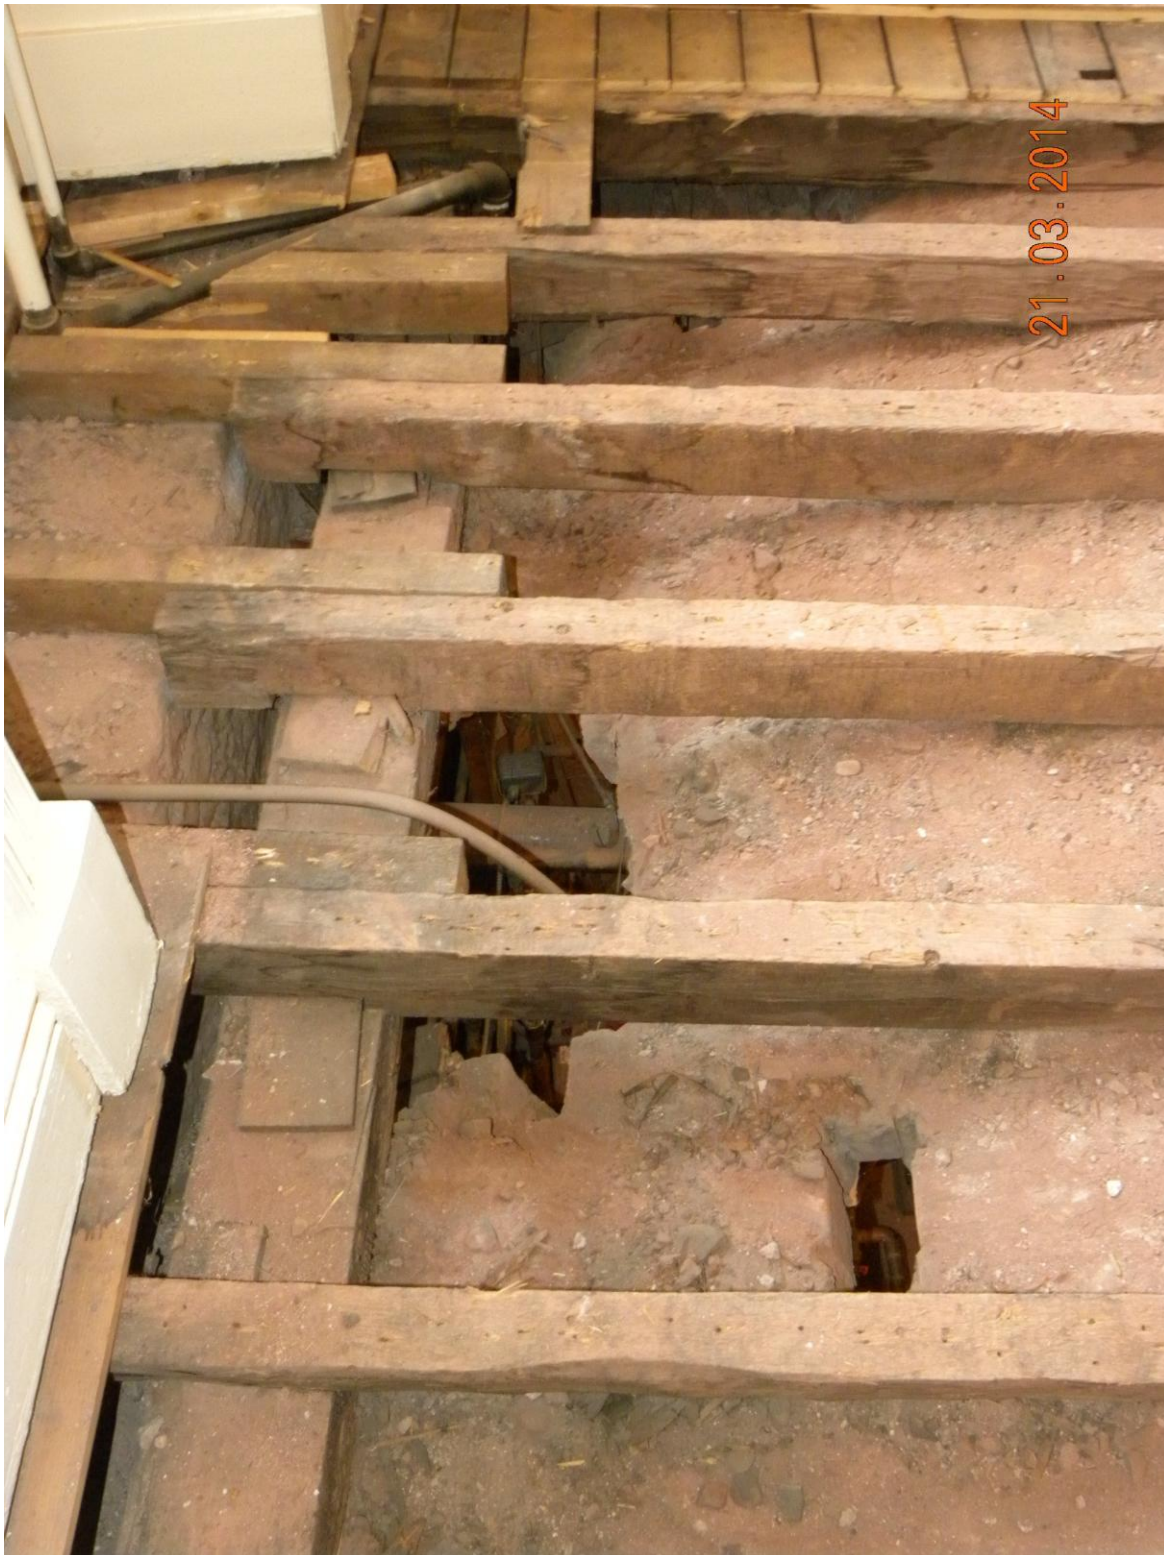
PHOTOGRAPH SR-11:

Viewing North along the North/South spanning timber beam. Shows Holes; 3 and 4 within the brick masonry arch roof of the vault below. Hole 3 is approximately 4 in. x 8 in. while Hole 4 is approximately 1 ft. 8 in. x 2 ft. 10 in. (Refer to Figure 5 (Holes; 3 and 4), Appendix "A", Volume I).

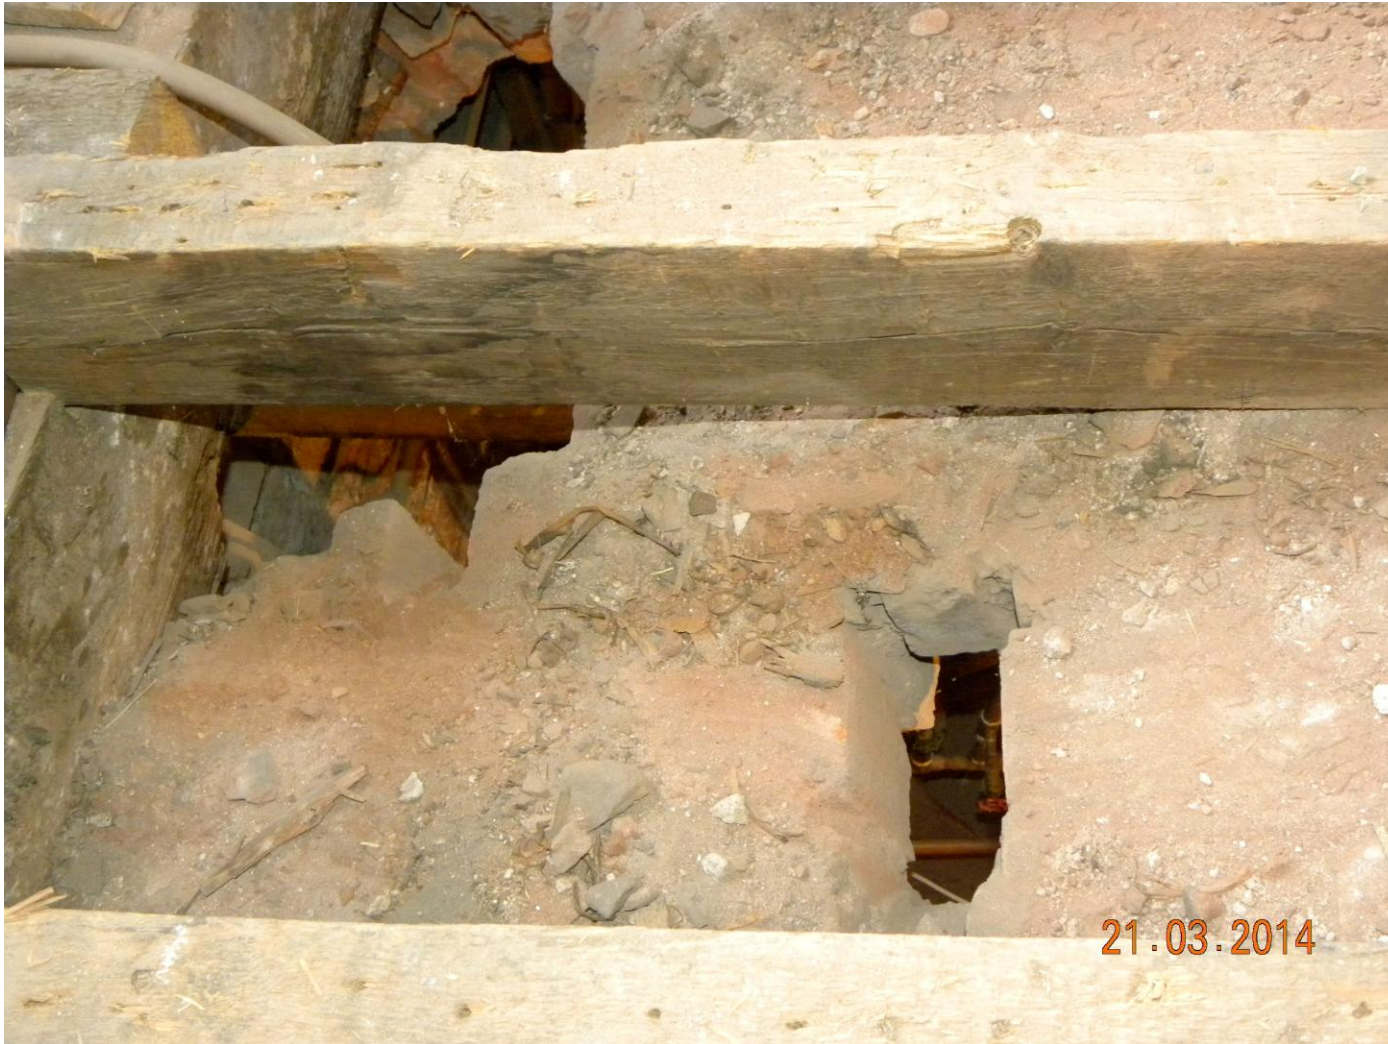
PHOTOGRAPH SR-12:

Close-up view of Hole 3 and the South edge of Hole 4. (Refer to Figure 5, Appendix "A", Volume I).

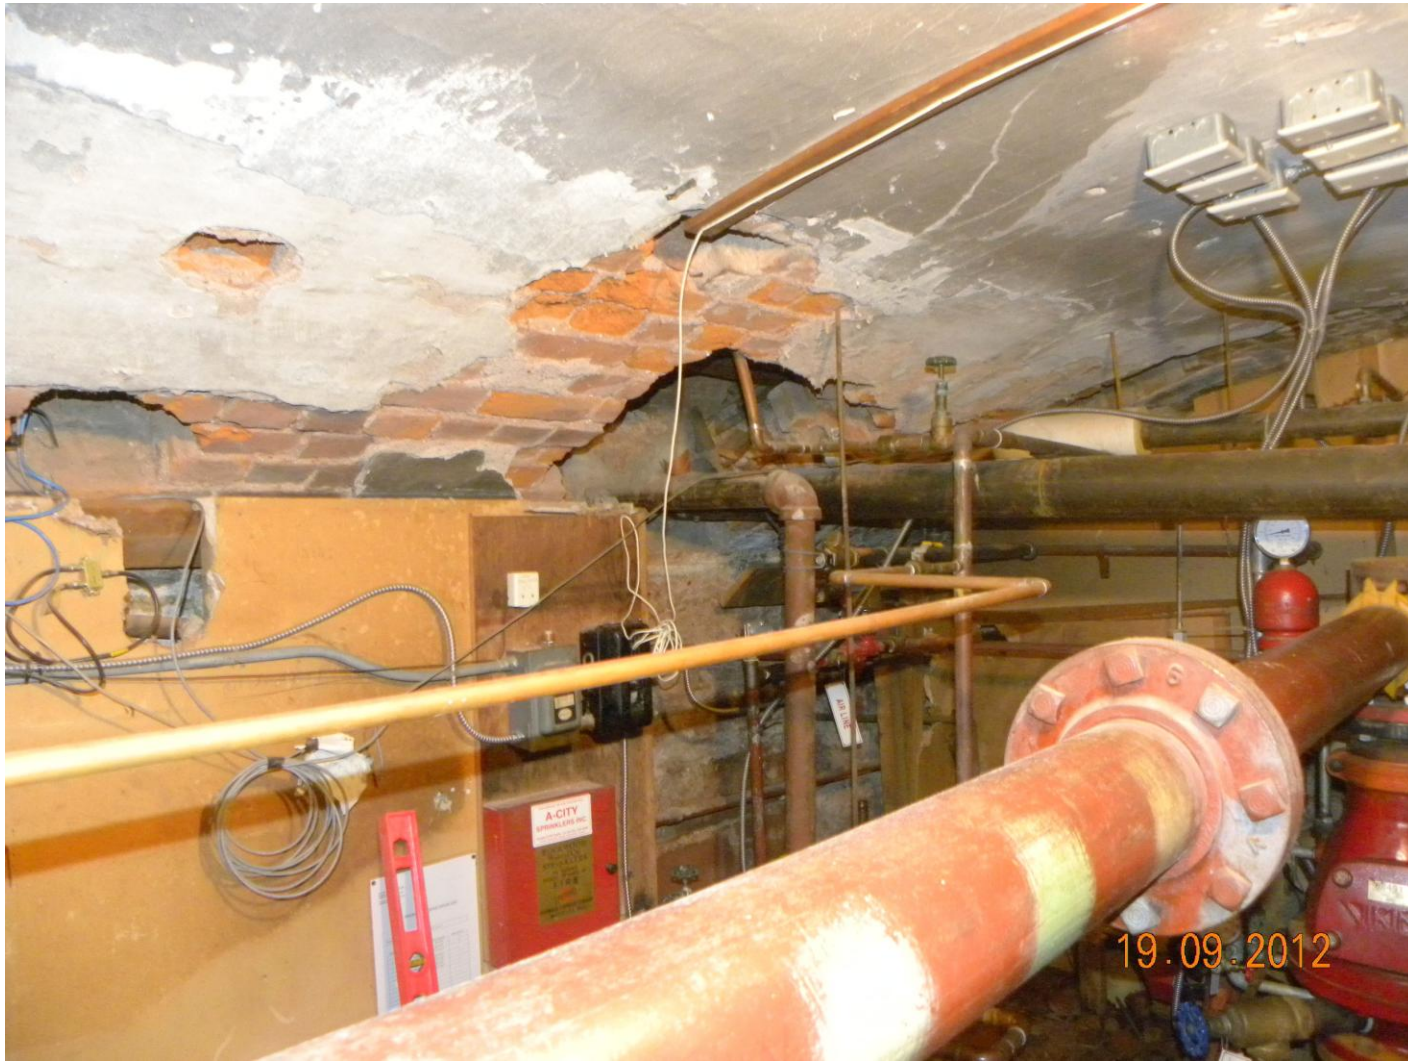
PHOTOGRAPH SR-13:

View of the West side of the arch roof of the vault housing the Sprinkler Room. Shows Holes; 2, 3 and 4.

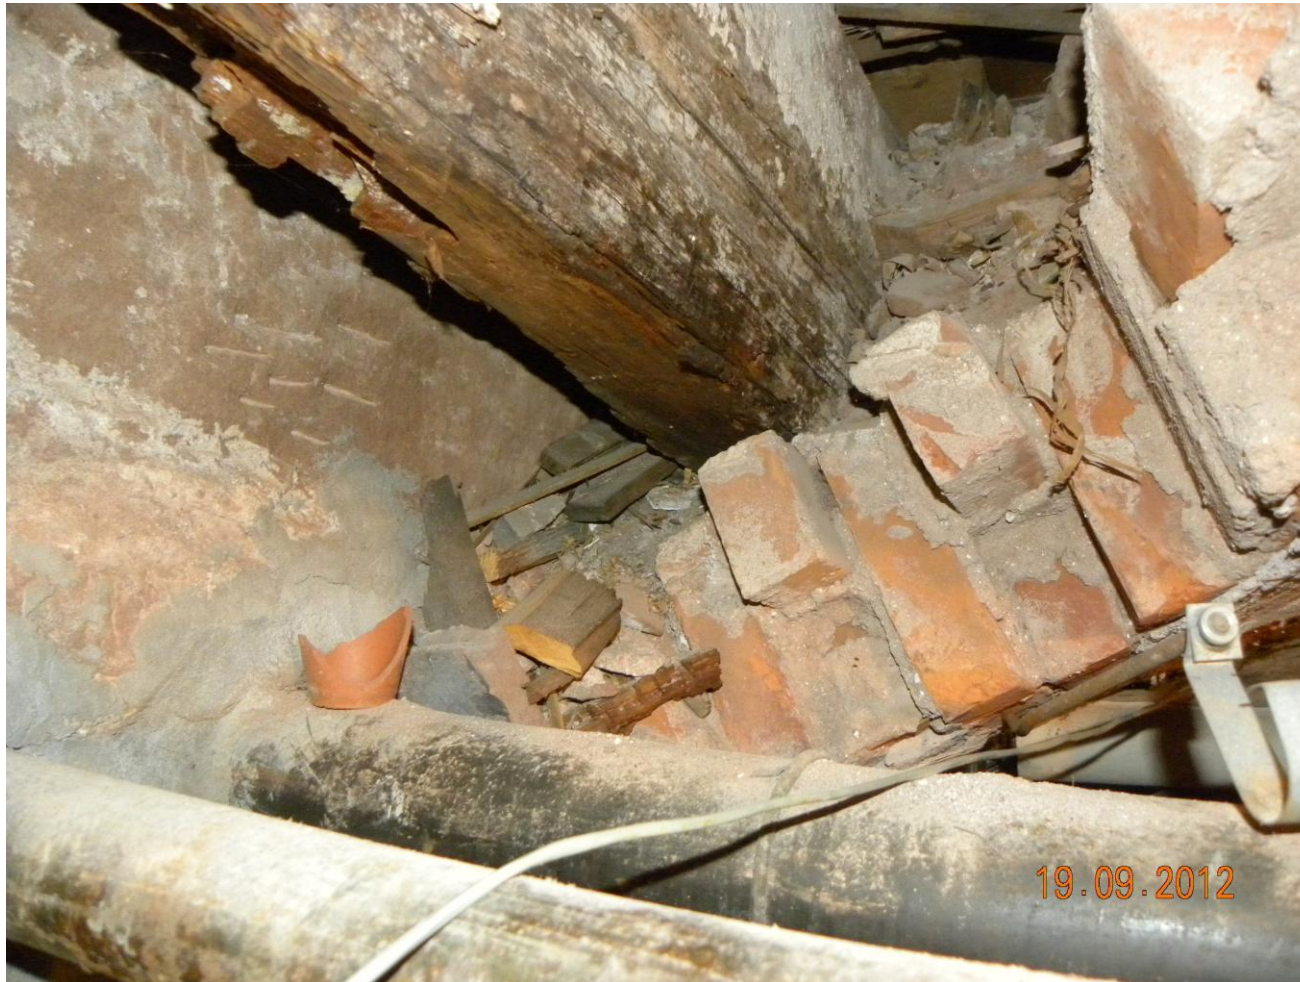
PHOTOGRAPH SR-14:

Underside of the 7 ½ in. x 14 in. timber beam viewing through Hole 4 located on the West side of the brick masonry arch roof of the vault housing the Sprinkler Room. Viewing Northwest.

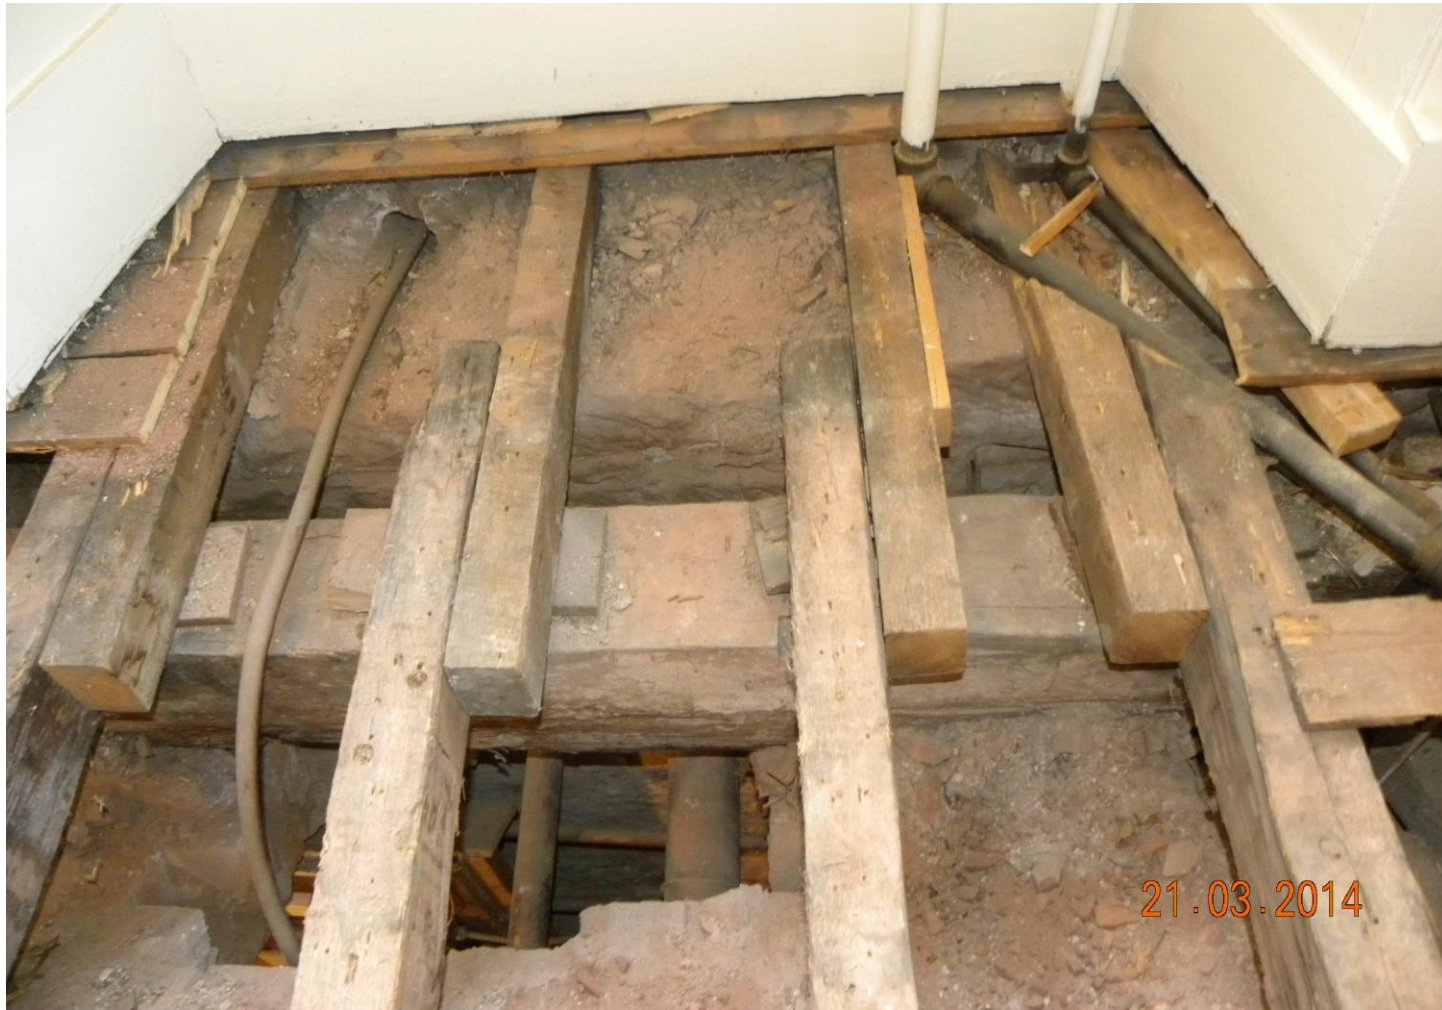
PHOTOGRAPH SR-17:

Shows the extensions to the 3 in. wide x 4 in. deep timber "sleepers" for support of the floor deck within the recessed wall opening at the window. Also shows the existing piping.

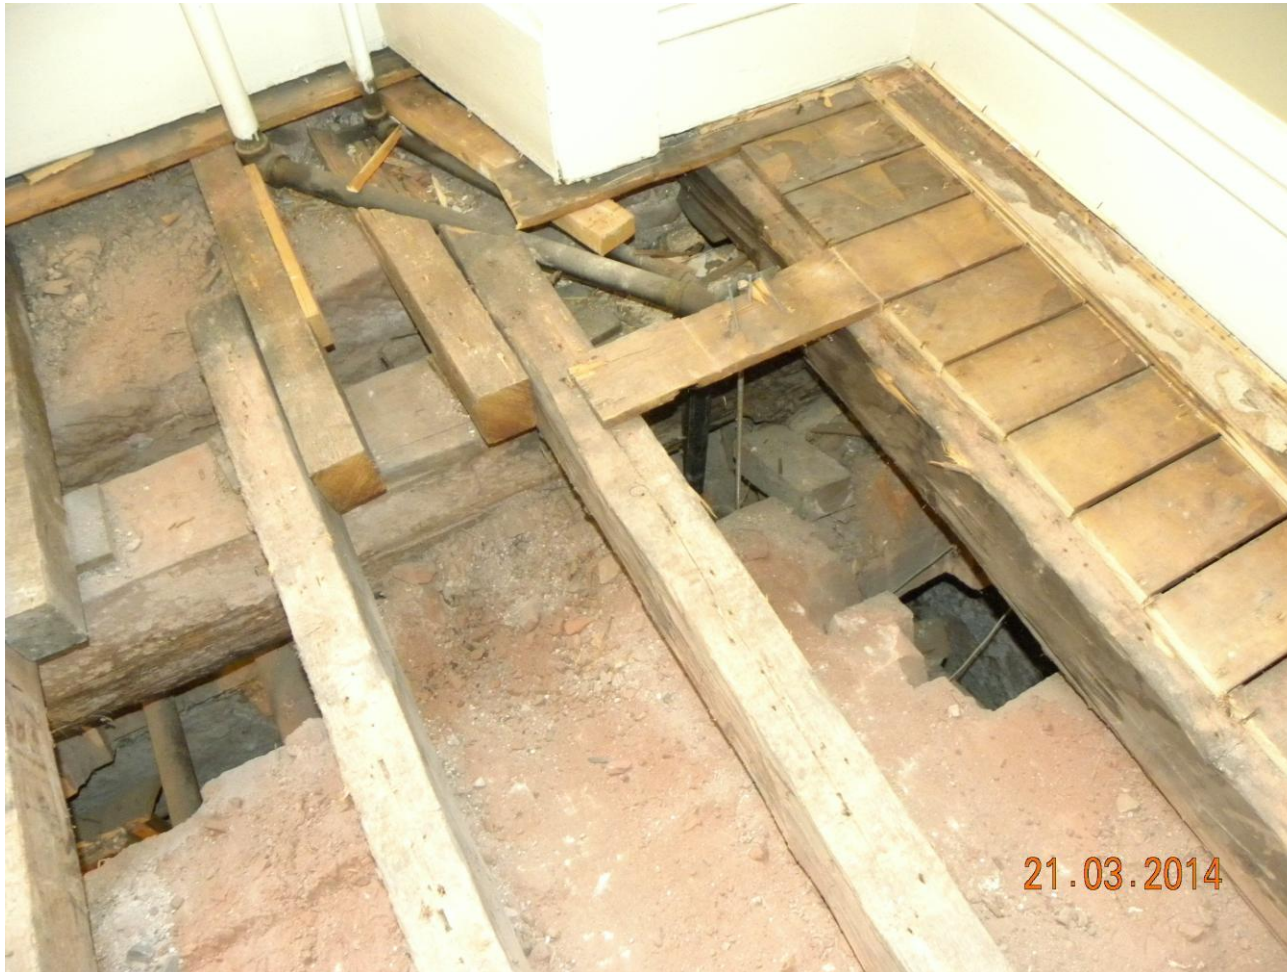
PHOTOGRAPH SR-18:

Northwest corner of the Speaker's Office floor. Shows Holes; 5 and 6 within the brick masonry arch of the vault. Shows a heating pipe passing diagonally through and across a "sleeper" adjacent to the North side of the wall opening at the window.

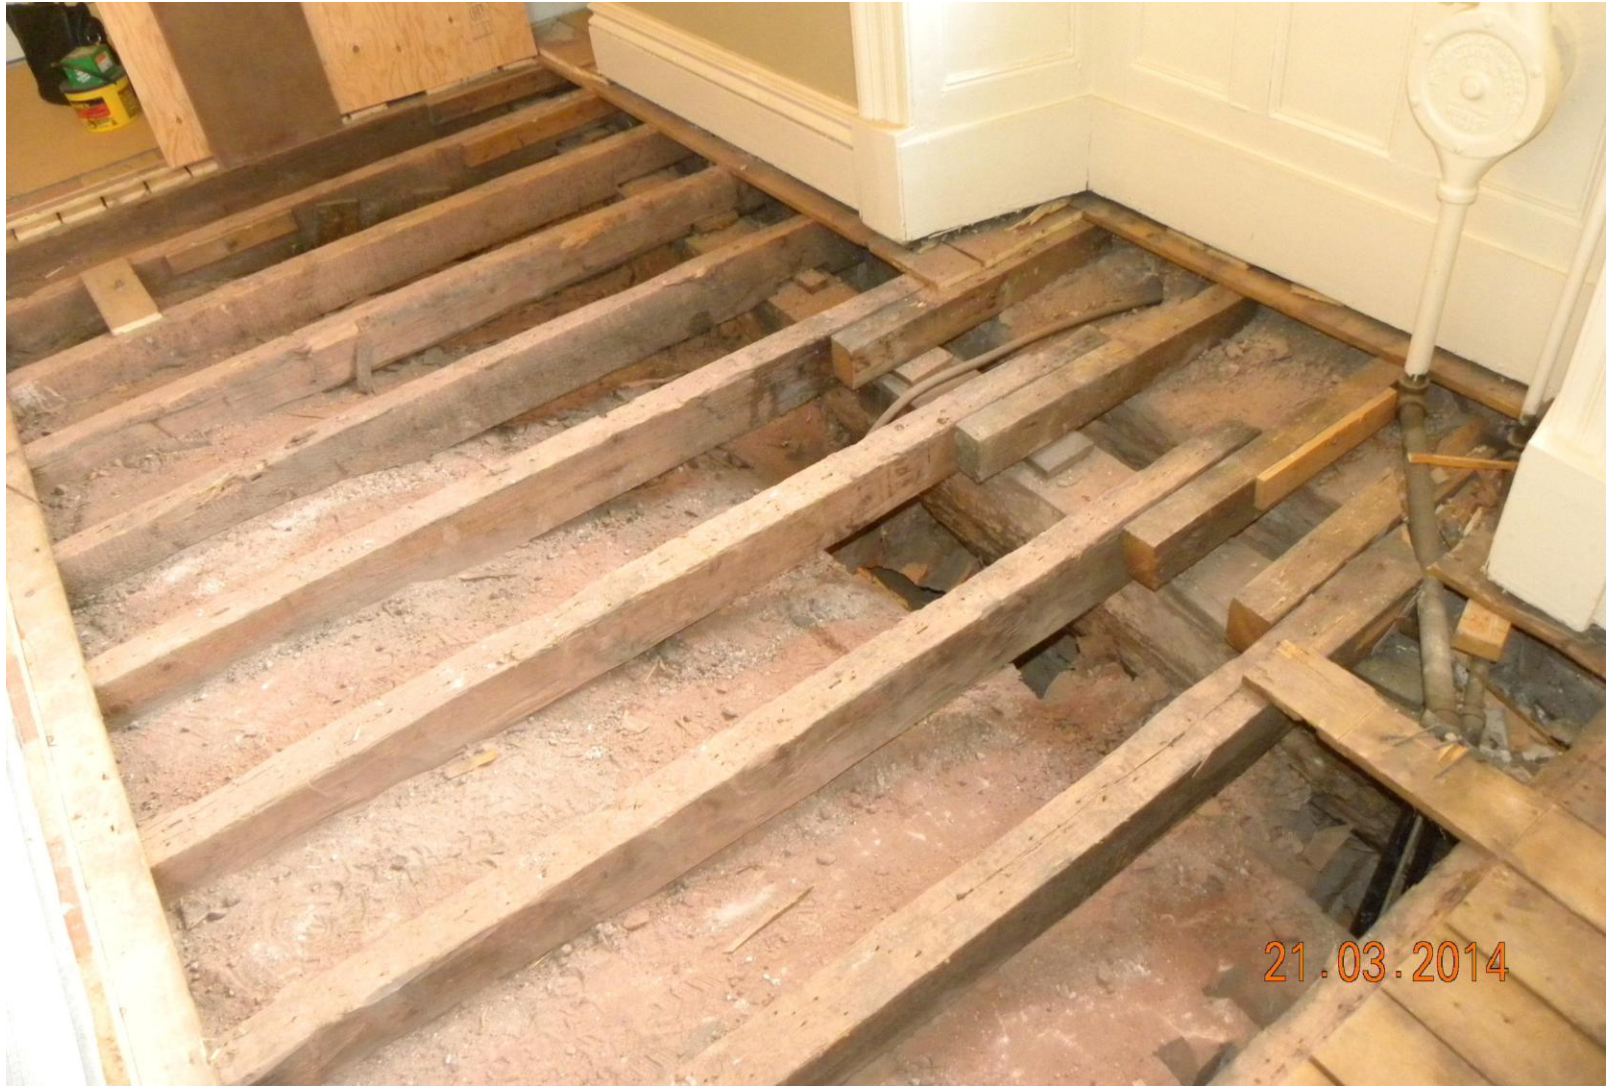
PHOTOGRAPH SR-19:

Viewing Southwest across the Western half of the Speaker's Office floor.

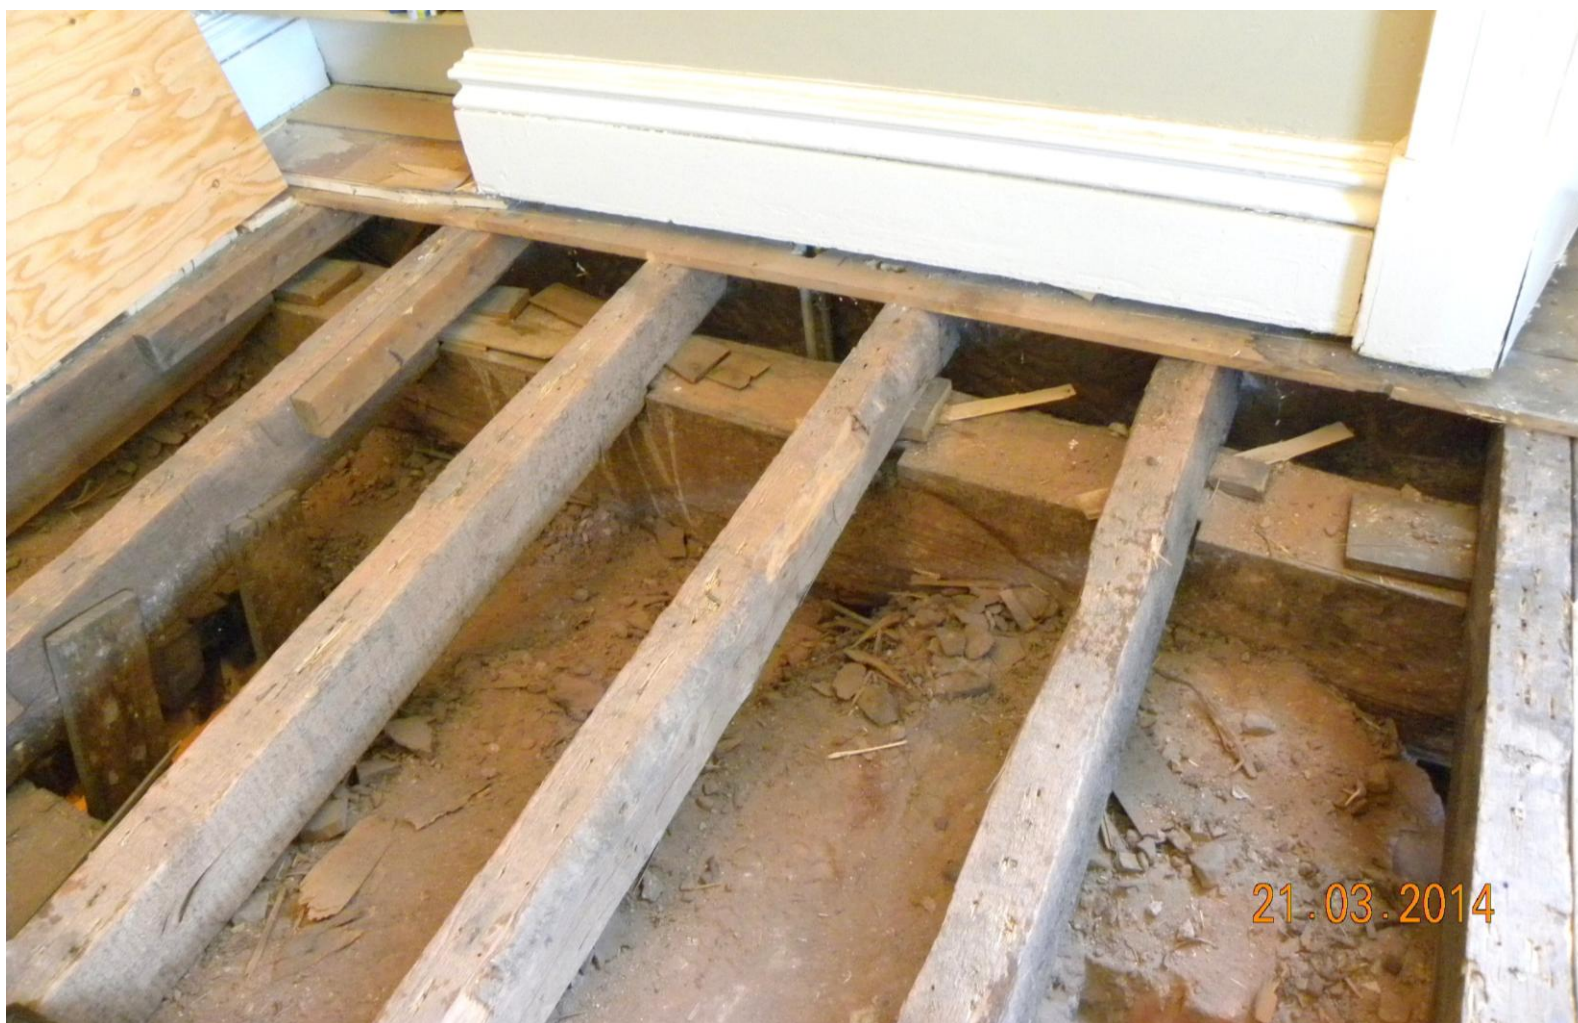
PHOTOGRAPH SR-20:

3 in. wide x 4 in. deep timber "sleepers" bearing on top of the 7 ½ in. x 14 in. timber beam located at the Southwest end of the Speaker's Office. Viewing Southwest.

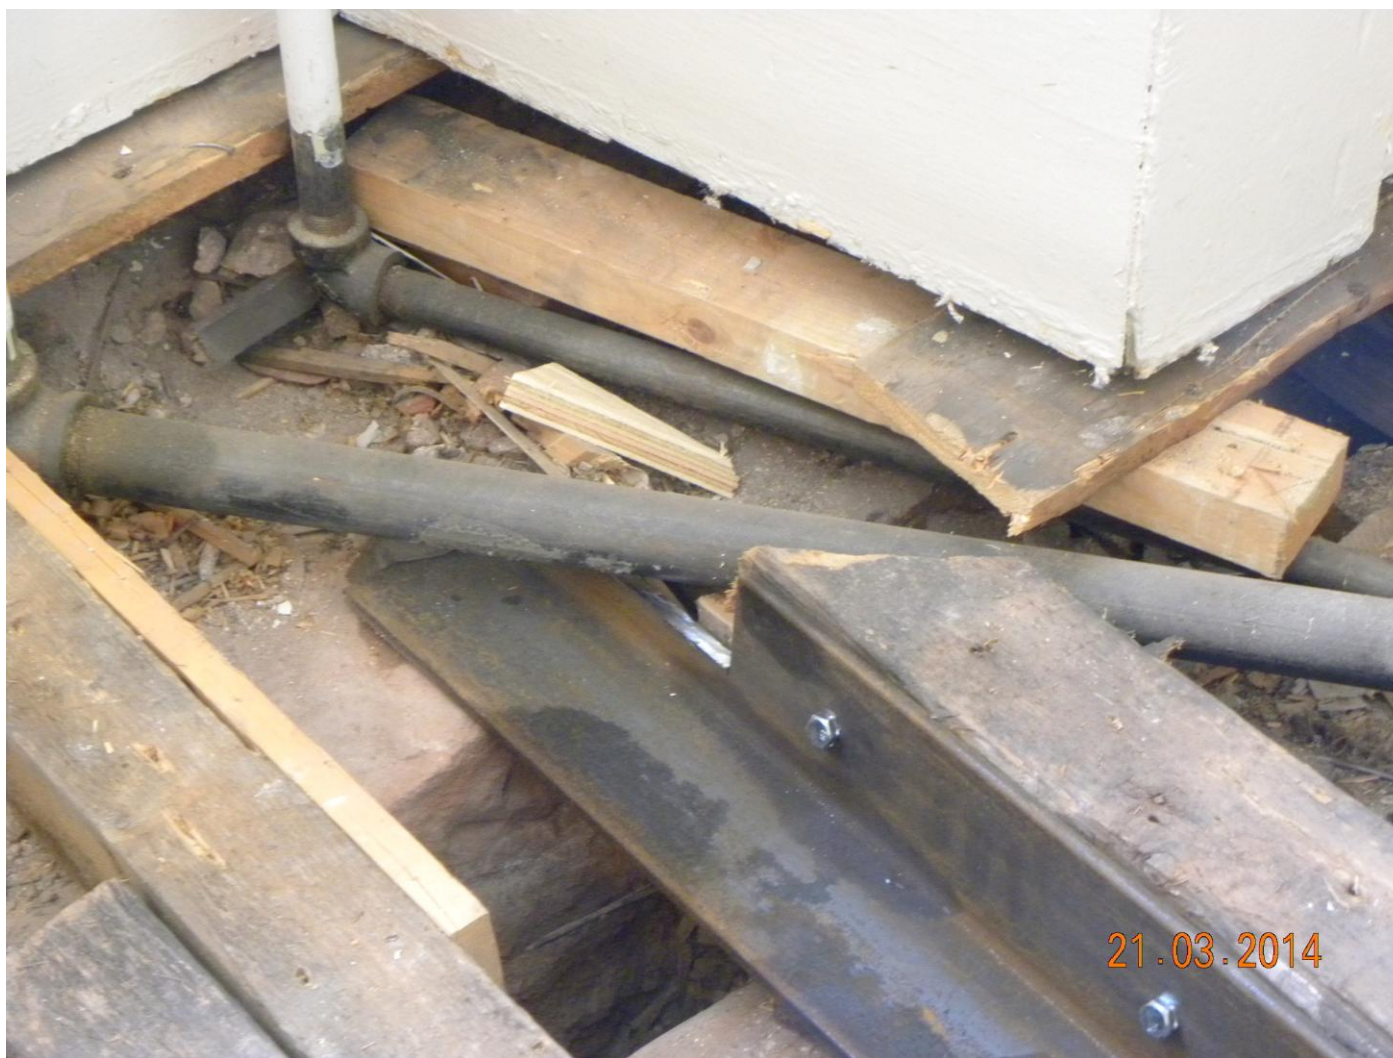
PHOTOGRAPH SR-28:

Shows the West bearing end of the 4 in. x 4 in. steel angle having its vertical leg coped to permit passage of the pipe.

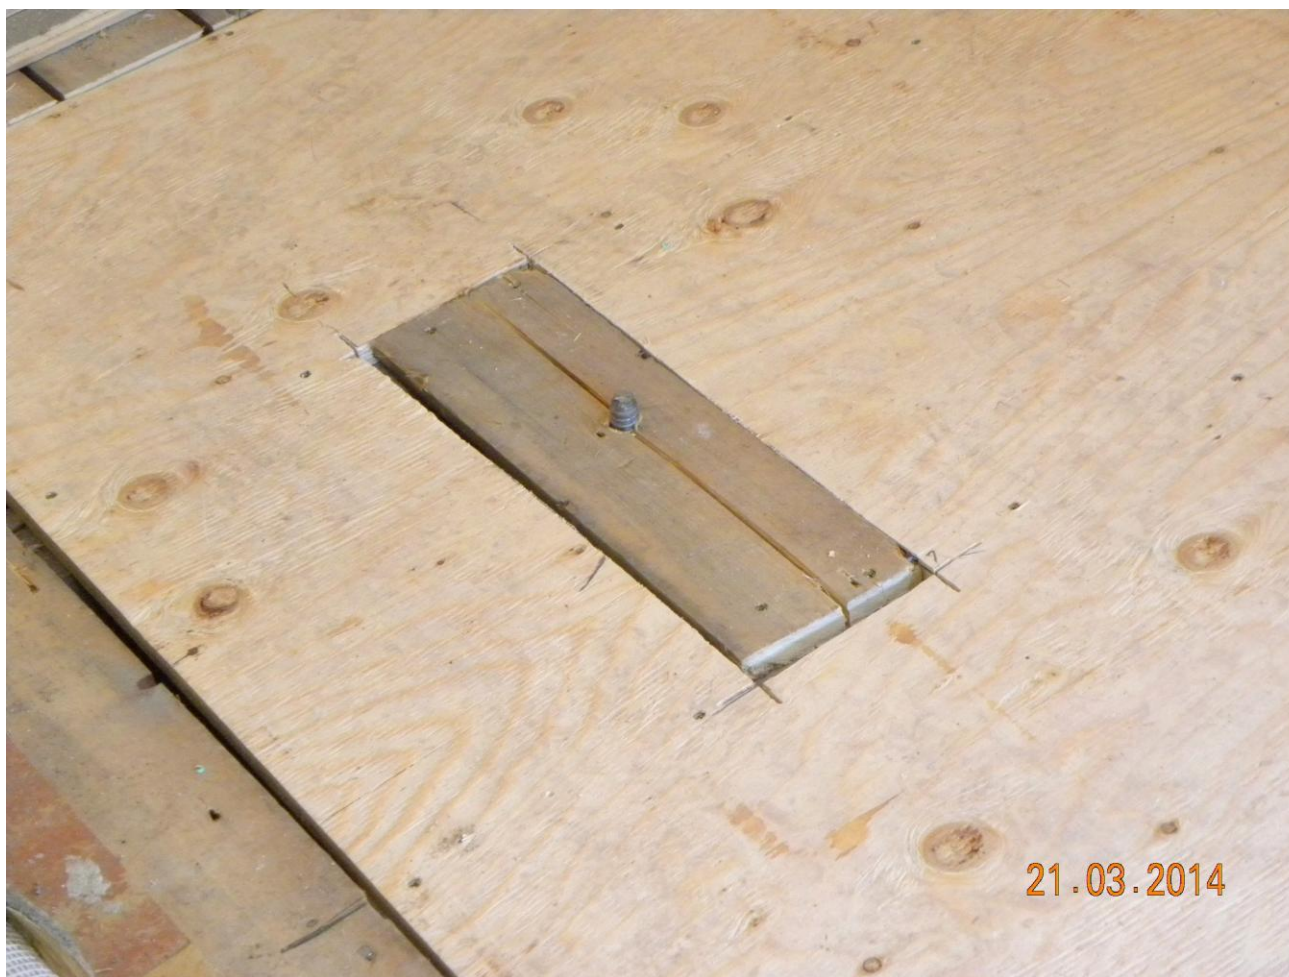
PHOTOGRAPH SR-30:

Shows the end of the threaded rod pipe hanger previously used for the support of the water supply pipe to the Sprinkler Room below. The water supply pipe is presently temporarily supported from the floor of the Sprinkler Room. (Refer to Photograph SR-32, Appendix "B", Volume II).

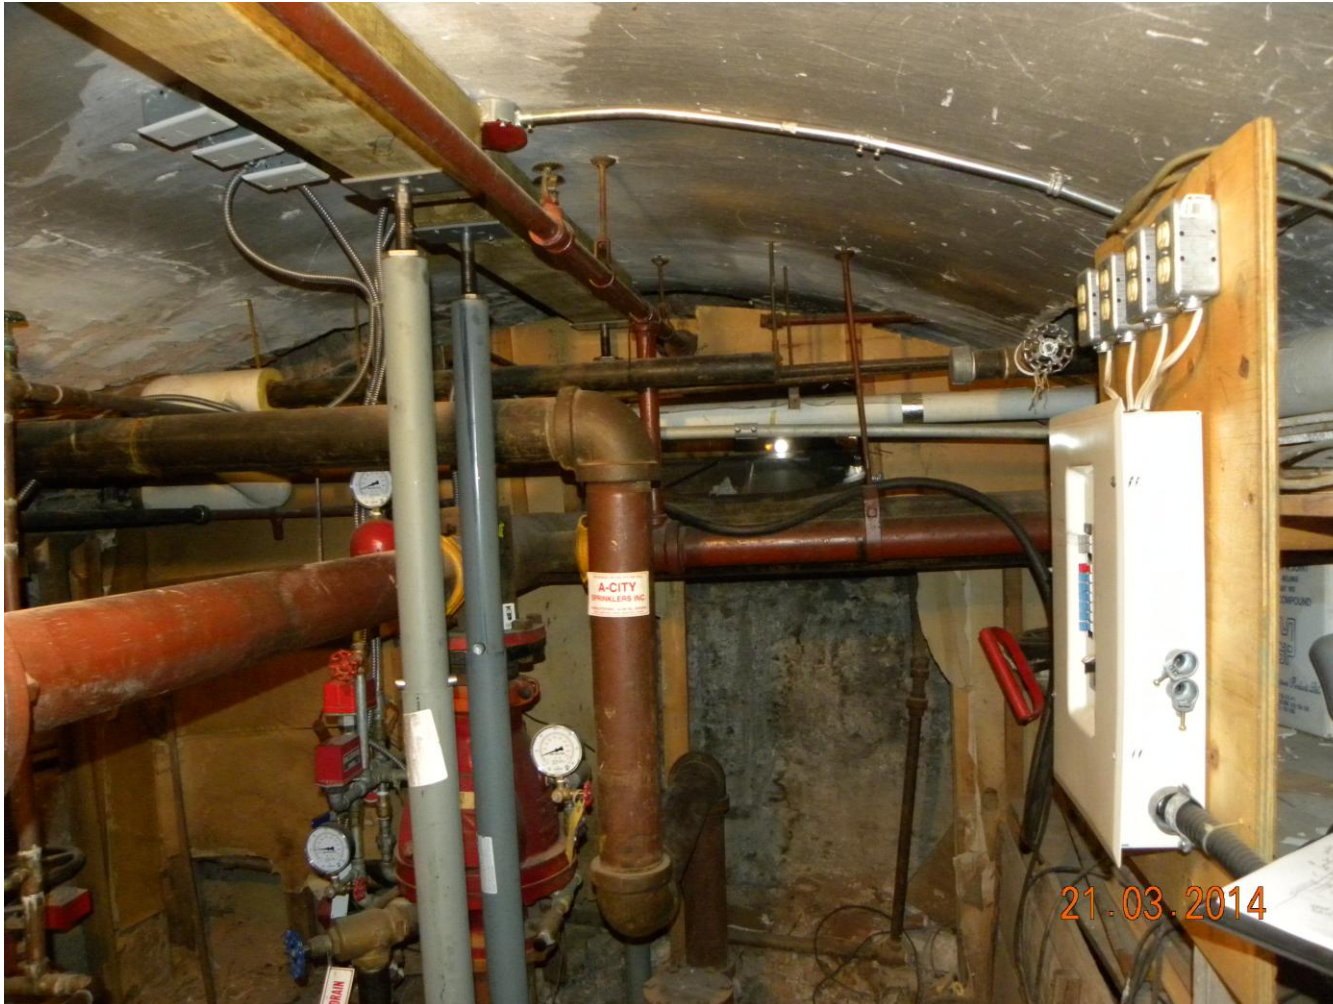
PHOTOGRAPH SR-33:

Viewing towards the North end of the vault housing the Sprinkler Room. The two white lights in the centre of the photograph are from holes in the temporary plywood covering of the basement window opening.

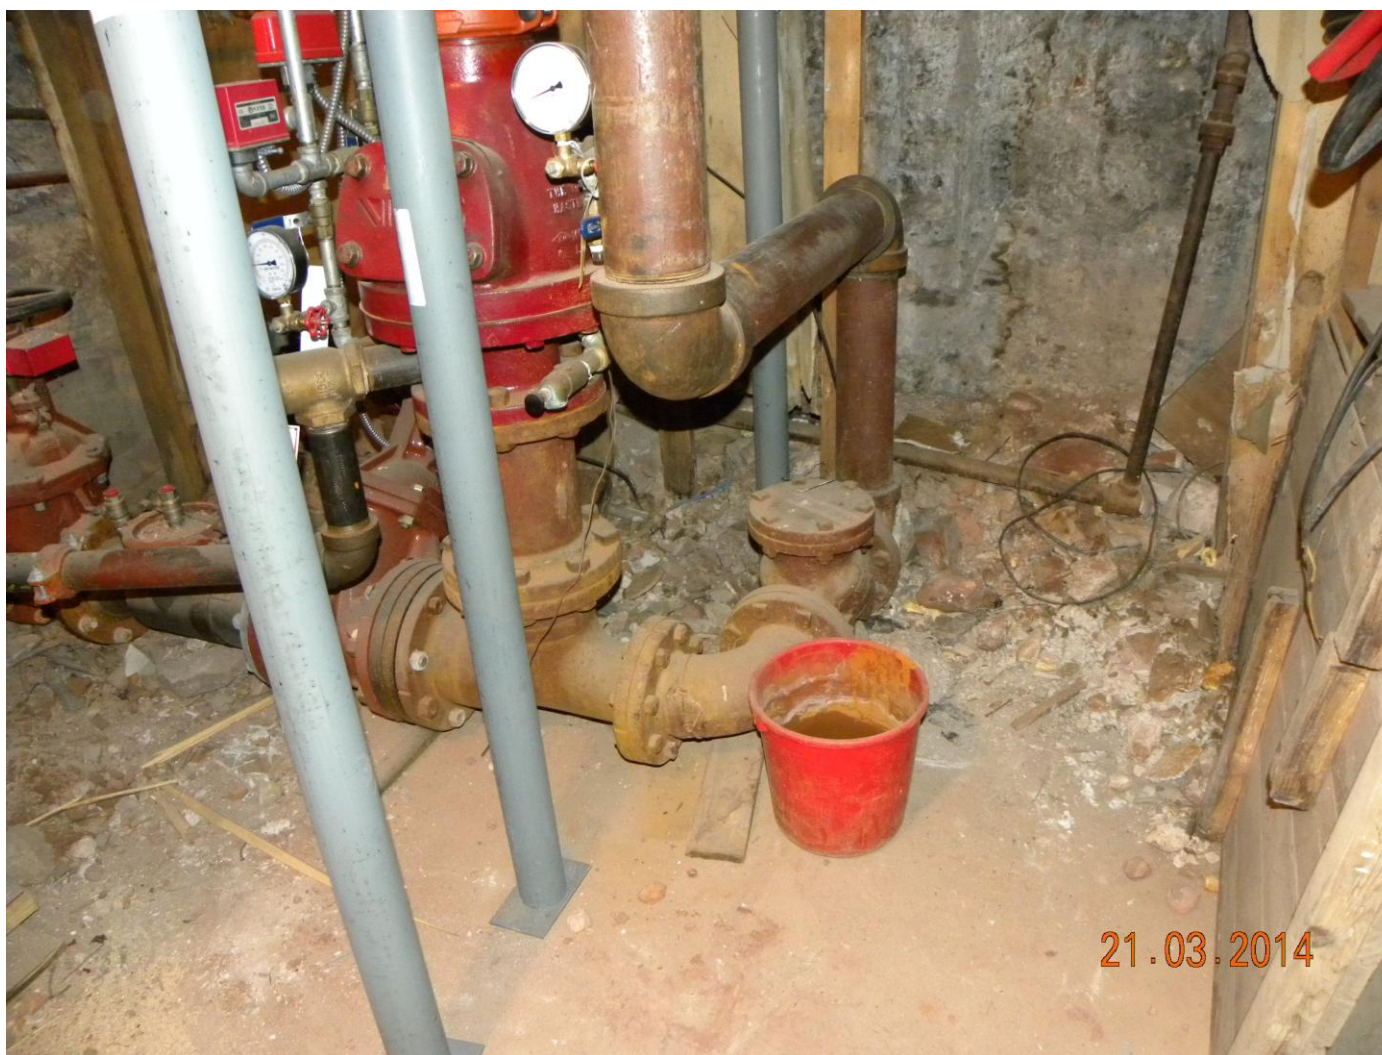
PHOTOGRAPH SR-35:

Northern end of the Sprinkler Room containing the sprinkler system and three steel "jack posts" bearing on the concrete slab on grade of the Sprinkler Room floor.

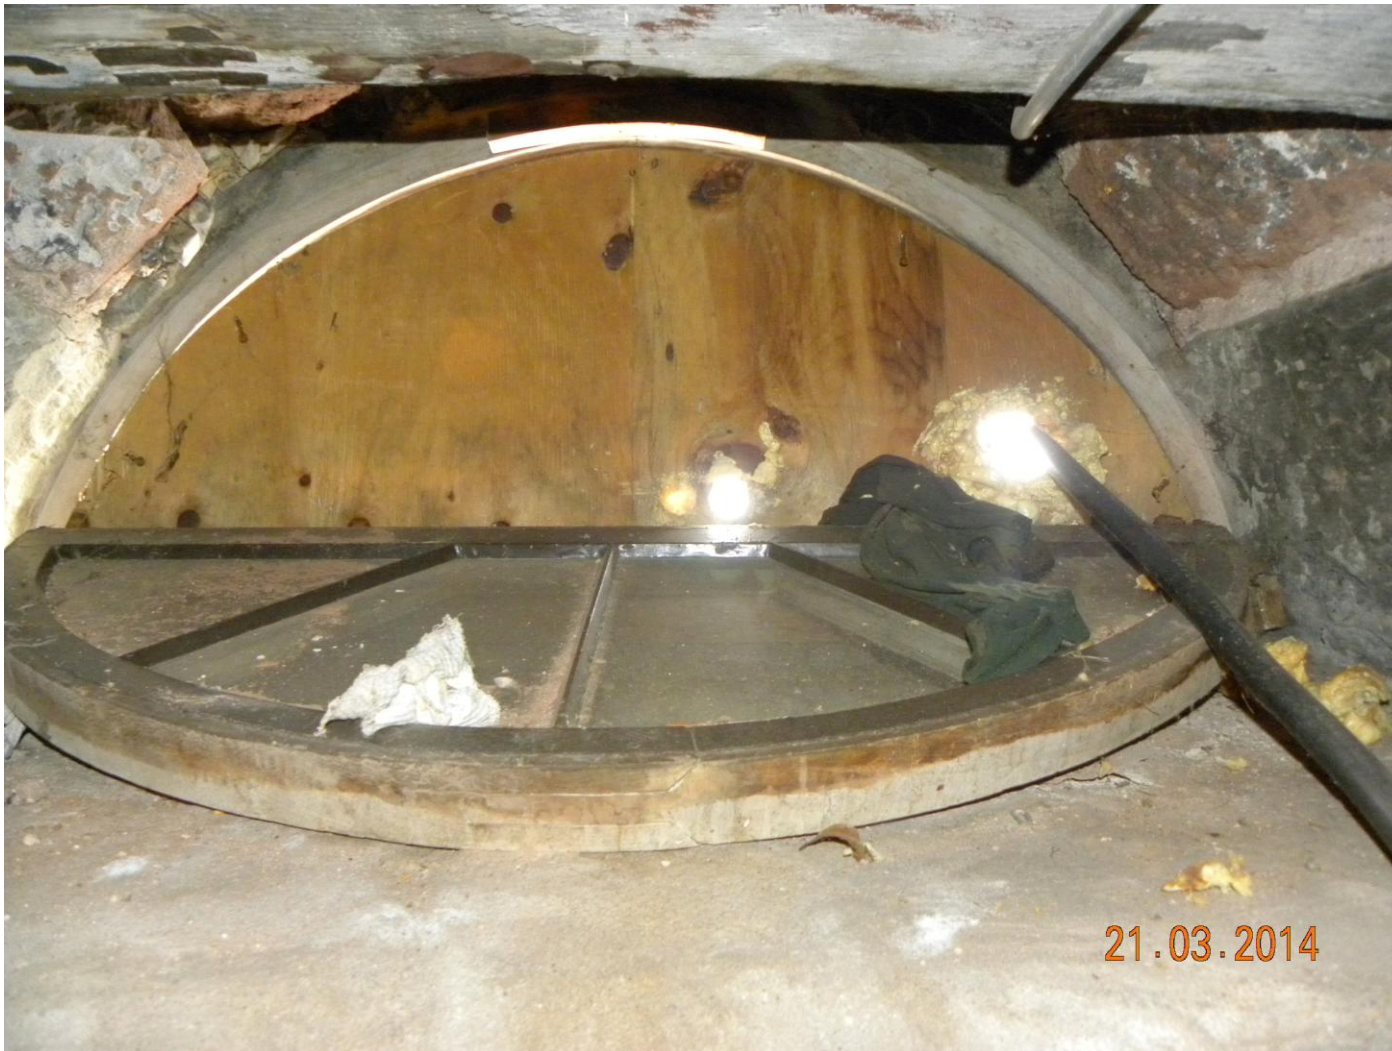
PHOTOGRAPH SR-36:

View of the window opening at the North end of the Sprinkler Room. The plywood is not tight fitting around the window opening and two holes exist permitting rainwater entry.

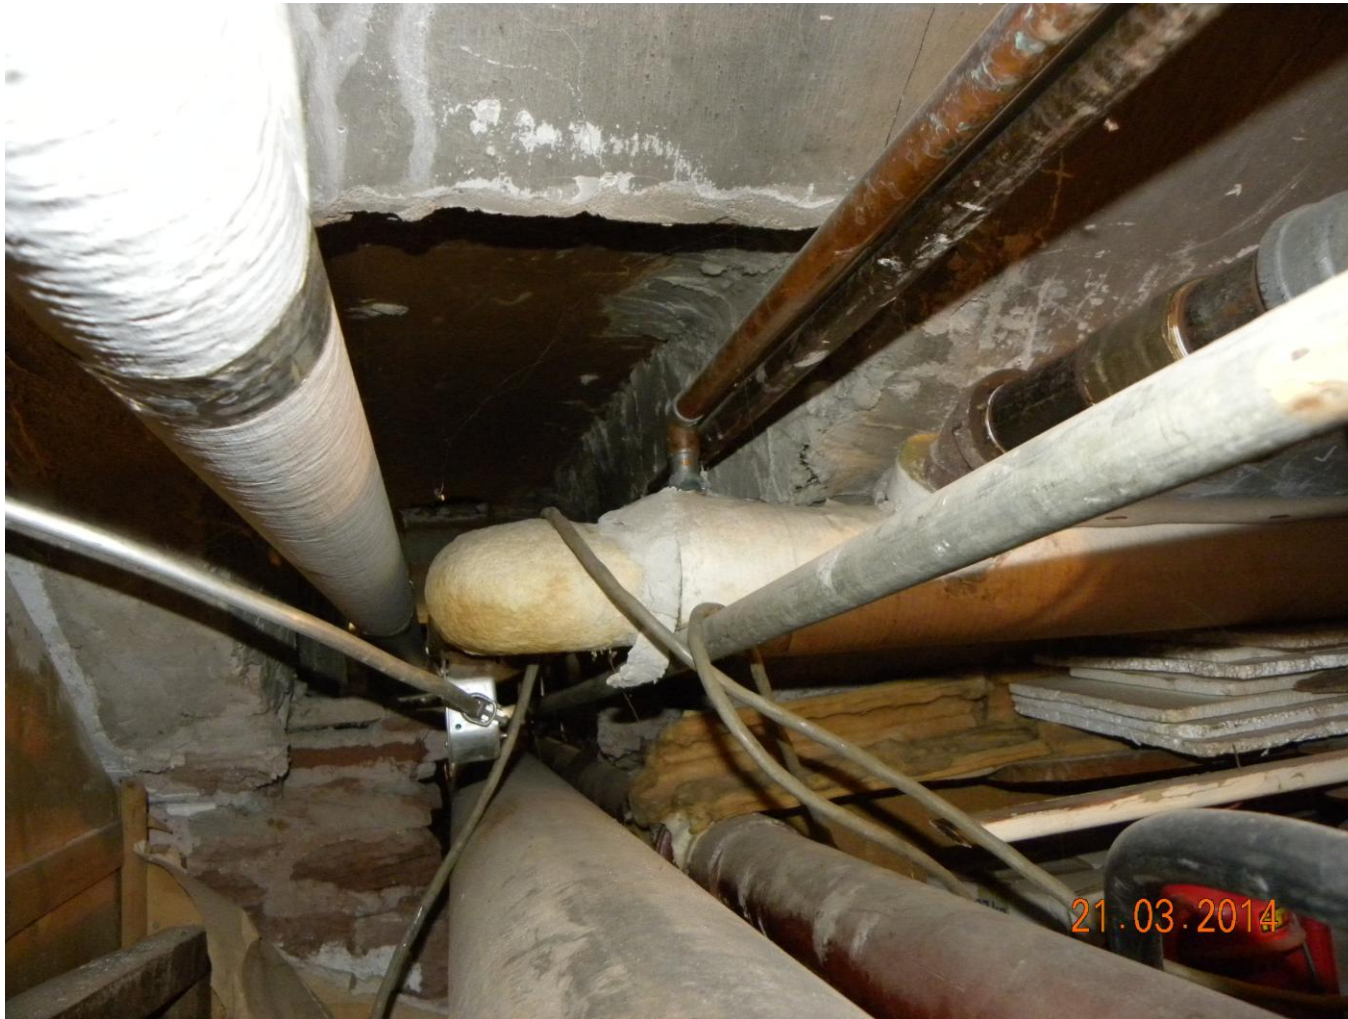
PHOTOGRAPH SR-38:

Horizontal pipe chase causing a reduction in the roof thickness of the Sprinkler Room vault as well as the roof of the adjacent vault (Room 104). (For reference purposes, horizontal pipe chase is noted as Hole 8, Figure 5, Appendix "A", Volume I).

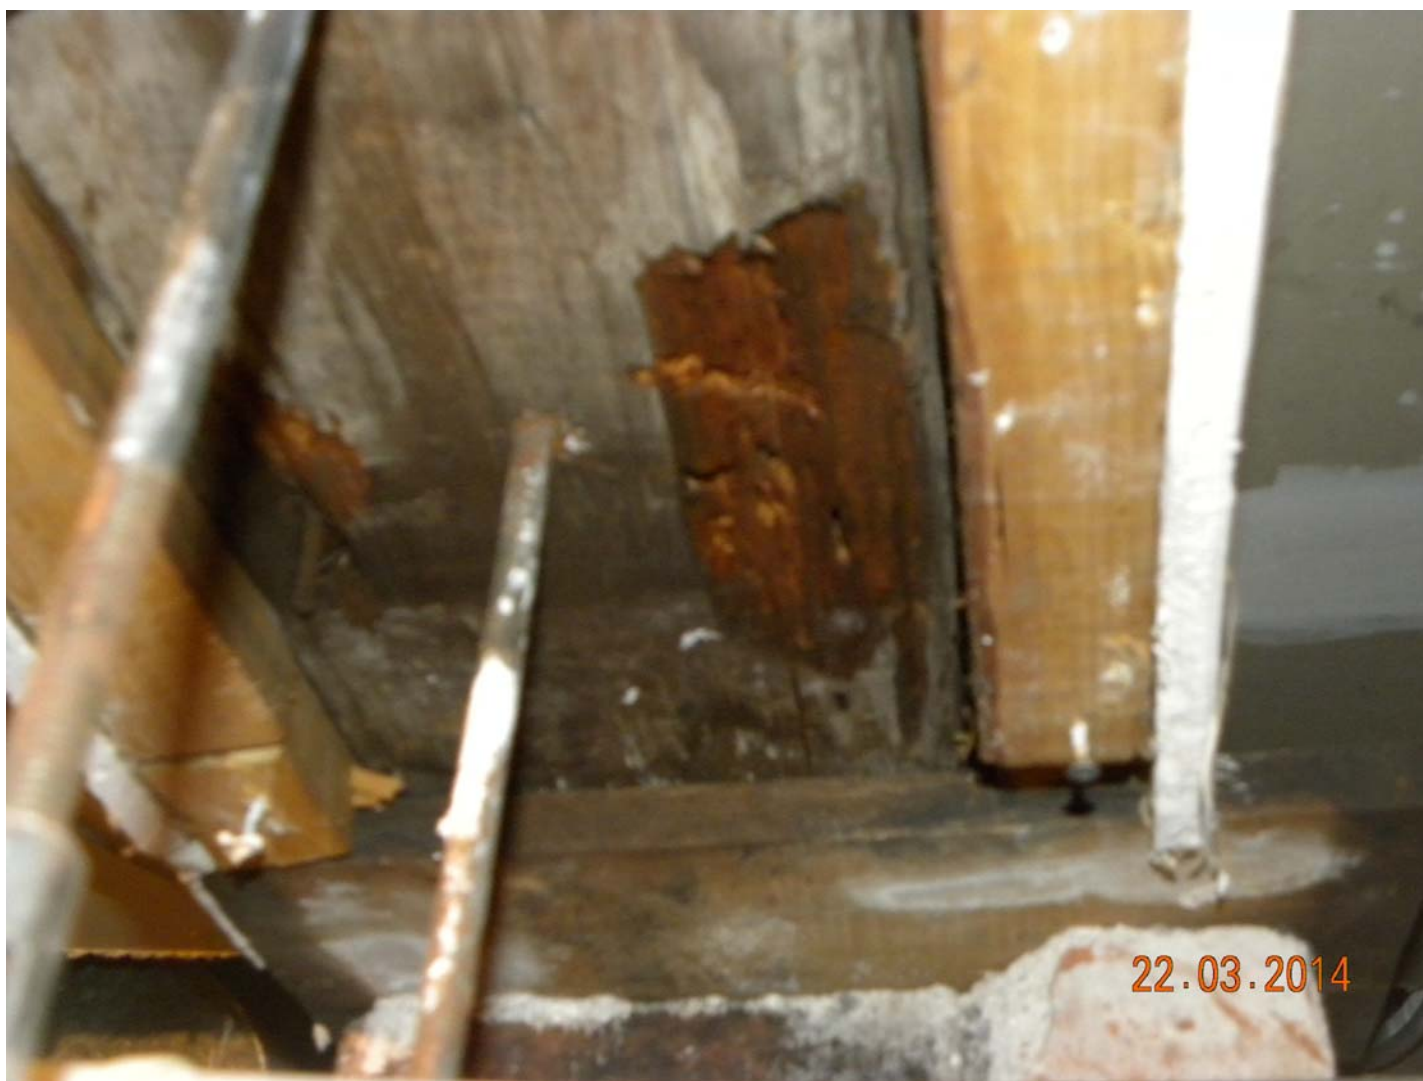
PHOTOGRAPH BSE-7:

View of the underside of the 7 ¼ in. wide x 1 ft. 2 in. deep timber beam with 2 in. x 10 in. (nominal) timber joists connected to the East and West sides of the timber beam. Considerable wood rot was detected on the underside of the 7 ¼ in. x 1 ft. 2 in. timber beam.
