“Draft” Interim Report

**Cursory Structural Review of Province House
Charlottetown, PEI**

**Parks Canada
Historic Properties
1869 Upper Water Street
Halifax, NS
B3J 1S9**

**J.W. Cowie Engineering Limited
1046 Barrington Street, Suite#200
Halifax, Nova Scotia
B3H 2R1**

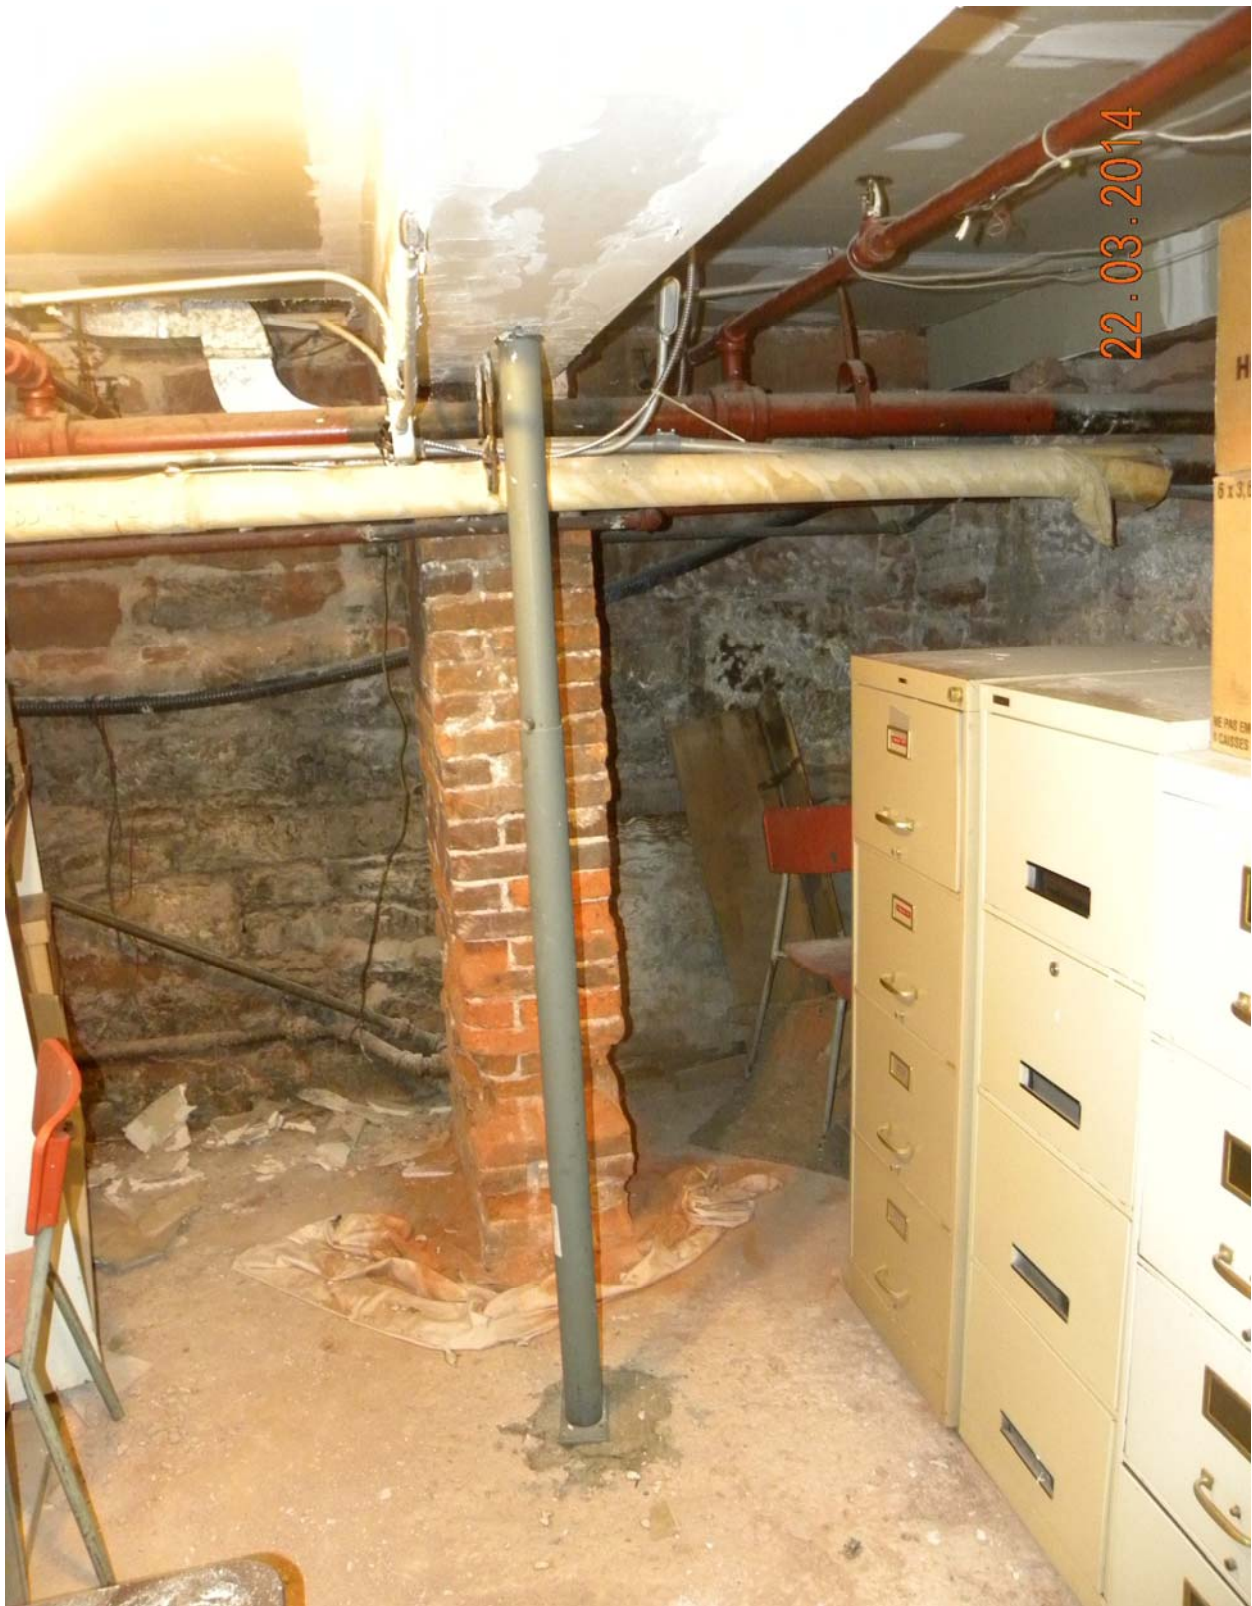
PHOTOGRAPH BSE-8:

Close-up of a rotten section on the underside of the timber beam in Room B15.

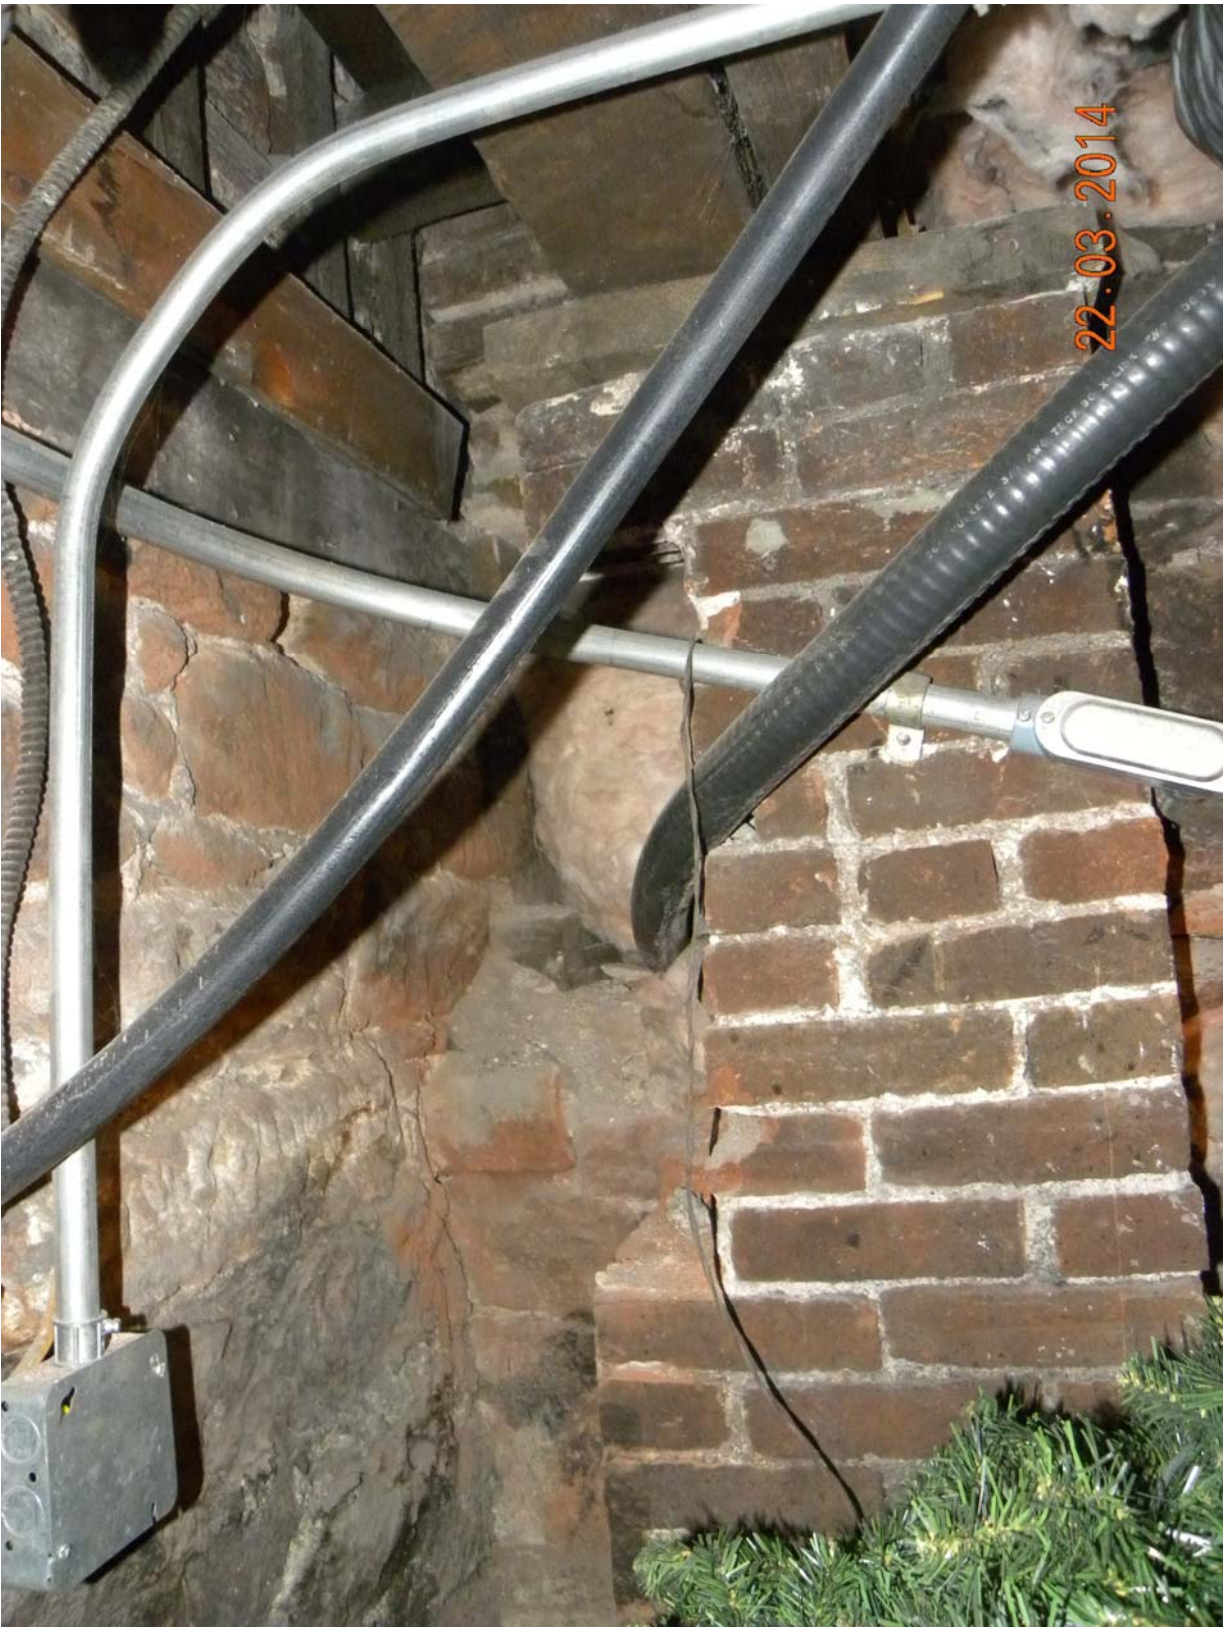
PHOTOGRAPH BSE-10:

Brick masonry Column 2a located at the Southwest corner of the Basement Room B14. (Refer to Figure 6 "Southeast Basement Area, Rooms B13, B14 and B15", Appendix "A", Volume I). A large section of the South top side of the brick masonry column has been removed from the column during the installation of the electrical conduit. (Refer to Figure 7 "East Elevation of Damaged Brick Masonry Column 2a, Southwest Corner of Basement Room B14", Appendix "A", Volume I). The plan dimensions of the column are 1 ft. 5 ¼ in. (North/ South) x 1 ft. ½ in. (East/West). Approximately 40% of the plan bearing area of the upper portion of the column has been demolished.

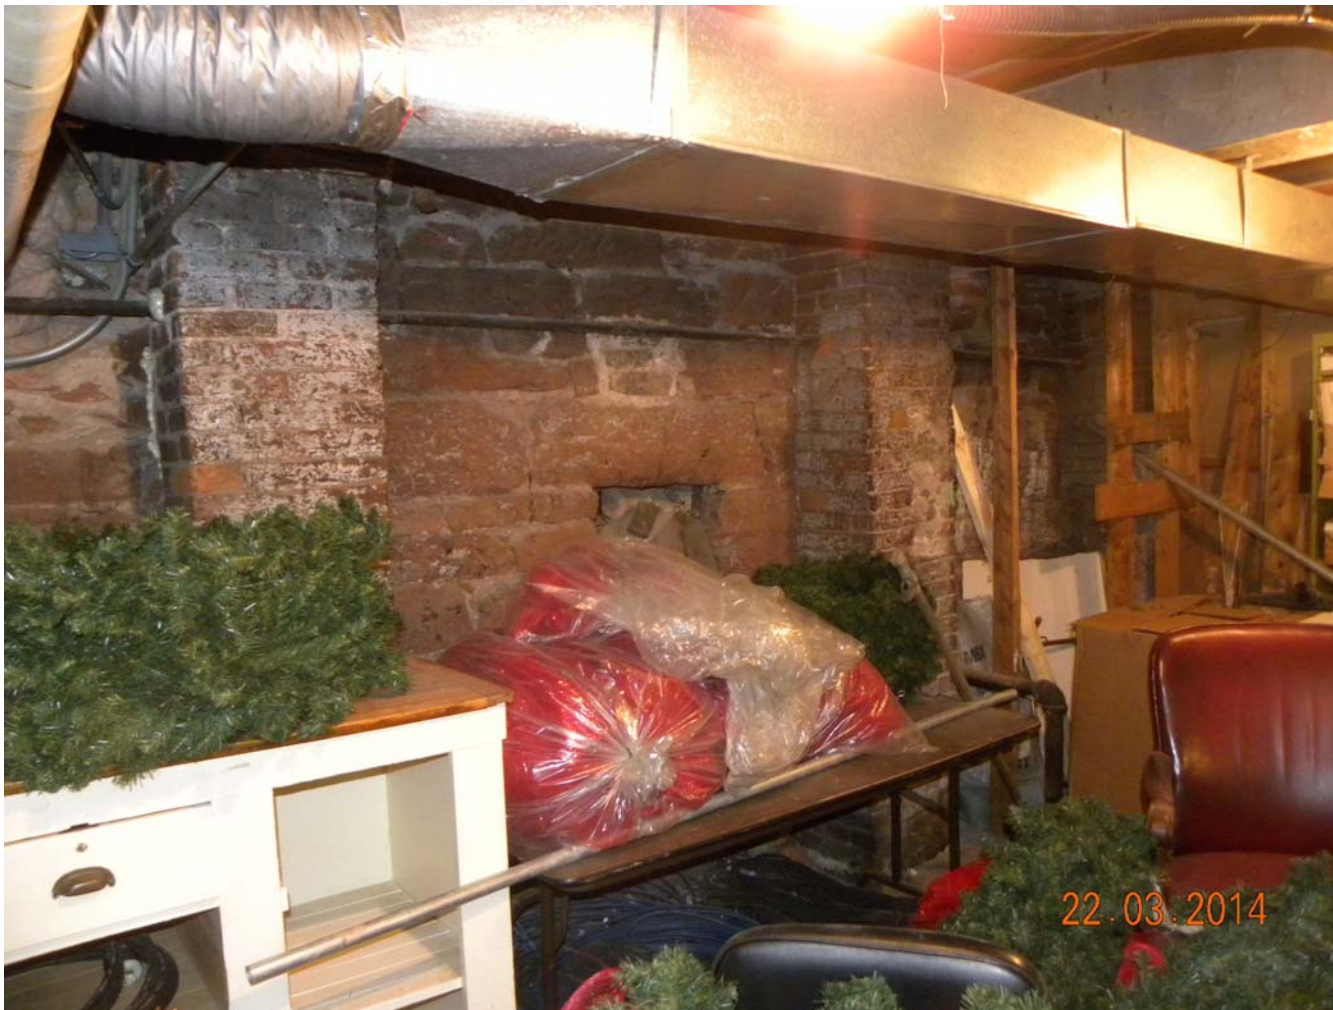
PHOTOGRAPH BSE-12:

Left of centre of the photograph is Column 2c located at the Southwest corner of Basement Room B14. (Refer to Figure 6 "Southeast Basement Area Rooms; B13, B14 and B15", Appendix "A", Volume I).

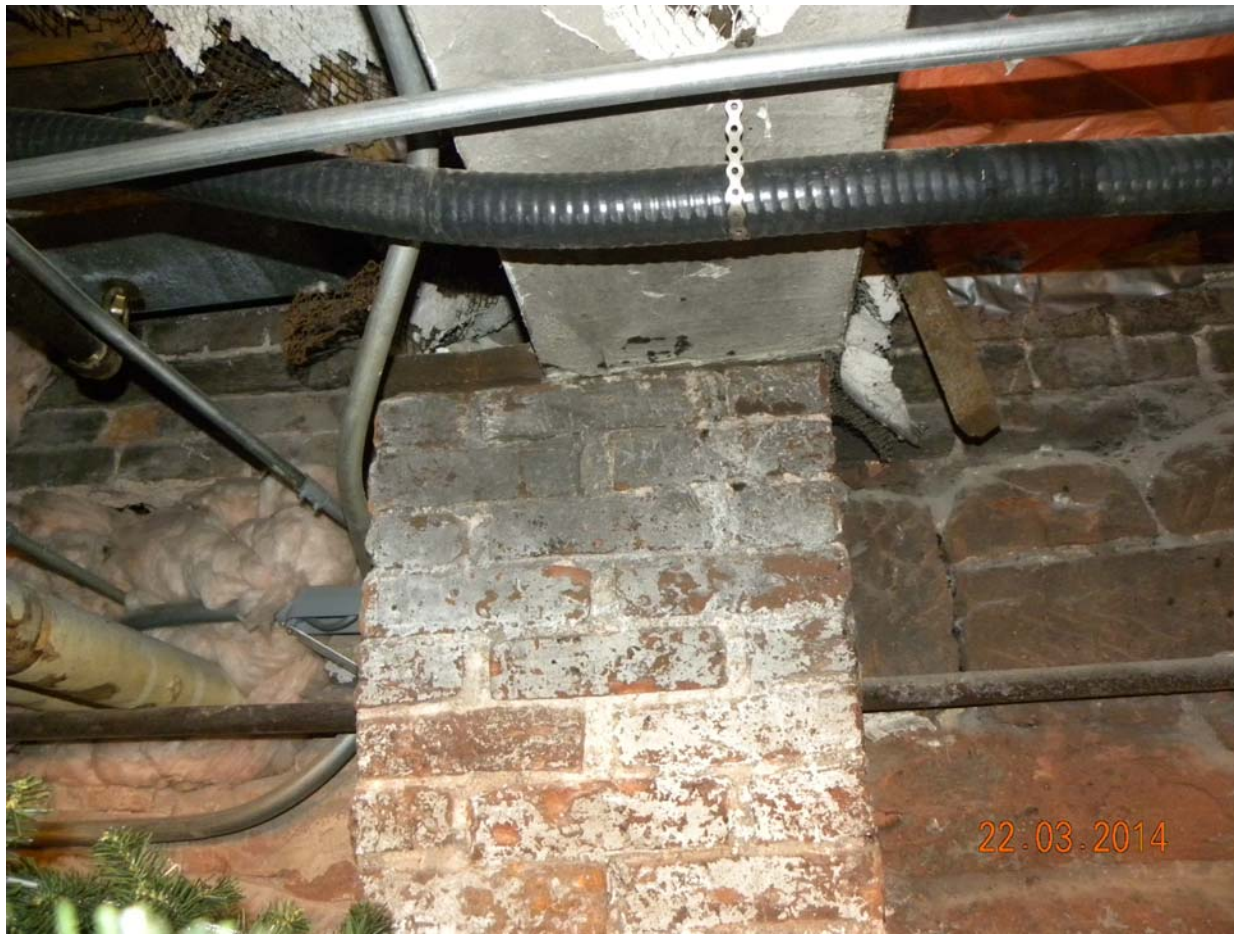
PHOTOGRAPH BSE-13:

The brick masonry column supports an East/West spanning timber beam. The timber beam is bearing on a 2 in. x 4 in. (actual) member placed along the East top edge of the column. (Refer to Figure 10, Appendix "A", Volume I). The centerline of the North/South spanning timber beam is located approximately 6 in. from the North face of the column. The beam reaction therefore has an eccentricity of approximately 2 ¾ in. from centerline of the North/South dimension of the column and approximately 3 ½ in. eccentricity from the centerline of the column in the East/West direction.

East face of brick masonry Column 2c. The East/West spanning timber beam (finished with a fire protective coating) is bearing on a 2 in. x 4 in. (actual) timber placed along the East top edge of the column. (Refer to Figures; 8 to 10, Appendix "A", Volume I). The North/South spanning horizontal 1 ½ in. diameter pipe passes through the brick masonry column. Viewing West.

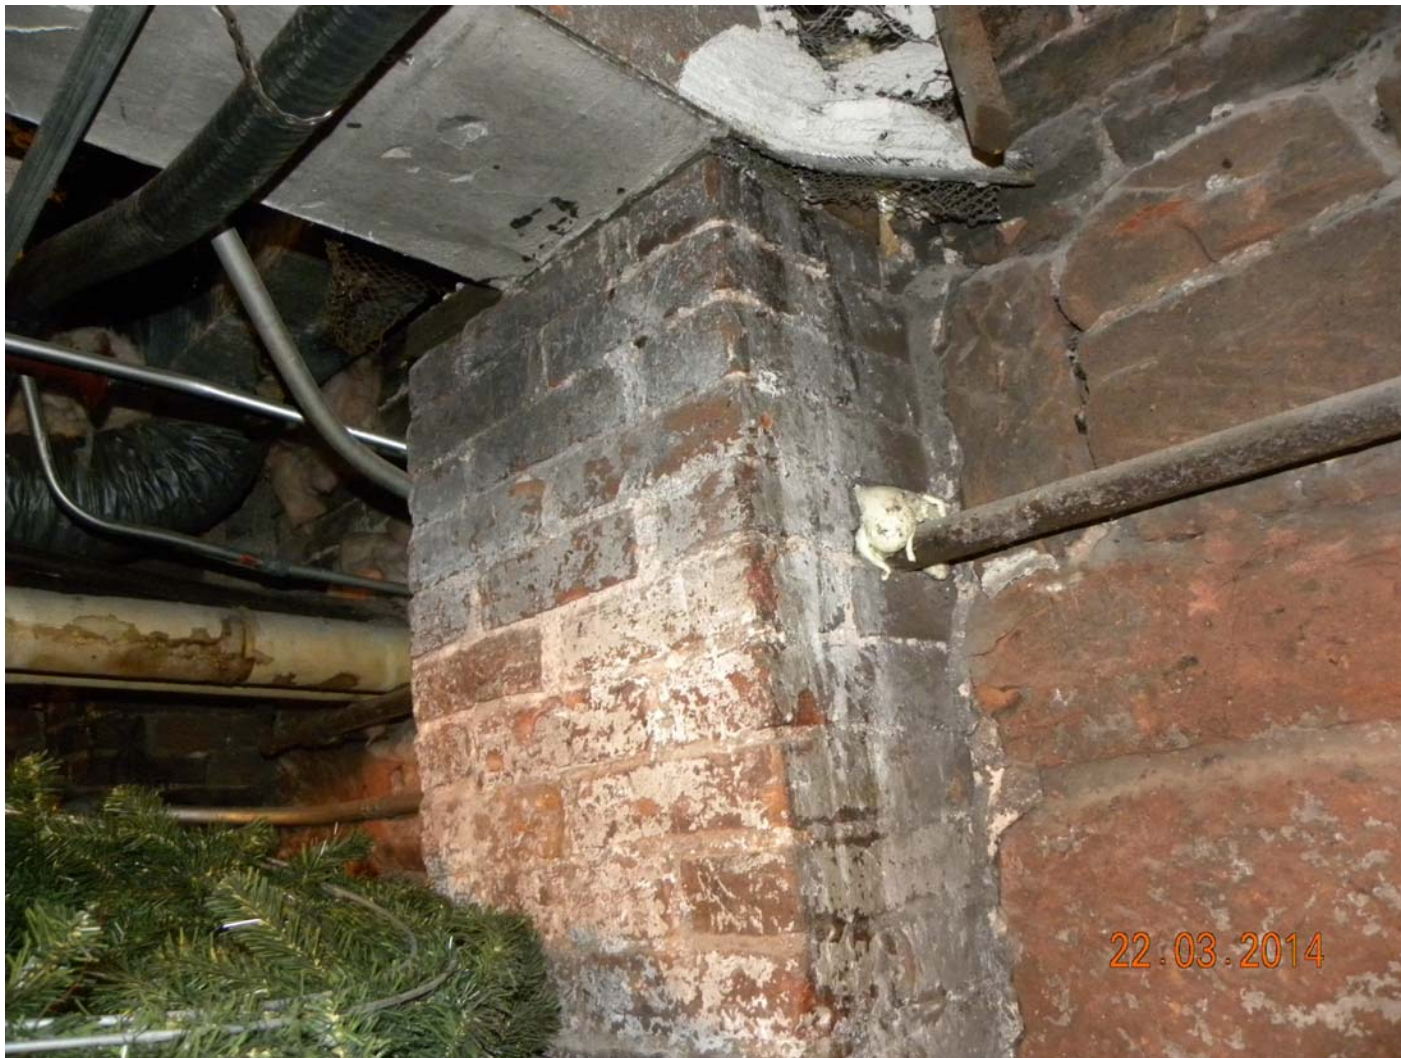
PHOTOGRAPH BSE-14:

East and North faces of brick masonry Column 2c. Viewing Southwest. (Refer to Figure 10, Appendix "A", Volume I).

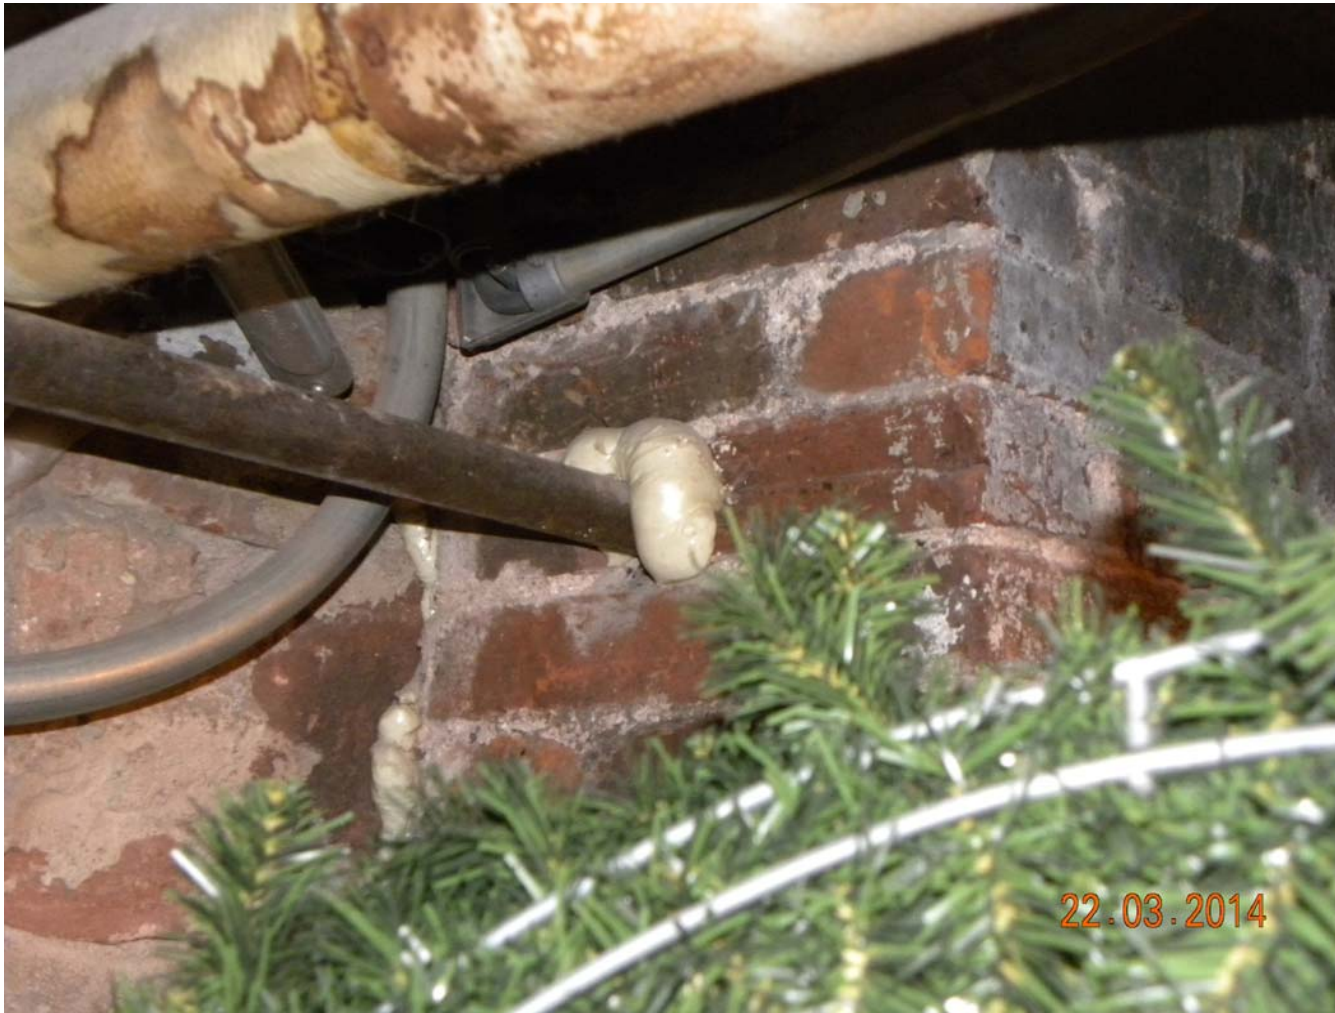
PHOTOGRAPH BSE-15:

South and East faces of column 2c. Shows the 1 ½ in. diameter pipe penetrating the South face of the column. Viewing Northwest. (Refer to Figures; 8 to 10, Appendix "A", Volume I).

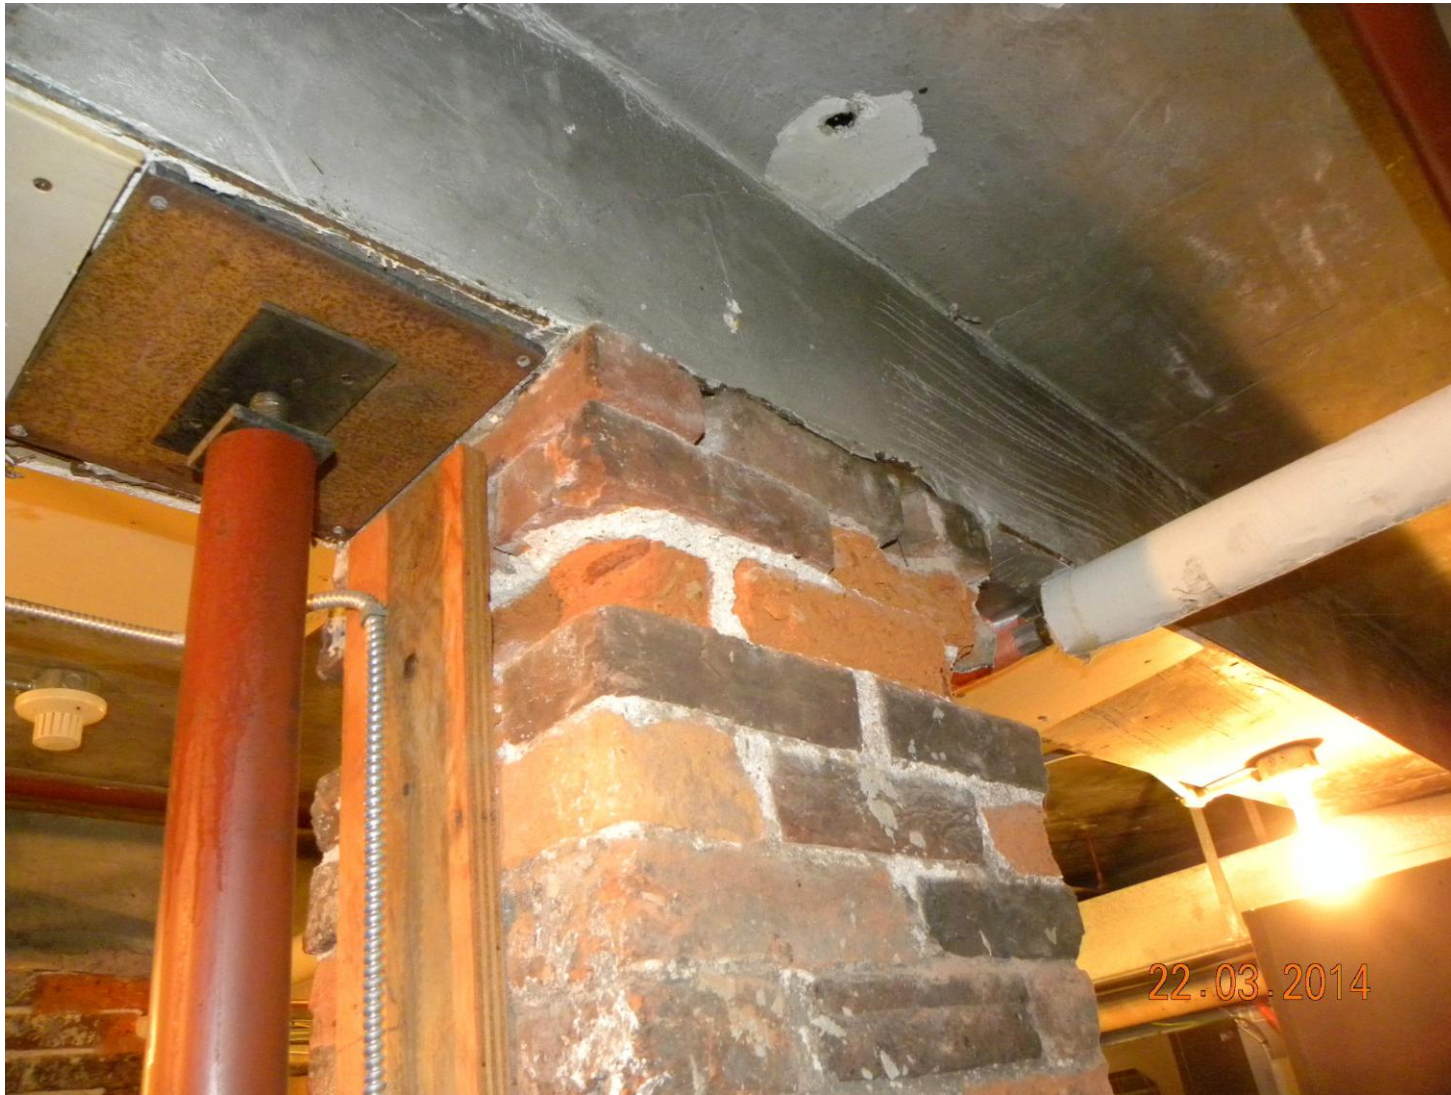
PHOTOGRAPH BSE-22:

Deteriorated clay brick top portion of West and South faces of Column 3c.

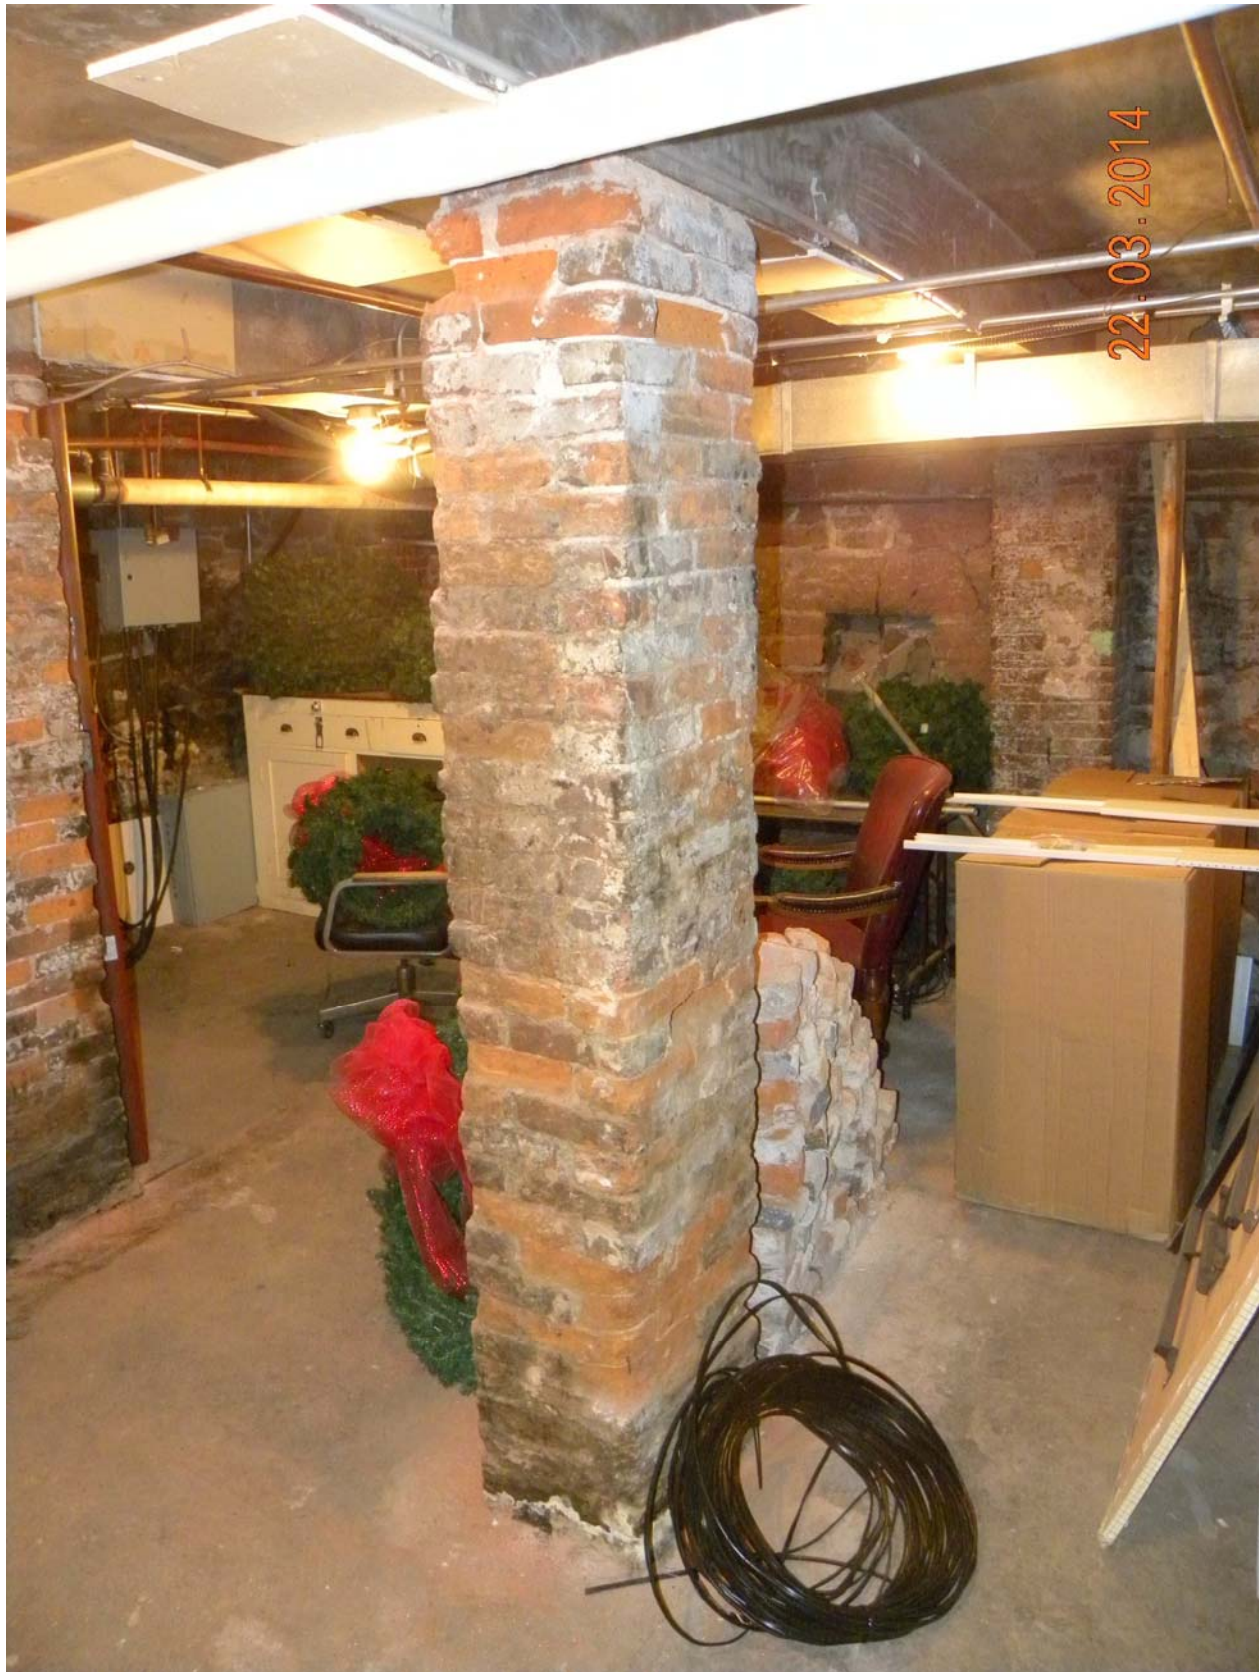
PHOTOGRAPH BSE-26:

Clay brick masonry Column 3d is the same size as brick masonry Column 3c and has undergone similar deterioration. As with Column 3c, approximately 45% of the cross sectional area of Column 3d has been lost due to brick deterioration. As a consequence of the cross sectional area loss and low strength bricks, a decision was made to place an adjustable “jack post” adjacent to the East face of the column for support of the East/West timber spanning beam. (Refer to Figure 6, Appendix “A” and Photographs; BSE-23 to BSE-26, Appendix “B”, Volume II).

Deteriorated clay bricks East and North face of brick masonry Column 3d.

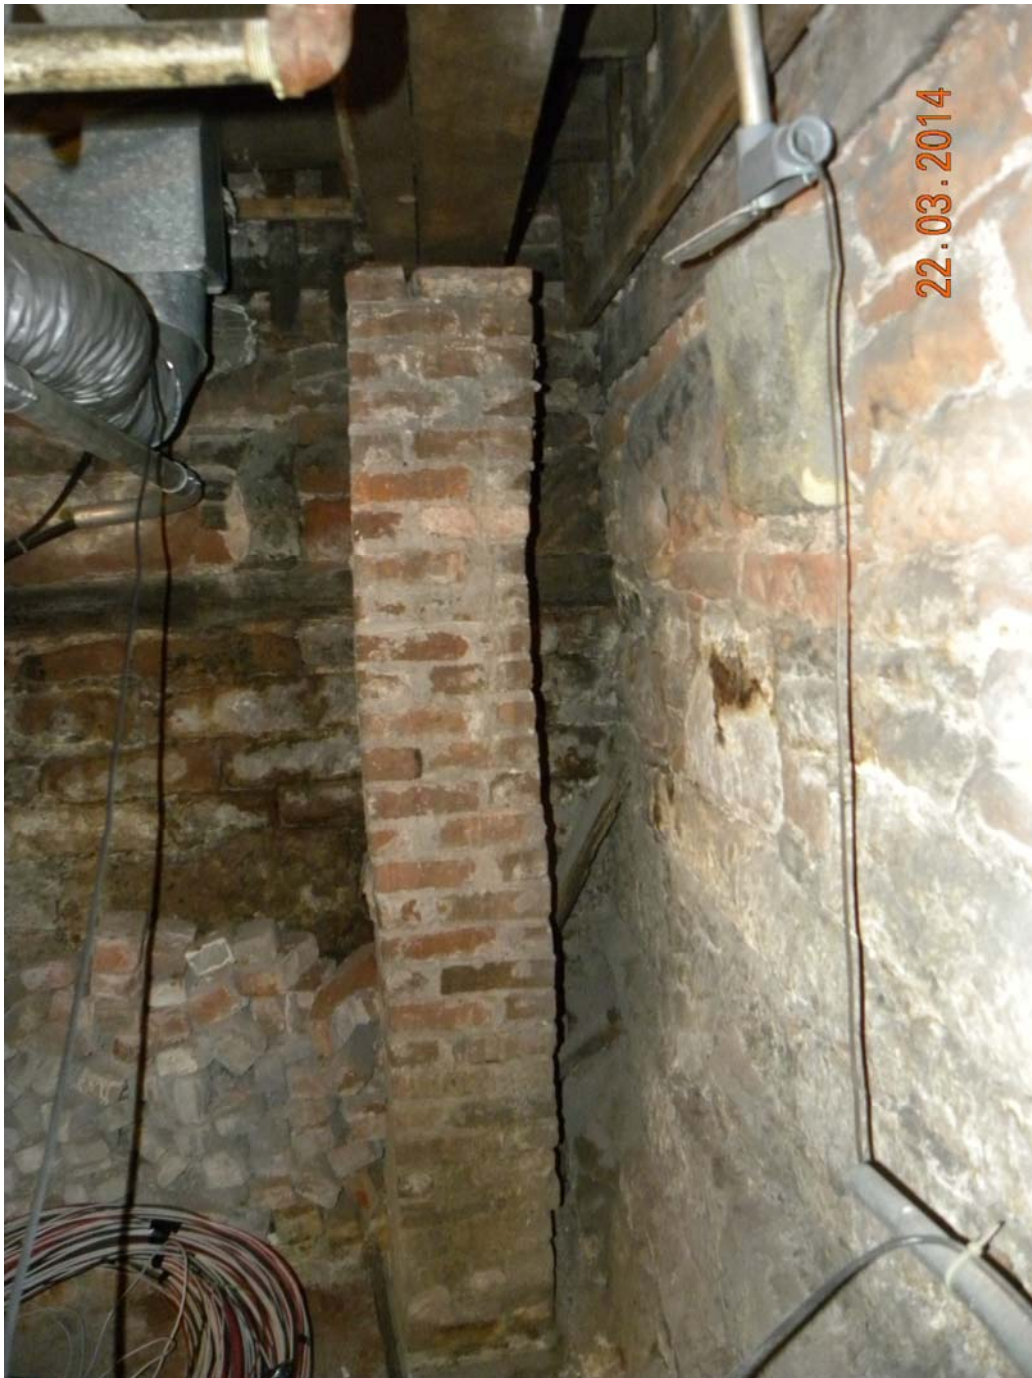
PHOTOGRAPH BSE-27:

West face of clay brick masonry Column 4a. (For location, refer to Figure 6, Appendix "A", Volume I).

The brick masonry column appears to be a replacement of an original brick masonry column. The brick masonry column is poorly constructed. The brickwork is distorted, the mortar joints are of an excessive width and the column is not plumb. Viewing East adjacent to the South foundation wall in Room B13.

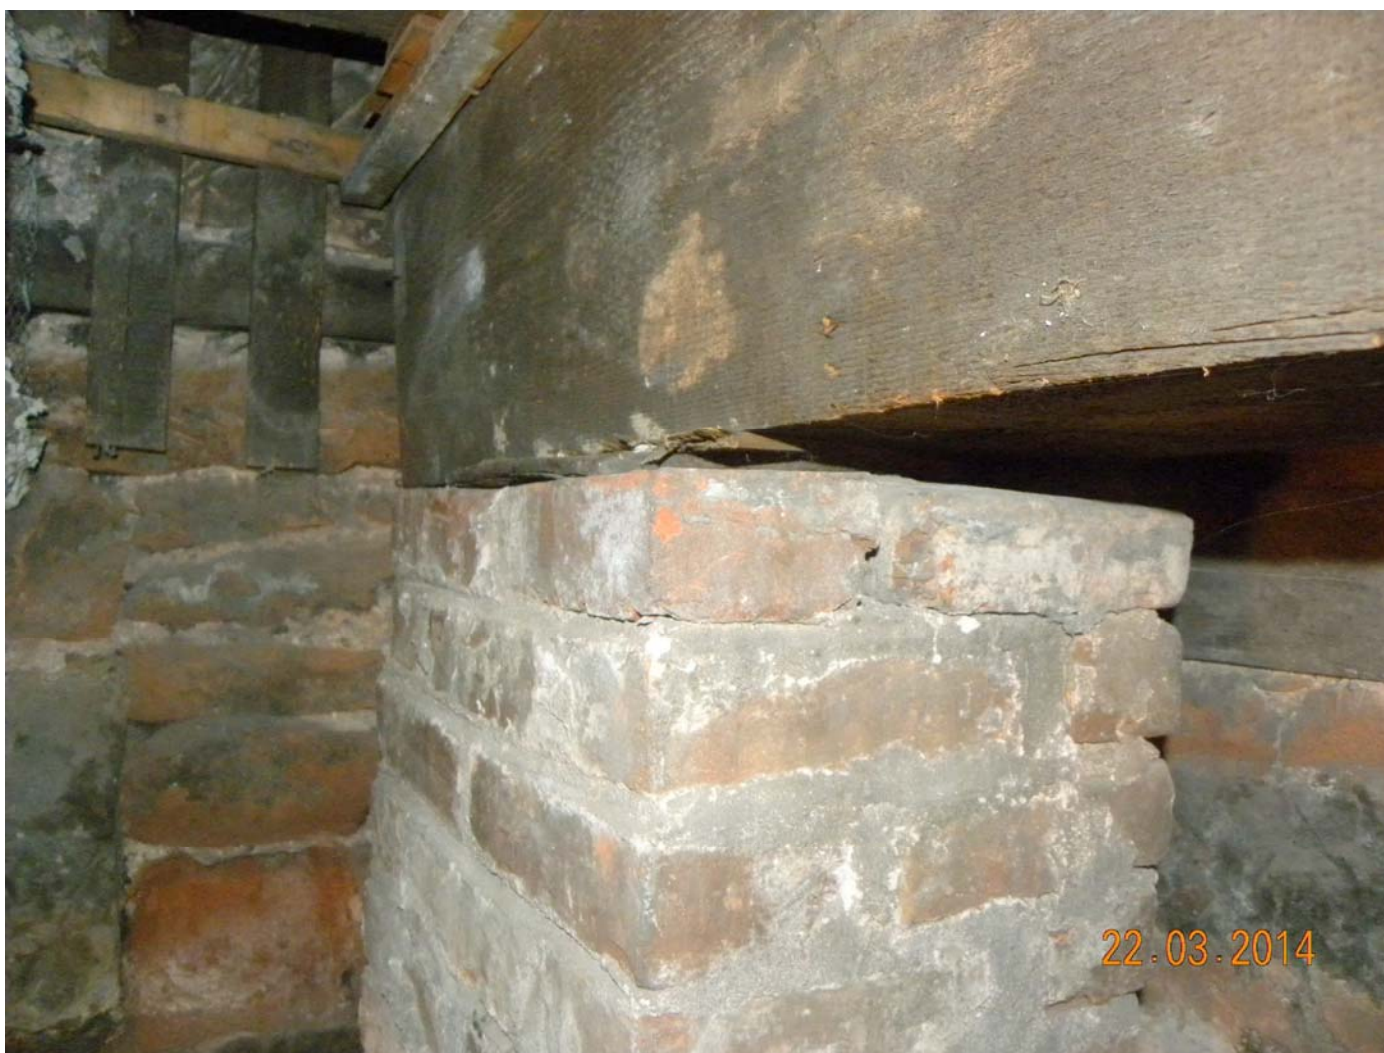
PHOTOGRAPH BSE-28:

The top West and North faces of Column 4a. Shows slate shingles used as shims between the underside of the timber beam and the top of column. Viewing Southeast.

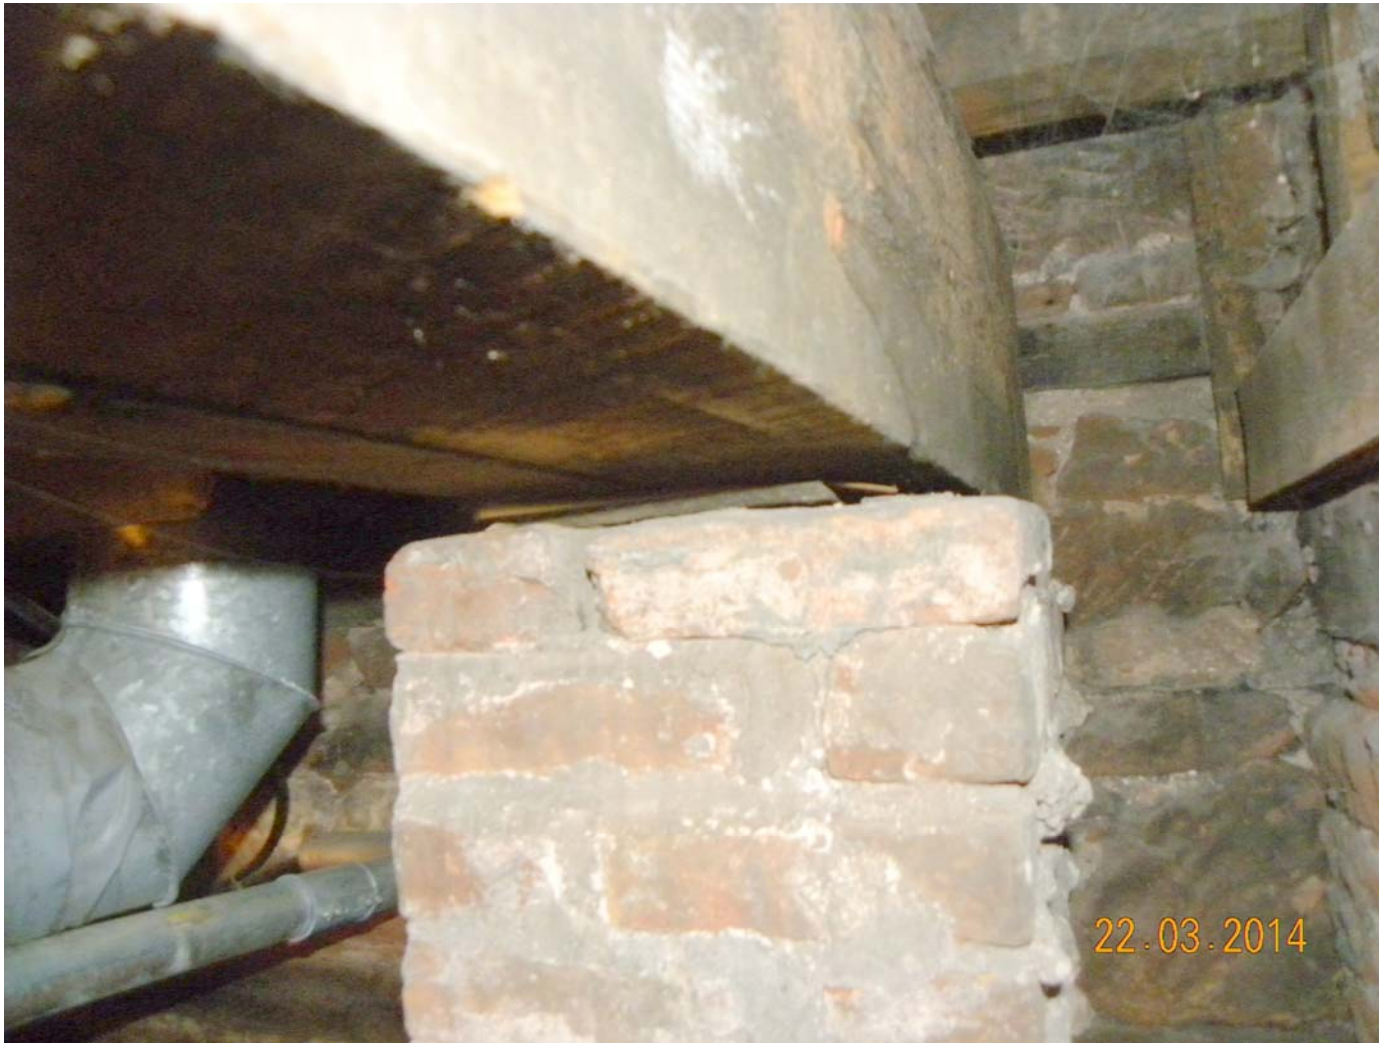
PHOTOGRAPH BSE-29:

Top West face of Column 4a. Shows the timber beams bearing on slate shingles at the top of the column.

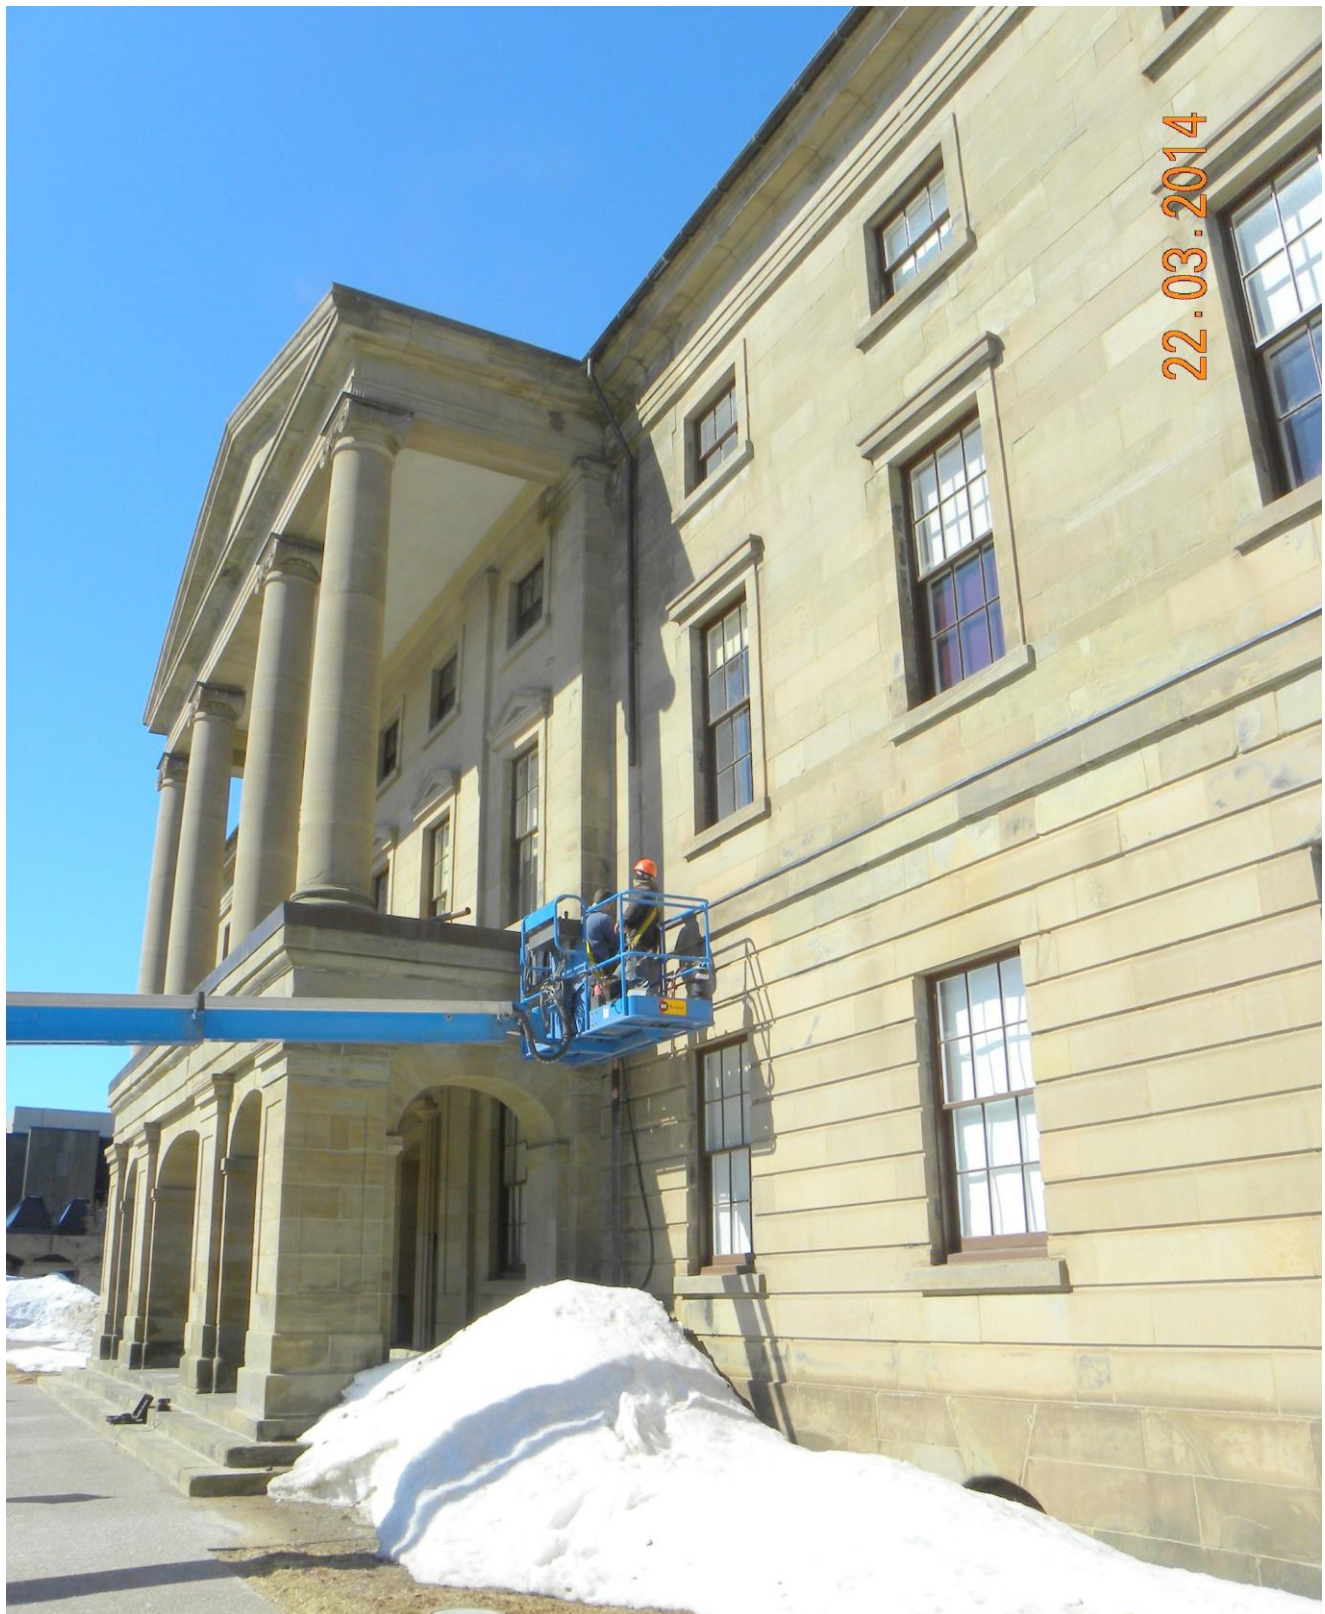
PHOTOGRAPH BSE-32:

Remnants of snow piled against the South face of the building in front of basement window at the Southeast corner of Basement Room B14. Viewing West on 22 March 2014.

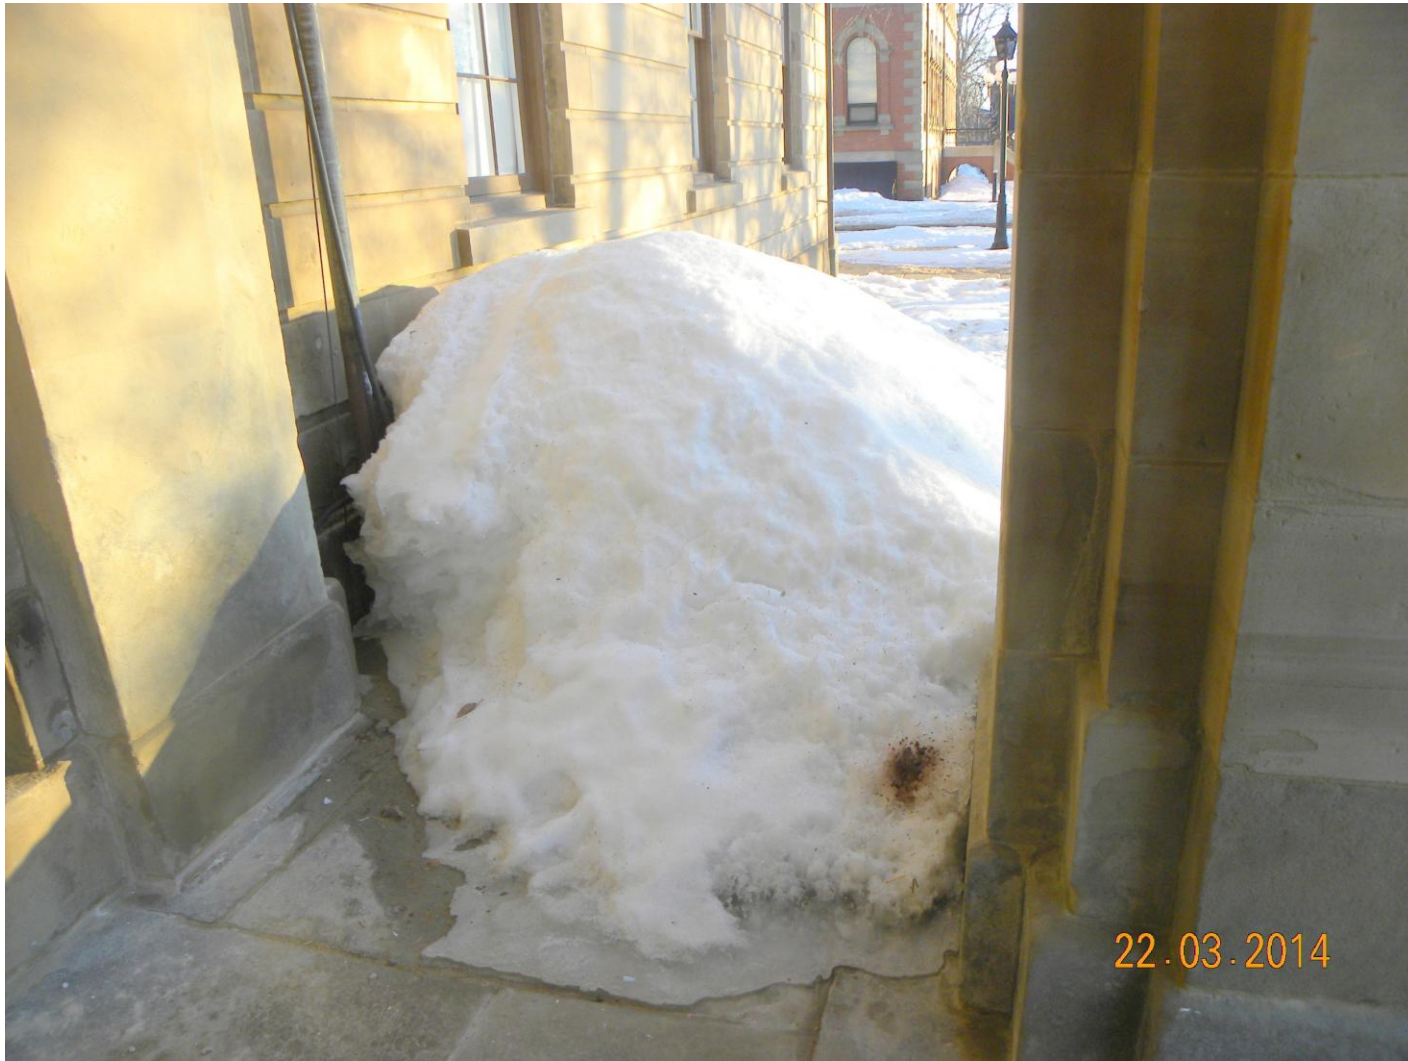
PHOTOGRAPH BSE-33:

Remnants of snow piled against the Southeast face of the building. Viewing Northeast on 22 March 2014.
