“Draft” Interim Report

**Cursory Structural Review of Province House
Charlottetown, PEI**

**Parks Canada
Historic Properties
1869 Upper Water Street
Halifax, NS
B3J 1S9**

**J.W. Cowie Engineering Limited
1046 Barrington Street, Suite#200
Halifax, Nova Scotia
B3H 2R1**

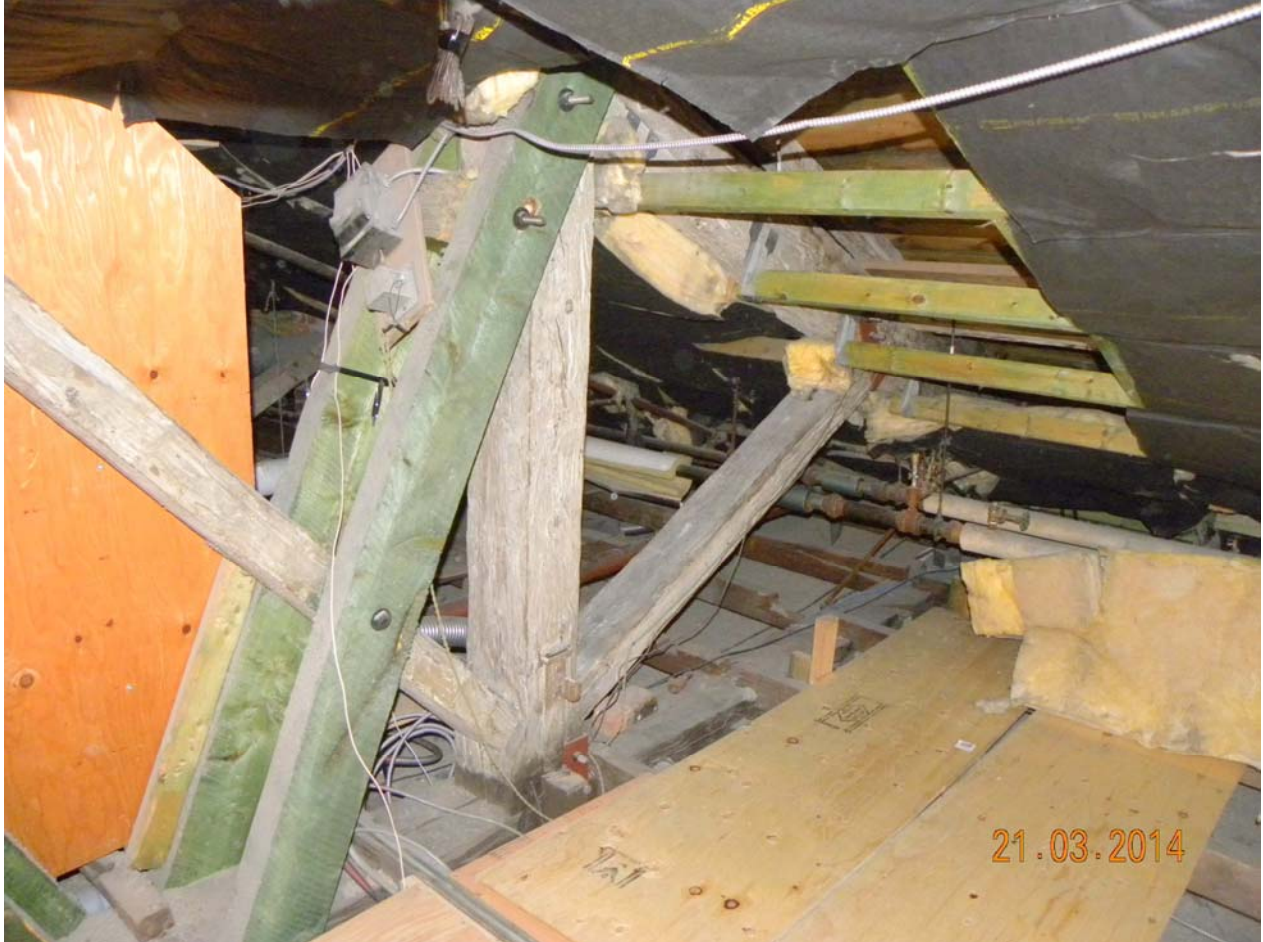
PHOTOGRAPH RF-1:

Timber roof truss on Gridline 7. (The Southern end of the roof truss is located over the West end of Room 310 - third floor Press Room). The timber roof truss has a clear span across the building with bearing on the top of the North and South exterior walls. The green coloured diagonal members of the roof truss were installed during the 1980's restoration work. The green colour is the result of the preservative treatment. Viewing Southeast in the mid span of the truss.

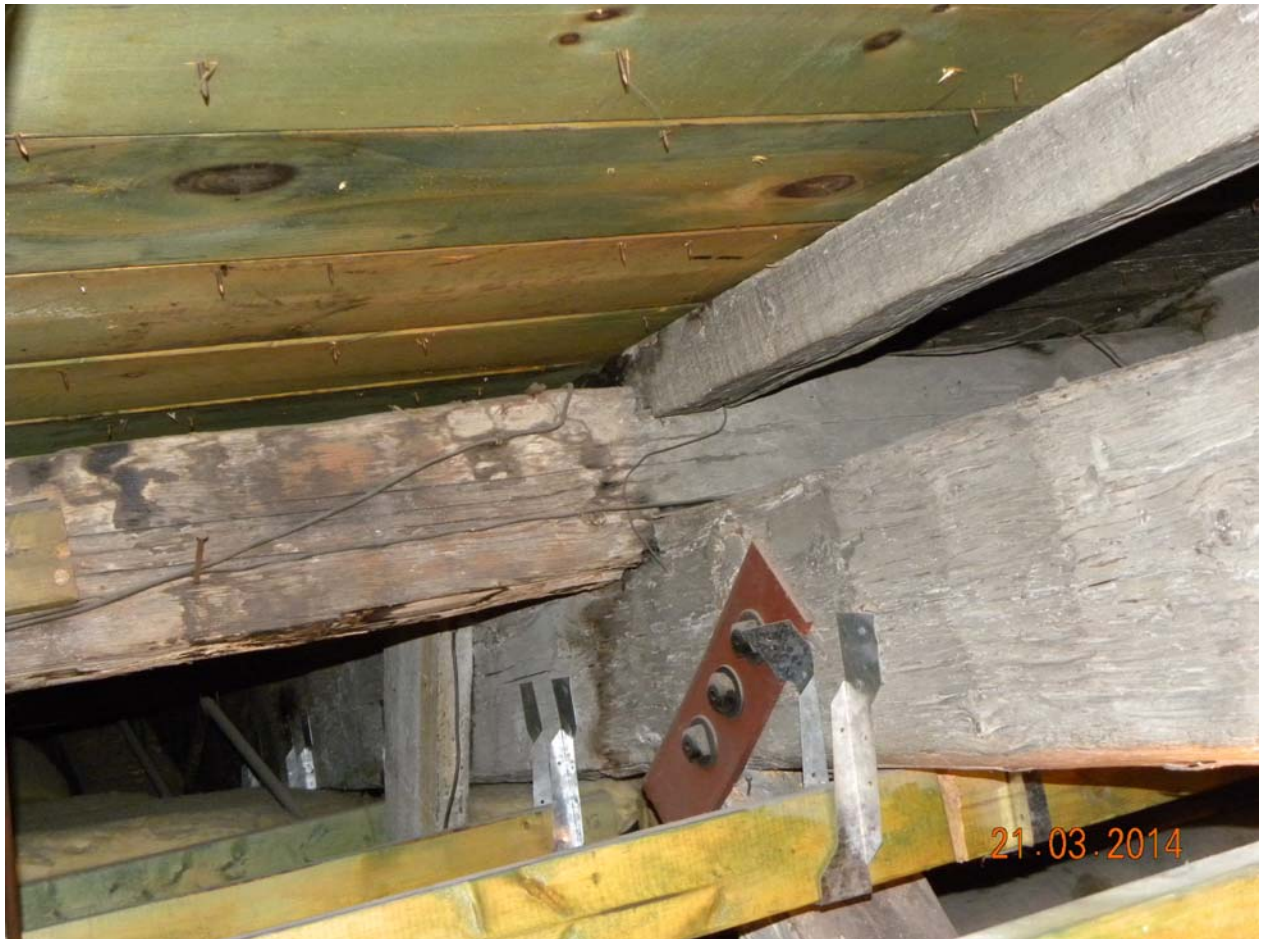
PHOTOGRAPH RF-6:

Top chord of roof truss on Gridline 3. Viewing Southwest. Shows new roof deck (green colour) bearing on an existing 3 ½ in. deep x 4 in. wide roof rafter (located above the top chord of the roof truss) with its South end bearing on an East/West spanning original roof beam.

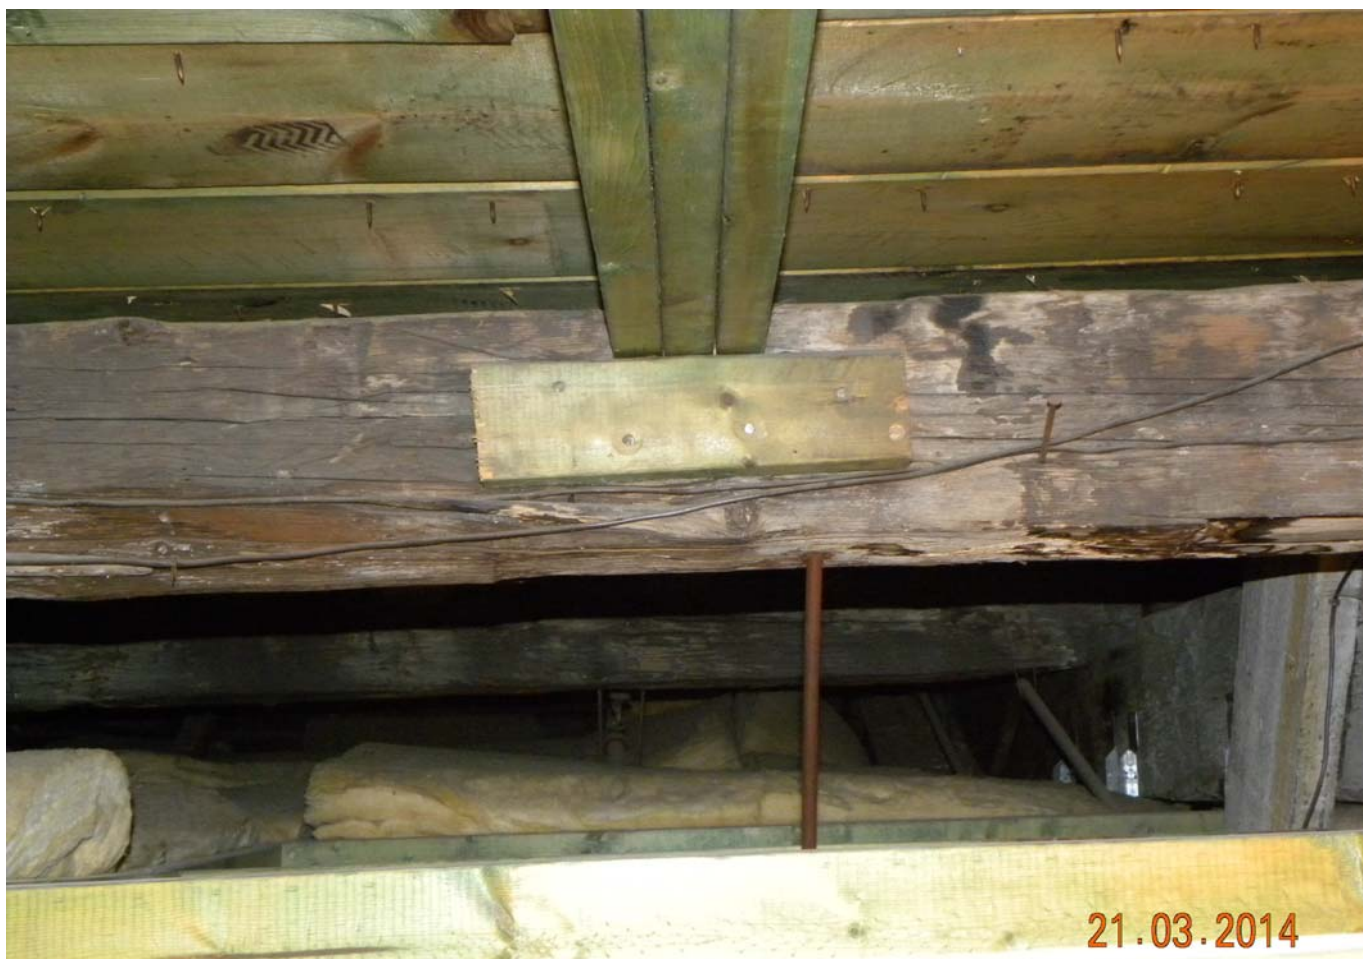
PHOTOGRAPH RF-7:

New roof rafter located 2 ft. 3 in. East of the roof rafter shown in Photograph RF-6. This roof rafter consists of three 2 in. x 4 in. (nominal) timber studs that replaced the original 3 ½ in. deep x 4 in. wide rafter. Viewing South adjacent to the roof truss on Gridline 3.

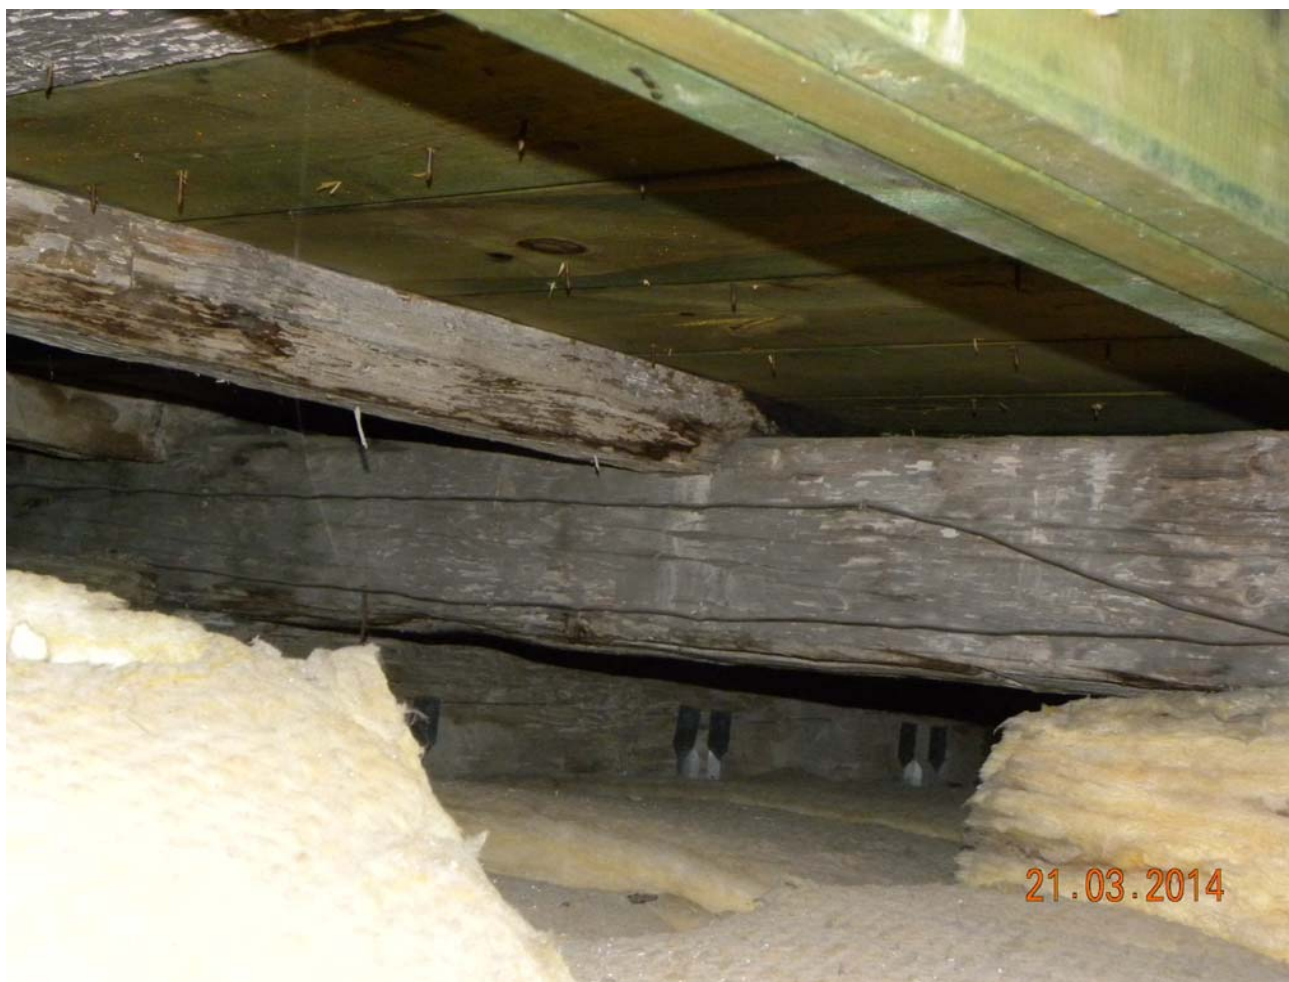
PHOTOGRAPH RF-8:

Left of centre of the photograph is an original roof rafter located 2 ft. 3 in. East of the new rafter shown in Photograph RF-7. Shows the 1980's replacement green coloured roof deck and the 1980's replacement green coloured rafter shown in Photograph RF-7.

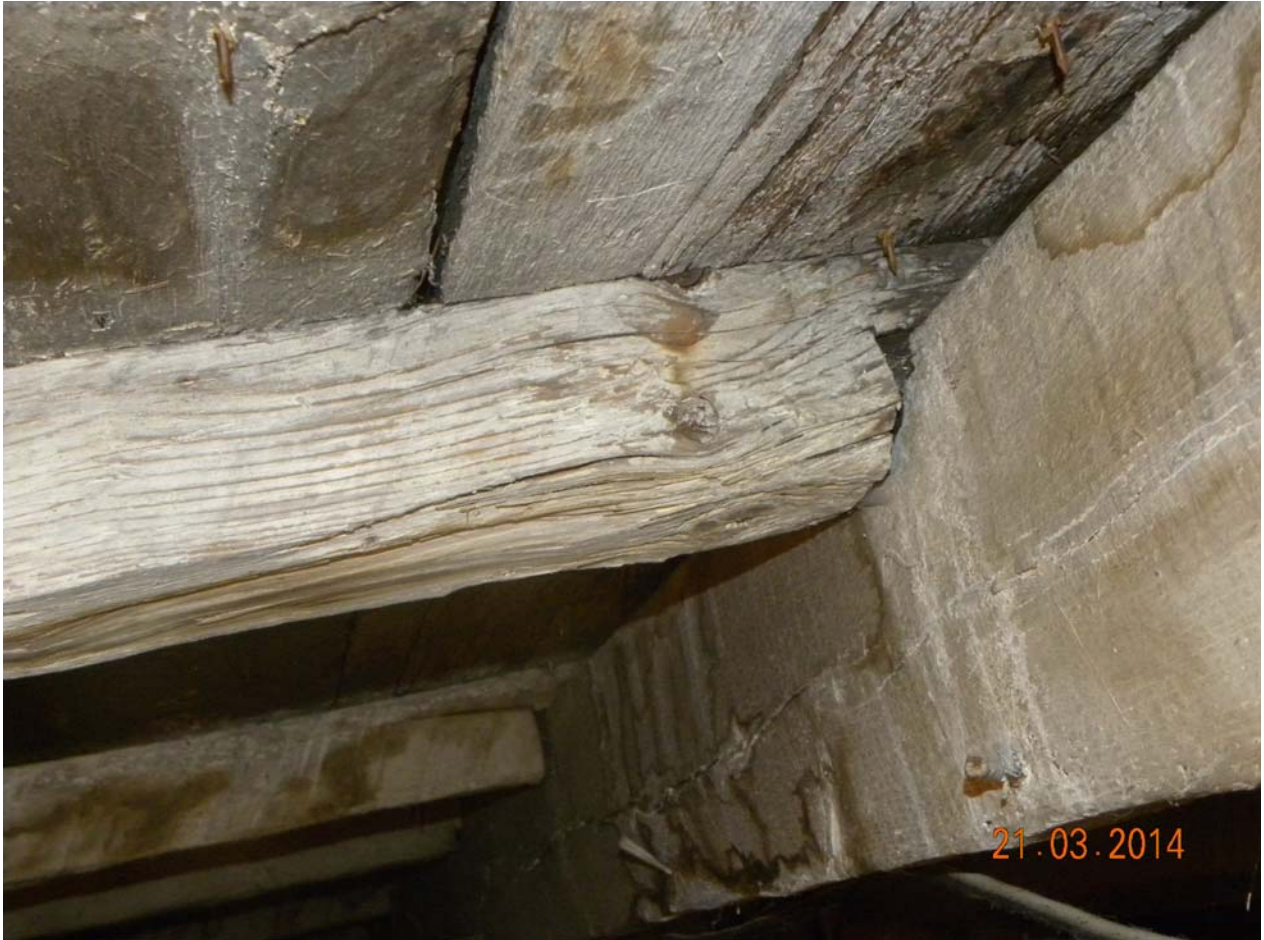
PHOTOGRAPH RF-9:

Two roof rafters spanning North/South located West of the roof truss on Gridline 3. Particular attention should be given to the notched end (North end) of the closest rafter and the notched end of the roof rafter located approximately 2 ft. 3 in. West of the closest roof rafter. (Refer to Photograph RF-10, Appendix "B", Volume II).

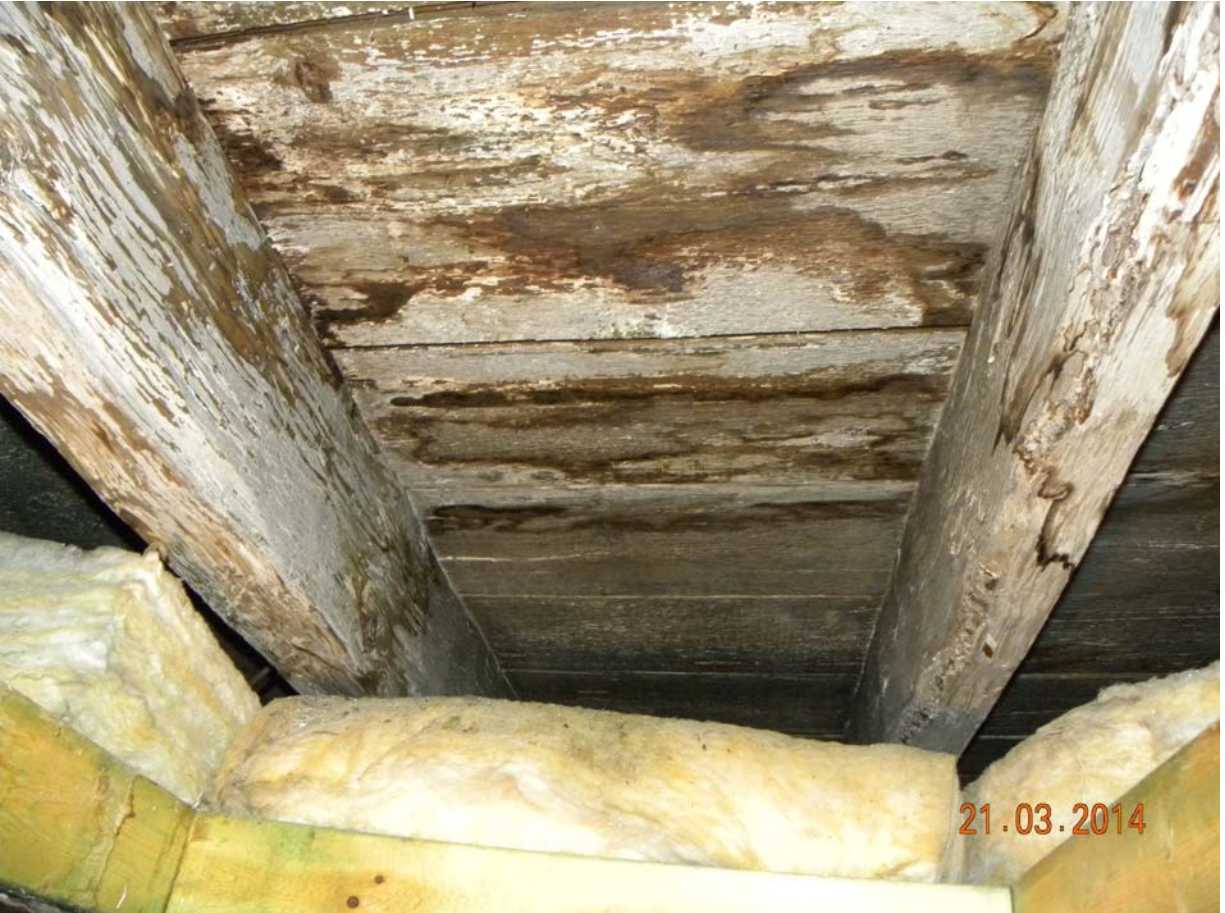
PHOTOGRAPH RF-11:

Extensive water staining to original roof deck and original North/South spanning roof joists. The roof joists are located at 2 ft. 4 in. centre to centre. The roof joists measure 3 ½ in. wide x 8. deep (actual). Viewing West from the central attic area adjacent to roof tops on Gridline 5.

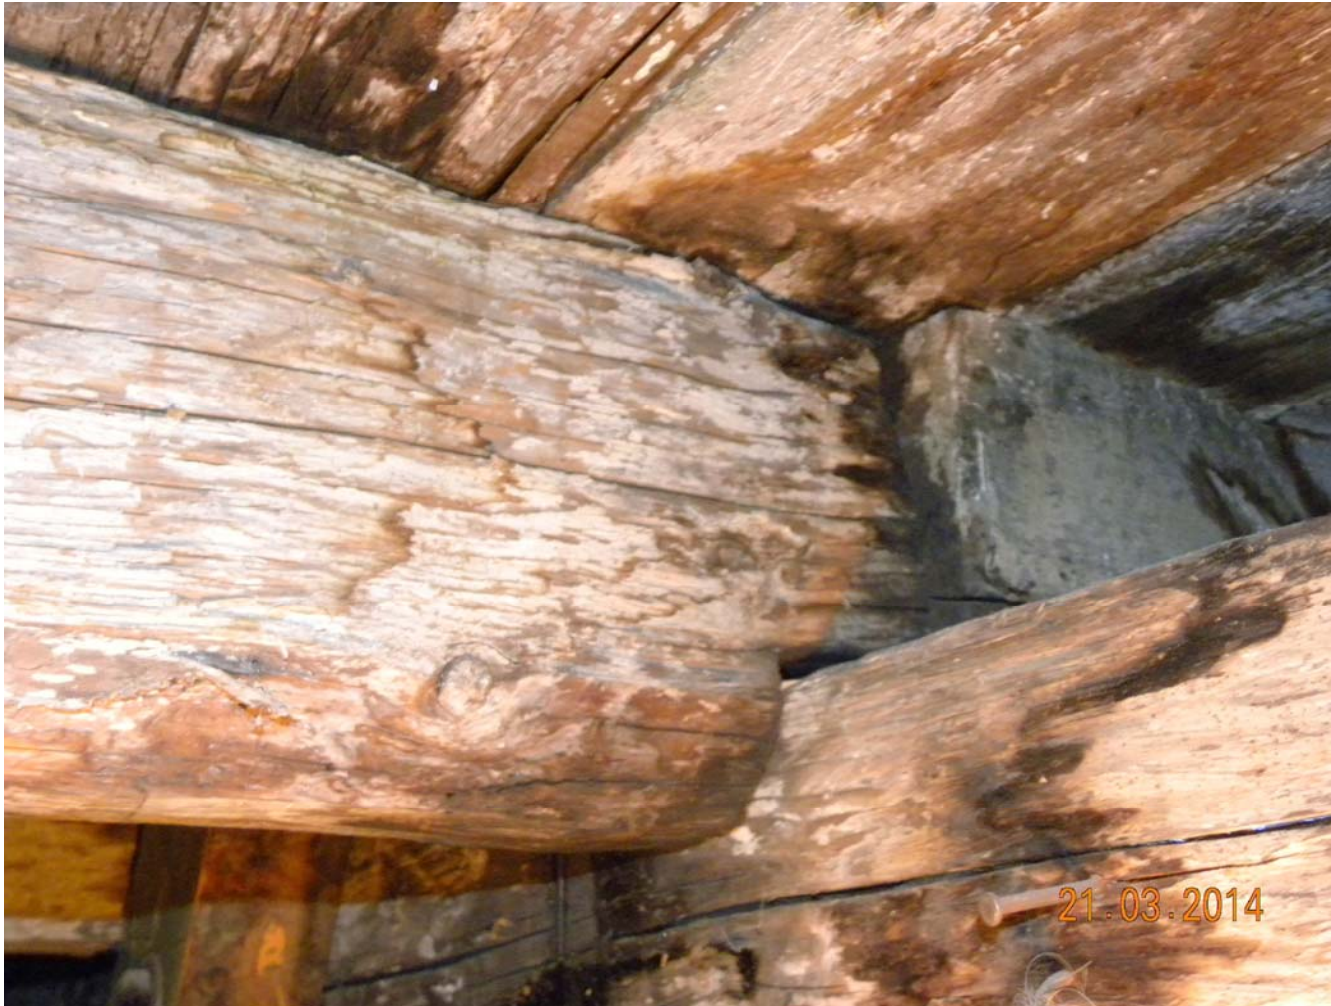
PHOTOGRAPH RF-12:

Evidence of long history of water staining on the roof framing components bearing on the top chord of the roof truss on Gridline 5 located at approximately mid span. Viewing Northeast.

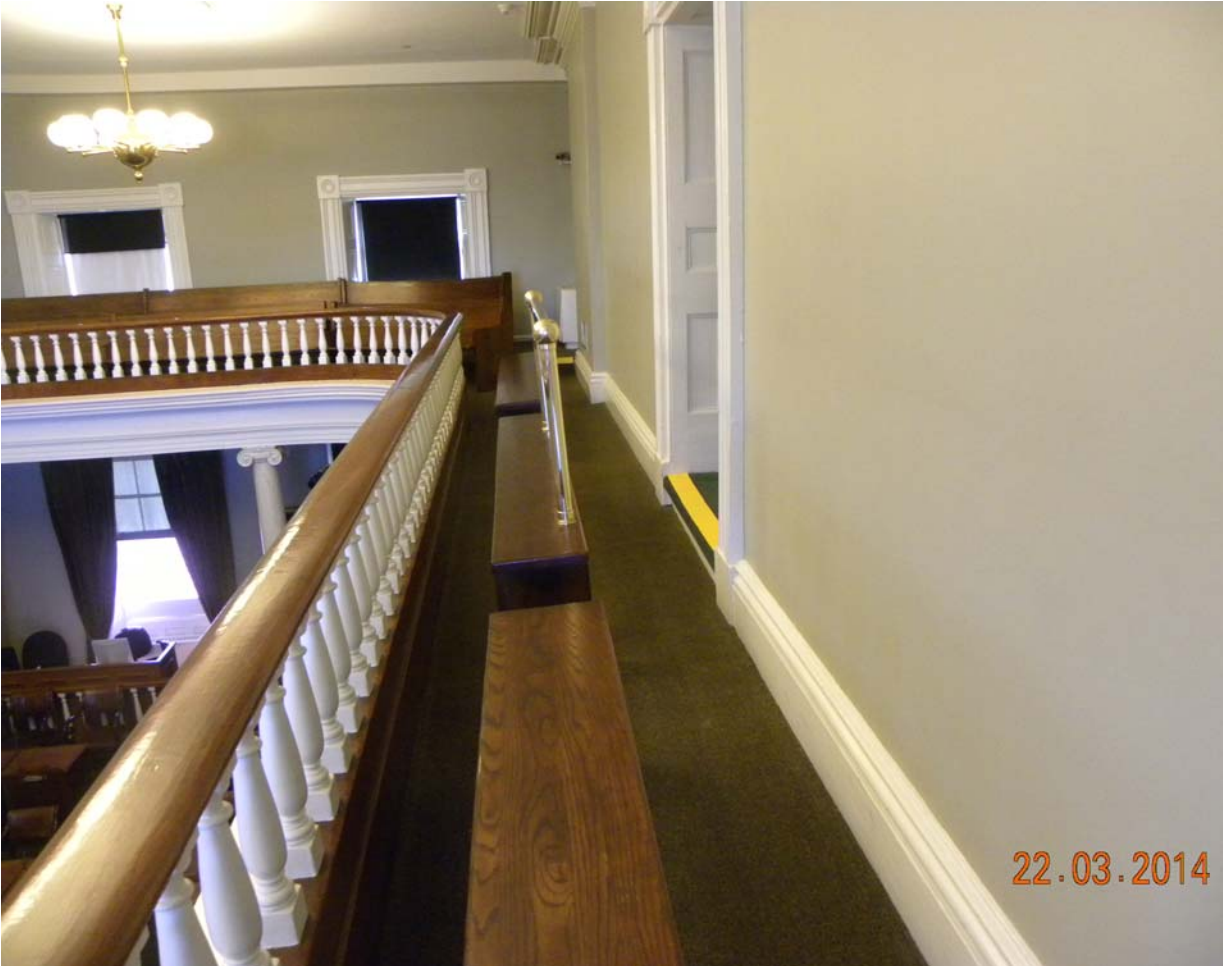
PHOTOGRAPH GF-2:

West side of gallery of Legislative Assembly. Viewing South. Shows the posts and guardrail at the door entrance to the gallery are leaning East. At the entrance to the gallery, the floor of the gallery has deflected down at its East end 2 15/16 in.

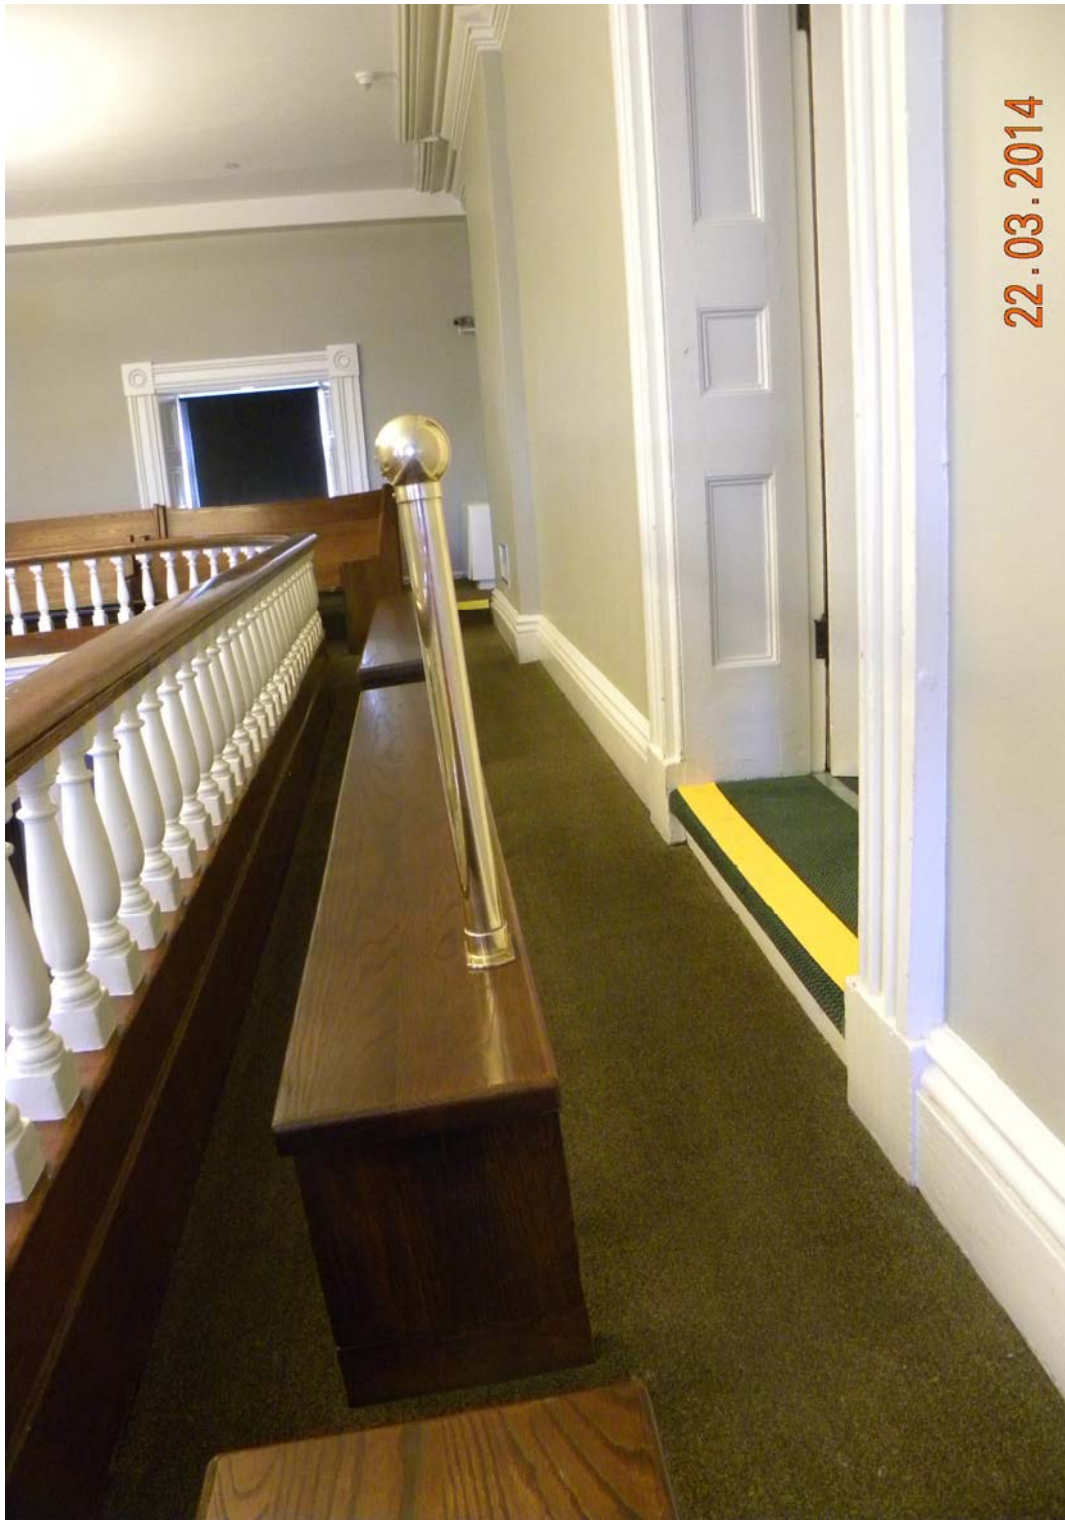
PHOTOGRAPH GF-3:

Close-up of third floor entrance to the gallery. Shows the posts with horizontal guard leaning Eastward. The floor of the gallery at this location has deflected 2 15/16 in. over its width. (East end deflected 2 15/16 in. lower than the West side at the entrance). Viewing South.

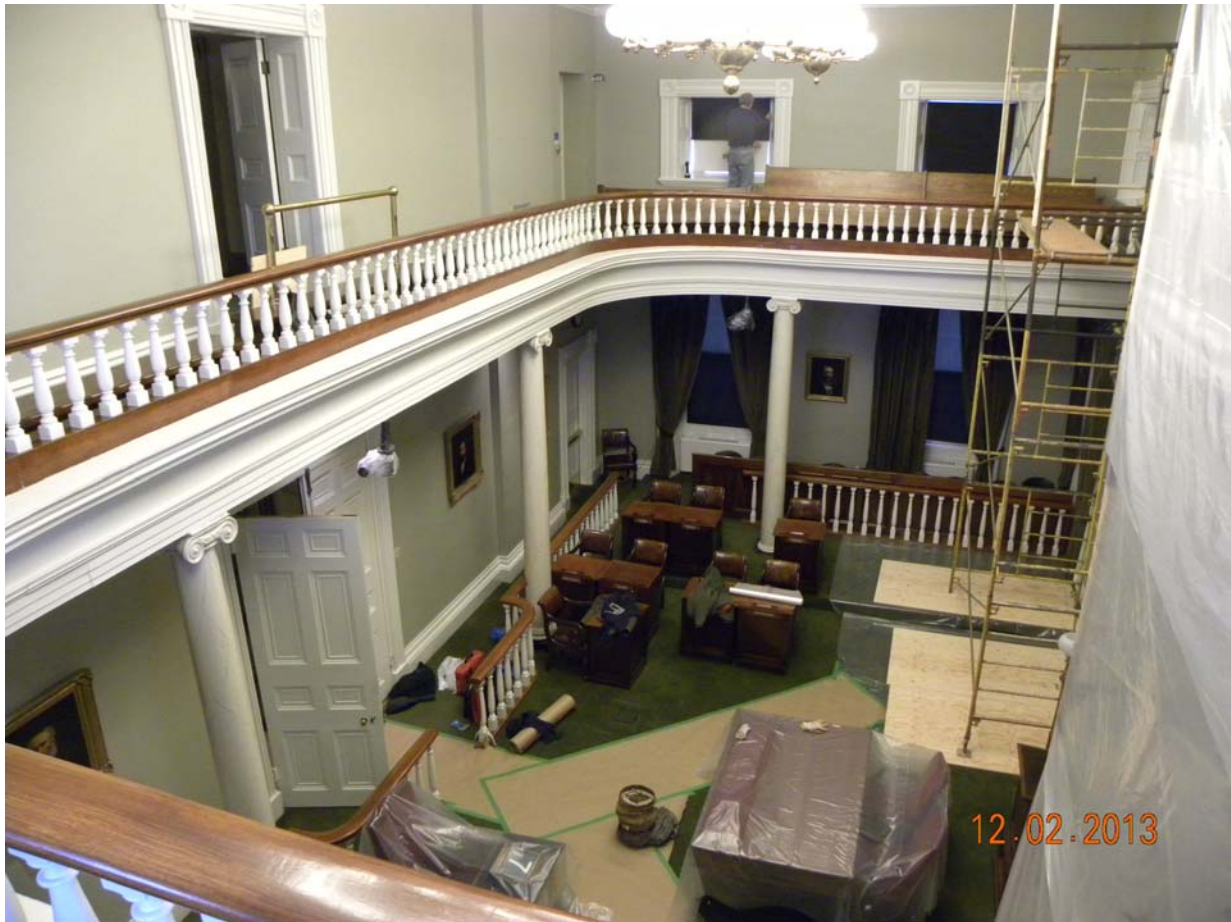
PHOTOGRAPH GF-4:

Viewing West side of gallery with its third floor entrance. Shows the two brass posts with the brass horizontal guardrail shown in Photographs; GF-1 to GF-3, Appendix "B", Volume II. Two columns support the East end of the gallery floor. There is no evidence of cracking in the wall and ceiling finishes below. The cause of the gallery floor deflection is unknown. Further investigation is required.

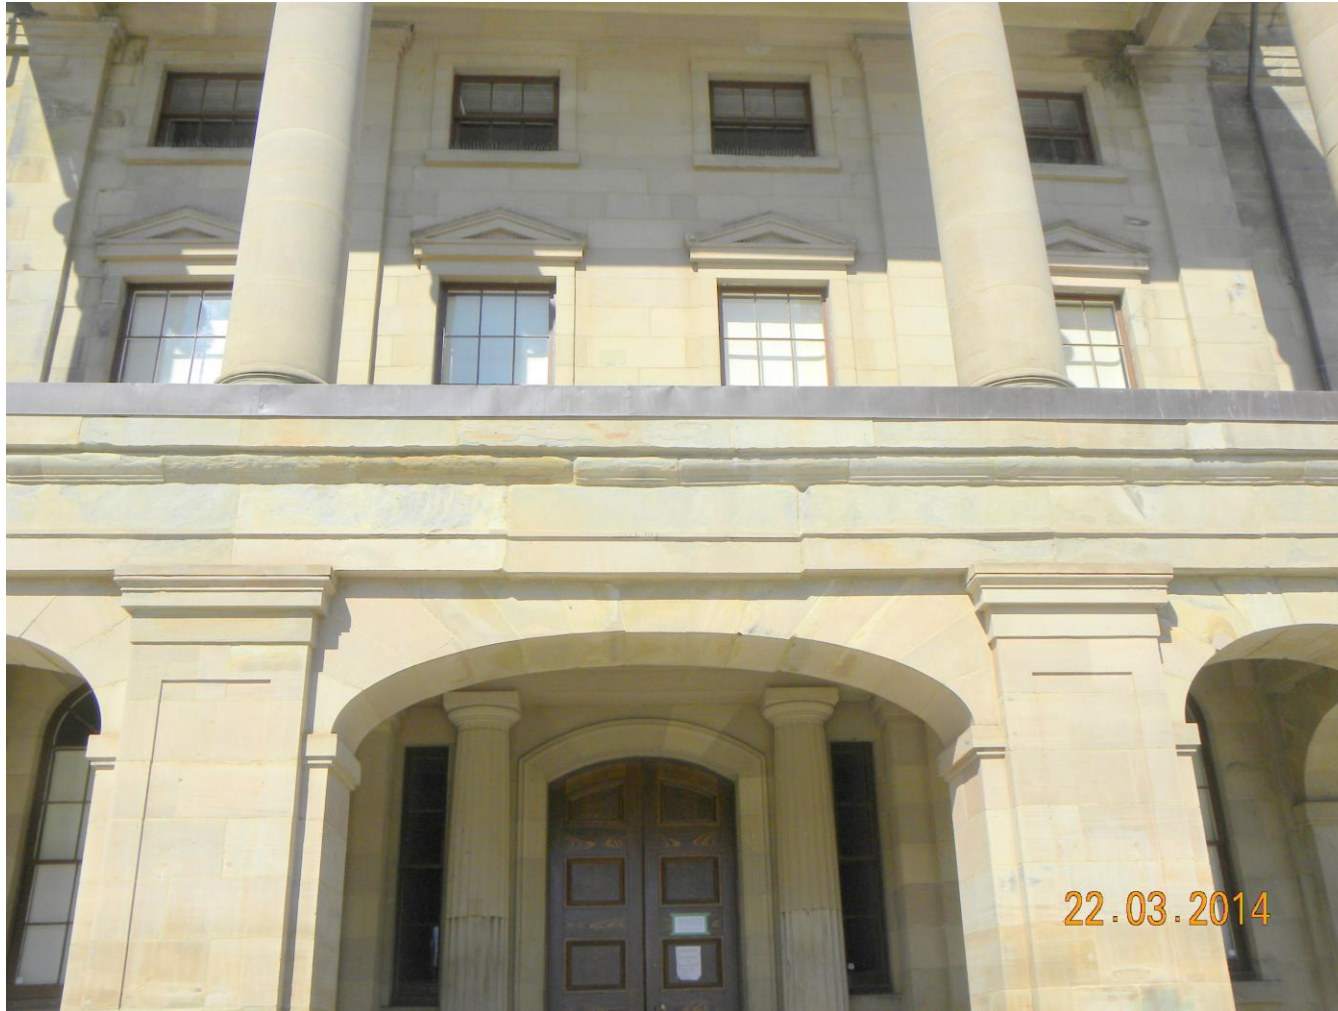
PHOTOGRAPH SM-2:

Central stone masonry arch of the portico, South elevation. Viewing North on 23 March 2014. Shows displaced sandstone units of the masonry arch as well as displaced sandstone units above the arch.

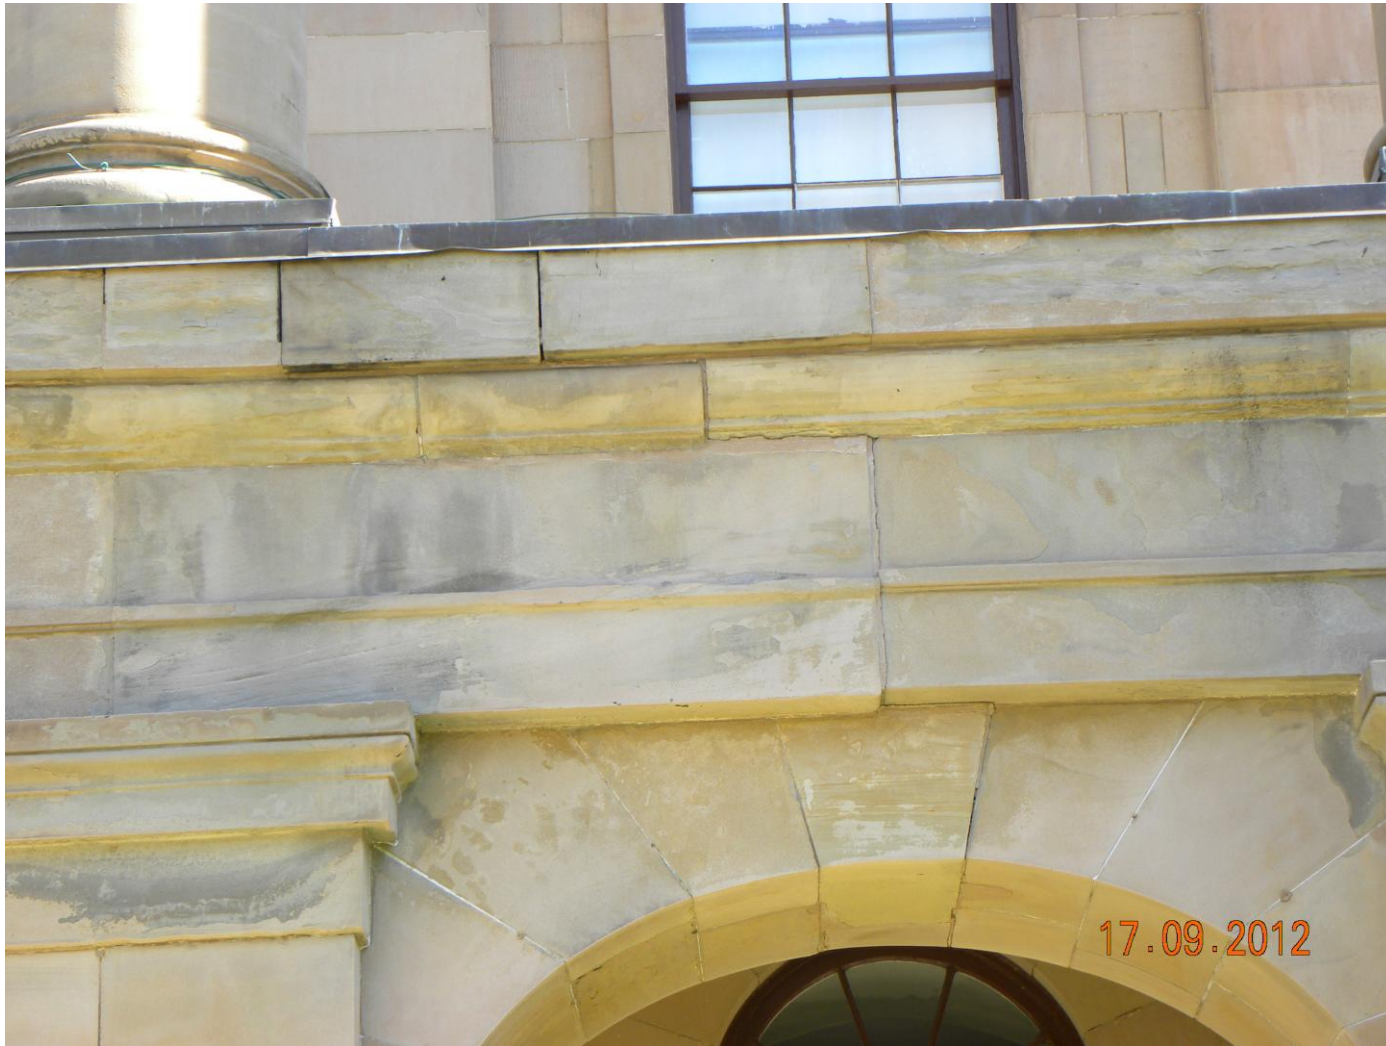
PHOTOGRAPH SM-6:

Displaced sandstone units above the West stone masonry arch of the portico on the North elevation.
