REPORT TO
CAMECO - A CANADIAN MINING & ENERGY CORPORATION

COMPLETION REPORT
BLUFFS STABILIZATION DEMONSTRATION
SECTIONS B5 AND B13
LAKE ONTARIO BLUFFS AREA
PORT GRANBY WASTE MANAGEMENT FACILITY
PORT GRANBY, ONTARIO

December, 1989

891-1529

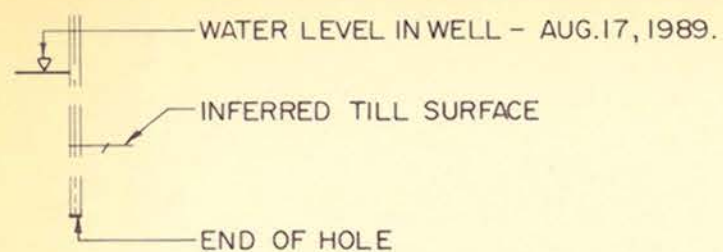
FIGURE 4

A 13 mm diameter CPVC piezometer was installed in each auger hole along with the eductor well casing. Typical well casing and piezometer installations are shown on Figure 3. The depths of installation of the key elements of each well are summarized on Table 1. The well installations are shown in profile on Figure 4.

SECTION 5 - 5 PROFILE ALONG EDUCTOR WELLS
