**Iqaluit, Nunavut
DFO Bunkhouse Building 1074,
Hazardous Material Abatement
Solicitation # E0208-151273/A**

ADDENDUM #2 February 19, 2015

DEMOLITION WASTE SURVEY

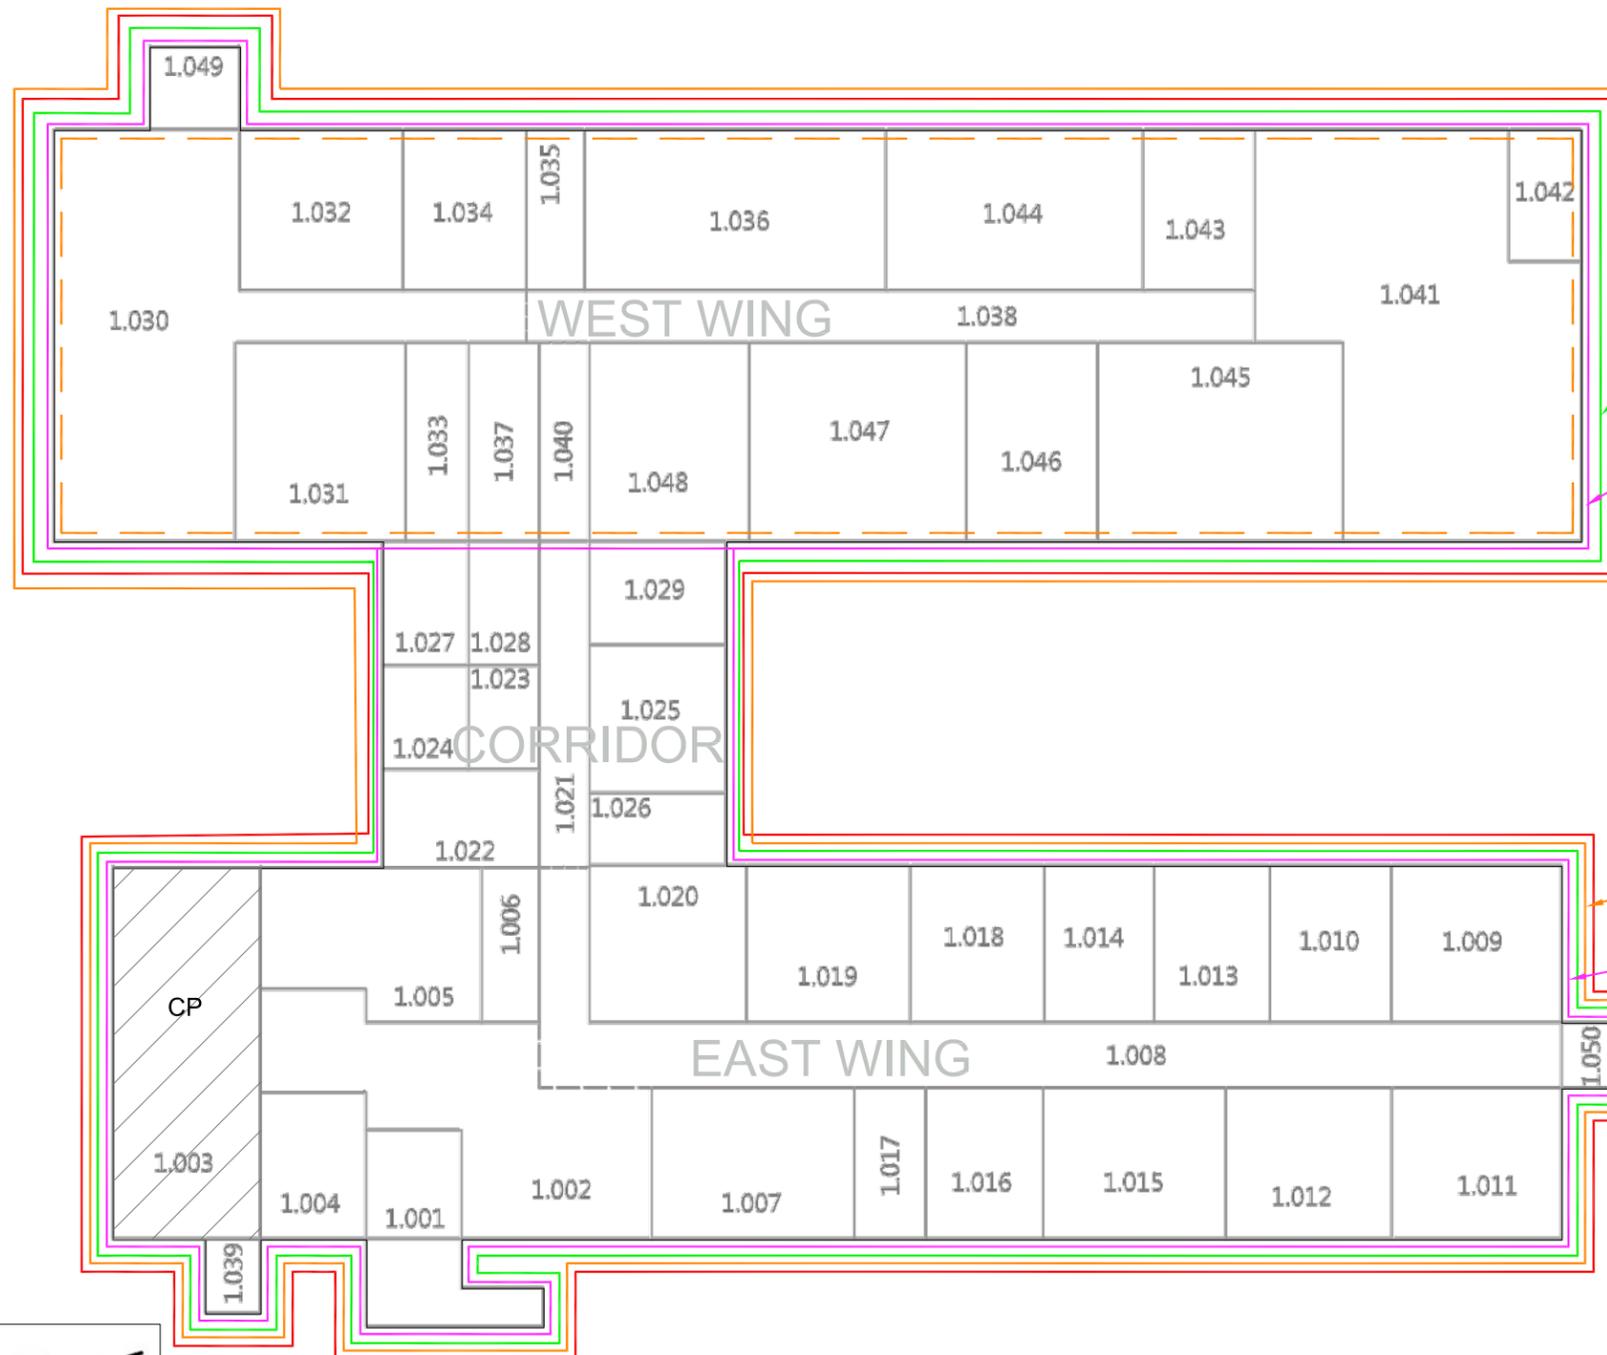
Drawn By: P.A.L.	Approved By: C.F.G.	Project No: 350600-519
Date: FEB. 2015	Scale: 1:200±	FIGURE 2

Confirmation of the locations of asbestos-containing material was made based on the results of the bulk sample analysis, visual observations and physical characteristics of the applications as well as our knowledge of the uses of asbestos in building materials. The locations of the asbestos-containing materials are shown in place on Figure 2.

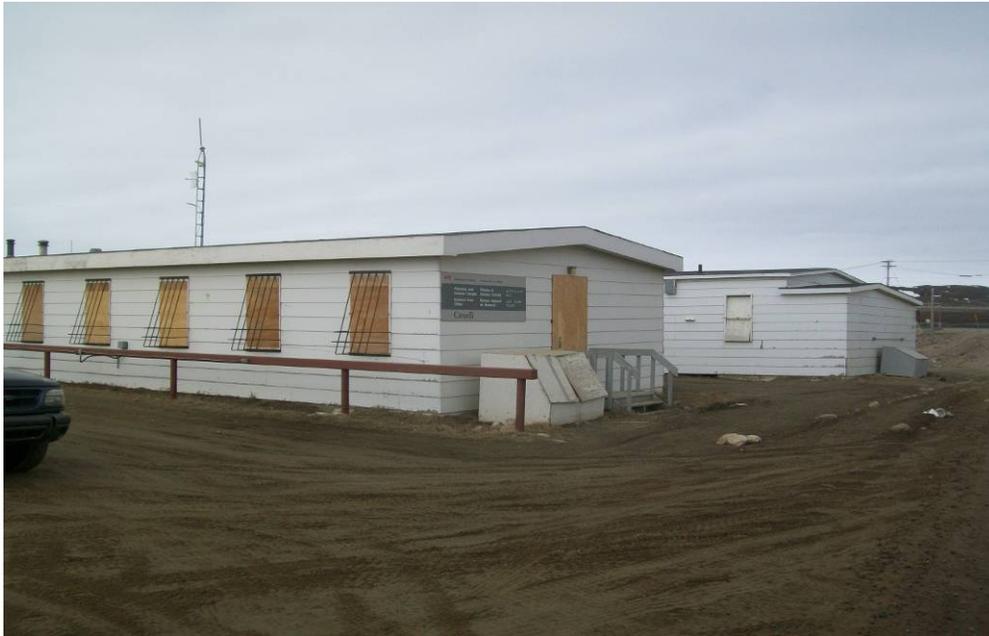
Photograph 1: View of vacant CFO Bunkhouse building, Iqaluit, Nunavut.

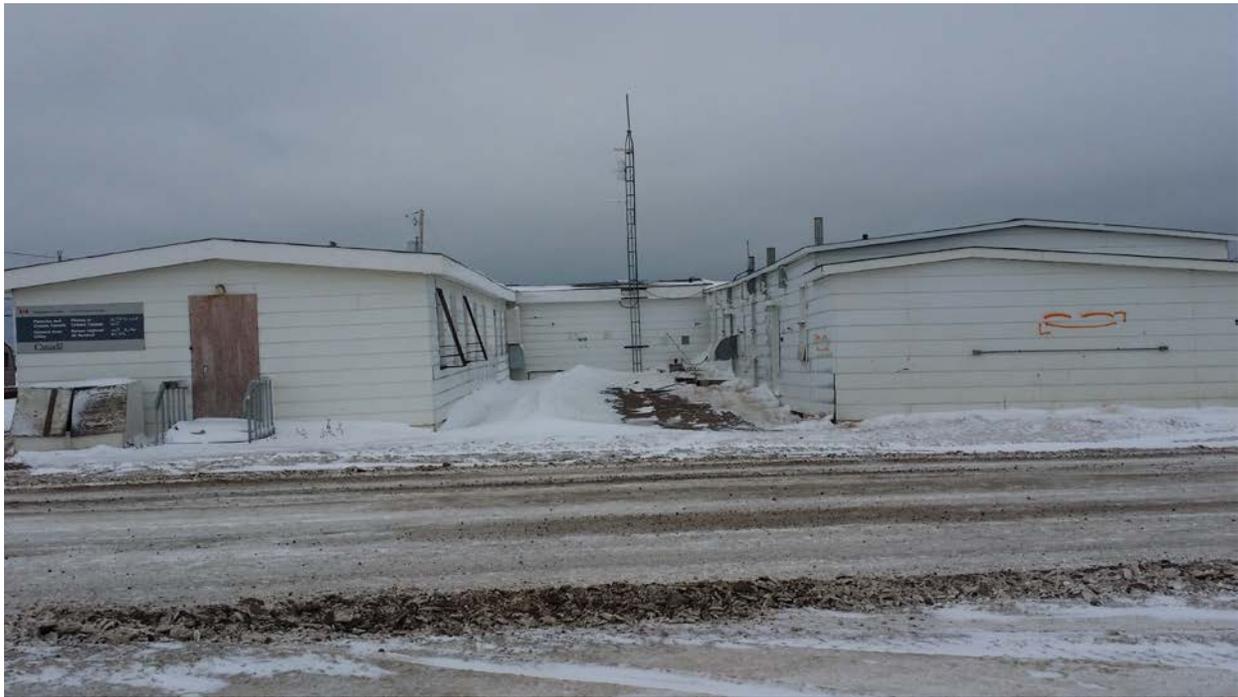
Photograph No. 3: View looking south between the east and west wings. The area on the right is where the former fuel tank was reported to have been.
