GRANVILLE ISLAND MARINE STRUCTURE REPAIRS OVERVIEW AQUATIC EFFECTS ASSESSMENT

File: 789-010.01 March 2015

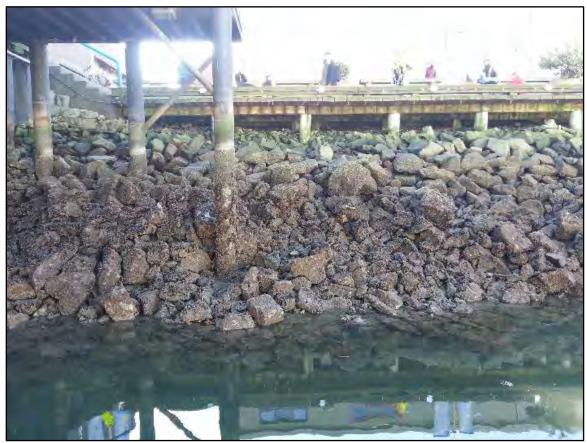
Photo 5 View of the Rip Rap Slope adjacent to the Public Market Boardwalk

Note: The rip rap is providing an attachment site for some algal species and invertebrates.

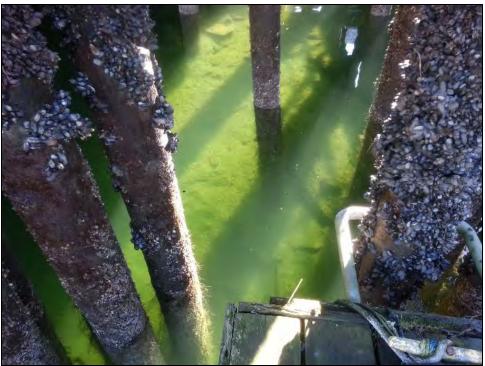
Photo 6 Wooden Piles underneath West Dock

Notes: Wooden piles were encrusted with marine life, predominantly barnacles and mussels, such as these piles underneath West Dock.
