AMEC Geotechnical Report #TY1230281

**ADDITIONAL GEOTECHNICAL TEST HOLE INVESTIGATION
PROPOSED STRUCTURAL STABILIZATION OF STORES BUILDING
SAULT STE. MARIE, ONTARIO**

11 March 2014

AMEC Project No.: **TY1230281**

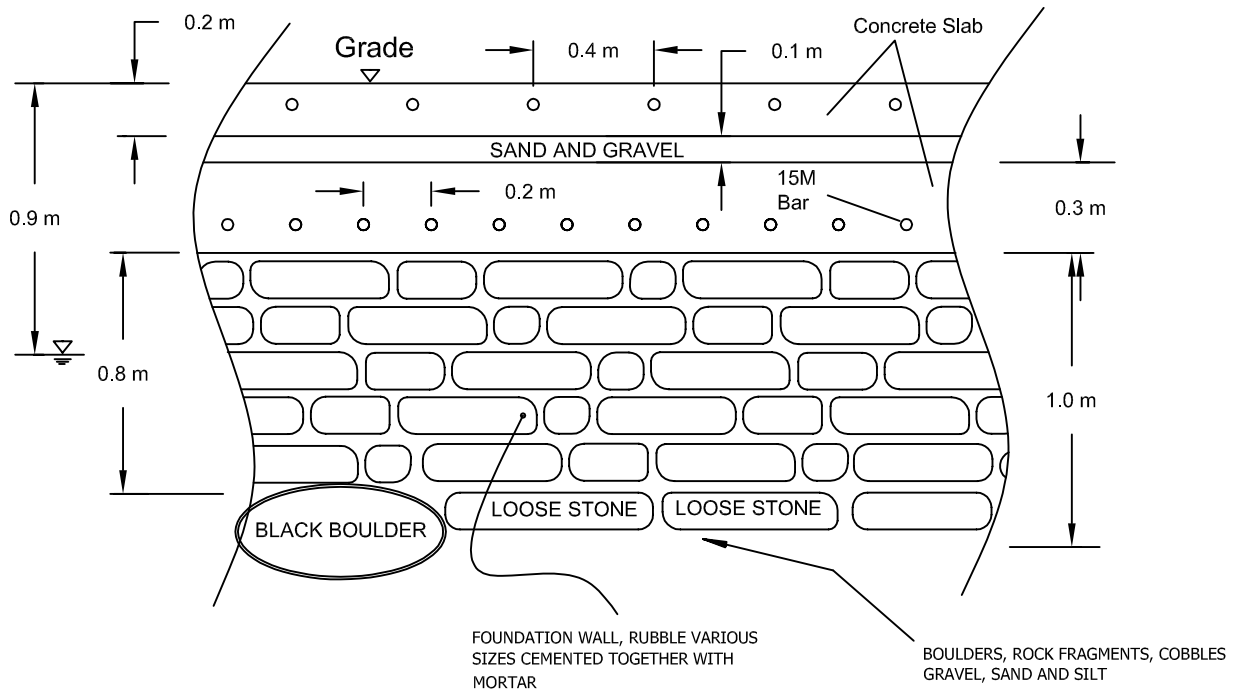
The cores taken of the foundation wall indicate the concrete curb inside the building is of good quality, but the large aggregate size would indicate it is of an older vintage. The cobbler foundation wall behind the concrete section is difficult to evaluate, however, it should be noted the mortar appeared to be deteriorated, although that may be in part due to the coring procedure and use of water for drilling.

A cross-section of the foundation wall is depicted on Figure 3.
