CCGS Henry Larsen

Status of Helicopter Hanger

**Submitted
September 2011**

Indal Technologies
Telescopic Aluminum Helicopter Hanger
Model 1256-001, Cont No 110-0009
Ident No 36334, Job No 40-6571
Serial No 001, for CCG Type 1200

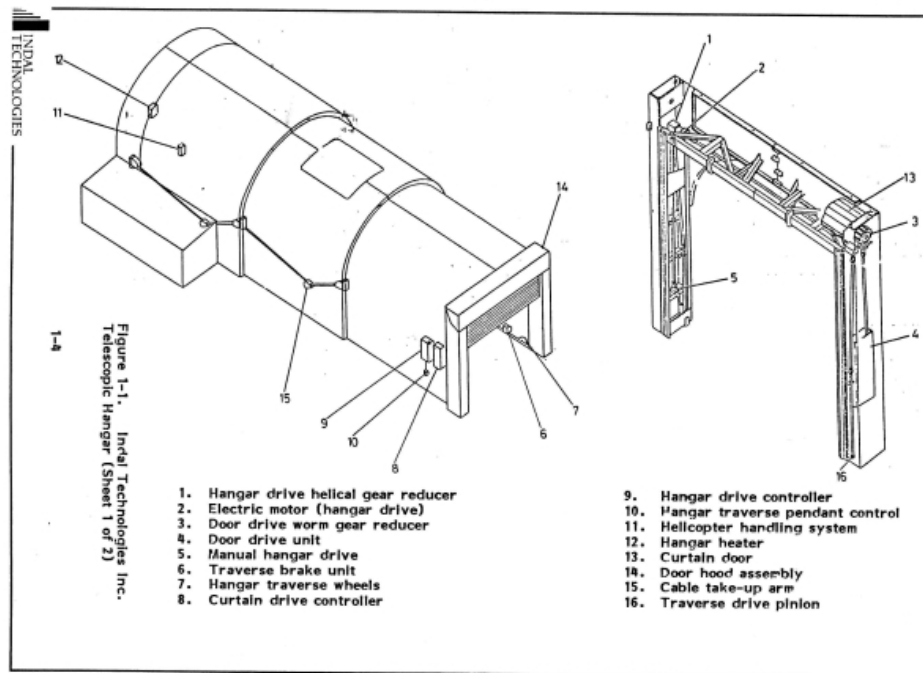
The telescoping hanger consists of arch shaped sections supported on aluminum wheels which ride on tracks fixed to the ship's deck. There are three arch shaped sections, fixed, trailing and lead. The lead section is the outermost. It carries the door assembly and contains all the mechanisms for hanger traversing and door movement.

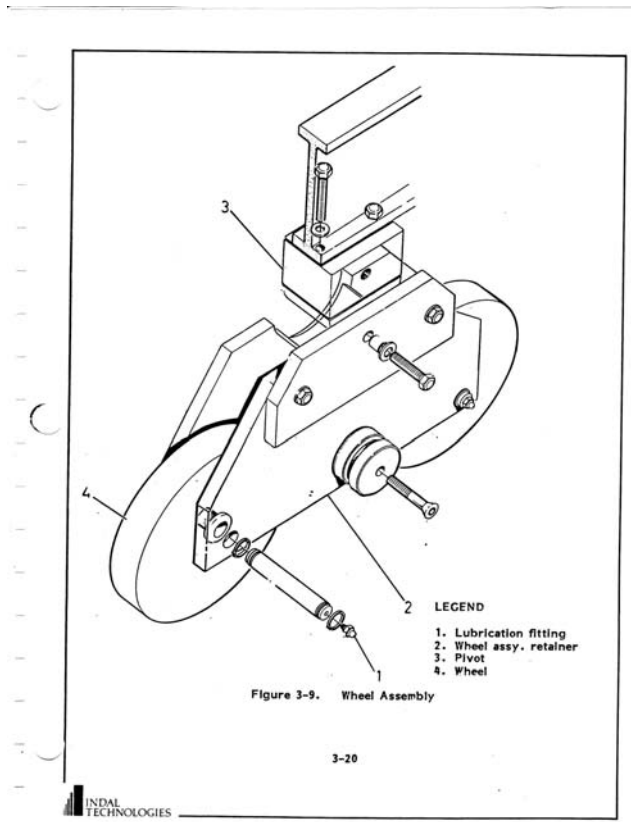
There are 8 hanger wheel assemblies as shown below. Four each on the leading and trailing hanger sections. Each assembly comprises 2 wheels mounted in a 'rocking' mounting. The wheels are aluminum fitted with phenolic bushings.

A rectangular phenolic strip screwed to the underside of the hanger at the wheel locations and is inserted into a Tee shaped guide in the hanger track extrusions to prevent any uplift tendency caused by high winds or ship movement.
