Addendum / Addenda

No./N^o
1

Project Description / Description de projet M-22 Aircraft Cabin Comfort and Environment Research Facility		
Solicitation No./ No de sollicitation 15-22004	Project No./N ^o de projet M-22 3788	W.O. No./N ^o d'ordre de travail
Departmental Representative / représentant ministériel Maurice Richard		Date June 24, 2015
<p>Notice: This addendum shall form part of the tender documents and all conditions shall apply and be read in conjunction with the original plans and specifications.</p>		<p>Nota: Cet addenda fait partie intégrale des dossiers d'appel d'offres; toutes les conditions énoncées doivent être lues et appliquées en conjonction avec les plans et les devis originaux.</p>

DESIGNATED SUBSTANCES SURVEY

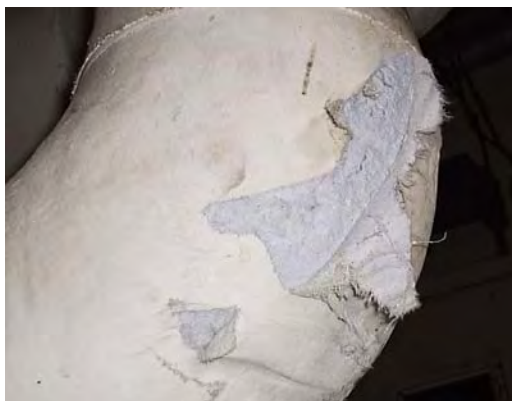
Mud Joint Compound

A representative photograph of mud joint compound fitting insulation. This material is a malleable grey insulation that has the appearance of granular mud. It appears smooth, round and hard when it is intact with appropriate exterior jacketing.

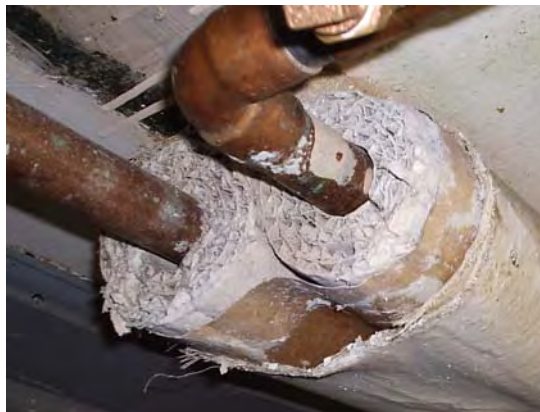
A representative photograph of aircell pipe insulation. This material is grey and white in colour. Aircell is layers of corrugated paper, which gives it the appearance of a honeycomb pattern when the profile is observed.

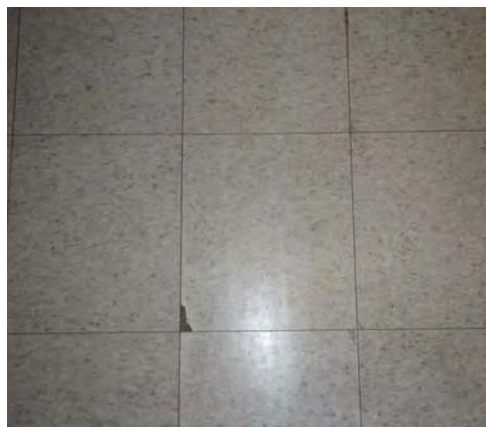
12"x12" Floor Tile

A representative photograph of 12" x 12" vinyl asbestos floor tile (VAT). This material may be found in any number of different colours and patterns. VAT's are normally quite rigid and non-friable. VAT's are sometimes found under carpeting or they may be present as the only flooring.

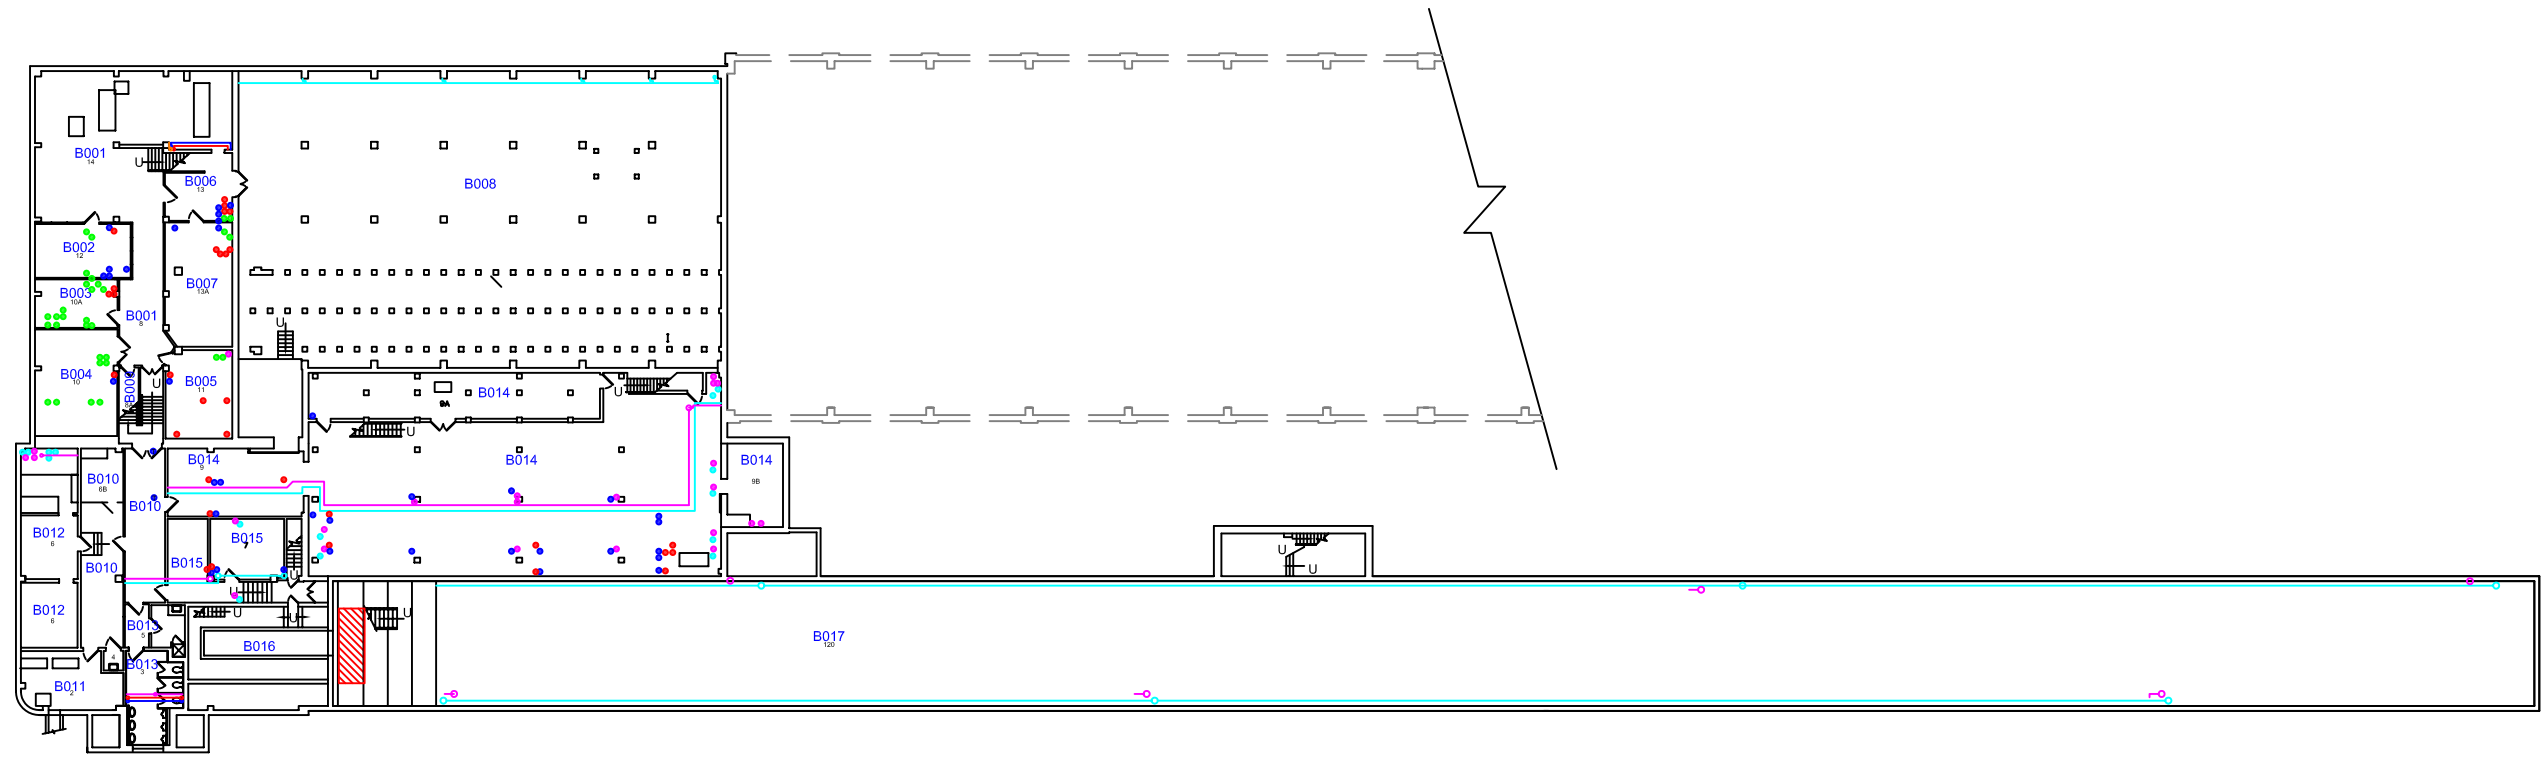
SHEET
B-1

TITLE
**-BASEMENT-
 ASBESTOS
 LOCATIONS**

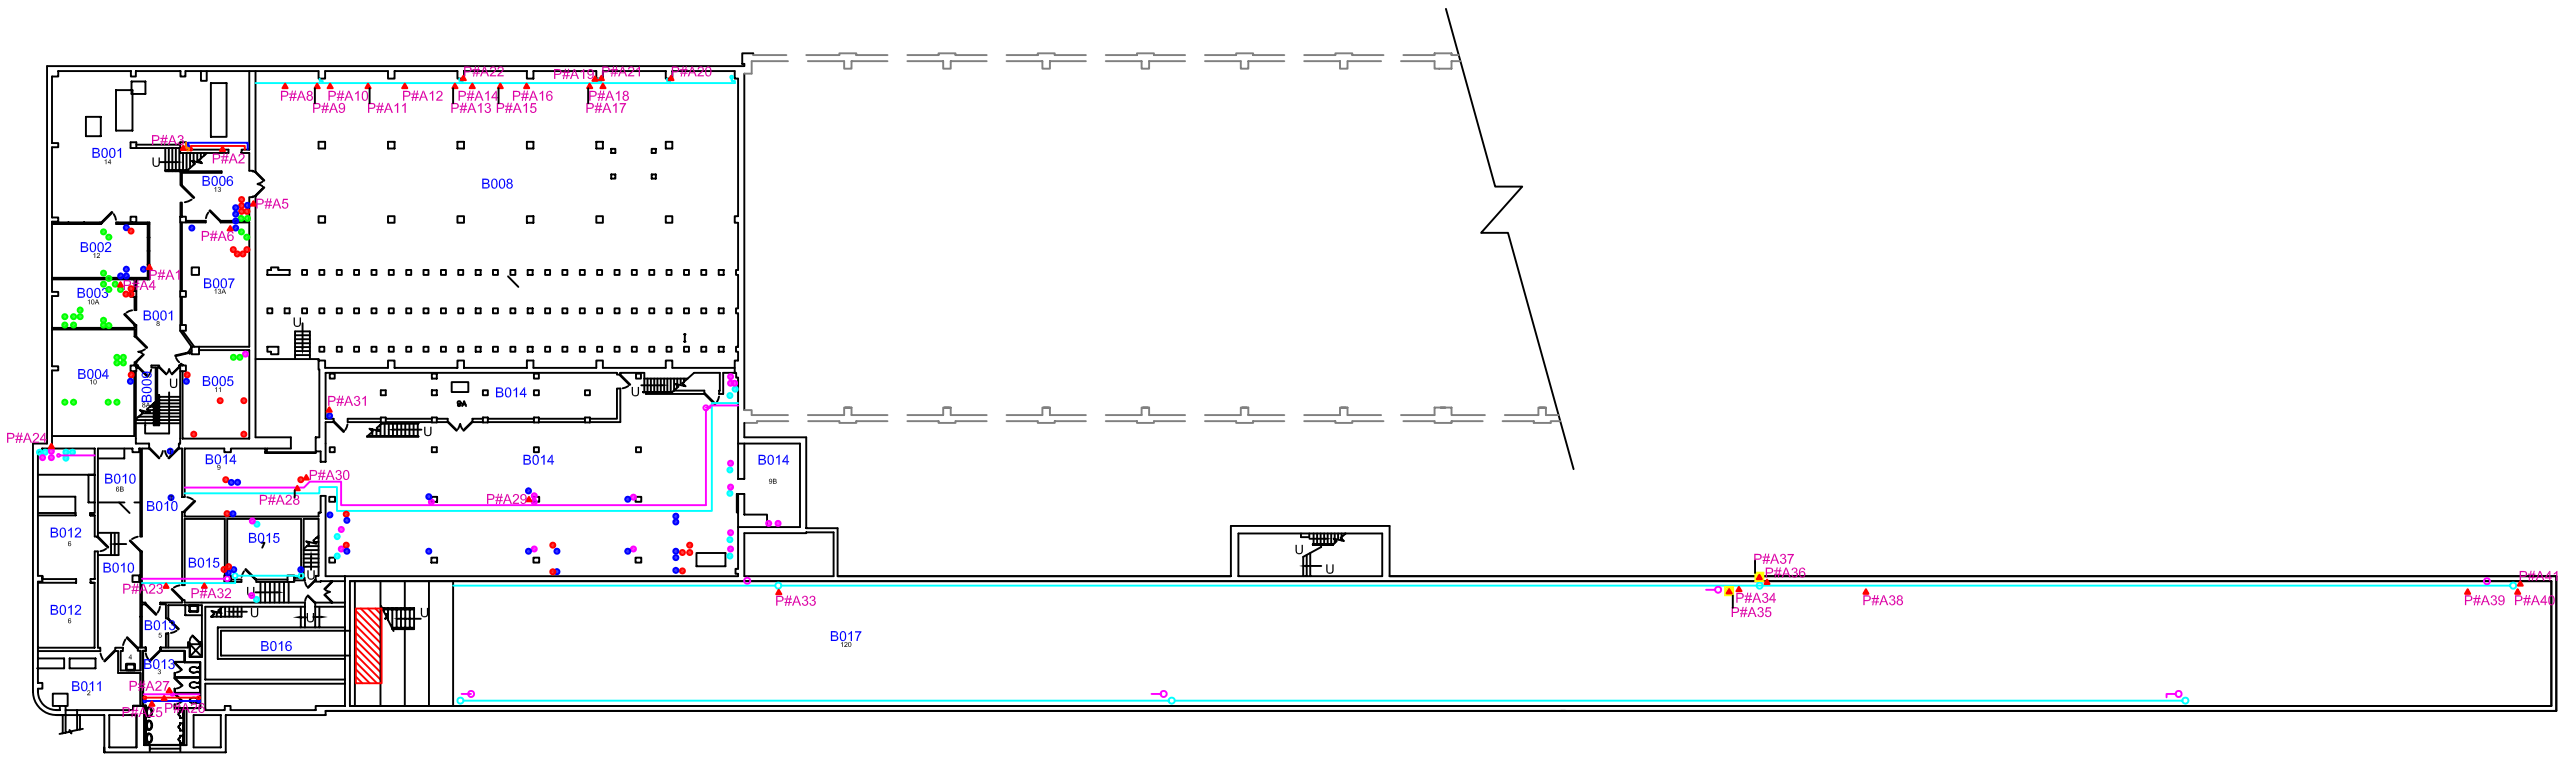
SHEET
B-2

TITLE
**-BASEMENT-
 ASBESTOS
 SURVEY**

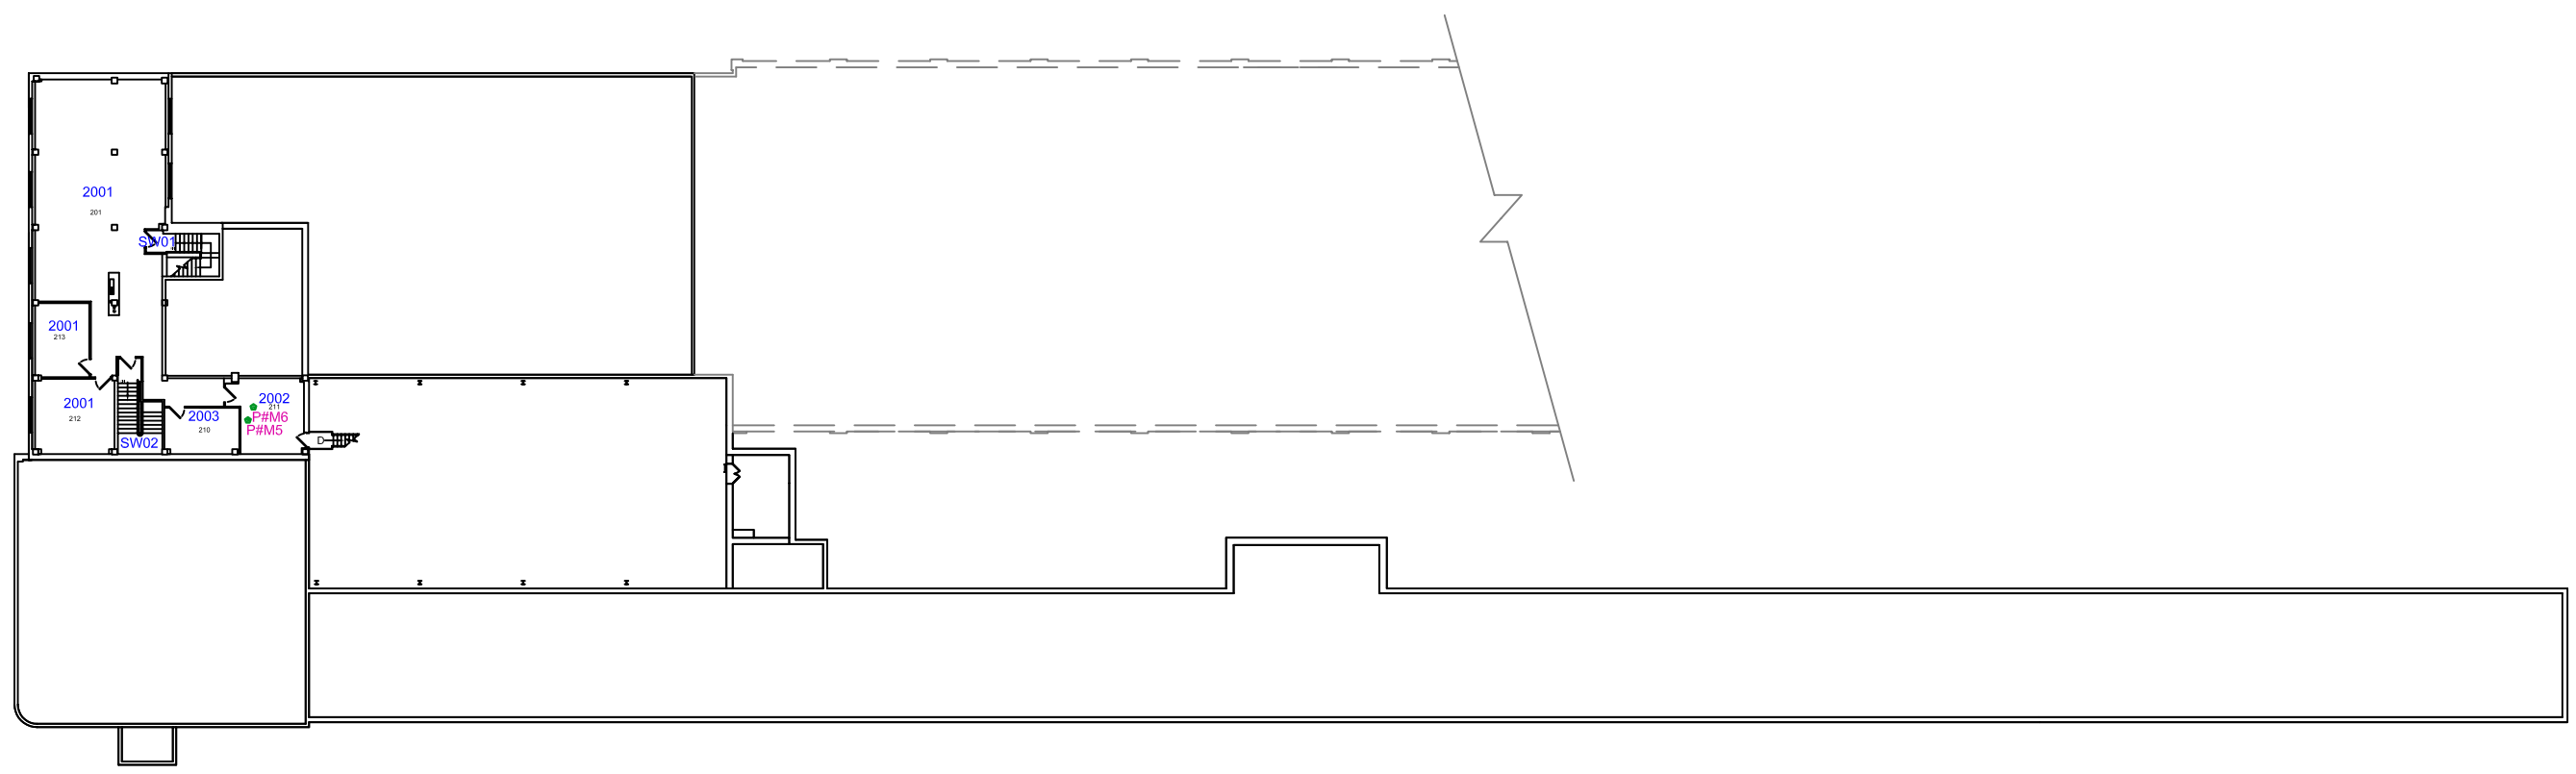
SHEET
2-1

TITLE
**SECOND FLOOR-
ASBESTOS
SURVEY
& MOULD
LOCATIONS**
