## DESIGN DEVELOPMENT REPORT

### **Centre Block, Parliament Hill, Ottawa East and West Pavilions Rehabilitation**

July, 2013  
(Final version)

Project # R.027594.018

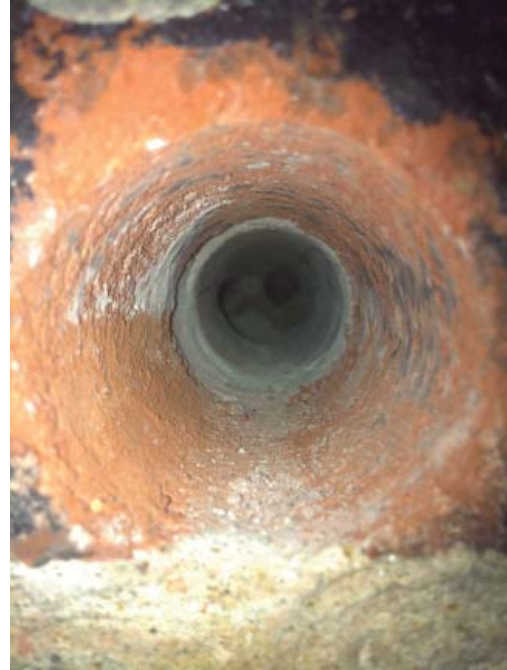
Figure 2-I: Bore hole through brick.

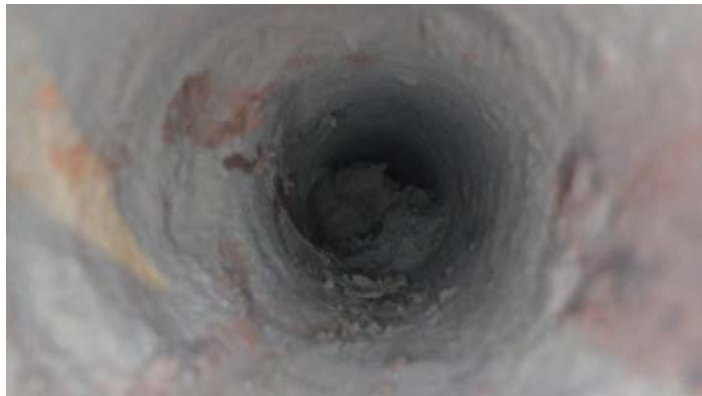
- Only two of the six bore holes demonstrated any voiding and one of those two had significant voiding.
- With the help of a boroscope it was possible to identify the number of wythes of brick inside some of the bore holes.

Figure 2-II: Bore hole into the back of face stone.

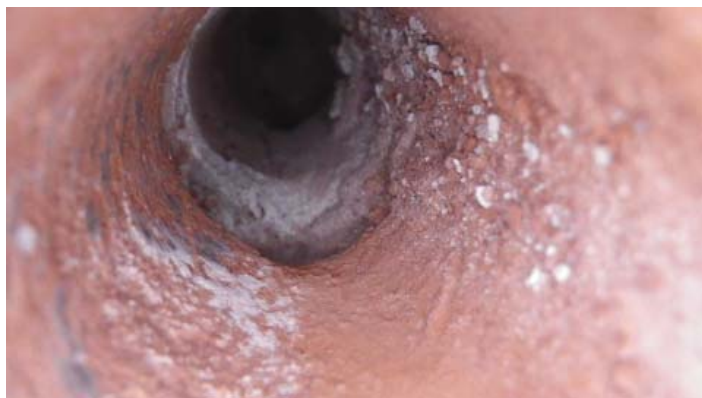
Figure 2-III: Bore hole showing minor voiding around mortar.

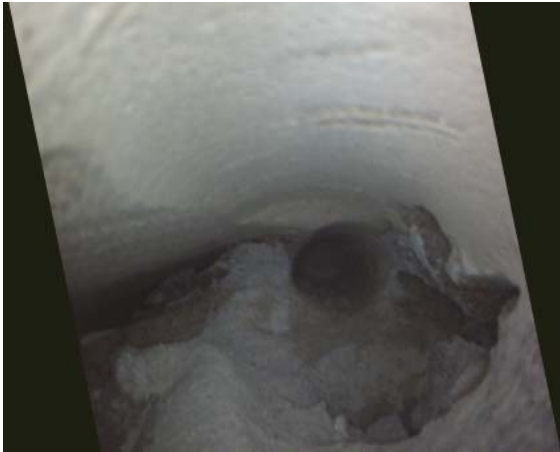
Figure 2-IV: Bore hole with significant voiding.

- The Eastern most bore hole on the North facing wall had the most significant levels of voiding.

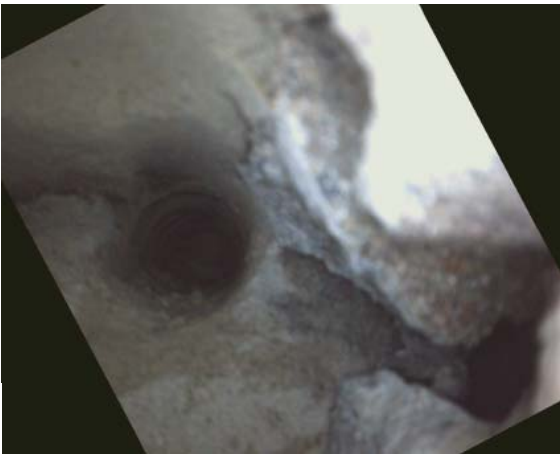
Figure 2-V: Voiding on right side.

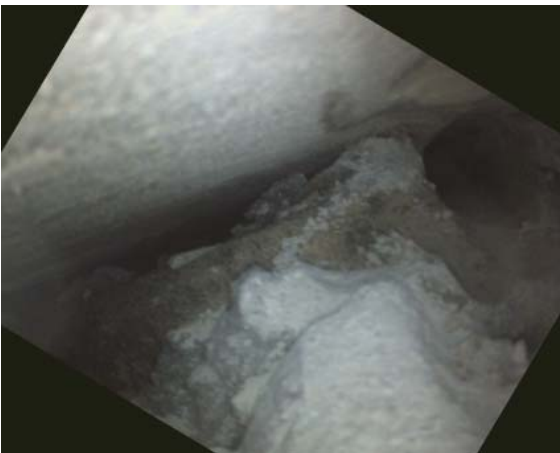
Figure 2-VI: Voiding on right side.

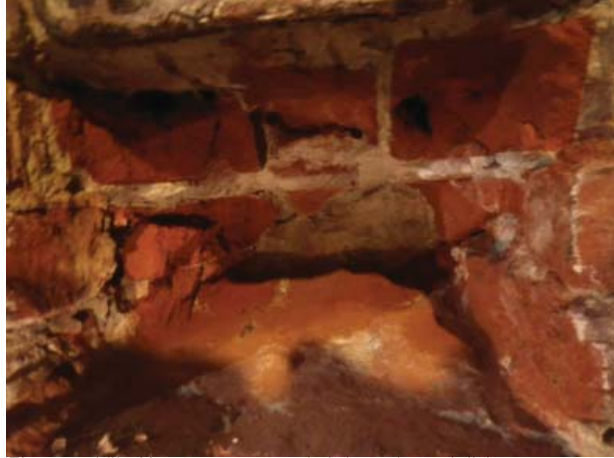
Figure 2-VII: Alternate course brick wythes visible.

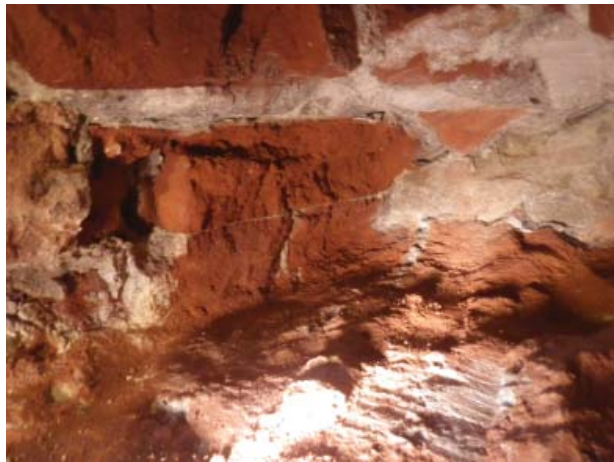
- There was no sign of masonry anchors inside the opening.
- It was possible to identify the number of wythes of brick inside some of the bore holes.
- Backing mortar is harder than the brick itself.

Figure 2-VIII: Excavated until the back of the face stone.

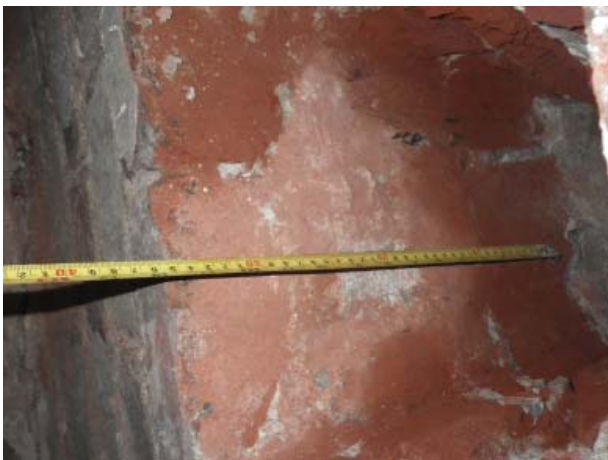
Figure 2-XII: Thickness of backwall at this location.

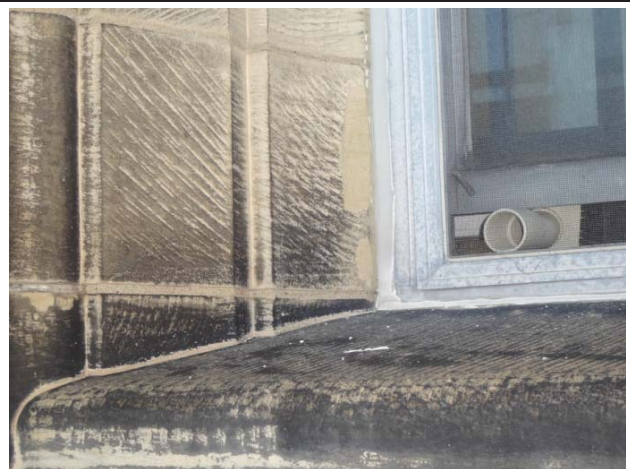
Photo n° 5: Dépôt sur la pierre et surface érodée

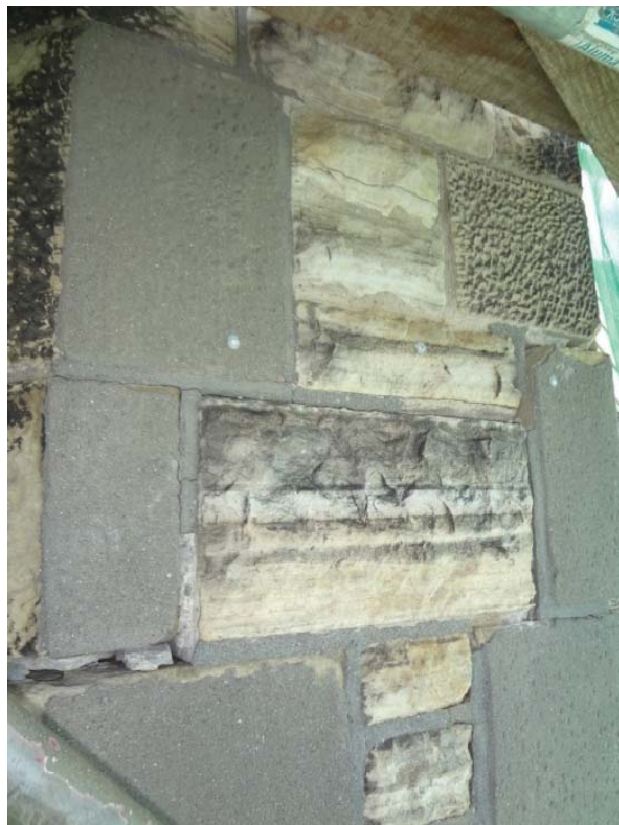
Photo n° 6: Joints ouverts et produit de resurfacement employé

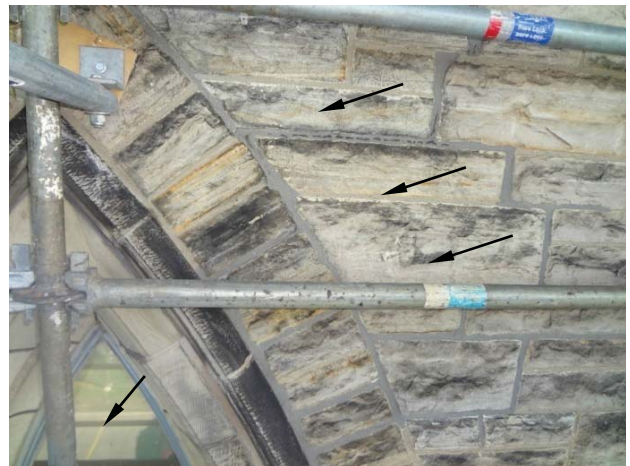
Photo n° 7: Déplacement de l'ogive et des pierres adjacentes

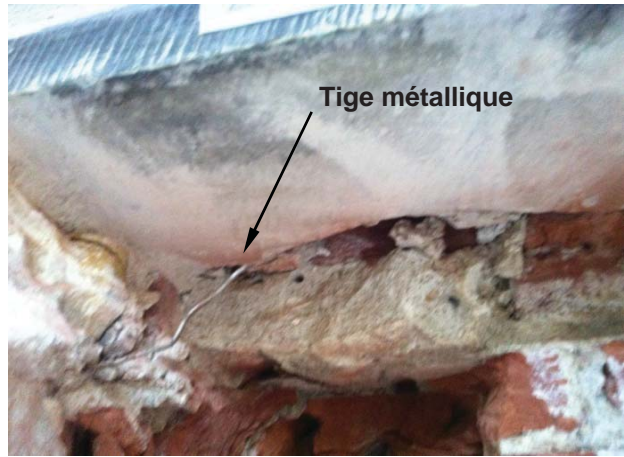
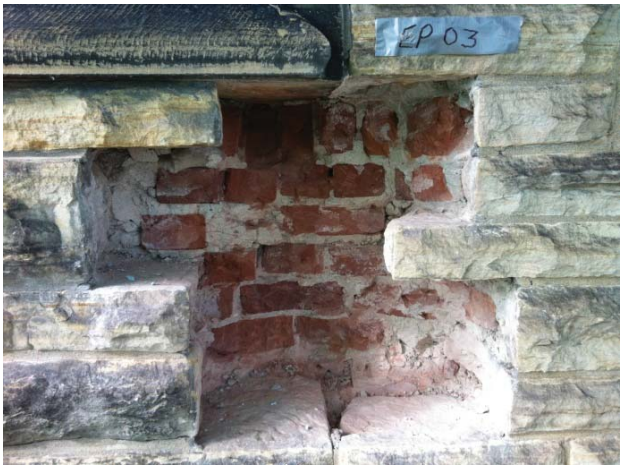
EP01 : La pierre de parement a été retirée et deux rangs de briques ont été exposés.	EP03 : La pierre de parement a été retirée et deux rangs de briques ont été exposés.

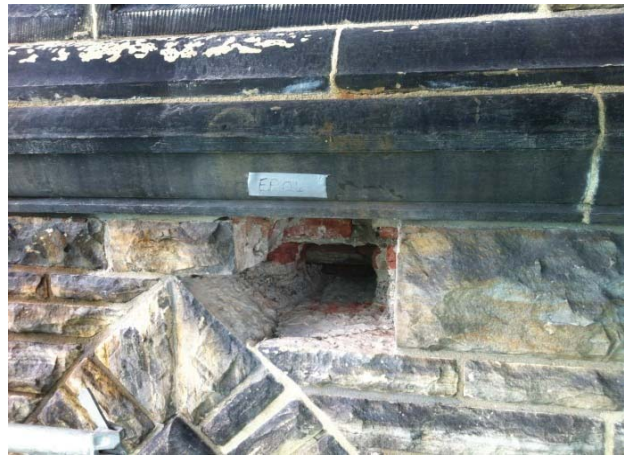
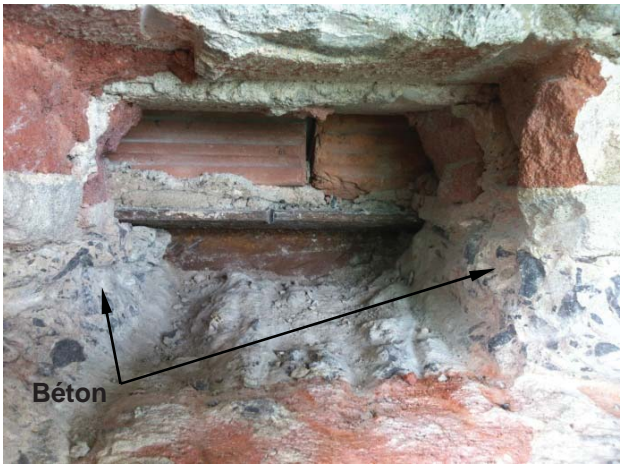
EP06 : La pierre de parement a été retirée ainsi que deux rangs de briques; les blocs de terracotta ont été exposés. Un élément de structure d'acier est apparent derrière la brique.	EP06 : Présence de béton entre les éléments de maçonnerie.

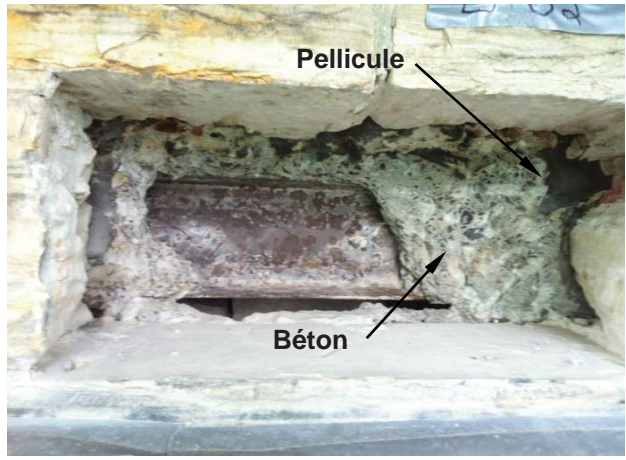
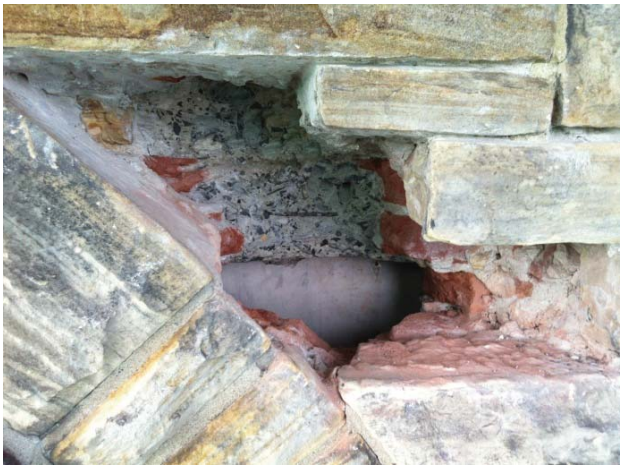
- Pour l'ouverture EP04, un enduit noir non identifié est présent sur la face arrière de la pierre de parement. De plus, un vide existe entre le parement et l'élément structural en béton ;

EP02 : La pierre de parement a été retirée, exposant une poutre d'acier en partie recouverte de béton.	EP04 : La pierre de parement a été retirée ainsi que deux rangs de briques. Derrière, on retrouve un espace vide d'environ 4 po, et le dos du revêtement de pierre intérieure est exposé.

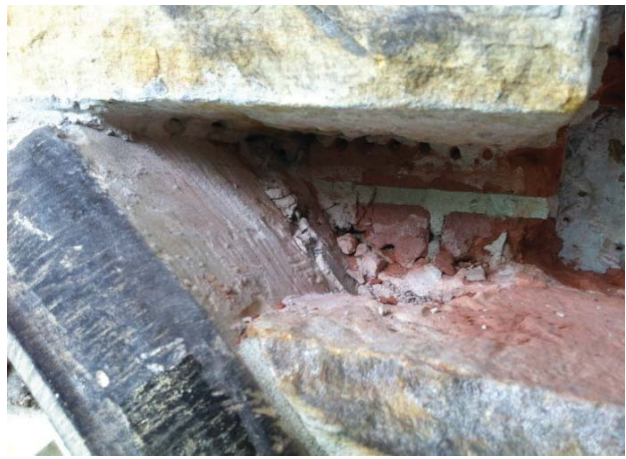
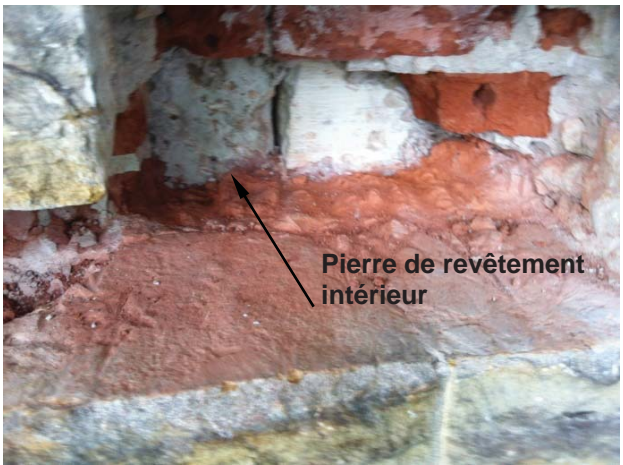
EP07 : La pierre de parement a été retirée ainsi qu'un rang de pierre, laissant le dos de la pierre de revêtement intérieur exposé.	EP07 : Endos de la pierre de revêtement intérieur de l'escalier.

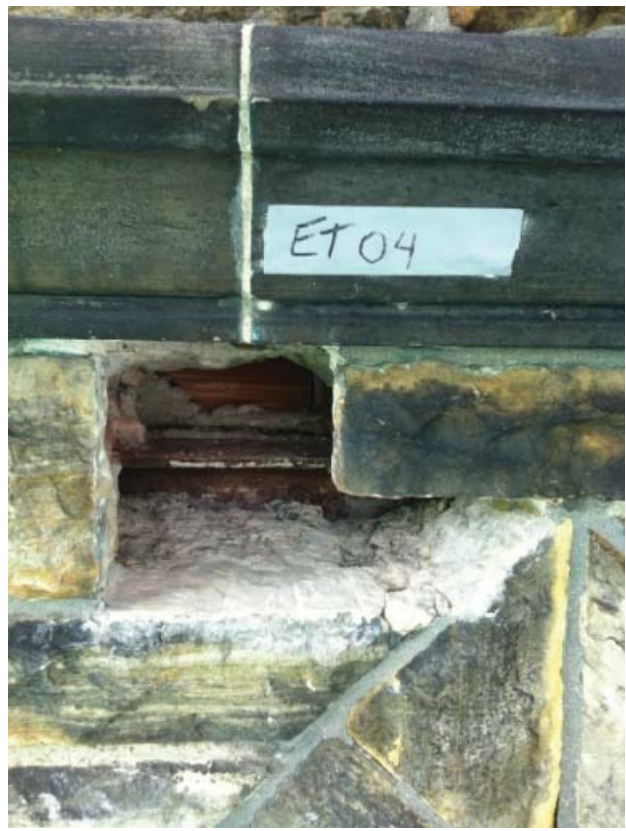
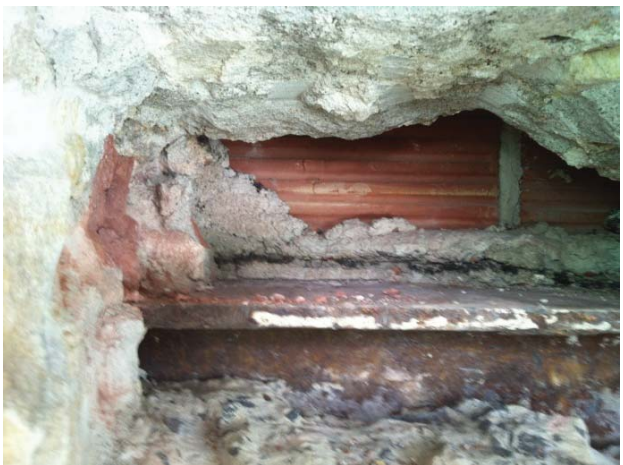
ET04 : La pierre de parement a été retirée, une poutre d'acier ainsi que des blocs de terracotta sont apparents.	ET04 : Ouverture inachevée au moment de l'inspection. La pierre de parement a été retirée, laissant la brique apparente.

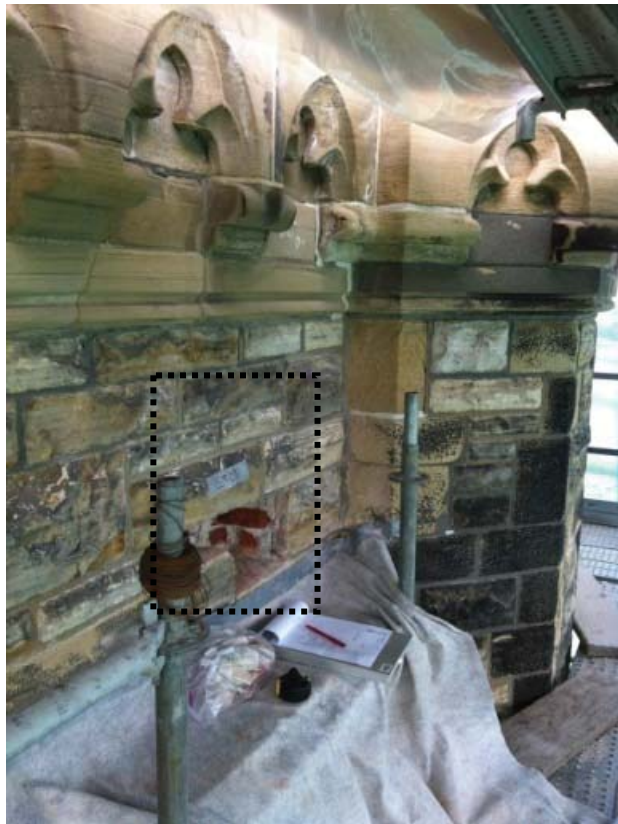
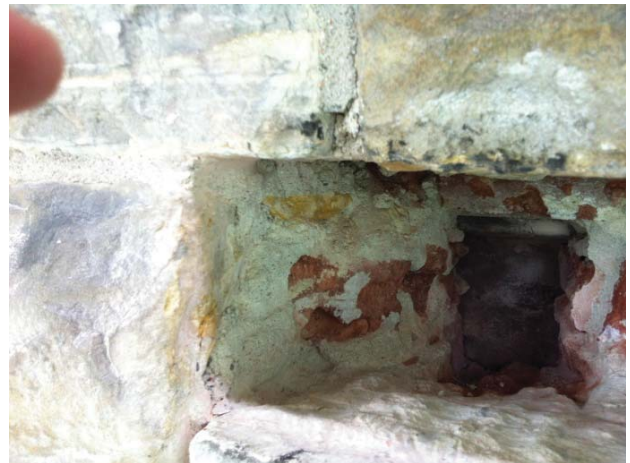
ET08 : Ouverture sous la bordure de toiture, dans la partie centrale de la façade; la pierre de parement a été retirée ainsi la maçonnerie de brique, exposant une poutre d'acier.

ET08 : Poutre d'acier apparente.

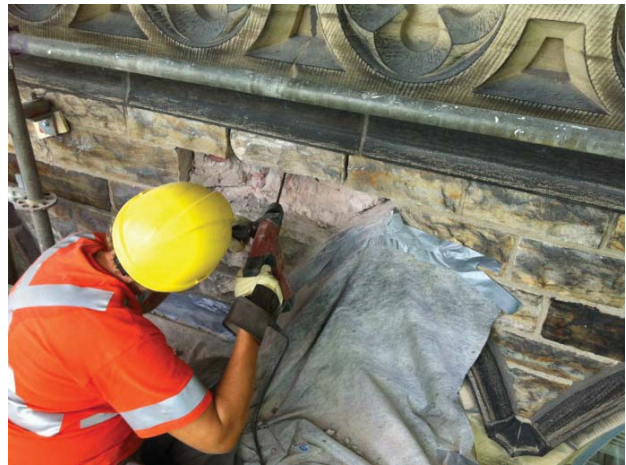
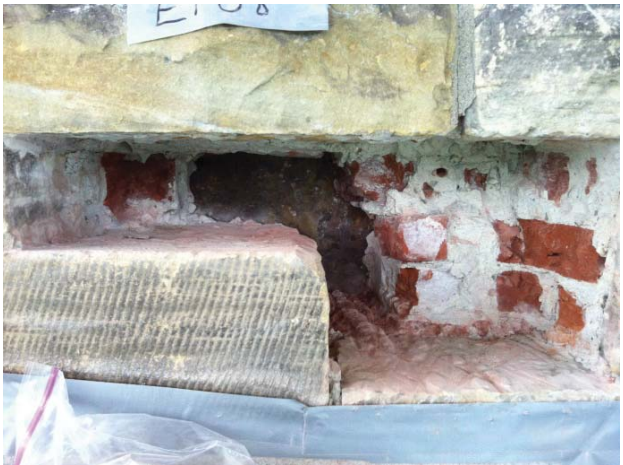
ETN02 : La pierre de parement a été retirée; l'ouverture n'était pas achevée lors de notre passage.	ETN08 : Pierre de parement et maçonnerie de briques retirées, exposant une poutre d'acier.

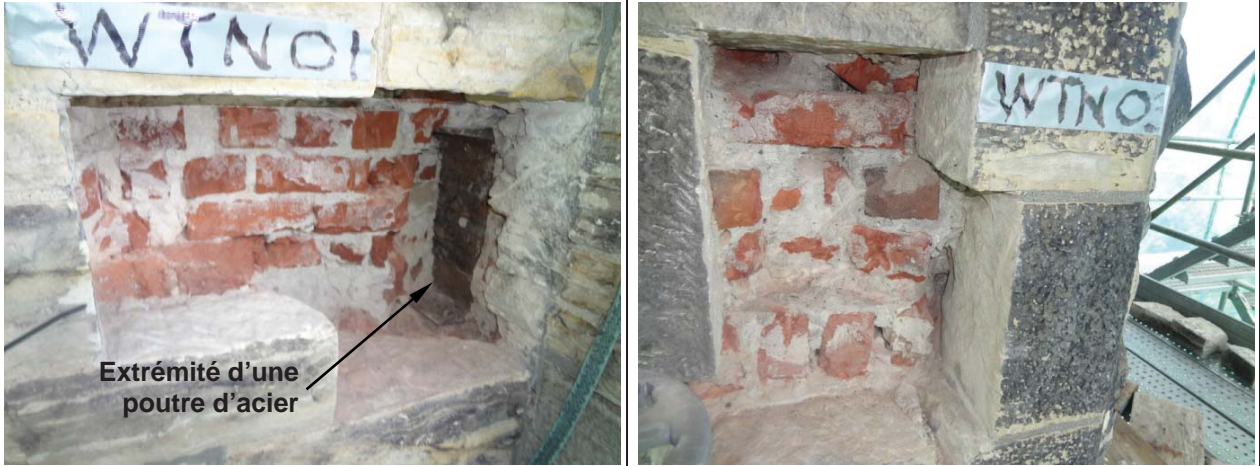
WTN01 : La pierre de parement a été retirée; l'extrémité d'une poutre d'acier est apparente.	WTN03 : La pierre de parement a été retirée, laissant la brique apparente.

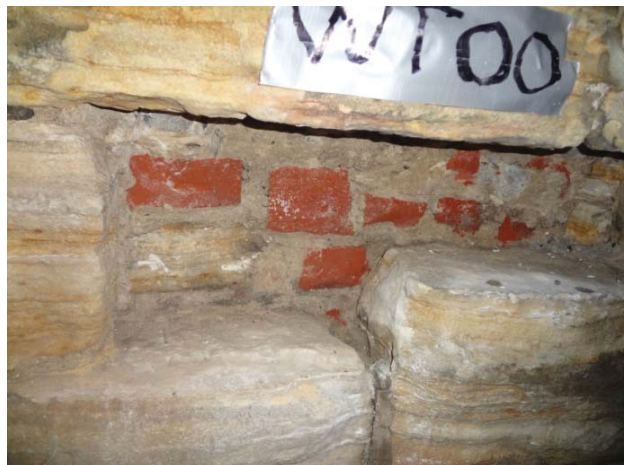
WT00 : La pierre de parement a été retirée, laissant la maçonnerie de brique apparente.	WT08 : La pierre de parement a été retirée, laissant la maçonnerie de briques apparente.

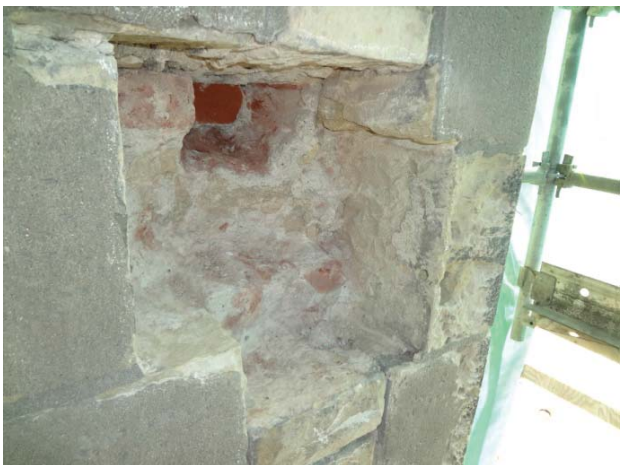
WT09 : La pierre de parement a été retirée, laissant la maçonnerie de briques apparente.	WT10 : La pierre de parement ainsi que le premier rang de briques ont été retirés, laissant un deuxième rang de briques apparent.

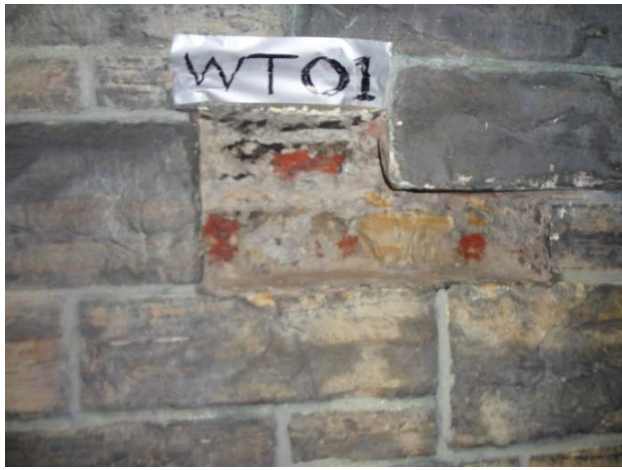
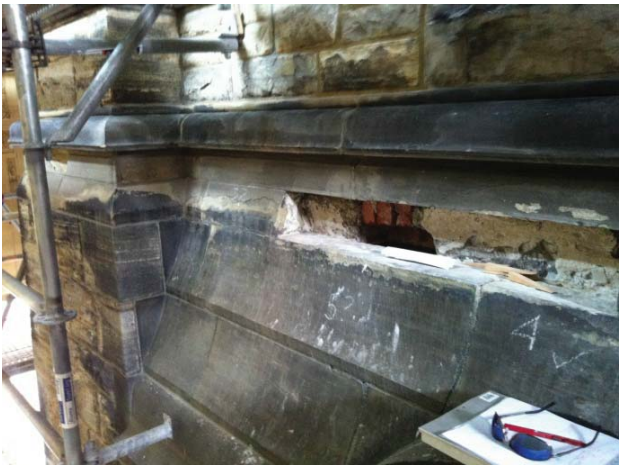
WT01 : La pierre de parement a été retirée, laissant la maçonnerie de brique apparente.	WT02 : La pierre de parement a été retirée, laissant la maçonnerie de briques apparente ainsi qu'une poutre d'acier. Présence de quelques vides de construction dans l'arrière-mur de maçonnerie.

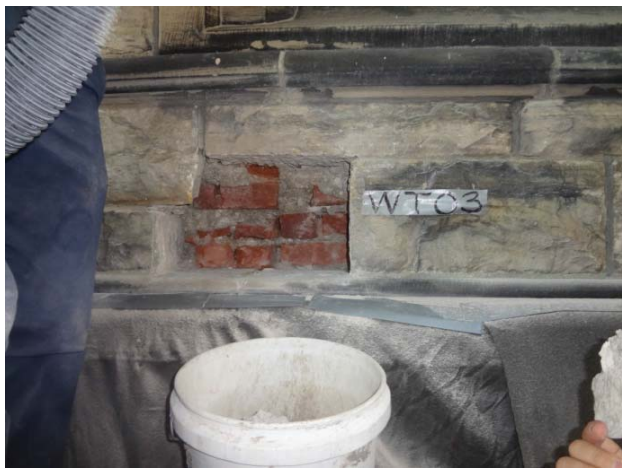
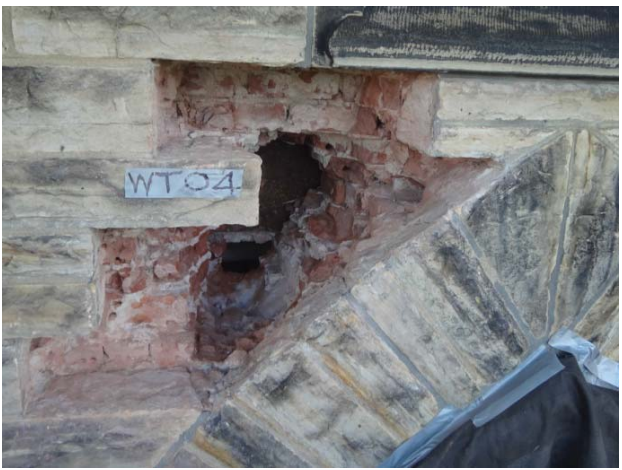
WT03 : La pierre de parement a été retirée, laissant la maçonnerie de briques apparente.	WT04 : La pierre de parement ainsi que la maçonnerie de briques ont été retirées, exposant une poutre d'acier.

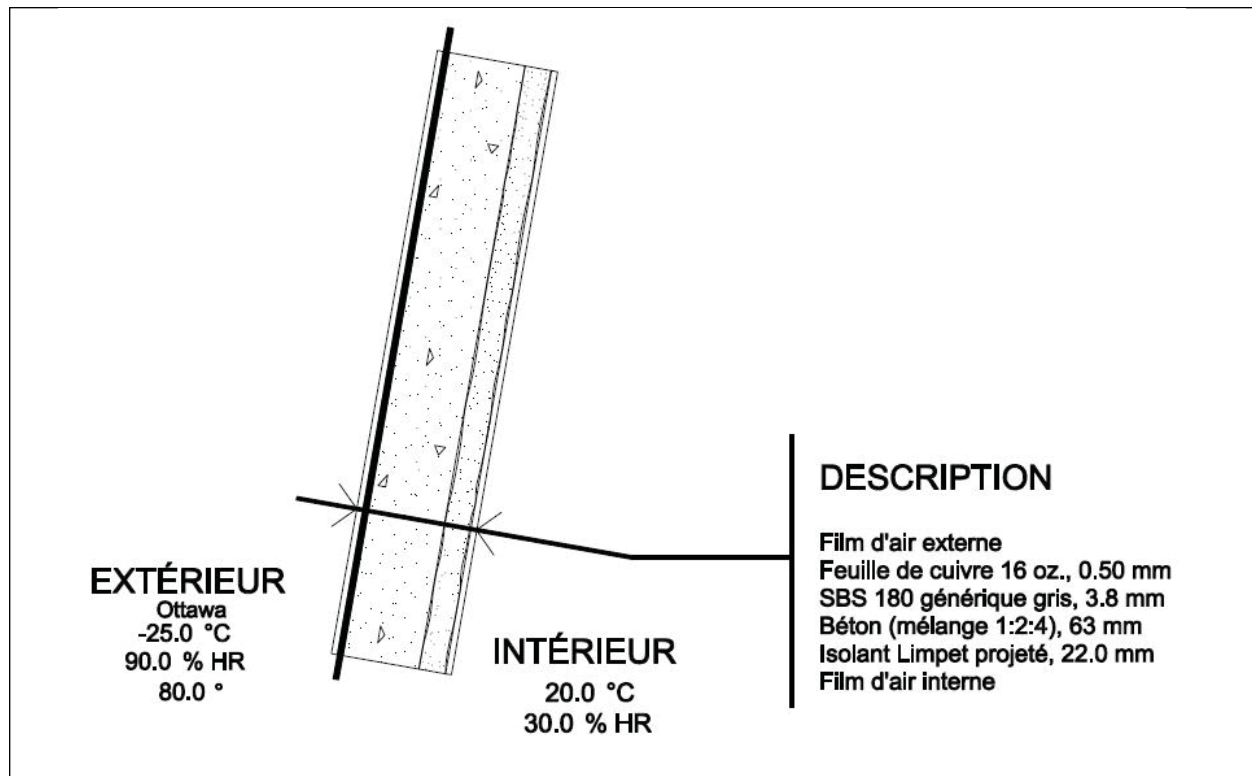
Figure n° 3: Modélisation de l'assemblage n°1

Aux conditions fixées pour les simulations, un risque de condensation de la vapeur d'eau en diffusion est présent dans les deux assemblages.

Comme la chute de température dans les deux assemblages se retrouve donc principalement au niveau de l'ignifuge, c'est à cet endroit que la pression de vapeur à saturation est atteinte et qu'il y a risque de condensation. Cette condition peut occasionner l'apparition d'humidité du côté intérieur de l'enveloppe.

Cependant, les taux de condensation calculés sont très faibles (faible quantité d'eau produite par condensation). Par conséquent, selon les informations qui nous ont été données, il semblerait que cette condition n'a pas occasionné de problèmes notables au niveau des assemblages existants.

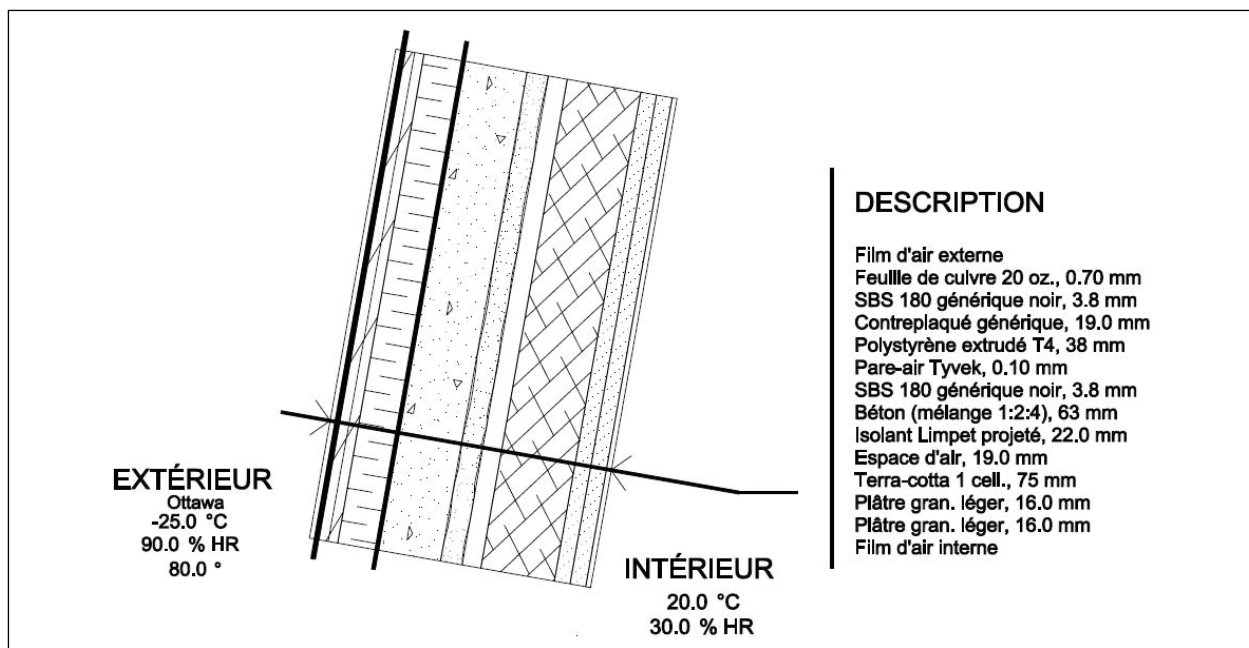
**Figure n° 6: Modélisation de l'assemblage n°2 modifié**

L'assemblage n°2 modifié offre une résistance thermique RSI théorique de 2,82.

Pour cet assemblage, l'ajout d'isolation du côté extérieur est insuffisant pour réchauffer suffisamment le béton et éviter les risques de condensation à ce niveau (selon les simulations, le béton se maintient entre 0 et 3°C). En effet, les simulations indiquent un risque de condensation dans le béton, ce qui pourra se traduire en pratique par l'apparition de condensation en surface intérieure du béton ou en surface intérieure de la membrane de bitume élastomère installée sur le béton. Dans les deux cas, il y a risque d'apparition d'humidité du côté intérieur du plan d'étanchéité à la vapeur d'eau de l'enveloppe.

Encore ici, la membrane pare-air de type Tyvek n'est pas nécessaire dans cette composition, à condition que la membrane SBS installée en surface extérieure du béton offre une bonne continuité de l'étanchéité à l'air et à la vapeur d'eau de l'enveloppe.

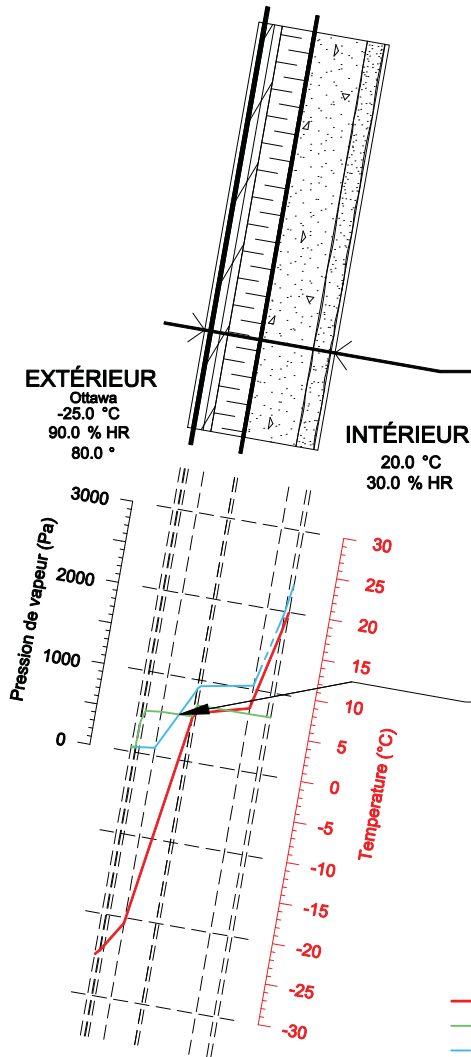
Dans ces conditions, la condensation se produit à cet endroit de l'assemblage.  
Le taux de condensation est de 1.180E-06 g/m2/sec.  
ou 1.019E-04 litres/m2/jour.

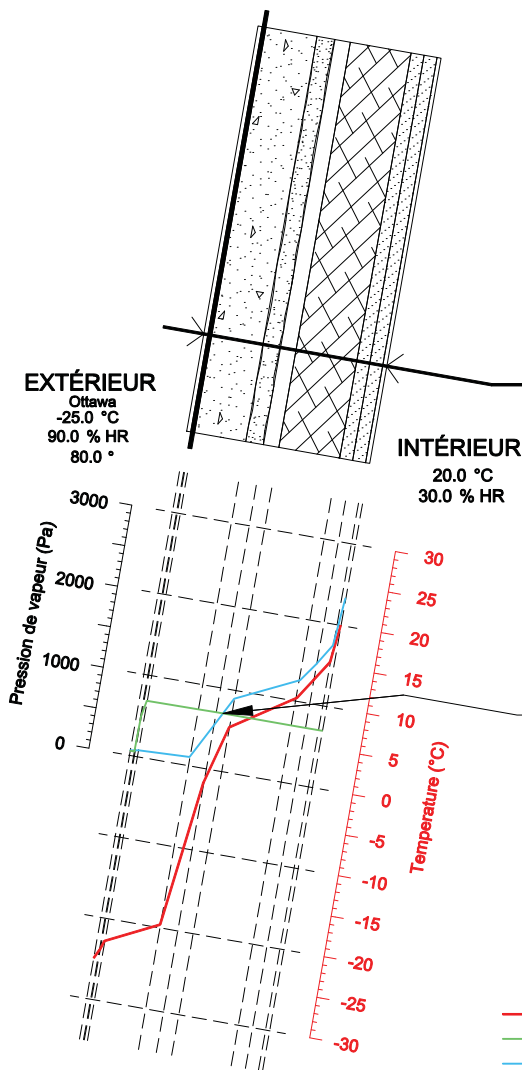
Dans ces conditions, la condensation se produit à cet endroit de l'assemblage.  
Le taux de condensation est de 4.551E-05 g/m2/sec.  
ou 3.932E-03 litres/m2/jour.
