Pachena Light Tower Photos - WSP Inspection Trip Aug 2014

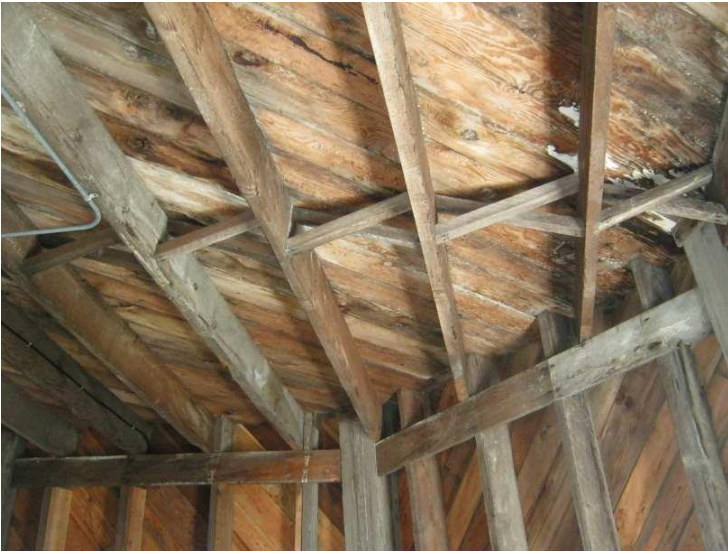
#37 - 2nd Floor Framing

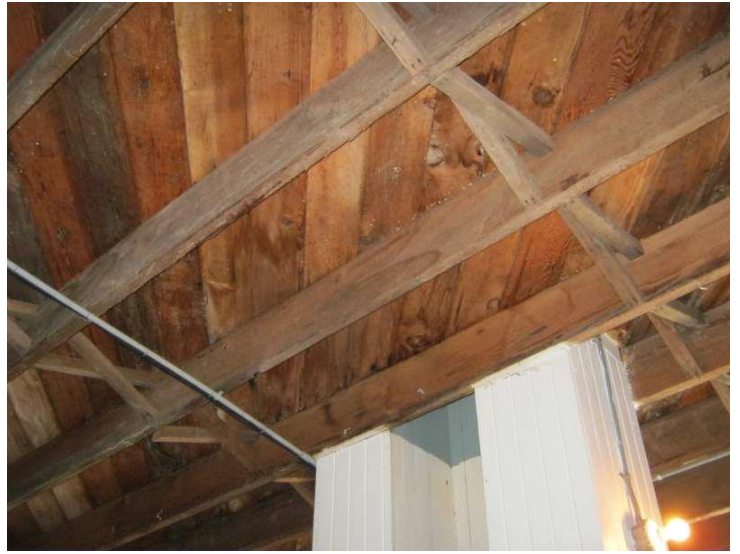
#38 - 2nd Floor Framing

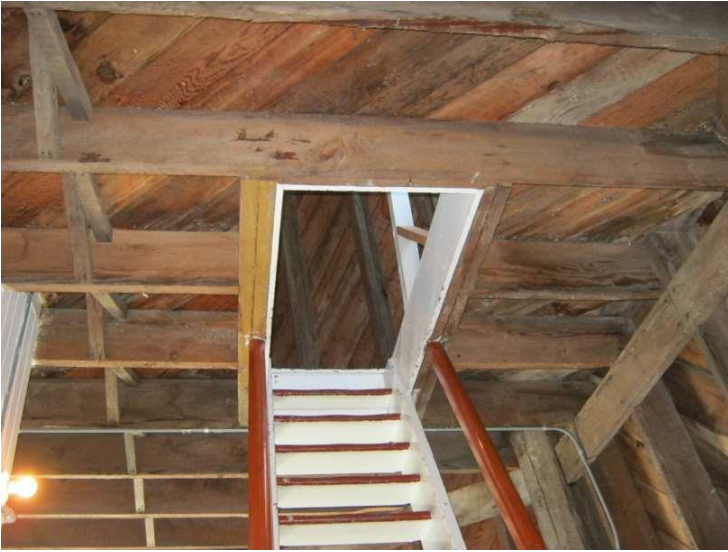
#39 - 2nd Floor Framing

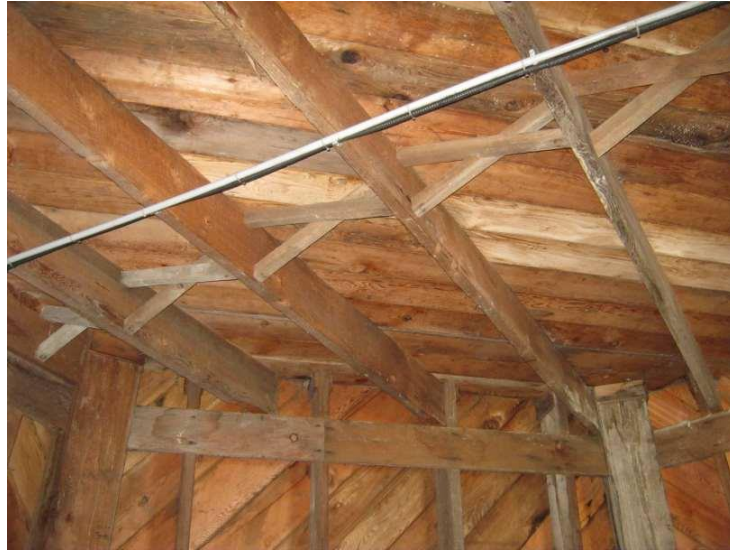
#40 - 2nd Floor Framing

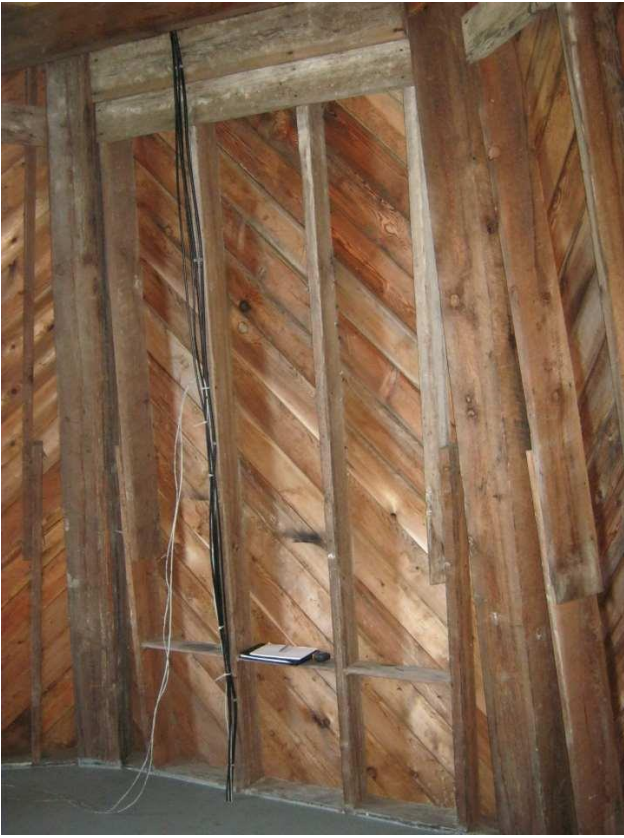
#41 - 2nd Floor Wall Framing

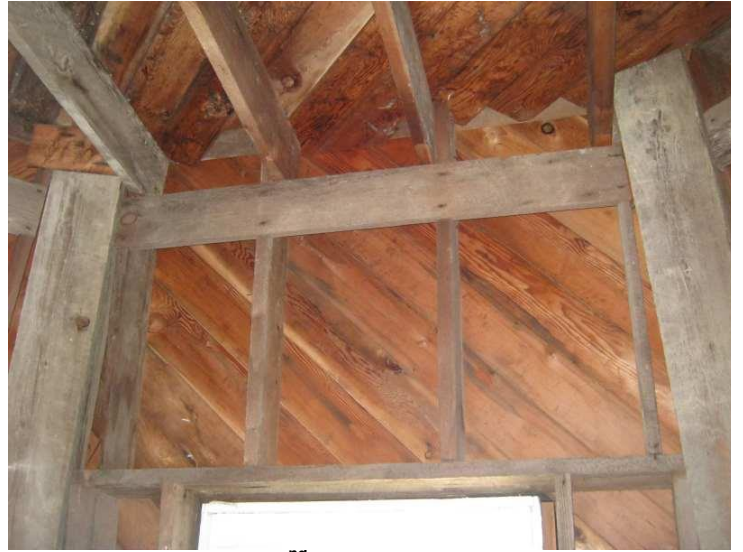
#42 - 2<sup>nd</sup> Floor Wall Framing

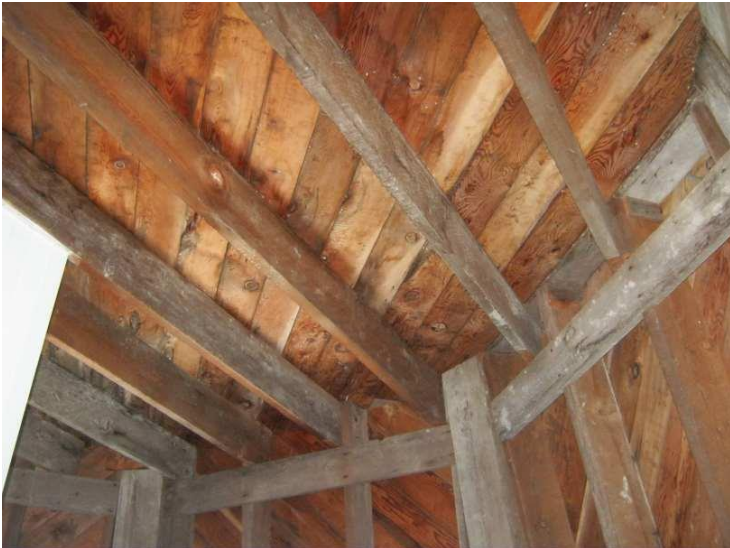
#43 - 3rd Floor Framing

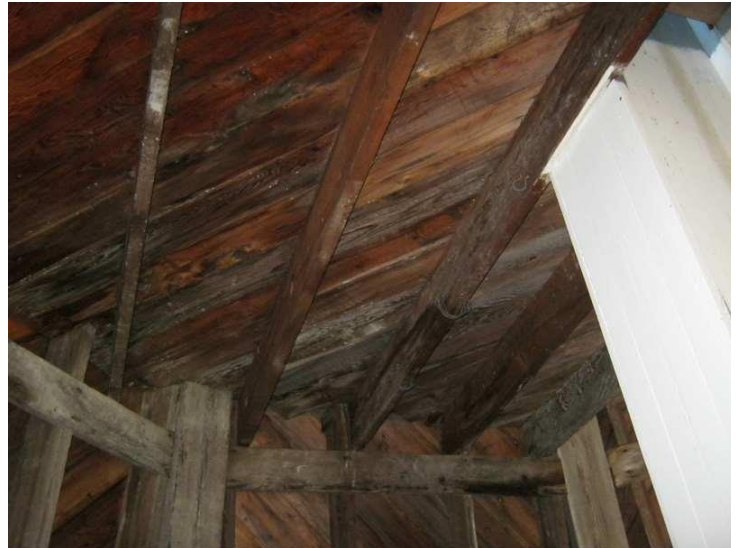
#44 - 3rd Floor Framing

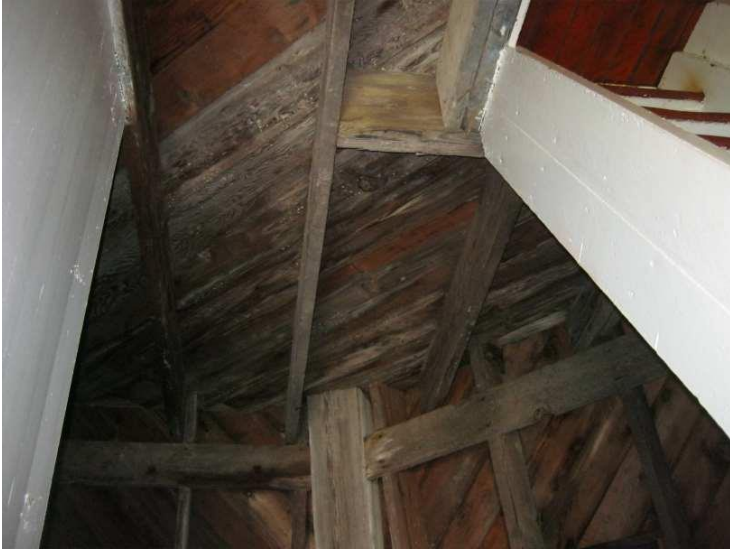
#45 - 3rd Floor Framing

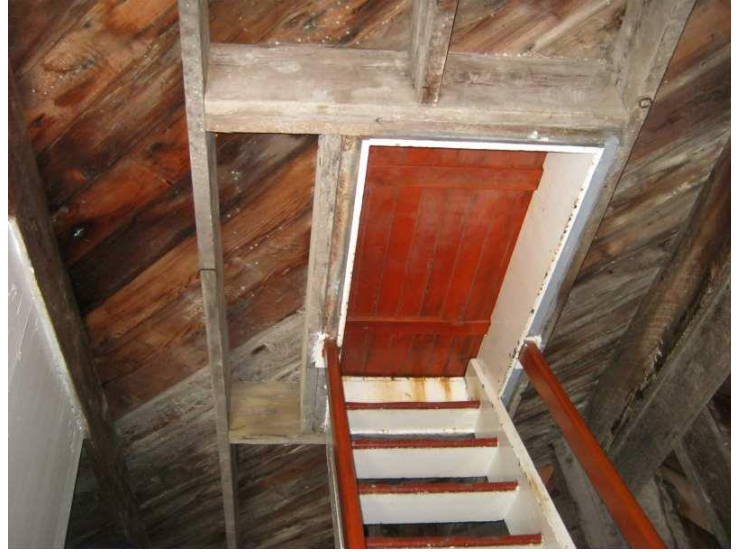
#46 - 3rd Floor Framing

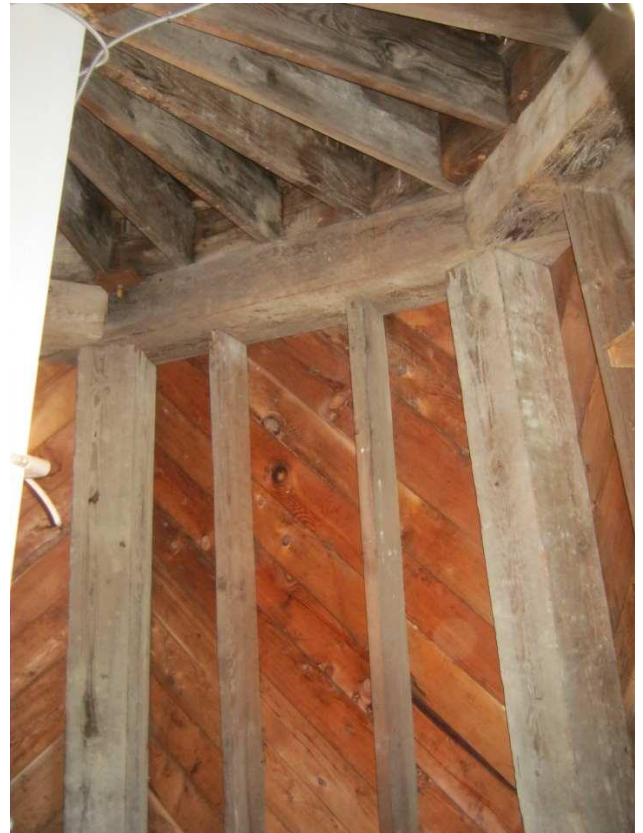
#48 - 3rd Floor Wall Framing

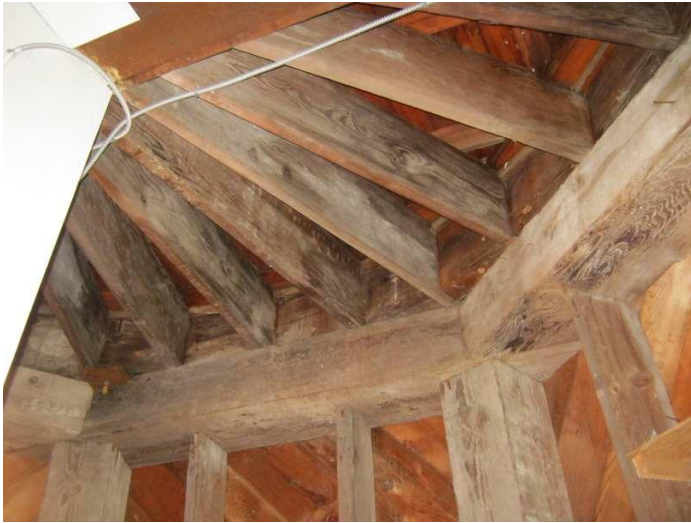
#49 - 4th Floor Framing

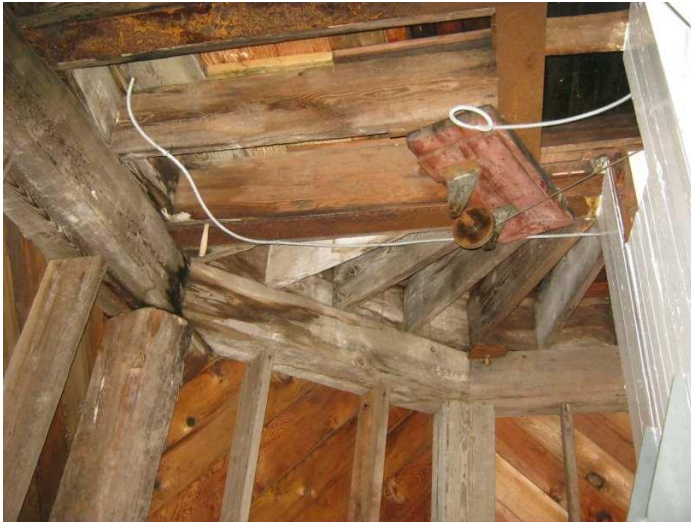
#51 - 4th Floor Framing

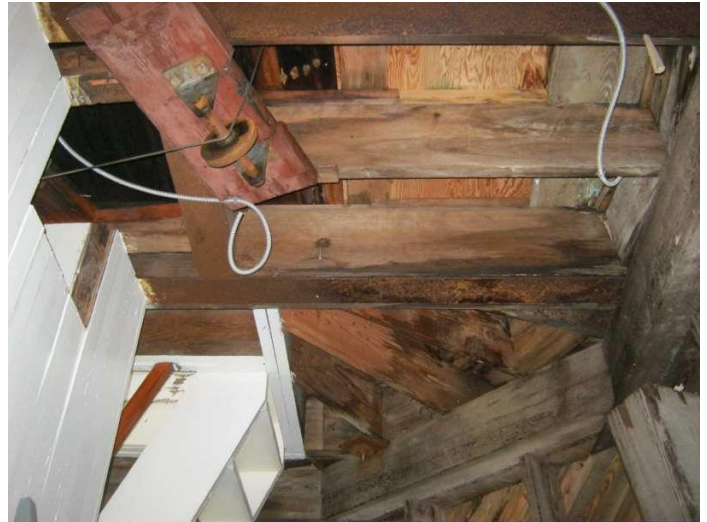
#52 - 4th Floor Framing

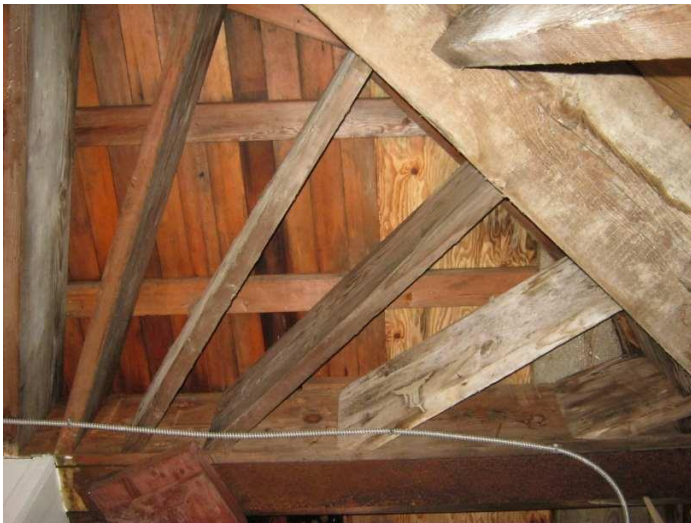
#53 - 4th Floor Framing

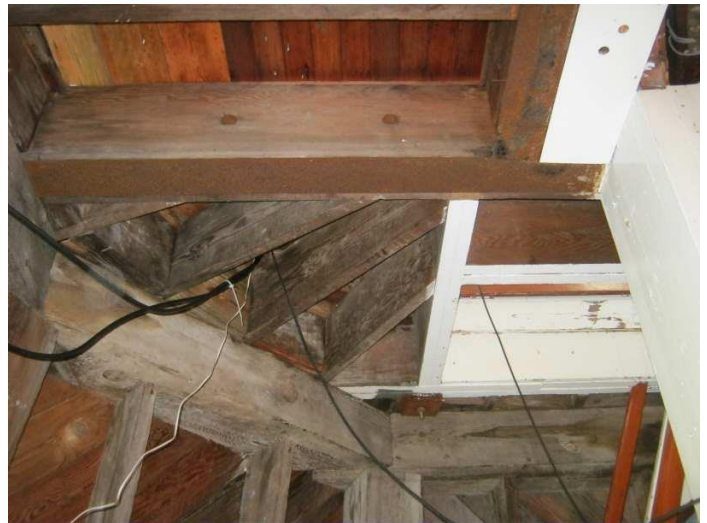
#54 - 4th Floor Framing

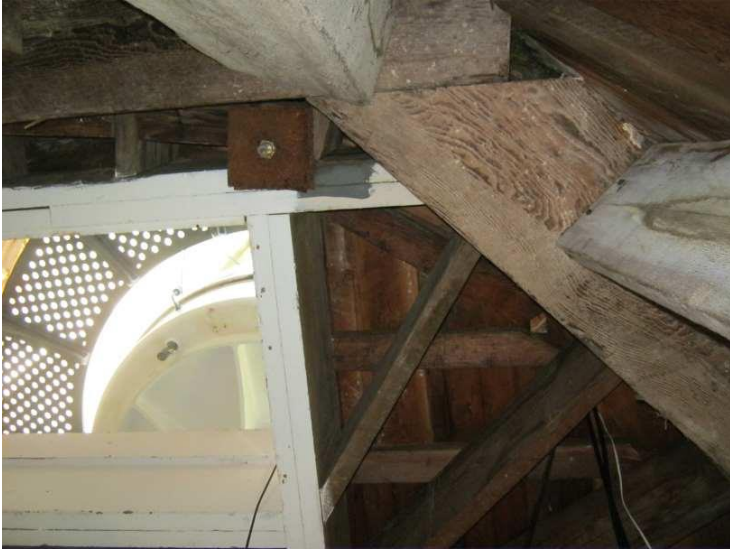
#55 - Lantern Room Anchor to 4th Floor

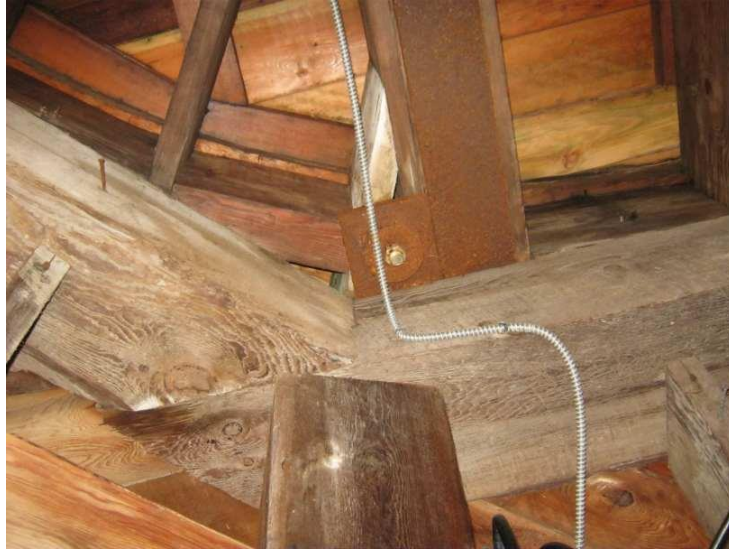
#56 - Lantern Room Anchor to 4th Floor

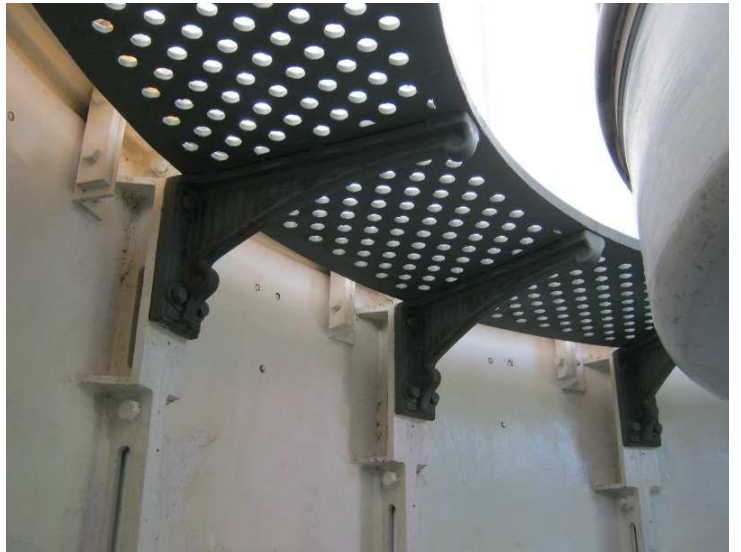
#58 - Lantern Room Interior Platform

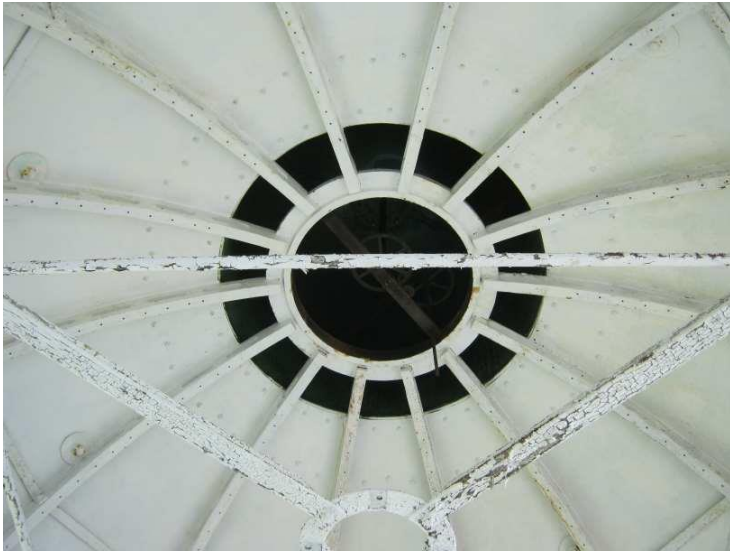
#59 - Lantern Room Roof Framing
