Department of Fisheries and Oceans, Pacific Region

RE-INSPECTION OF WATER SUPPLY TUNNELS & RELATED FACILITIES
FOR THE FULTON RIVER SPAWNING CHANNEL, BABINE LAKE, B.C.
DFO PURCHASE ORDER: F1700-070271

V13101063

January 2008

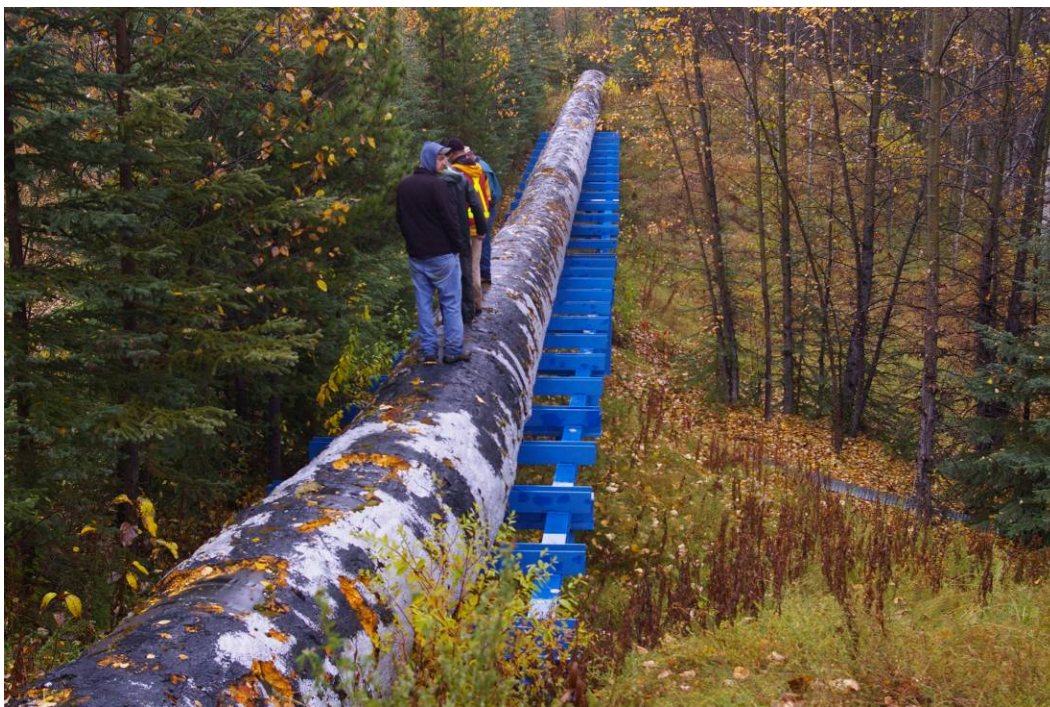
EBA only inspected the trestle supported section of the pipeline shown in Photo 22 during the recent inspection. As noted in previous inspections, the pipeline insulation coating has minor damage in a number of areas, but it is doubtful this has any measurable effect on water supply temperatures.

Photo 22 (October 9, 2007) Pipeline Trestle (looking downstream)
