**Asbestos-Containing Building Materials
Survey
Natural Resources Canada
Northern Forestry Building
Edmonton, Alberta**

Document No. 1318900400-REP-V0001-02

PWGSC Project No.: R.061377.001

JUNE 2013

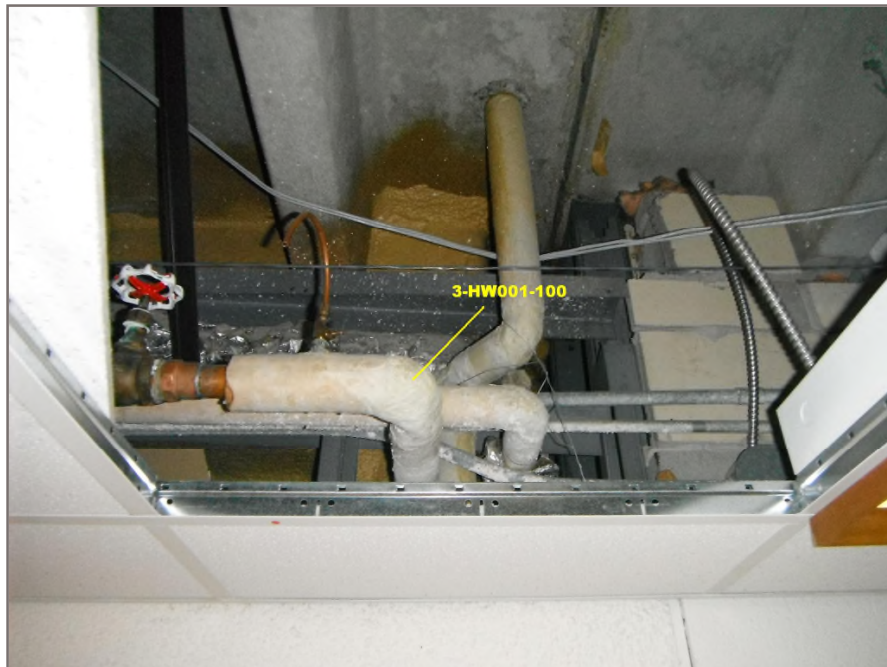
- Asbestos-containing friable mudded insulation (Tetra Tech sample 3-HW001-100) containing 10% chrysotile asbestos applied to the 2" diameter pipe elbow within the northeastern hallway as shown on Figure 4a totalling approximately 3 elbows. The ACM was in good condition at the time of assessment as shown in Photo 52 and should be managed in place. The ACM within the hallway is considered Access (C) concealed.

Photo 52: Asbestos-containing mudded insulation applied to the 2" diameter pipe elbow within the third floor northeastern hallway ceiling space. Tetra Tech sample 3-HW001-100.

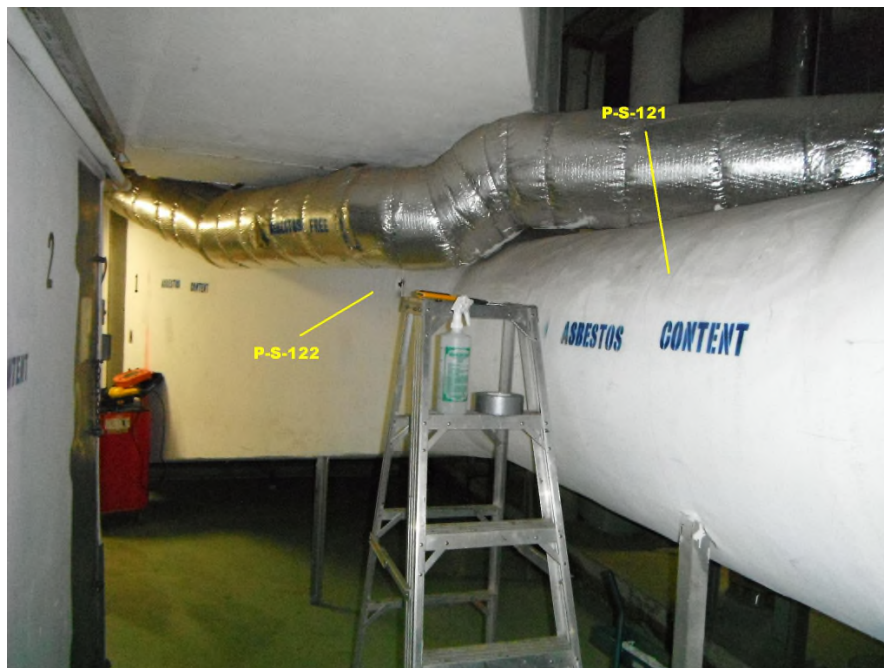
- Asbestos-containing friable mudded mechanical insulation (Tetra Tech sample P-S-122) containing 40% chrysotile asbestos applied to the AHU #1 cold deck within the penthouse as shown on Figures 5a and 5b totalling approximately 145 m². The ACM was in good condition at the time of assessment as shown in Photo 66 and should be managed in place. The ACM within the penthouse is considered Access (B).

Photo 66: Asbestos-containing mudded mechanical insulation applied to the AHU #1 cold deck within the penthouse. Tetra Tech sample P-S-122.

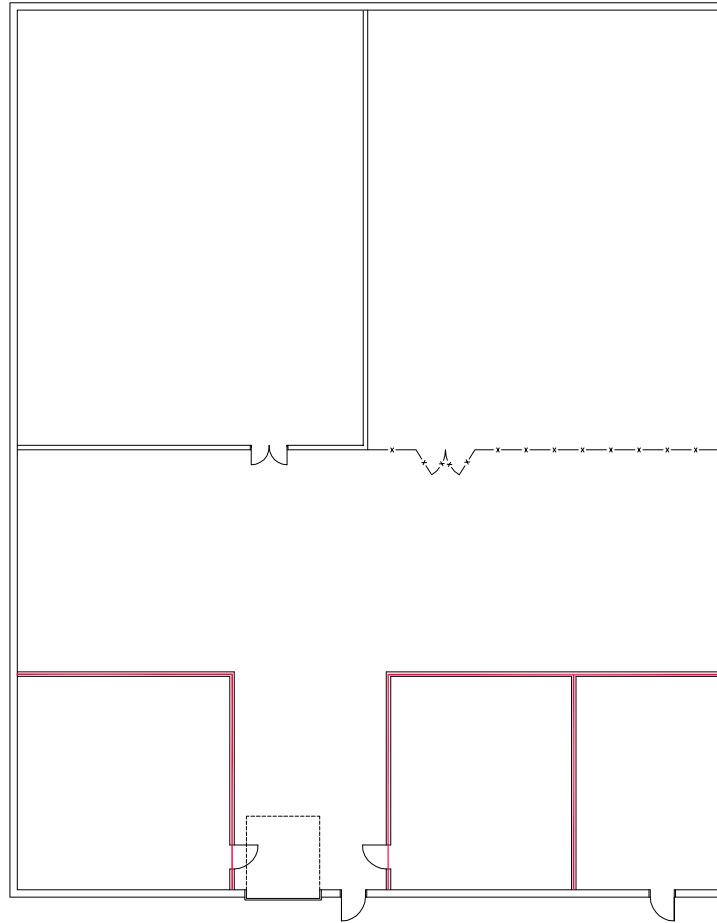
**FIGURE 6: ASBESTOS - CONTAINING MATERIALS LOCATIONS - HAZARDOUS MATERIALS SHED
NRCAN FORESTRY BLDG - EDMONTON, AB**

Within the main building vermiculite insulation known to be contaminated with asbestos fibres was not identified. Within the HAZMAT shed vermiculite insulation was used to insulate the interior walls of the storage rooms. Vermiculite insulation debris was identified on the floor within the corrosive/acid storage room as shown in Photo 65. Tetra Tech estimates there is approximately 1200 m² of cinder block walls that contain the asbestos contaminated vermiculite insulation within the HAZMAT shed.
