Tetsa Creek Bridge-Culvert No. 4

Alaska Highway km 595.3

Significant Inspection Concerns	<ol style="list-style-type: none"> Both barrels are in poor condition with significant distortion and significant cracking along plate seams. The south barrel has a maximum of 15.4% vertical distortion and 10 of 15 rings cracked with as little as 50 mm remaining steel plate between cracks. The north barrel has a maximum of 12.7% vertical distortion and 7 of 15 rings cracked with as little as 23 mm remaining steel plate between cracks (down from 35 mm in 2005 but unchanged from 2009) (see Photo P17). Both barrels have historically cantilevered (gun barreled) out of the highway embankment a few metres. The eroded gap below the outlet barrels has been backfilled periodically over the years and cycles between the backfilled and scoured state. The barrels are currently well backfilled with riprap at the outlet. Both barrels have drooped at the outlets with the bottom plates in the last few rings dropping as much as 400 mm. There are two large (200 mm) dents in roof the south barrel at rings 5 and 14. The bottom corrugations are flattened by rock flow in both barrels. These barrels (particularly th

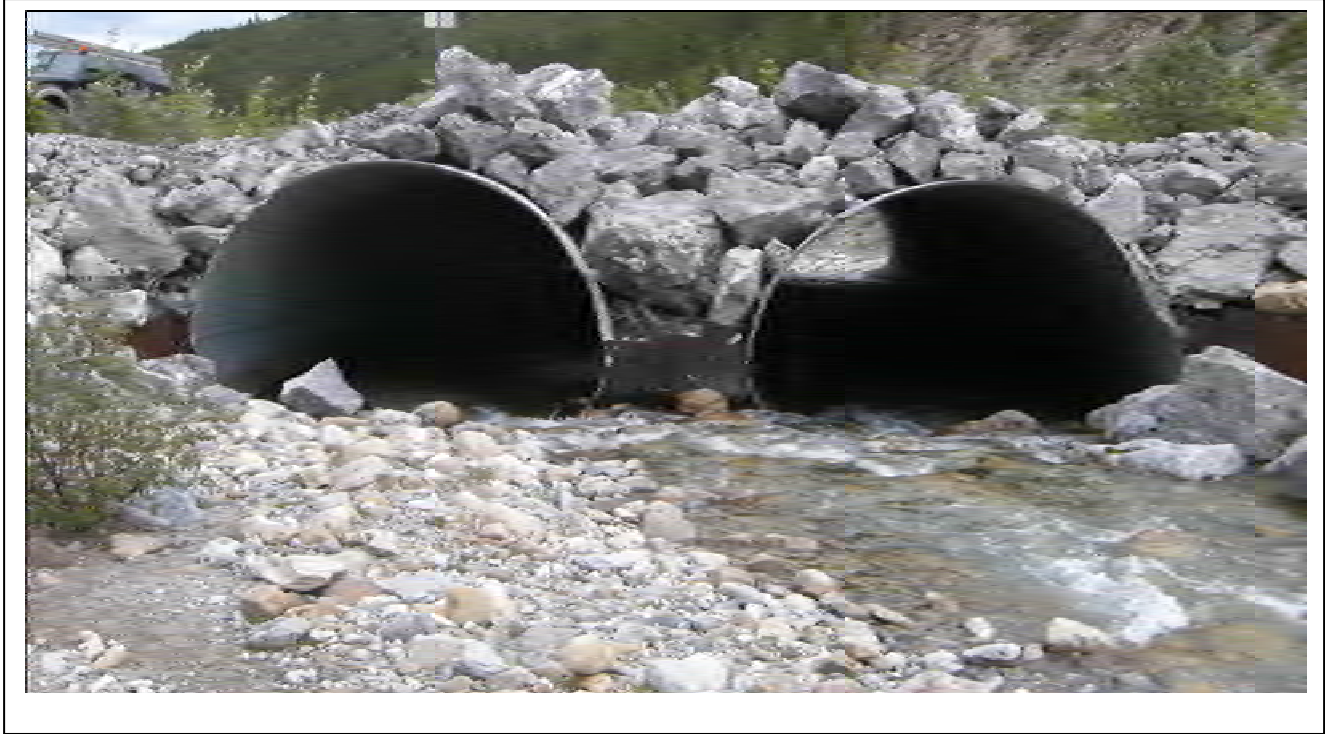
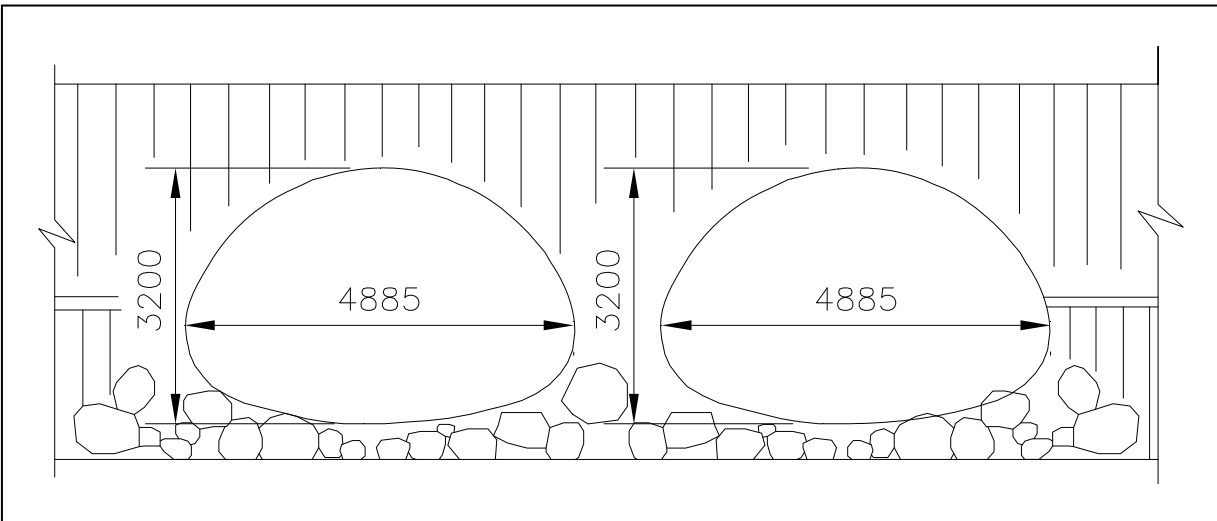
ELEVATION

1. Two pipe arch galvanized corrugated steel plate culverts
2. Galvanized, corrugated steel binwalls at inlets and outlets
