EXECUTIVE SUMMARY

Delcan Corporation (Delcan) has been retained by Public Works and Government Services Canada to conduct visual evaluations of 56 bridge structures and 6 culvert structures along the British Columbian portion of the Alaska Highway in both 2009 and 2011. Also, as part of this contract, Delcan was to complete live load capacity factor structural evaluations for 11 of the Alaska Highway bridge structures. In 2009, Delcan performed 6 of these live load capacity factor structural evaluations: Beaton River at km 232.8, Sikanni Chief River at km 256.1, Buckinghorse River at km 277.6, Bougie Creek at km 357.4, Adsett Creek at km 366.0, and Jackfish Creek at km 424.8. Enclosed in this submission are the live load capacity factor structural evaluations performed for the 5 other bridge structures: Kledo River at km 509.1, Steamboat Creek at km 515.3, Tetsa River 1 at km 584.6, Toad River at km 671.7, and Peterson Creek at km 678.6. Also enclosed are the 2009 condition inspection reports for these 5 bridges.

Kledo River Bridge, Alaska Highway, km 509.1 Live Load Capacity Factor Structural Evaluation

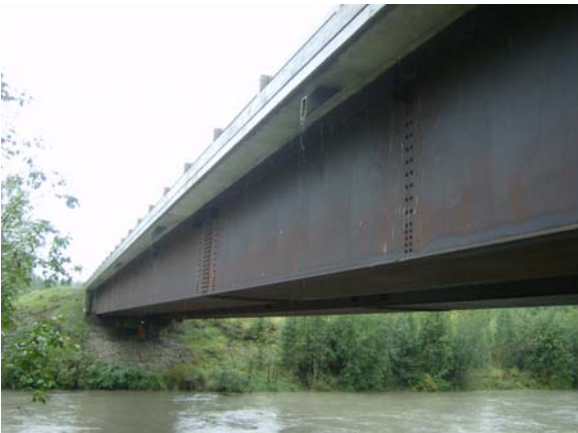
Figure 5: Exterior of Box Girder.

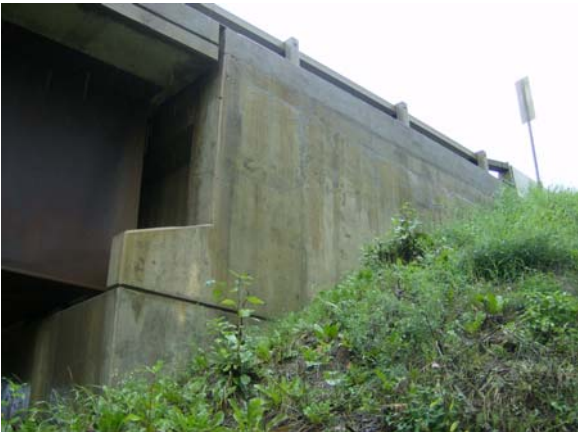
Figure 6: Abutment and Wingwall.

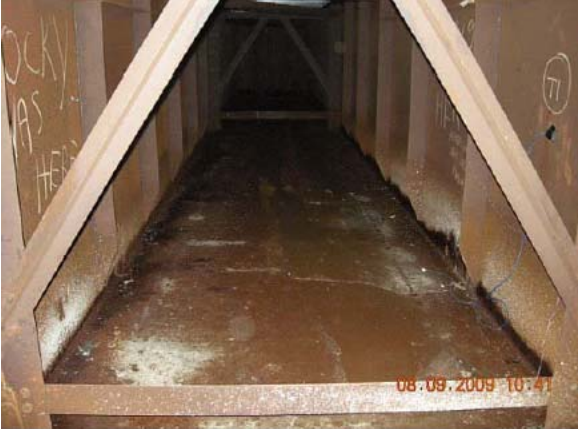
Figure 10: Typical Diaphragm Inside of Box Girder.

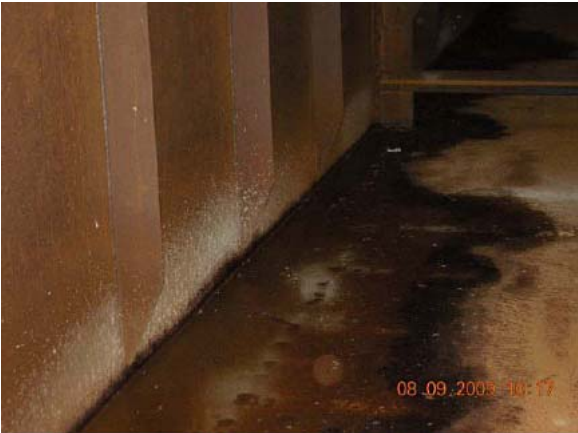
Figure 11: Water-Pooling Inside of Both Box Girders.

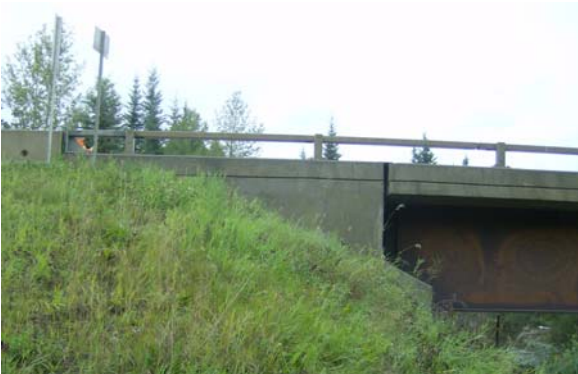
Figure 6: Abutment and Wingwall.

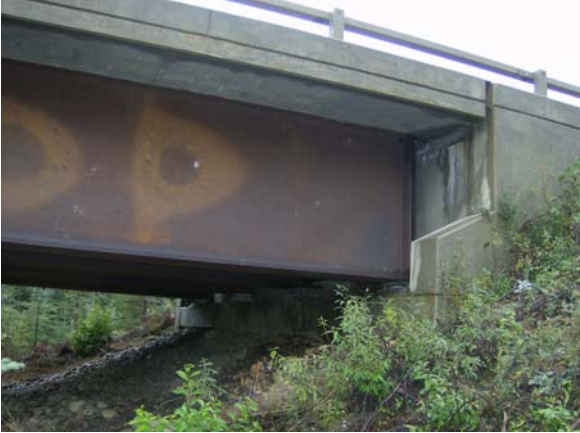
Figure 7: Exterior Girder Bearing.

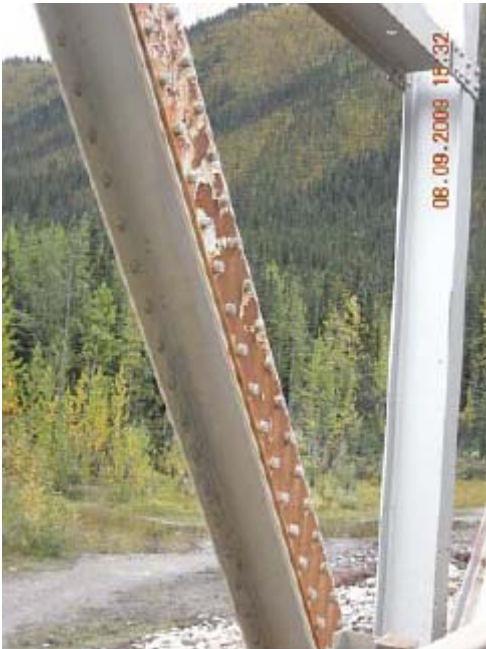
Figure 14: Previously Strengthened Diagonal Compression Truss Member.

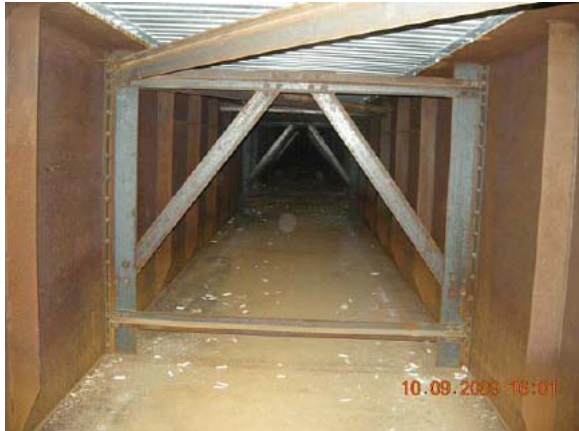
Figure 12: Typical Diaphragm Inside of Box Girder.

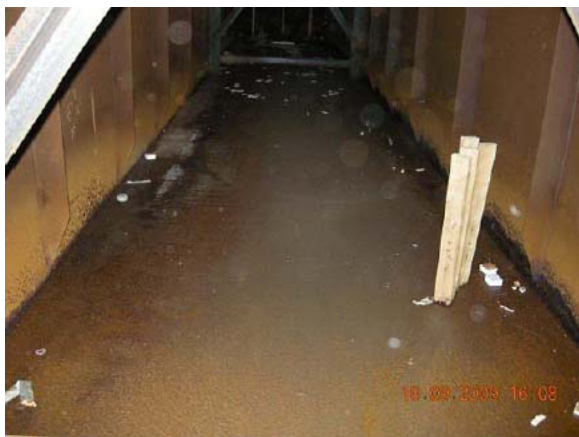
Figure 13: Water-Pooling Inside of West Box Girder.
