PWGSC
Atlantic Region
Renovations to AAFC Lab
Bldg 25, SJRDC, St. John's, NL
Project No. R.078141.001

**PUBLIC WORKS AND GOVERNMENT SERVICES CANADA
AGRICULTURE AND AGRI-FOODS CANADA BUILDING 25
ATLANTIC COOL CROP CLIMATE RESEARCH FACILITY
MOUNT PEARL, NEWFOUNDLAND AND LABRADOR**

ASBESTOS MANAGEMENT PLAN

FINAL REPORT

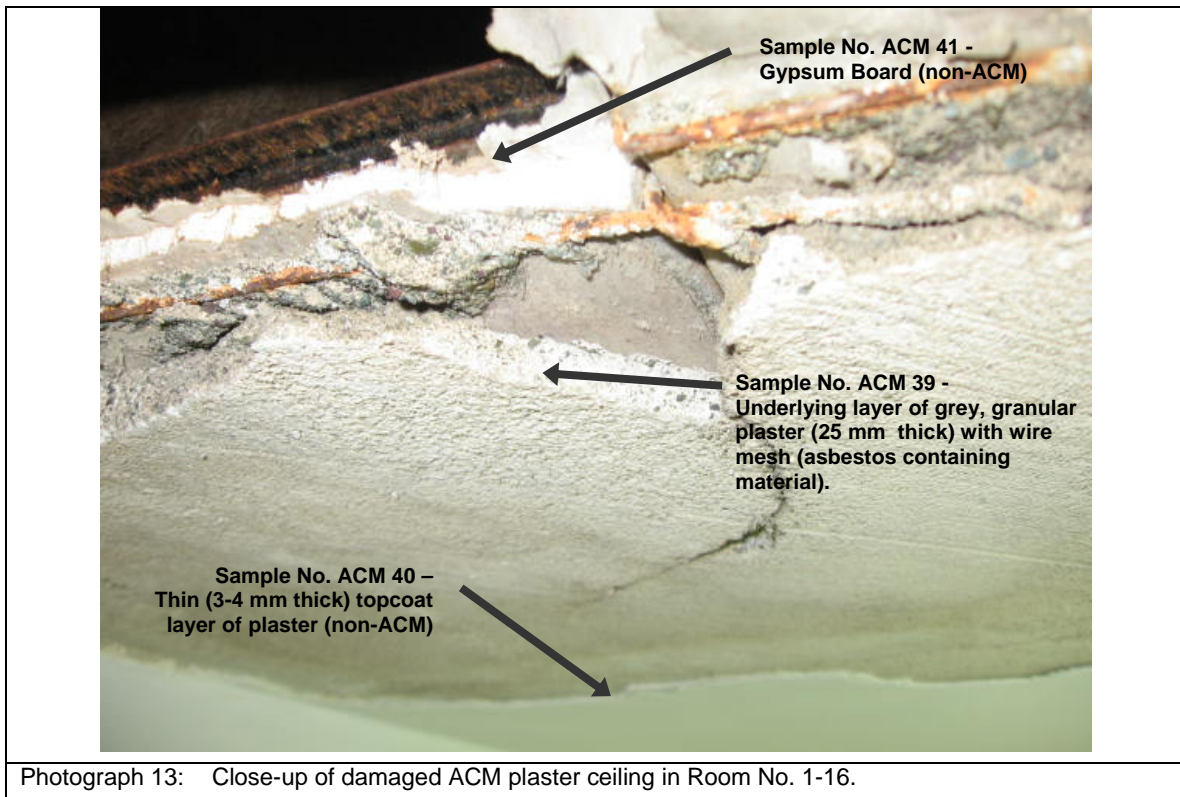
Plaster walls and ceilings were observed in the majority of the Building and were also reported by the Site Representative to be located behind recently installed gypsum board (within the past 10 years). Nine samples of wall and ceiling plaster were collected by AMEC throughout the Building. Four of nine samples of wall/ceiling plaster were found to contain 2 - 5 % chrysotile asbestos (see Photos 12, 13, 14 & 19).

Photograph 12: Damaged ACM plaster ceiling, Room No. 1-16.
