Metchosin BC
William Head Institution

Fire Alarm Replacement

Project No. R.071314.001
May 2016

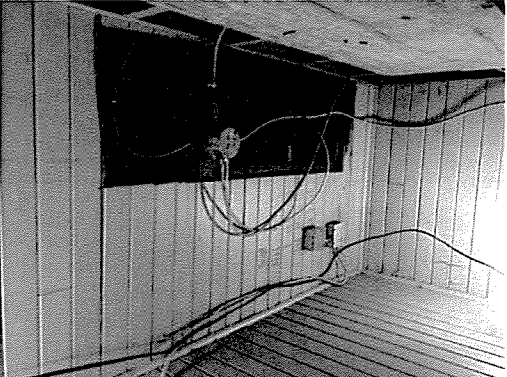
Identified LCP Description	Photo
<p>Green coloured paint on wood walls and floor within the attic space in room 106. This paint was observed to be in good condition (not bubbling, flaking, or peeling).</p>

Lead-containing paint observed in poor condition should be cleaned-up and/or addressed during the project, and to mitigate potential for additional deterioration and dispersal of lead-containing paint chips/dust. Consideration should be given to re-painting surfaces to mitigate the potential for additional deterioration and hazards associated with the lead-containing paint chips/dust that may be created. If re-painting is completed, appropriate precautions to protect workers and work areas from exposure to lead will be required during painting preparation activities.

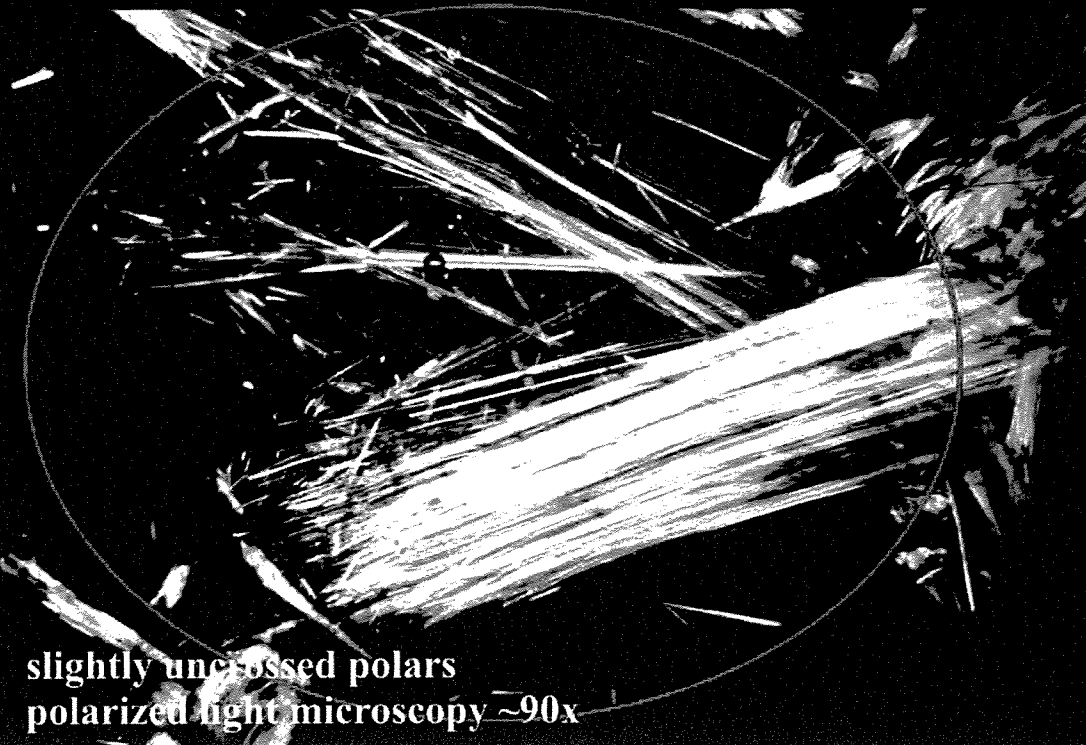
asbestos fibres
[asbestiform amphiboles]

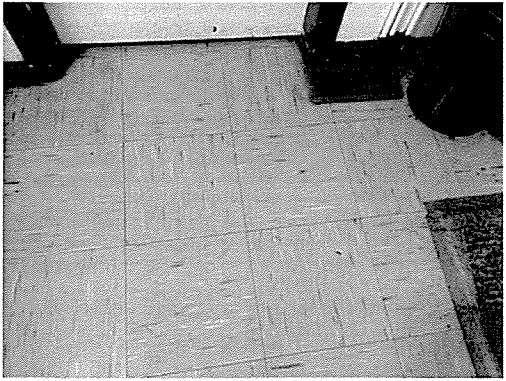
Identified ACM Description and Condition Information		Photo
12"x12" tan floor tile with white and brown streaks located within the entrance (107).

Friability	Non-friable	
Condition	Good	
Content	0.62% Chrysotile	
Black window pane caulking applied to windows throughout the subject area.

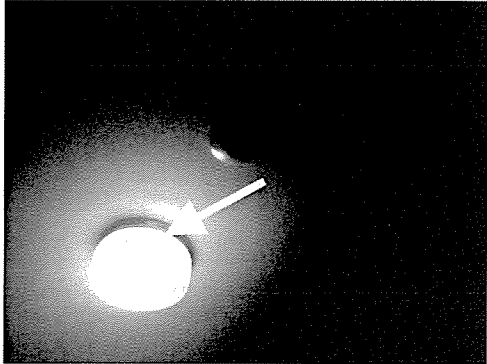
Identified ACM Description and Condition Information		Photo
Heat shield inside round incandescent light fixture within the Chapel entrance (107). The fixture is labelled asbestos containing.

Friability	Friable	
Condition	Good	
Content	50% Chrysotile	
Cement panel present behind heat registers on the ground floor.		<p style="text-align: center;">No Photo Available.</p>
Friability	Friable	
Condition	Good	
Content	90-100% Chrysotile This material was identified by previous sampling but is not present in ground floor areas included in this assessment. It may extend into the top of the crawlspace at perimeter walls.

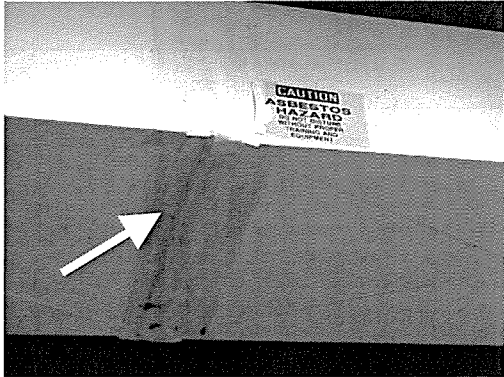
Identified ACM Description and Condition Information		Photo
Cream duct tape throughout. Duct tape is labelled asbestos containing in some locations.

Friability	Friable	
Condition	Good	
Content	65% Chrysotile	
Black window pane caulking throughout.

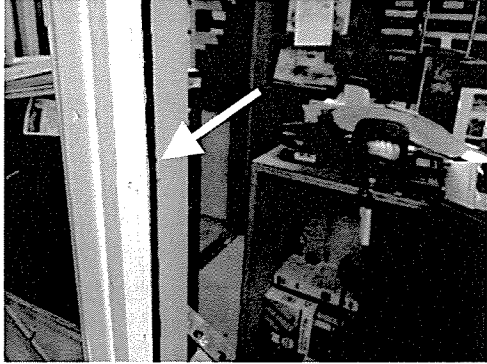
Friability	Non-friable	
Condition	Good	
Content	1.3% Chrysotile	
Grey/cream window frame caulking applied to the exterior.

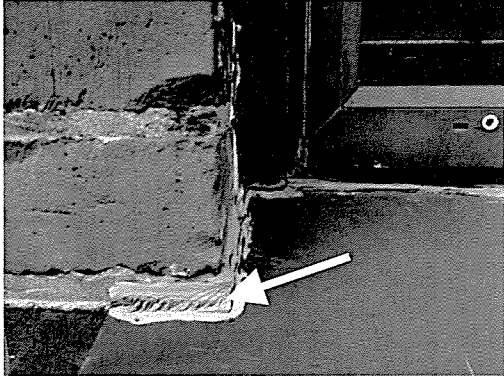
Friability	Non-friable	
Condition	Good	
Content	1.8% Chrysotile

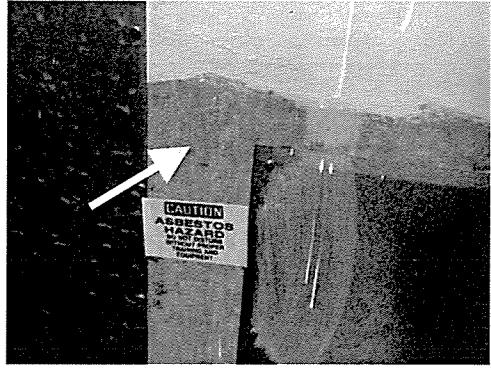
Identified ACM Description and Condition Information		Photo
Cement panel within room 116.

Friability	Non-friable	
Condition	Good	
Content	15% Chrysotile

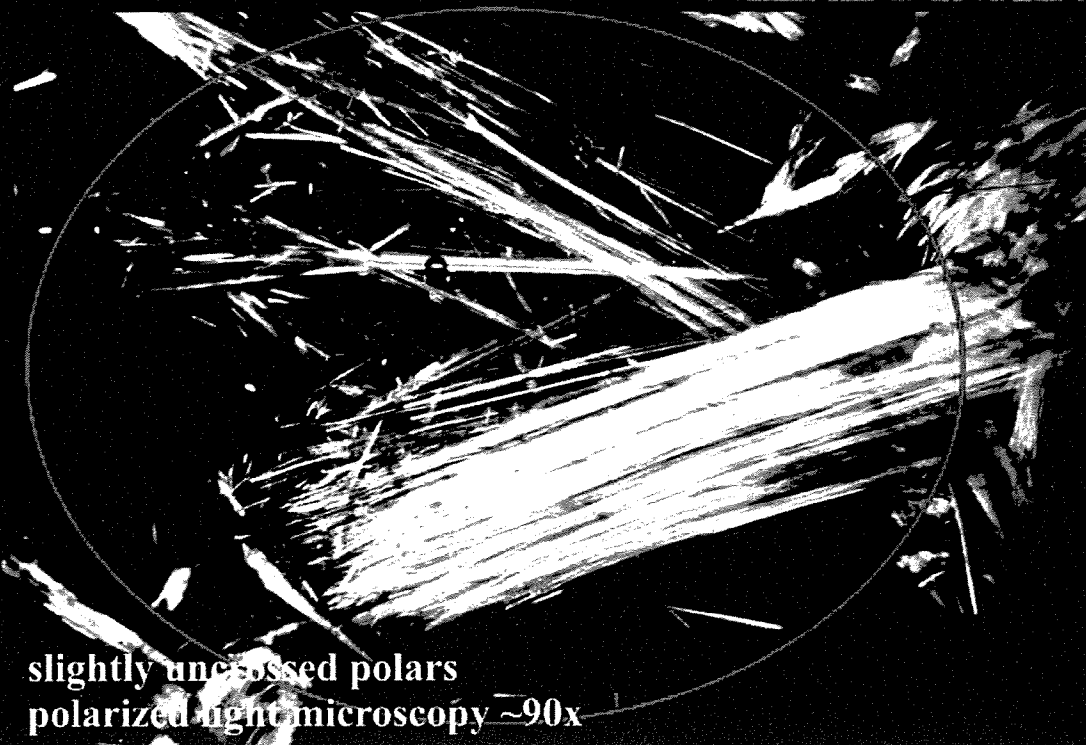
asbestos fibres
[asbestiform amphiboles]

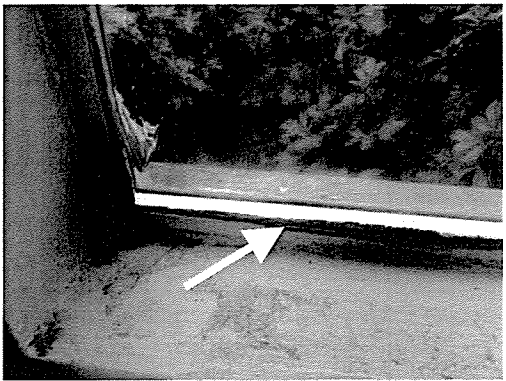
Identified ACM Description and Condition Information		Photo
Black window pane caulking (painted cream in some locations) throughout.

Friability	Non-friable	
Condition	Good	
Content	0.79% Chrysotile	
Cream interior door frame caulking throughout.

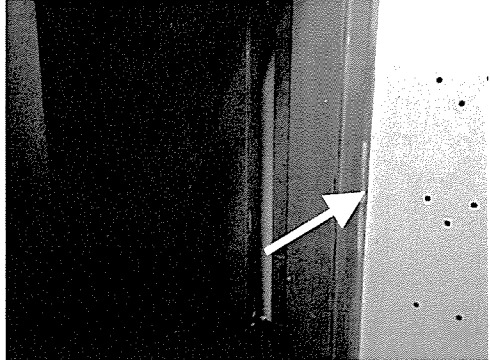
Friability	Non-friable	
Condition	Good	
Content	7.8% Chrysotile

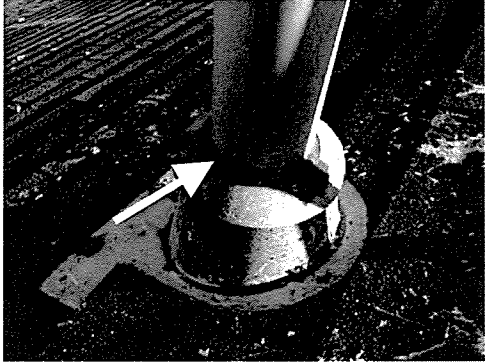
Identified ACM Description and Condition Information		Photo
Black vent sealant present on seams of two roof vents.

Friability	Non-friable	
Condition	Good	
Content	3.1% Chrysotile	
Texture coat applied to the plaster ceiling within rooms 014, 015, 016, 020, 103, 104, and 108.

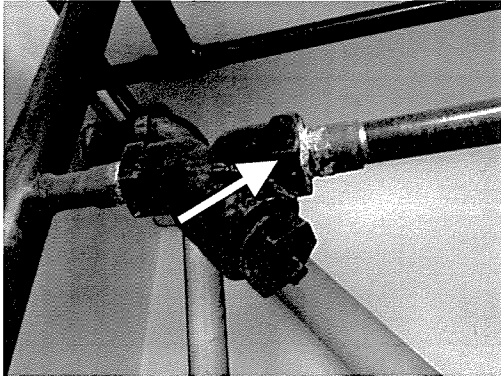
Identified ACM Description and Condition Information		Photo
Blue pipe sealant applied to the sprinkler lines within the main floor mechanical rooms of each living unit.

Friability	Non-friable	
Condition	Good	
Content	1.0% Chrysotile

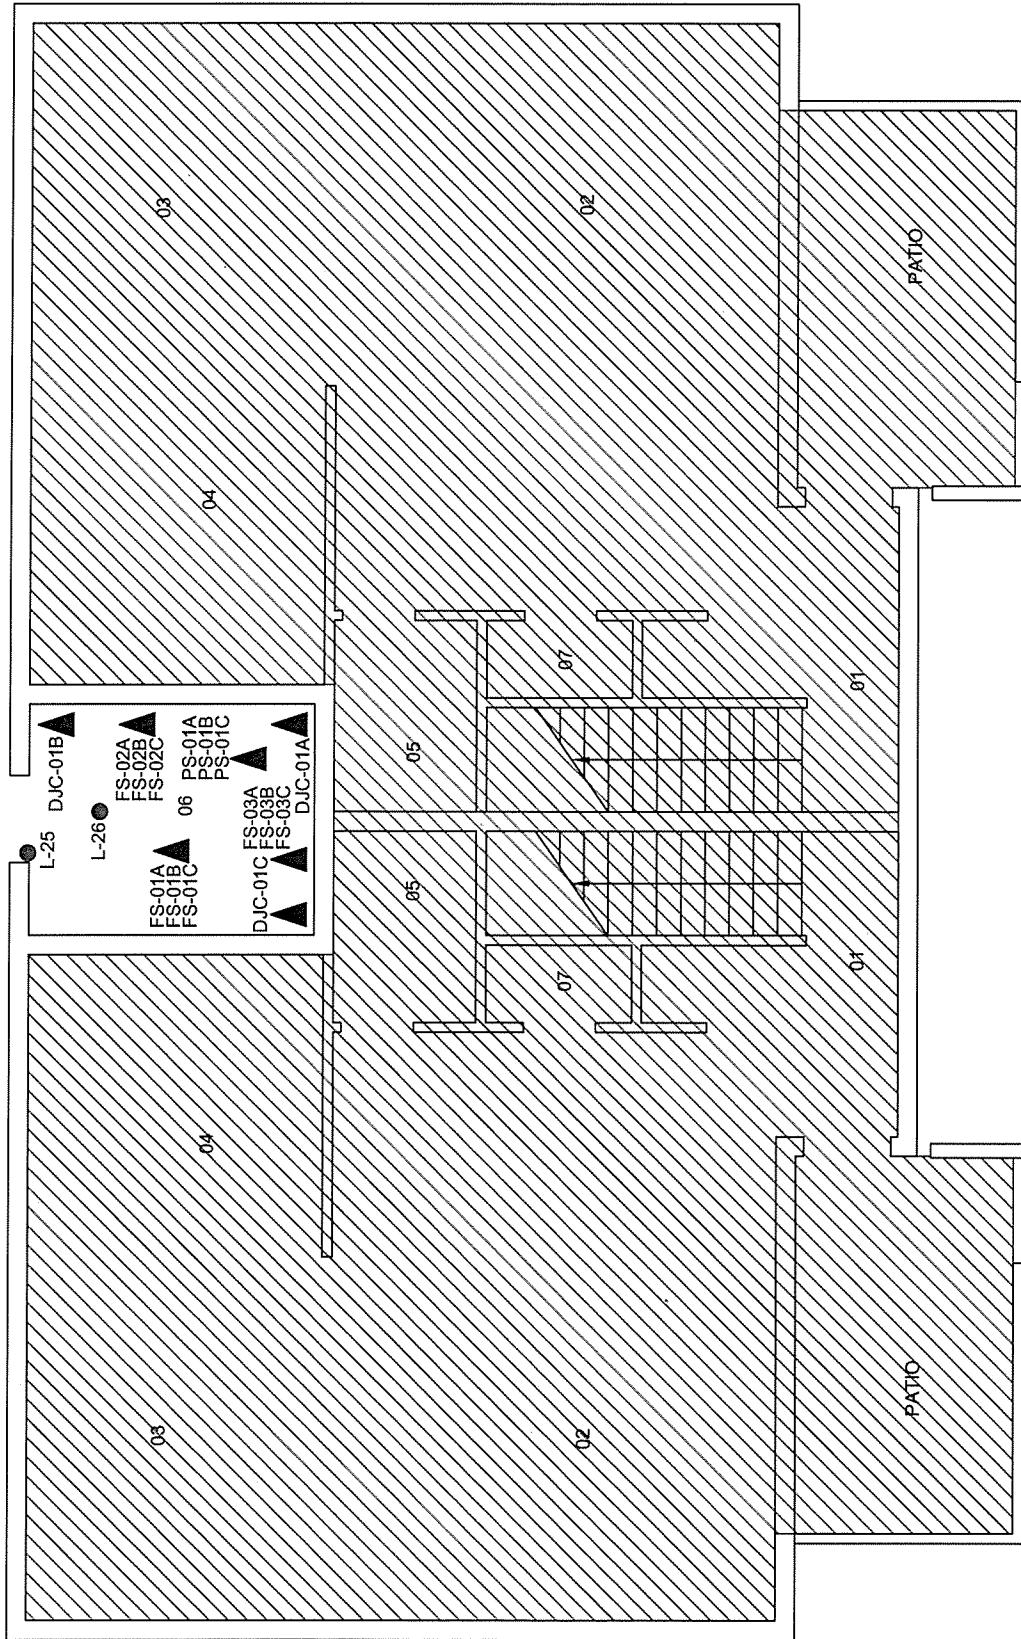
**MAIN FLOOR
LIVING UNIT A1**

NOTES: 1. BLUE PIPE SEALANT APPLIED TO SPRINKLER LINES IS ASBESTOS-CONTAINING.
 2. THIS DRAWING ILLUSTRATES SUPPORTING INFORMATION SPECIFIC TO A STANTEC CONSULTING LTD. REPORT AND MUST NOT BE USED FOR OTHER PURPOSES.

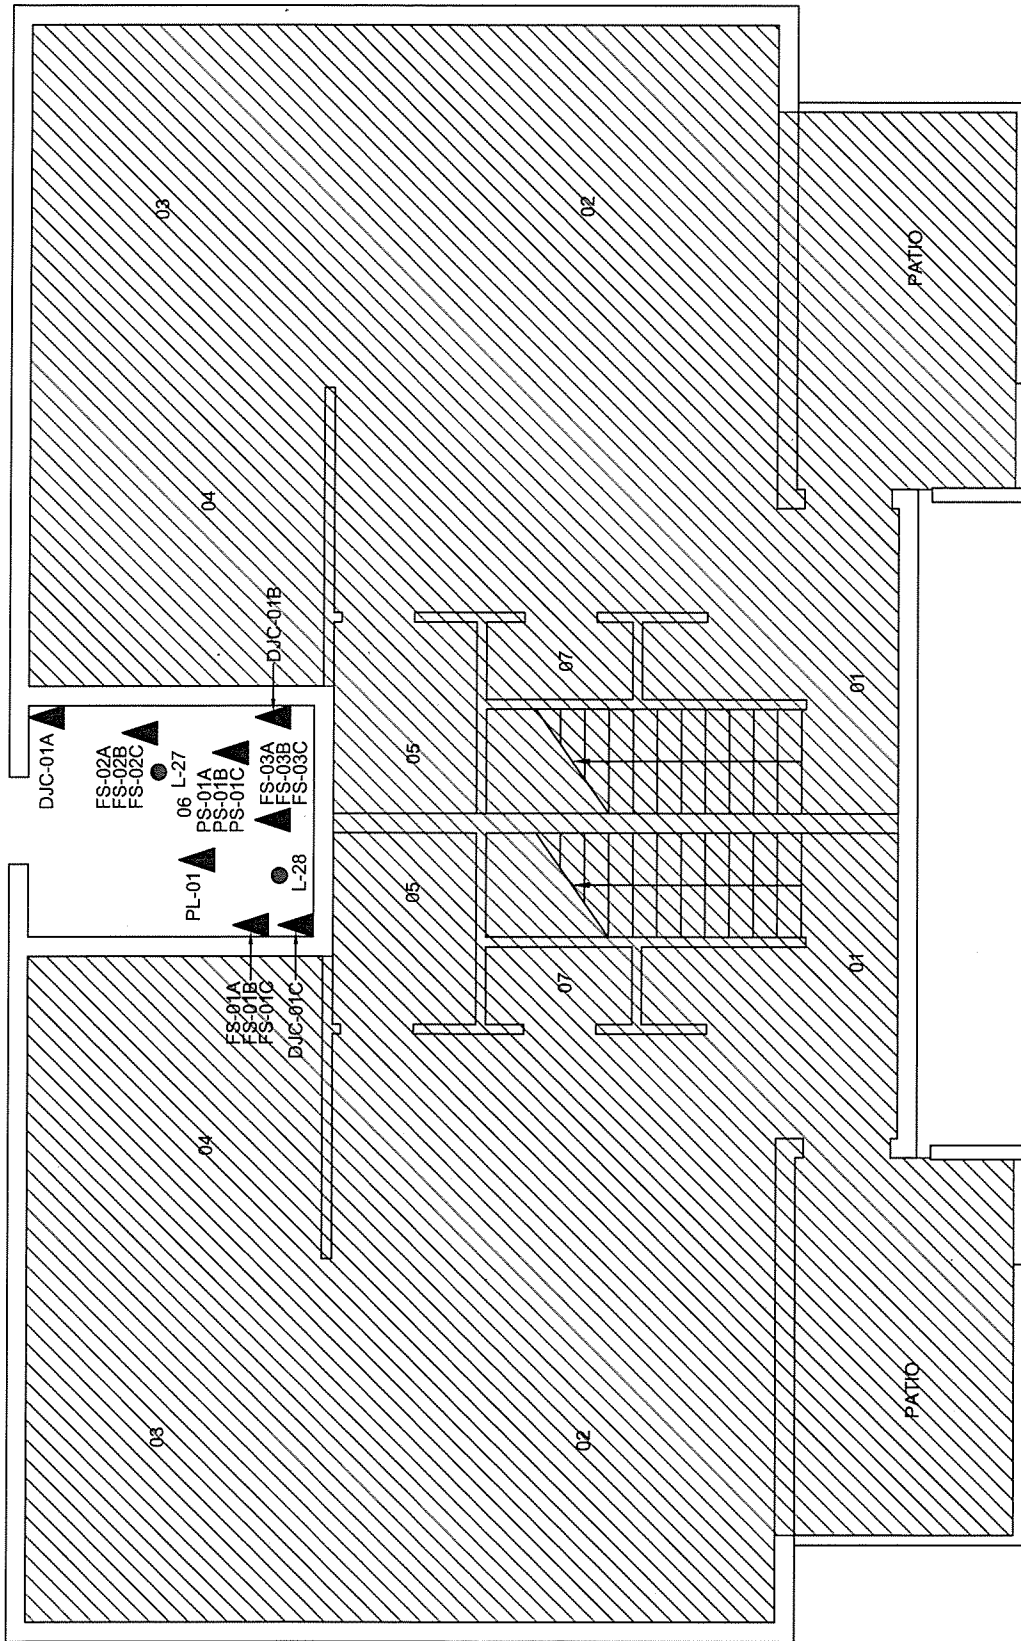
**MAIN FLOOR
LIVING UNIT A2**

NOTES: 1. BLUE PIPE SEALANT APPLIED TO SPRINKLER LINES IS ASBESTOS-CONTAINING.
 2. THIS DRAWING ILLUSTRATES SUPPORTING INFORMATION SPECIFIC TO A STANTEC CONSULTING LTD. REPORT AND MUST NOT BE USED FOR OTHER PURPOSES.

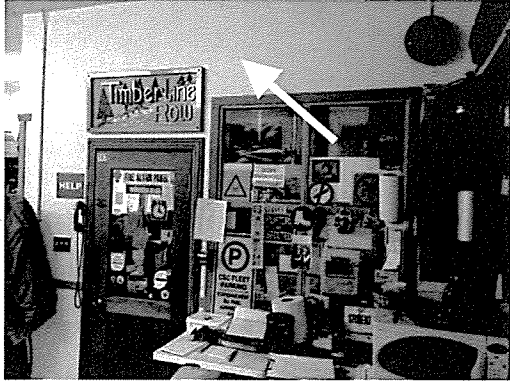
Identified LCP Description	Photo
<p>White coloured paint on interior brick and plaster walls.</p> <p>This paint was observed to be in good condition (not bubbling, flaking or peeling).</p>

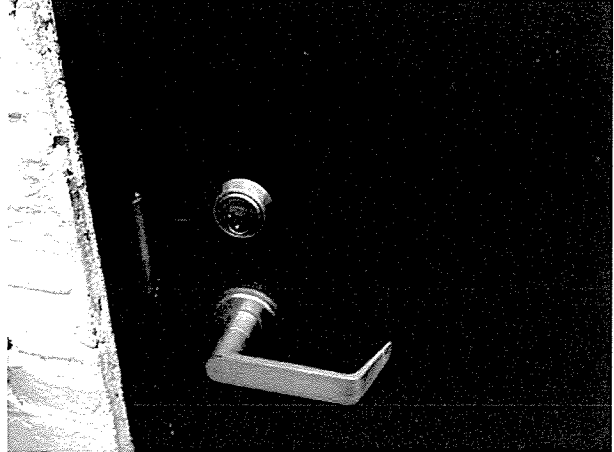
Identified LCP Description	Photo
<p>Brown coloured paint on the exterior doors and trim (potential LCP—additional sampling may indicate otherwise).</p> <p>This paint was observed to be in good condition (not bubbling, flaking, or peeling).</p>

If work will impact potential LCPs as outlined herein, additional sampling should be conducted to confirm lead content such that an appropriate risk assessment can be completed for the work that will be conducted.

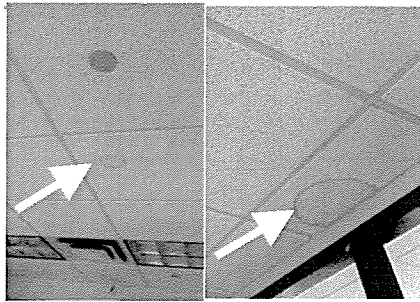
Building Area	Observation	Suspected Source of Moisture	Photo
Principal Entrance Room 102	Moisture-stained ceiling tiles in two locations	Pipe leaks

- Remove and replace moisture-stained ceiling tiles with new tiles. If staining re-appears on the new tiles, the source of moisture should be identified and corrected. This work can be conducted by regular facility maintenance staff, if conducted prior to the onset of mould growth.

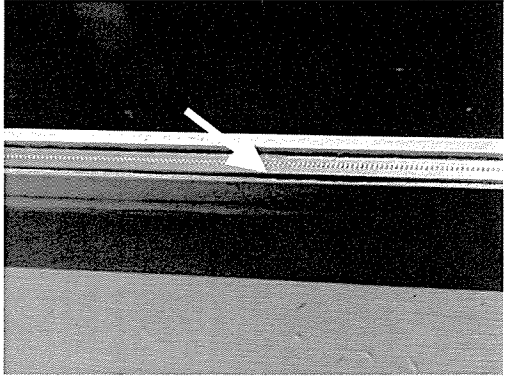
Identified ACM Description and Condition Information		Photo
Black window pane caulking throughout the building.

Friability	Non-friable	
Condition	Good	
Content	2.5% Chrysotile	
Black exterior door caulking.

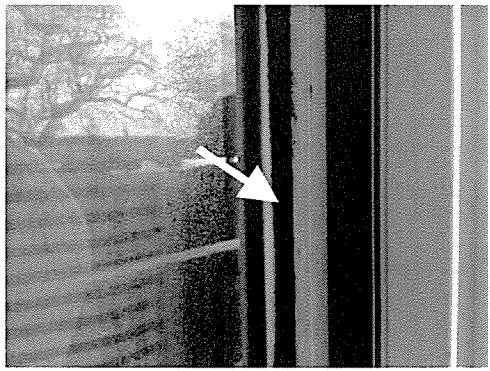
Friability	Non-friable	
Condition	Good	
Content	4.0% Chrysotile

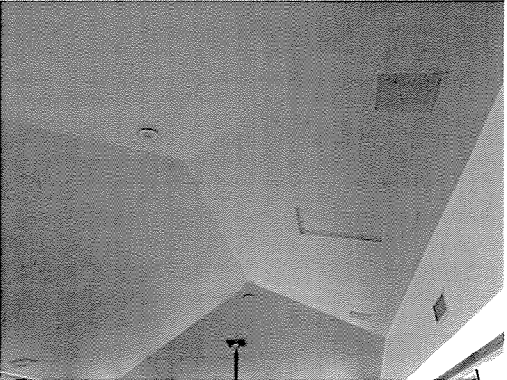
Identified LCP Description	Photo
<p>Off-white colored paint on drywall walls and ceiling (potential LCP—additional sampling may indicate otherwise).</p> <p>This paint was observed to be in good condition (not bubbling, flaking, or peeling).</p>

If work will impact potential LCPs as outlined herein, additional sampling should be conducted to confirm lead content such that an appropriate risk assessment can be completed for the work that will be conducted.
