**HAZARDOUS MATERIALS
REMOVAL SPECIFICATIONS
BEAVERLODGE RESEARCH CENTRE
PROJECT NO.: R.078150.002
BEAVERLODGE, ALBERTA**

Public Works and Government Services Canada

26 JULY 2016

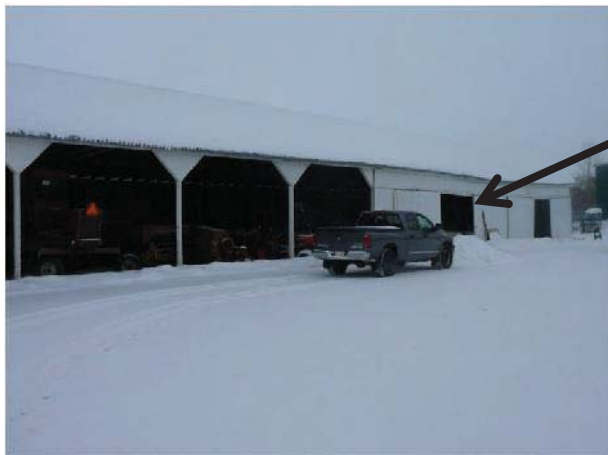
#10 Machine Pole Barn

Sample P31: White paint containing lead on one side of the barn

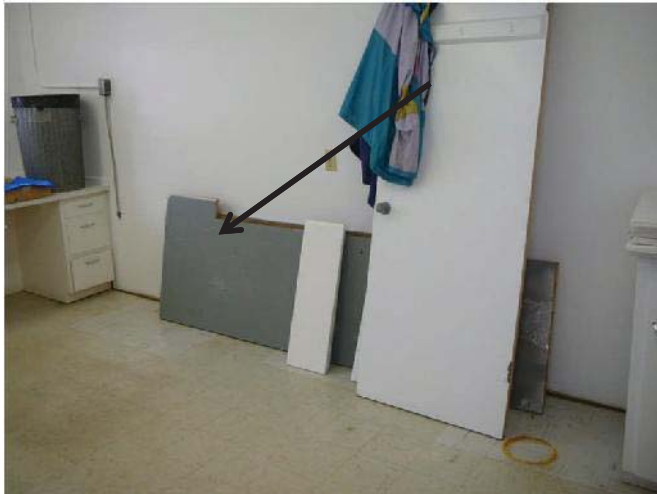
#14: Soils Research Building

Sample A167: Dark gray 9x9 floor tile on second floor power panel room floor

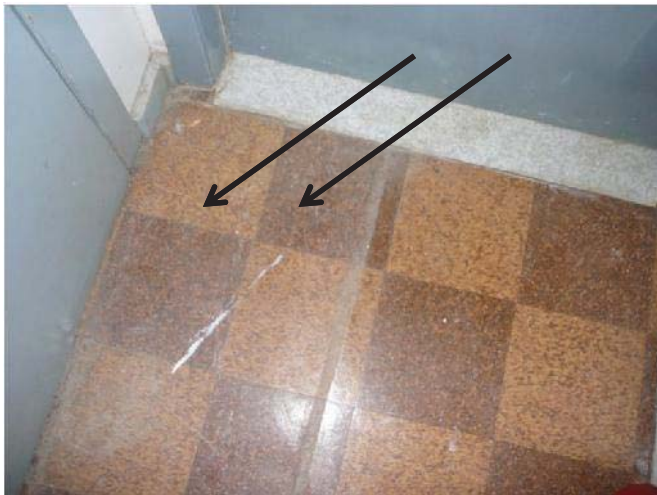
#14: Soils Research Building

Sample A153 & A154: Light brown & dark brown 9x9 floor tile under the stairwell

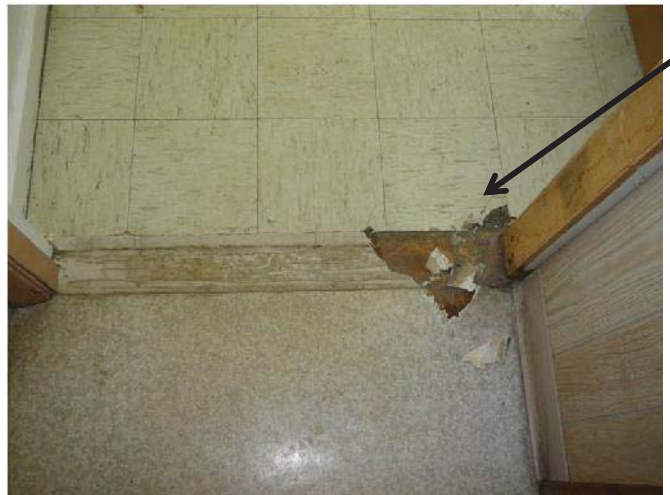
#14: Soils Research Building

Sample A155 & A156: Light brown & dark brown 9x9 floor tile on the main level northwest lab floor

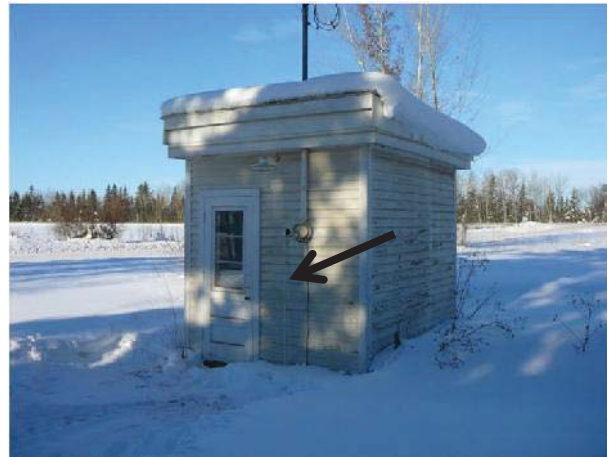
#57 Sewage Lift Pump House

Sample P15: White paint containing lead

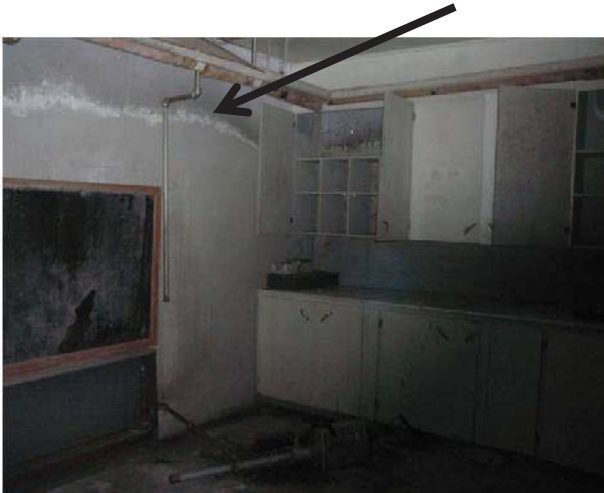
#2 Administration Office - Basement
Suspected high water mark from flooding

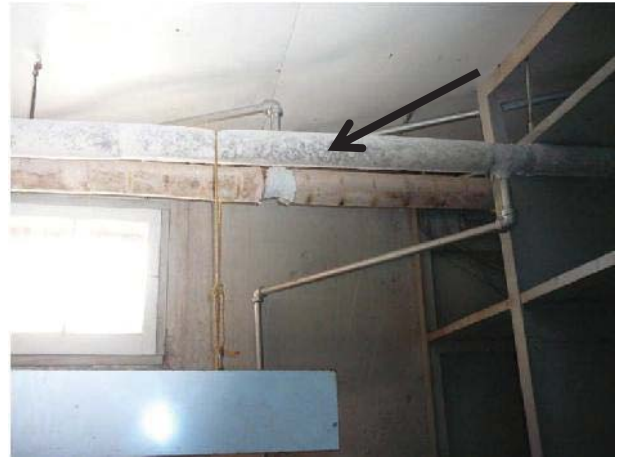
#2 Administration Office - Basement
Suspected mould growth on asbestos pipe insulation
