OPTIONS ANALYSIS REV 02 JERICHO DIAMOND MINE, NUNAVUT

Aboriginal Affairs and Northern Development Canada

APRIL 2015
ISSUED FOR USE
FILE: E14103202-01

EXECUTIVE SUMMARY

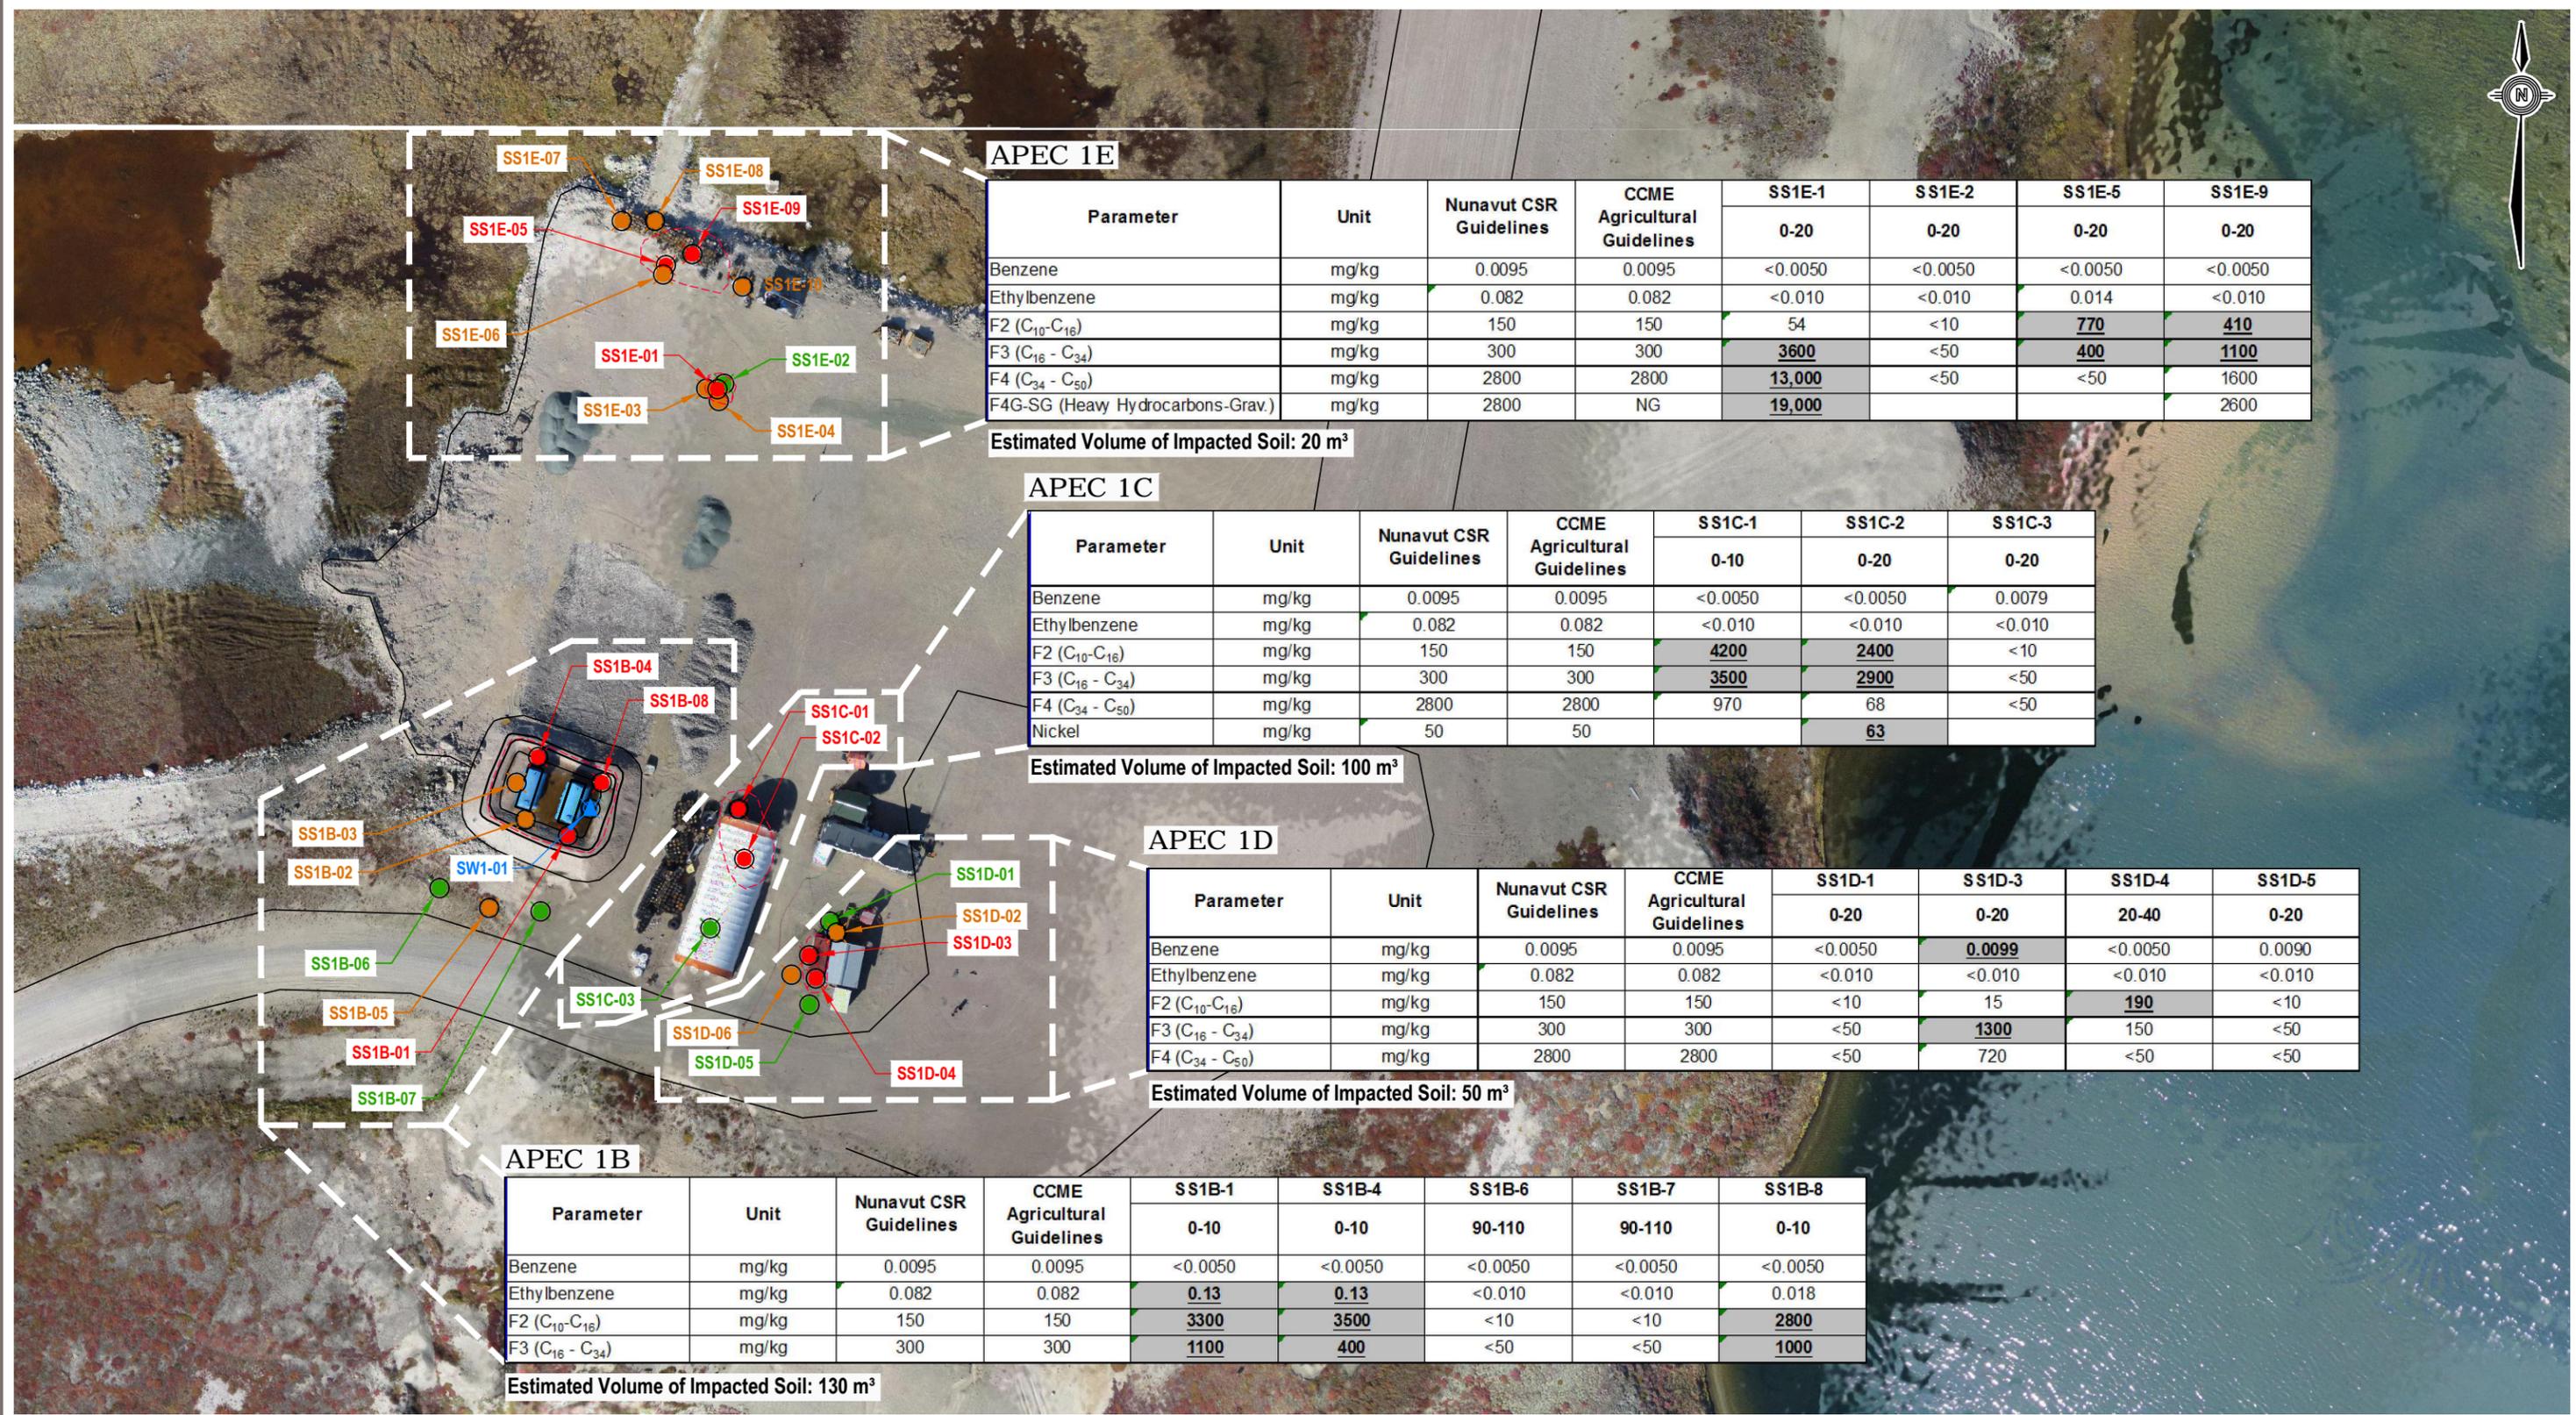
PROJECT NO. E14103202	DWN GDK/DBD	CKD WTH	REV 0
OFFICE EDM	DATE December 2014	Figure B.4

APEC 1E

Parameter	Unit	Nunavut CSR Guidelines	CCME Agricultural Guidelines	SS1E-1	SS1E-2	SS1E-5	SS1E-9
				0-20	0-20	0-20	0-20
Benzene	mg/kg	0.0095	0.0095	<0.0050	<0.0050	<0.0050	<0.0050
Ethylbenzene	mg/kg	0.082	0.082	<0.010	<0.010	0.014	<0.010
F2 (C ₁₀ -C ₁₆)	mg/kg	150	150	54	<10	770	410
F3 (C ₁₆ - C ₃₄)	mg/kg	300	300	3600	<50	400	1100
F4 (C ₃₄ - C ₅₀)	mg/kg	2800	2800	13,000	<50	<50	1600
F4G-SG (Heavy Hydrocarbons-Grav.)	mg/kg	2800	NG	19,000			2600

Estimated Volume of Impacted Soil: 130 m³

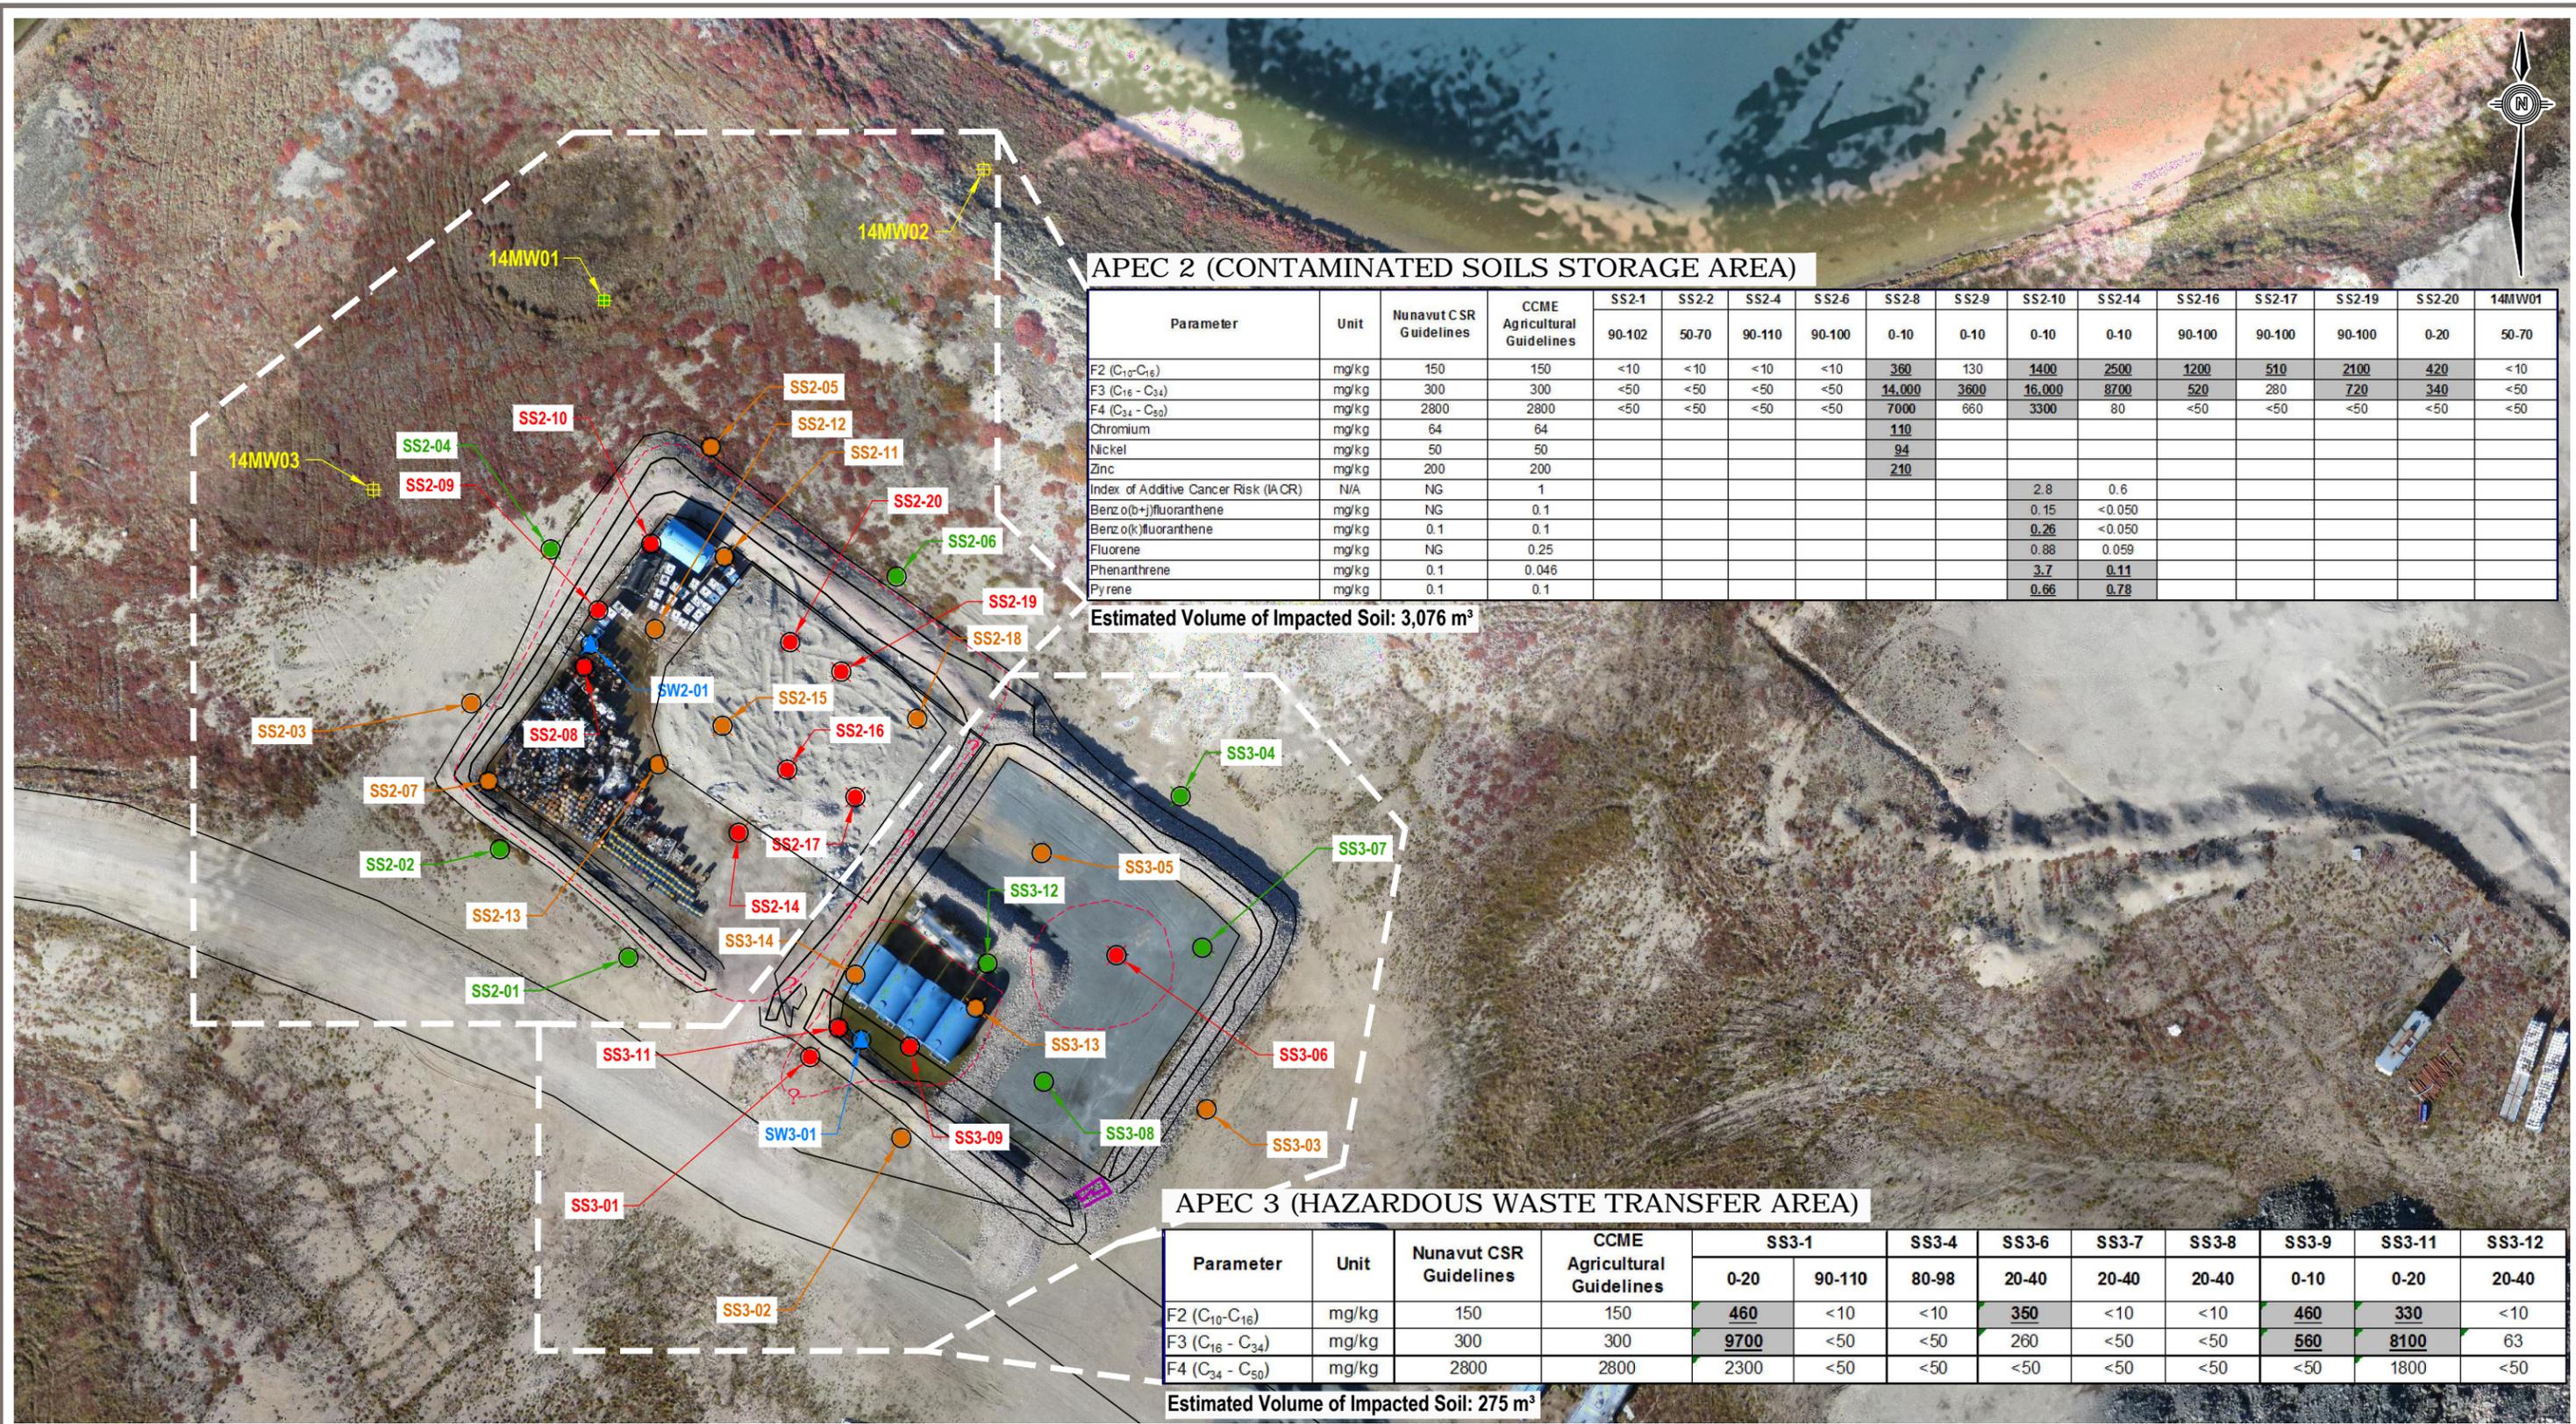
PROJECT NO. E14103202	DWN GDK/DBD	CKD WTH	REV 0	Figure B.5
OFFICE EDM	DATE December 2014

APEC 2 (CONTAMINATED SOILS STORAGE AREA)

Parameter	Unit	Nunavut CSR Guidelines	CCME Agricultural Guidelines	SS2-1	SS2-2	SS2-4	SS2-6	SS2-8	SS2-9	SS2-10	SS2-14	SS2-16	SS2-17	SS2-19	SS2-20	14MW01
				90-102	50-70	90-110	90-100	0-10	0-10	0-10	0-10	90-100	90-100	90-100	0-20	50-70
F2 (C ₁₀ -C ₁₆)	mg/kg	150	150	<10	<10	<10	<10	360	130	1400	2500	1200	510	2100	420	<10
F3 (C ₁₆ - C ₃₄)	mg/kg	300	300	<50	<50	<50	<50	14,000	3600	16,000	8700	520	280	720	340	<50
F4 (C ₃₄ - C ₅₀)	mg/kg	2800	2800	<50	<50	<50	<50	7000	660	3300	80	<50	<50	<50	<50	<50
Chromium	mg/kg	64	64					110								
Nickel	mg/kg	50	50					94								
Zinc	mg/kg	200	200					210								
Index of Additive Cancer Risk (IACR)	N/A	NG	1							2.8	0.6					
Benz o(b+j)fluoranthene	mg/kg	NG	0.1							0.15	<0.050					
Benz o(k)fluoranthene	mg/kg	0.1	0.1							0.26	<0.050					
Fluorene	mg/kg	NG	0.25							0.88	0.059					
Phenanthrene	mg/kg	0.1	0.046							3.7	0.11					
Pyrene	mg/kg	0.1	0.1							0.66	0.78

APEC 3 (HAZARDOUS WASTE TRANSFER AREA)

APEC 2 AND 3 - CONTAMINATED SOILS STORAGE AREA AND HAZARDOUS WASTE TRANSFER AREA
SOIL SAMPLE LOCATIONS

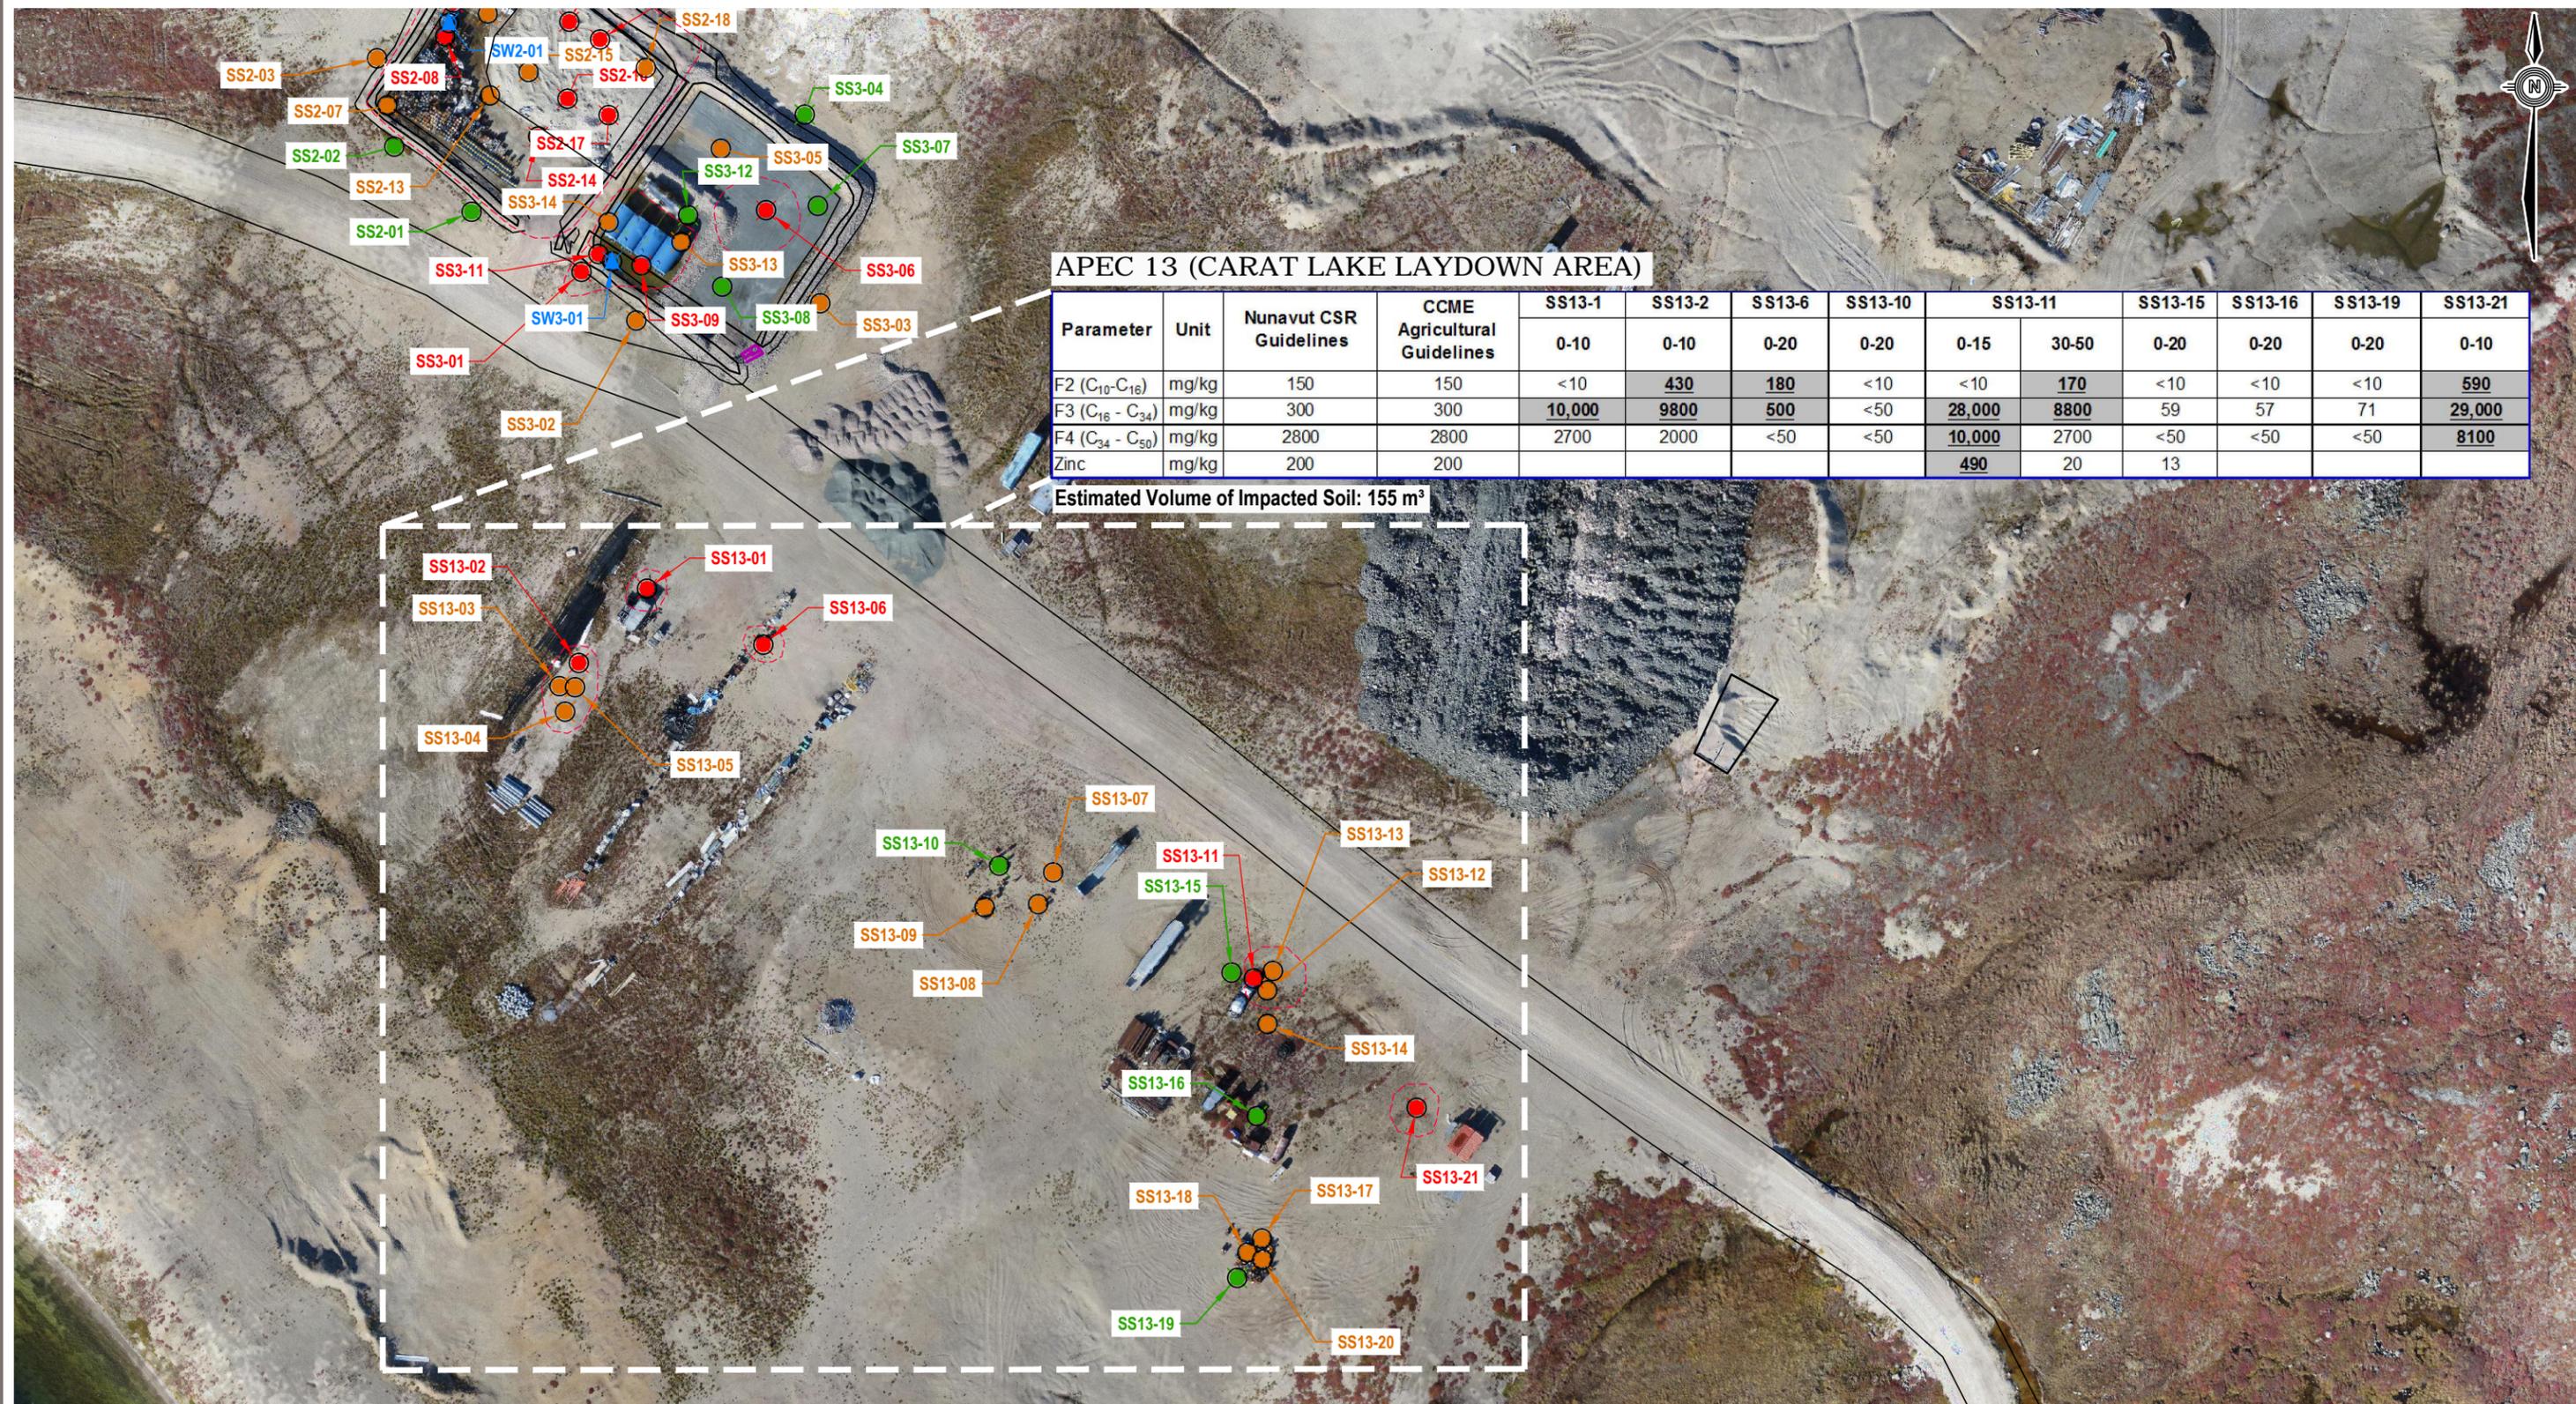
PROJECT NO. E14103202	DWN GDK/DBD	CKD WTH	REV 0	Figure B.6
OFFICE EDM	DATE December 2014

APEC 13 (CARAT LAKE LAYDOWN AREA)

Parameter	Unit	Nunavut CSR Guidelines	CCME Agricultural Guidelines	SS13-1	SS13-2	SS13-6	SS13-10	SS13-11		SS13-15	SS13-16	SS13-19	SS13-21
				0-10	0-10	0-20	0-20	0-15	30-50	0-20	0-20	0-20	0-10
F2 (C ₁₀ -C ₁₆)	mg/kg	150	150	<10	430	180	<10	<10	170	<10	<10	<10	590
F3 (C ₁₆ - C ₃₄)	mg/kg	300	300	10,000	9800	500	<50	28,000	8800	59	57	71	29,000
F4 (C ₃₄ - C ₅₀)	mg/kg	2800	2800	2700	2000	<50	<50	10,000	2700	<50	<50	<50	8100
Zinc	mg/kg	200	200					490	20	13

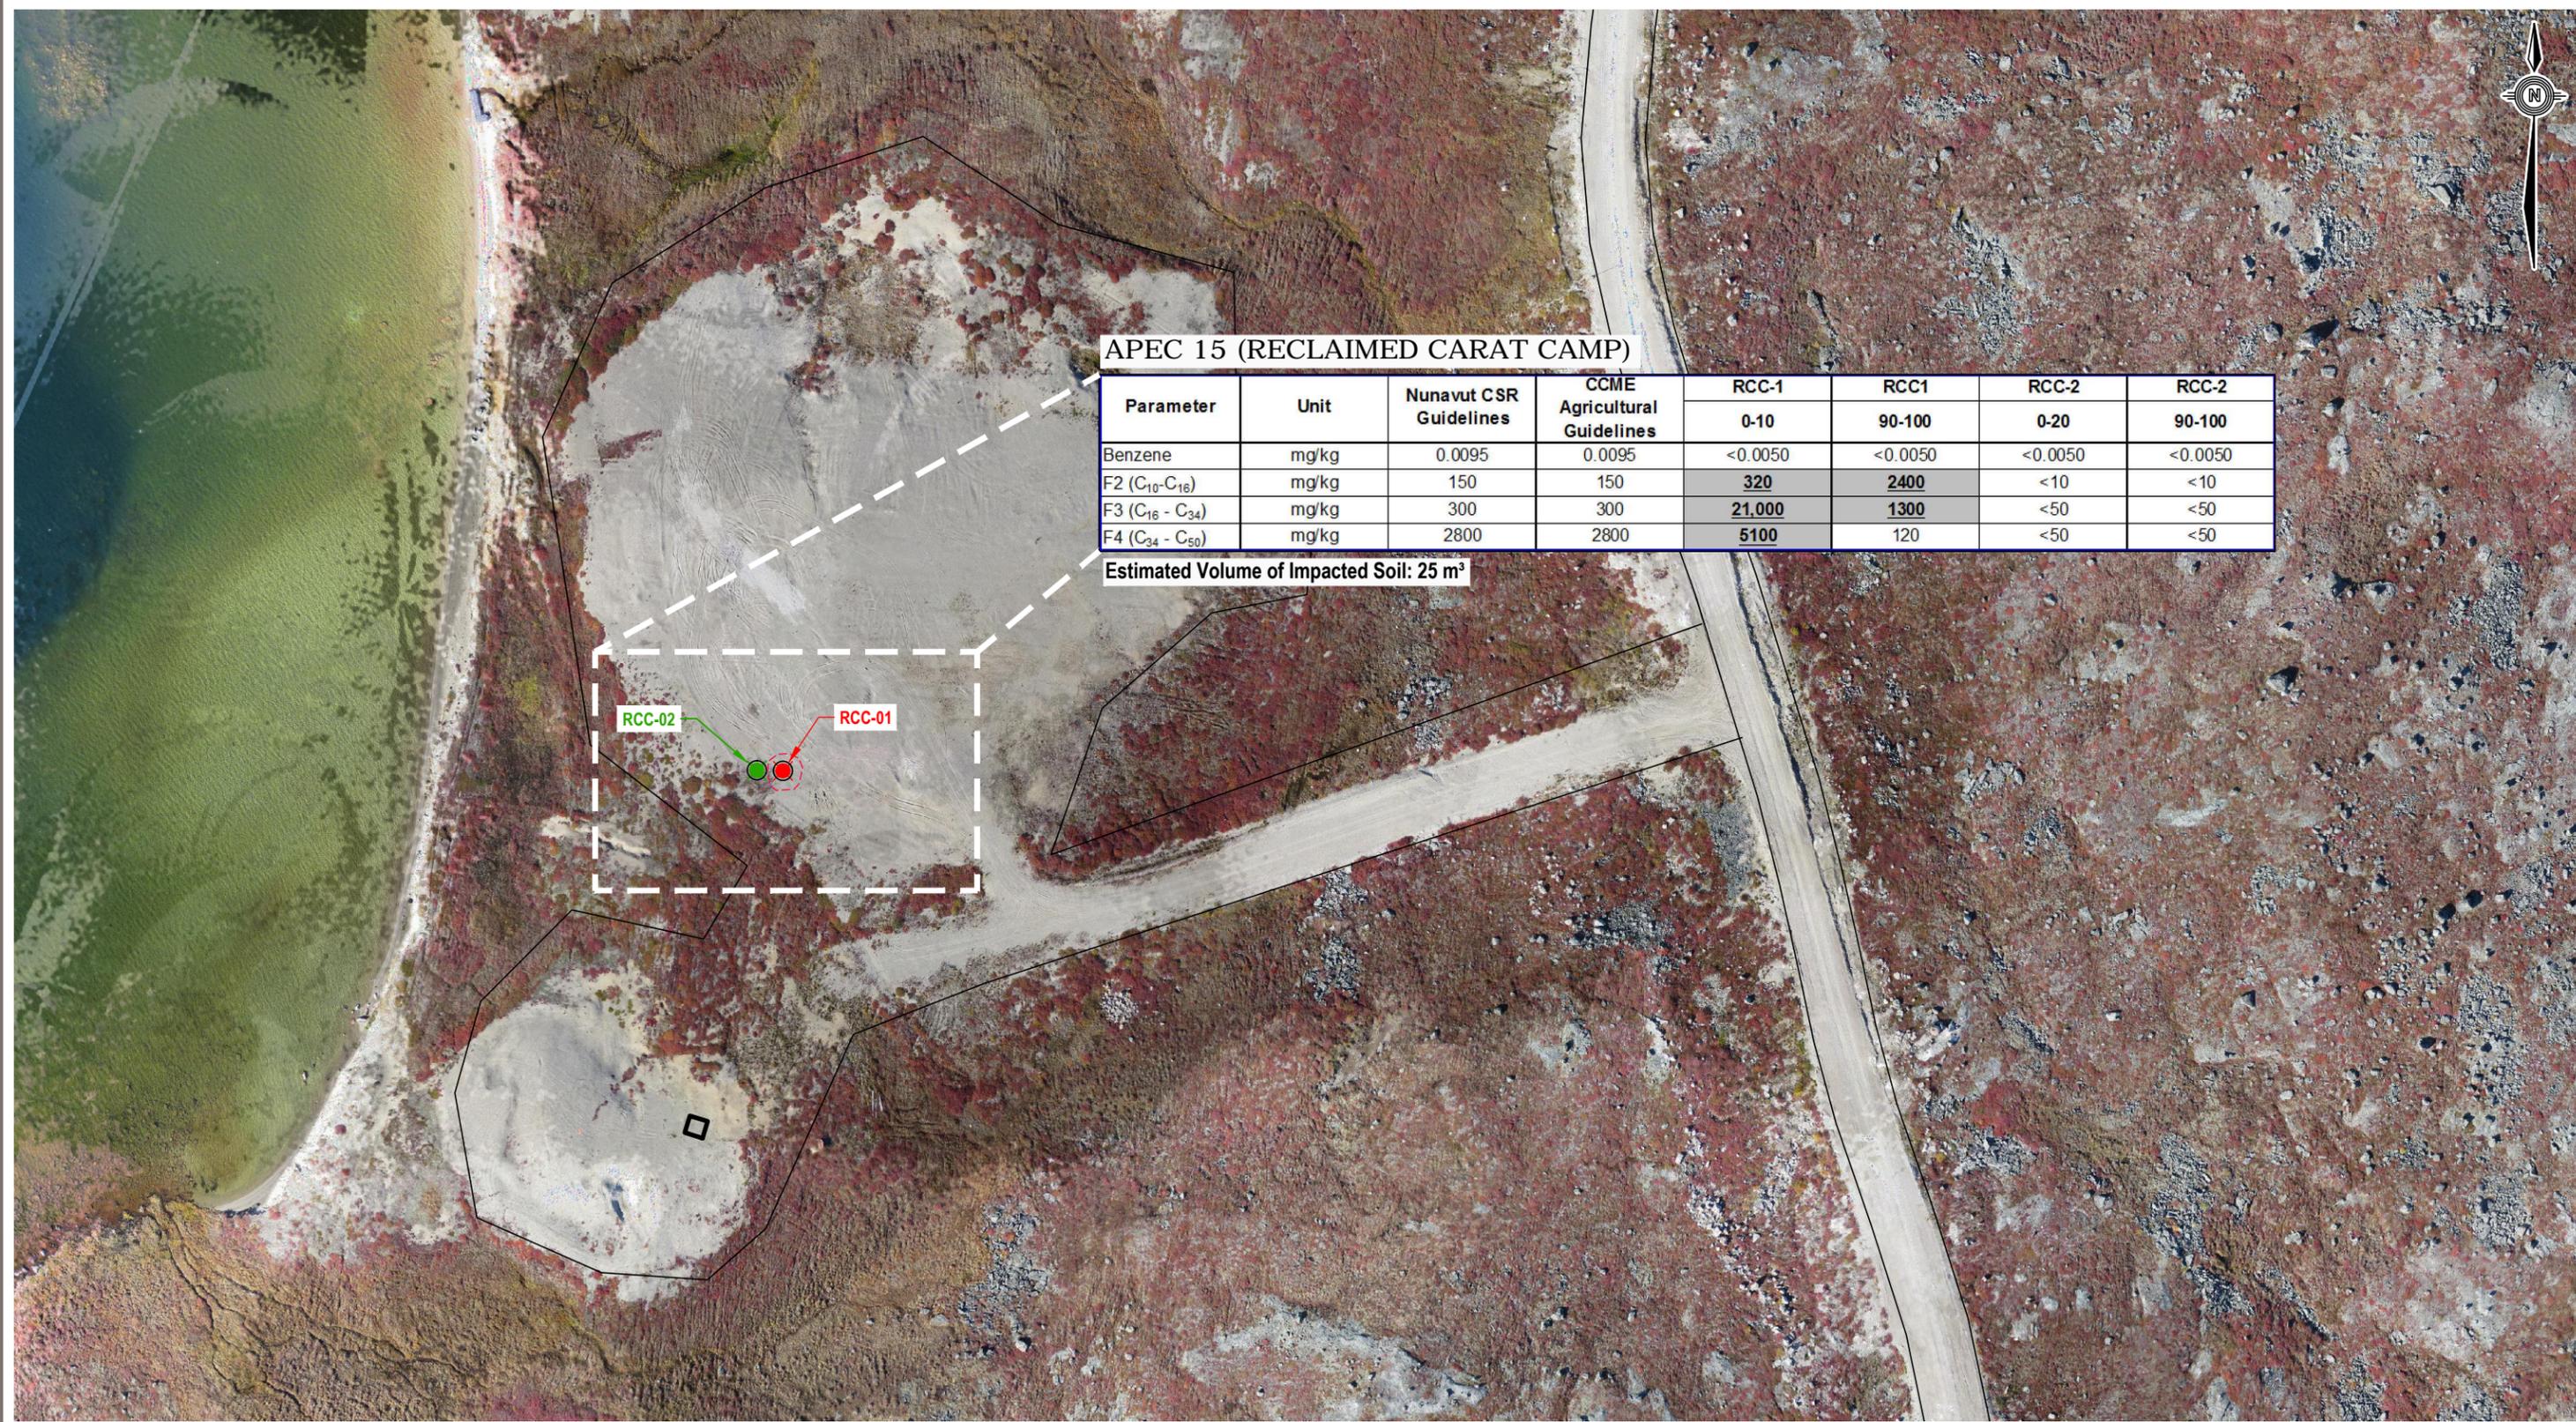
Figure B.7

APEC 15 (RECLAIMED CARAT CAMP)

Parameter	Unit	Nunavut CSR Guidelines	CCME Agricultural Guidelines	RCC-1	RCC1	RCC-2	RCC-2
				0-10	90-100	0-20	90-100
Benzene	mg/kg	0.0095	0.0095	<0.0050	<0.0050	<0.0050	<0.0050
F2 (C ₁₀ -C ₁₆)	mg/kg	150	150	320	2400	<10	<10
F3 (C ₁₆ - C ₃₄)	mg/kg	300	300	21,000	1300	<50	<50
F4 (C ₃₄ - C ₅₀)	mg/kg	2800	2800	5100	120	<50	<50

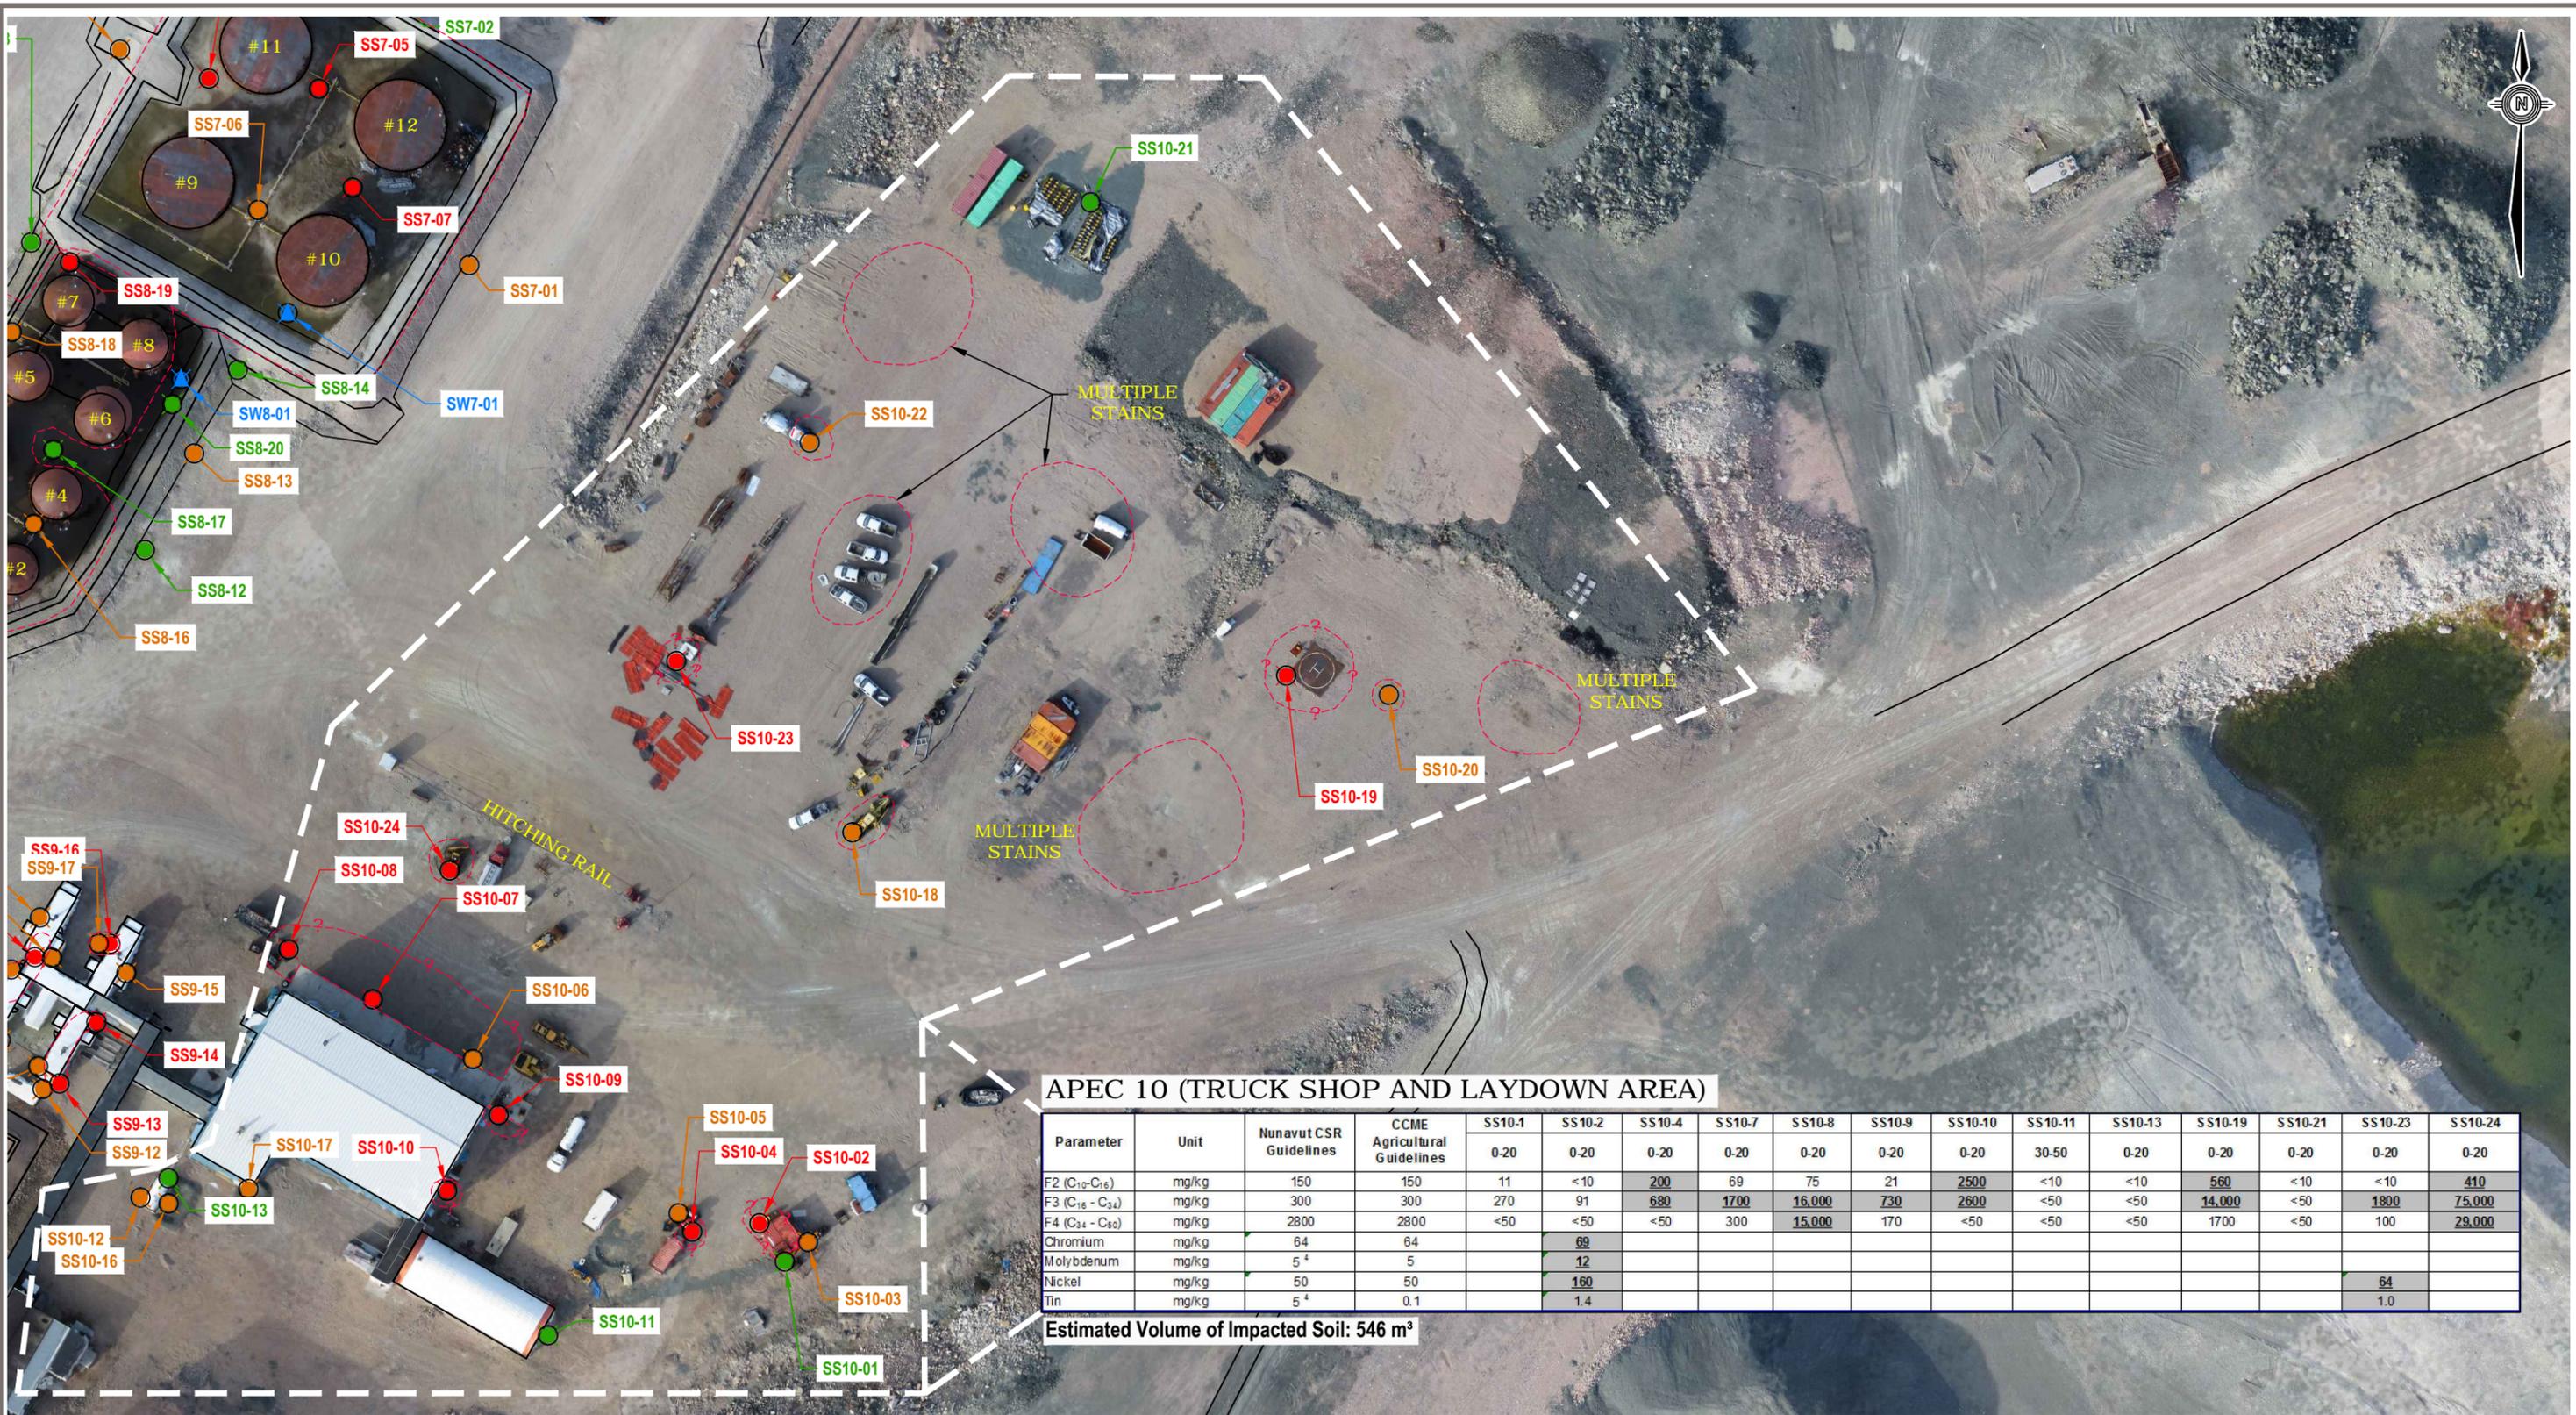
PROJECT NO. E14103202	DWN GDK/DBD	CKD WTH	REV 0
OFFICE EDM	DATE December 2014	Figure B.8

APEC 10 (TRUCK SHOP AND LAYDOWN AREA)

Parameter	Unit	Nunavut CSR Guidelines	CCME Agricultural Guidelines	SS10-1	SS10-2	SS10-4	SS10-7	SS10-8	SS10-9	SS10-10	SS10-11	SS10-13	SS10-19	SS10-21	SS10-23	SS10-24
				0-20	0-20	0-20	0-20	0-20	0-20	30-50	0-20	0-20	0-20	0-20	0-20	0-20
F2 (C ₁₀ -C ₁₆)	mg/kg	150	150	11	<10	200	69	75	21	2500	<10	<10	560	<10	<10	410
F3 (C ₁₆ -C ₂₄)	mg/kg	300	300	270	91	680	1700	16,000	730	2600	<50	<50	14,000	<50	1800	75,000
F4 (C ₂₄ -C ₅₀)	mg/kg	2800	2800	<50	<50	<50	300	15,000	170	<50	<50	<50	1700	<50	100	29,000
Chromium	mg/kg	64	64		69											
Molybdenum	mg/kg	5 ⁴	5		12											
Nickel	mg/kg	50	50		160											64
Tin	mg/kg	5 ⁴	0.1		1.4											1.0

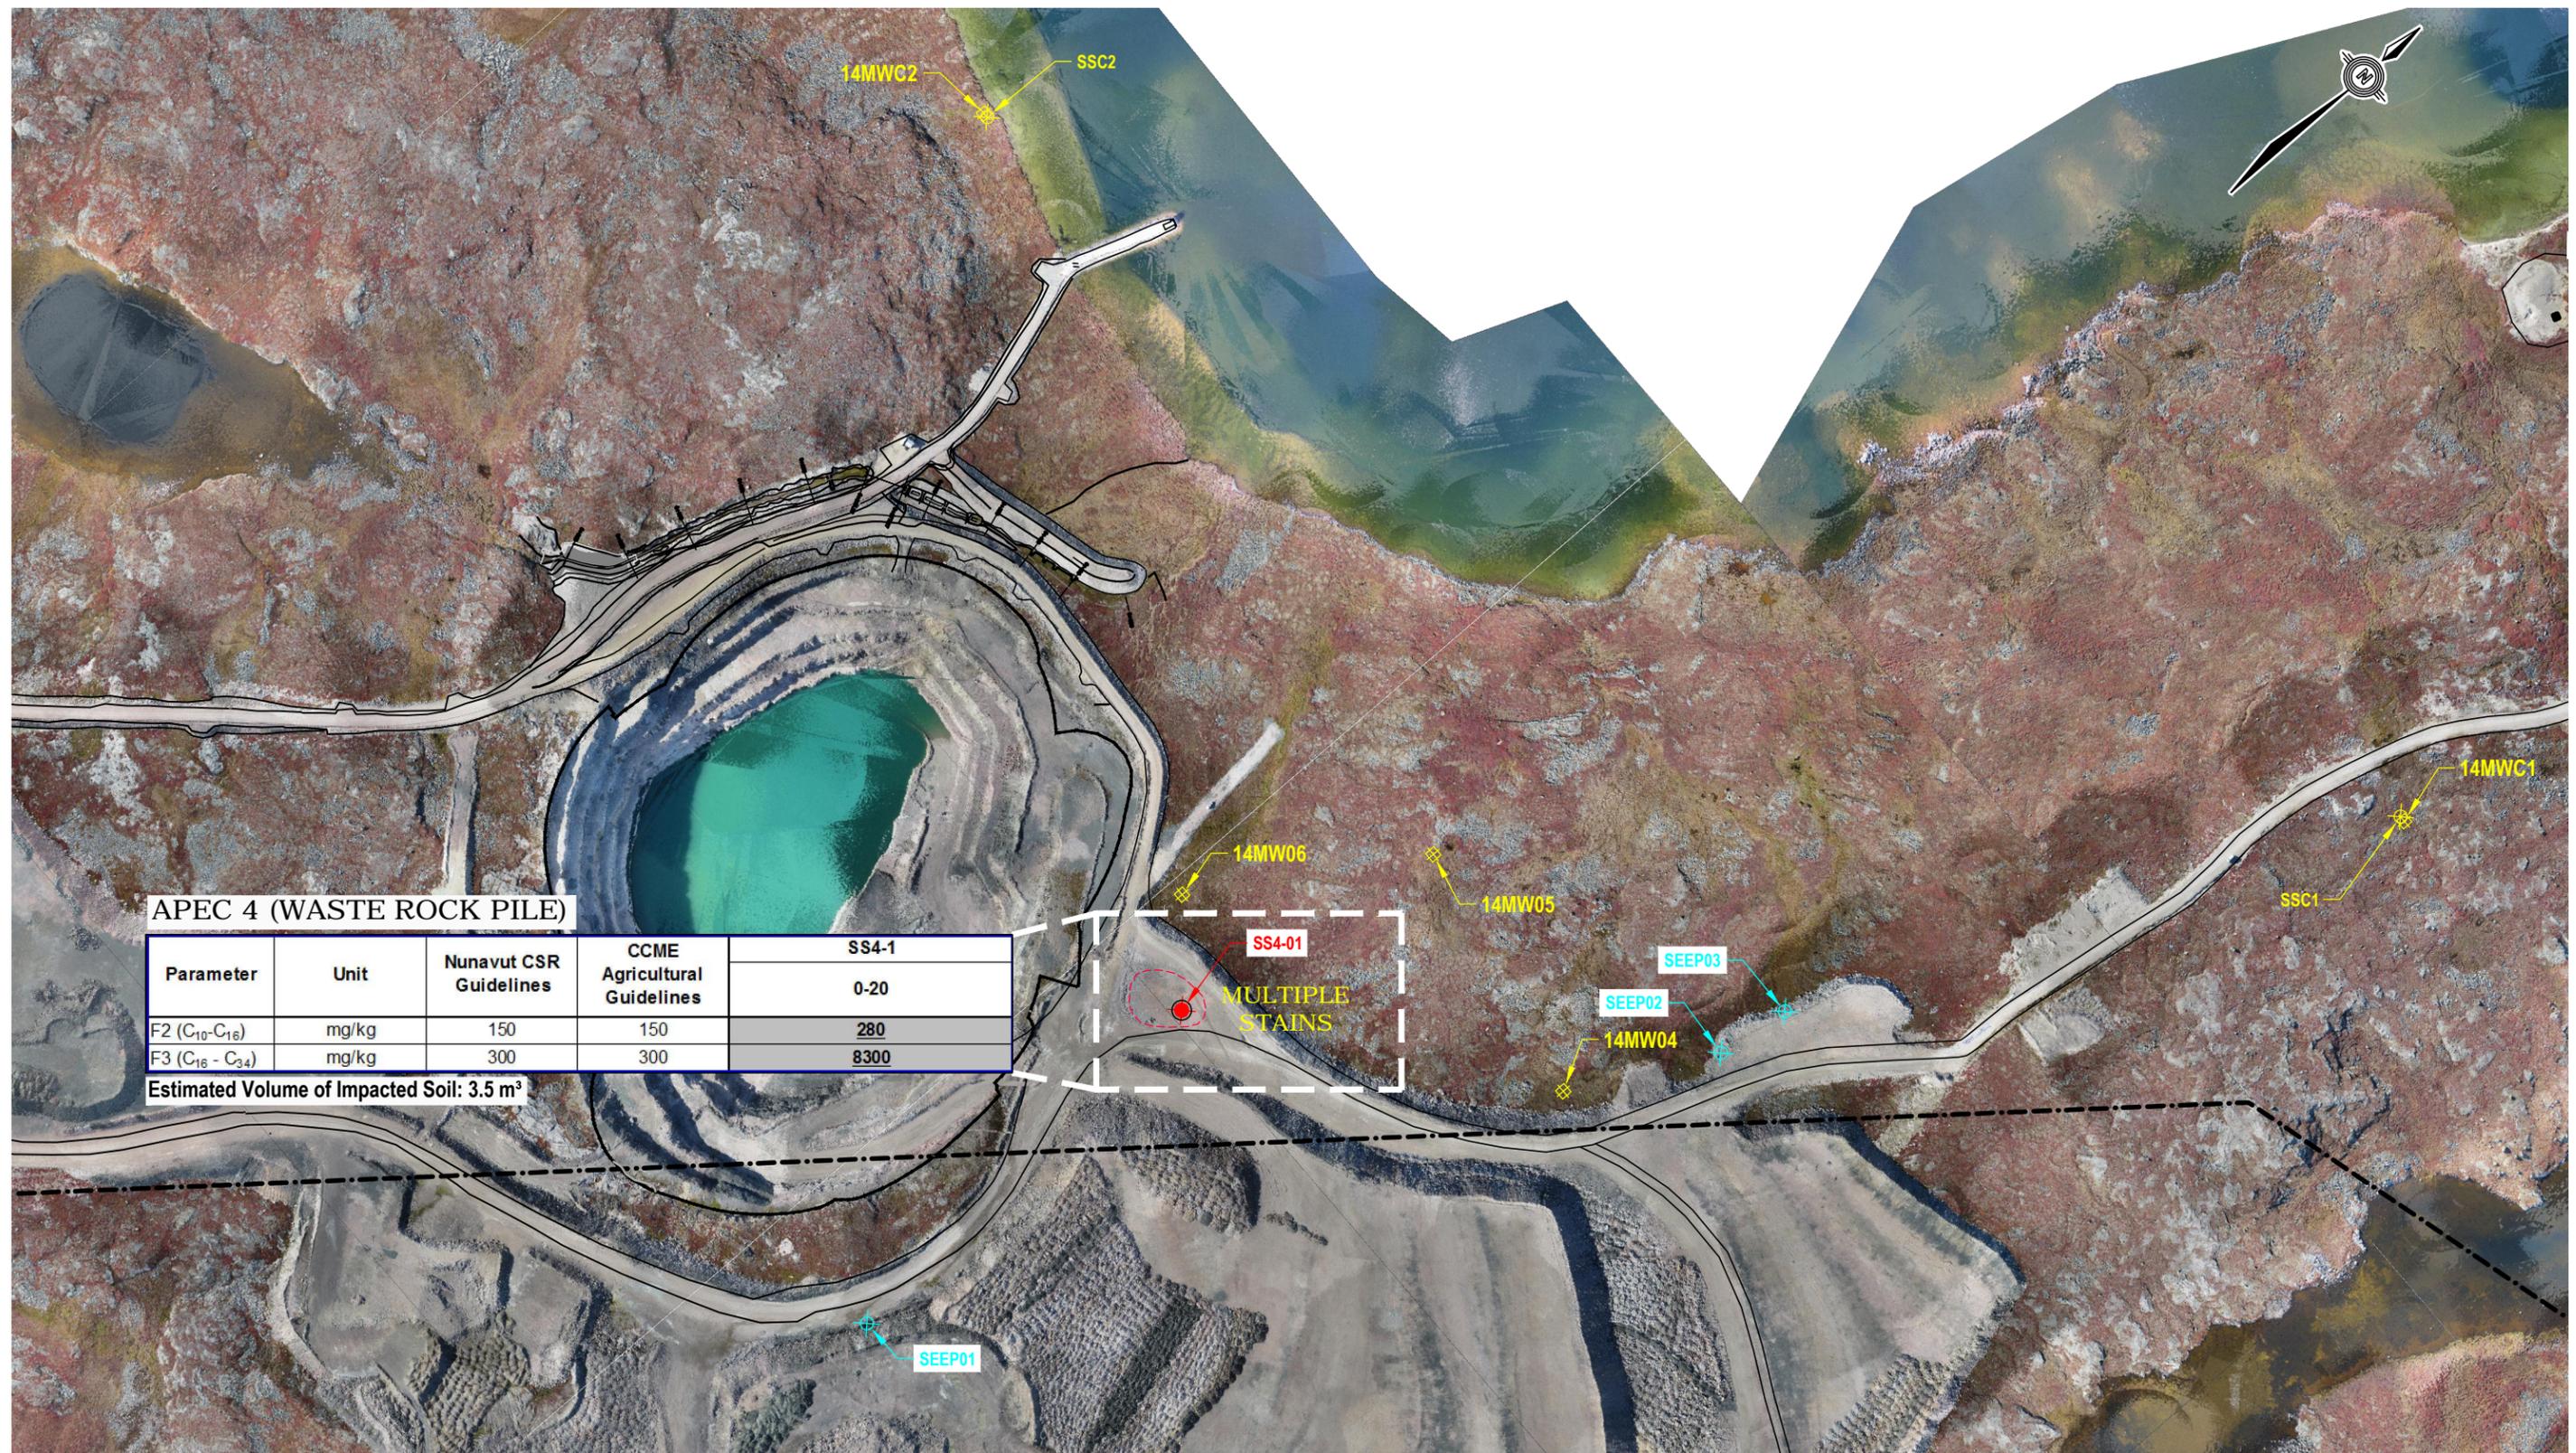
APEC 4 (WASTE ROCK PILE)

Parameter	Unit	Nunavut CSR Guidelines	CCME Agricultural Guidelines	SS4-1
F2 (C ₁₀ -C ₁₆)	mg/kg	150	150	280
F3 (C ₁₆ -C ₃₄)	mg/kg	300	300	8300
