OPTIONS ANALYSIS REV 02 JERICHO DIAMOND MINE, NUNAVUT

Aboriginal Affairs and Northern Development Canada

APRIL 2015
ISSUED FOR USE
FILE: E14103202-01

EXECUTIVE SUMMARY

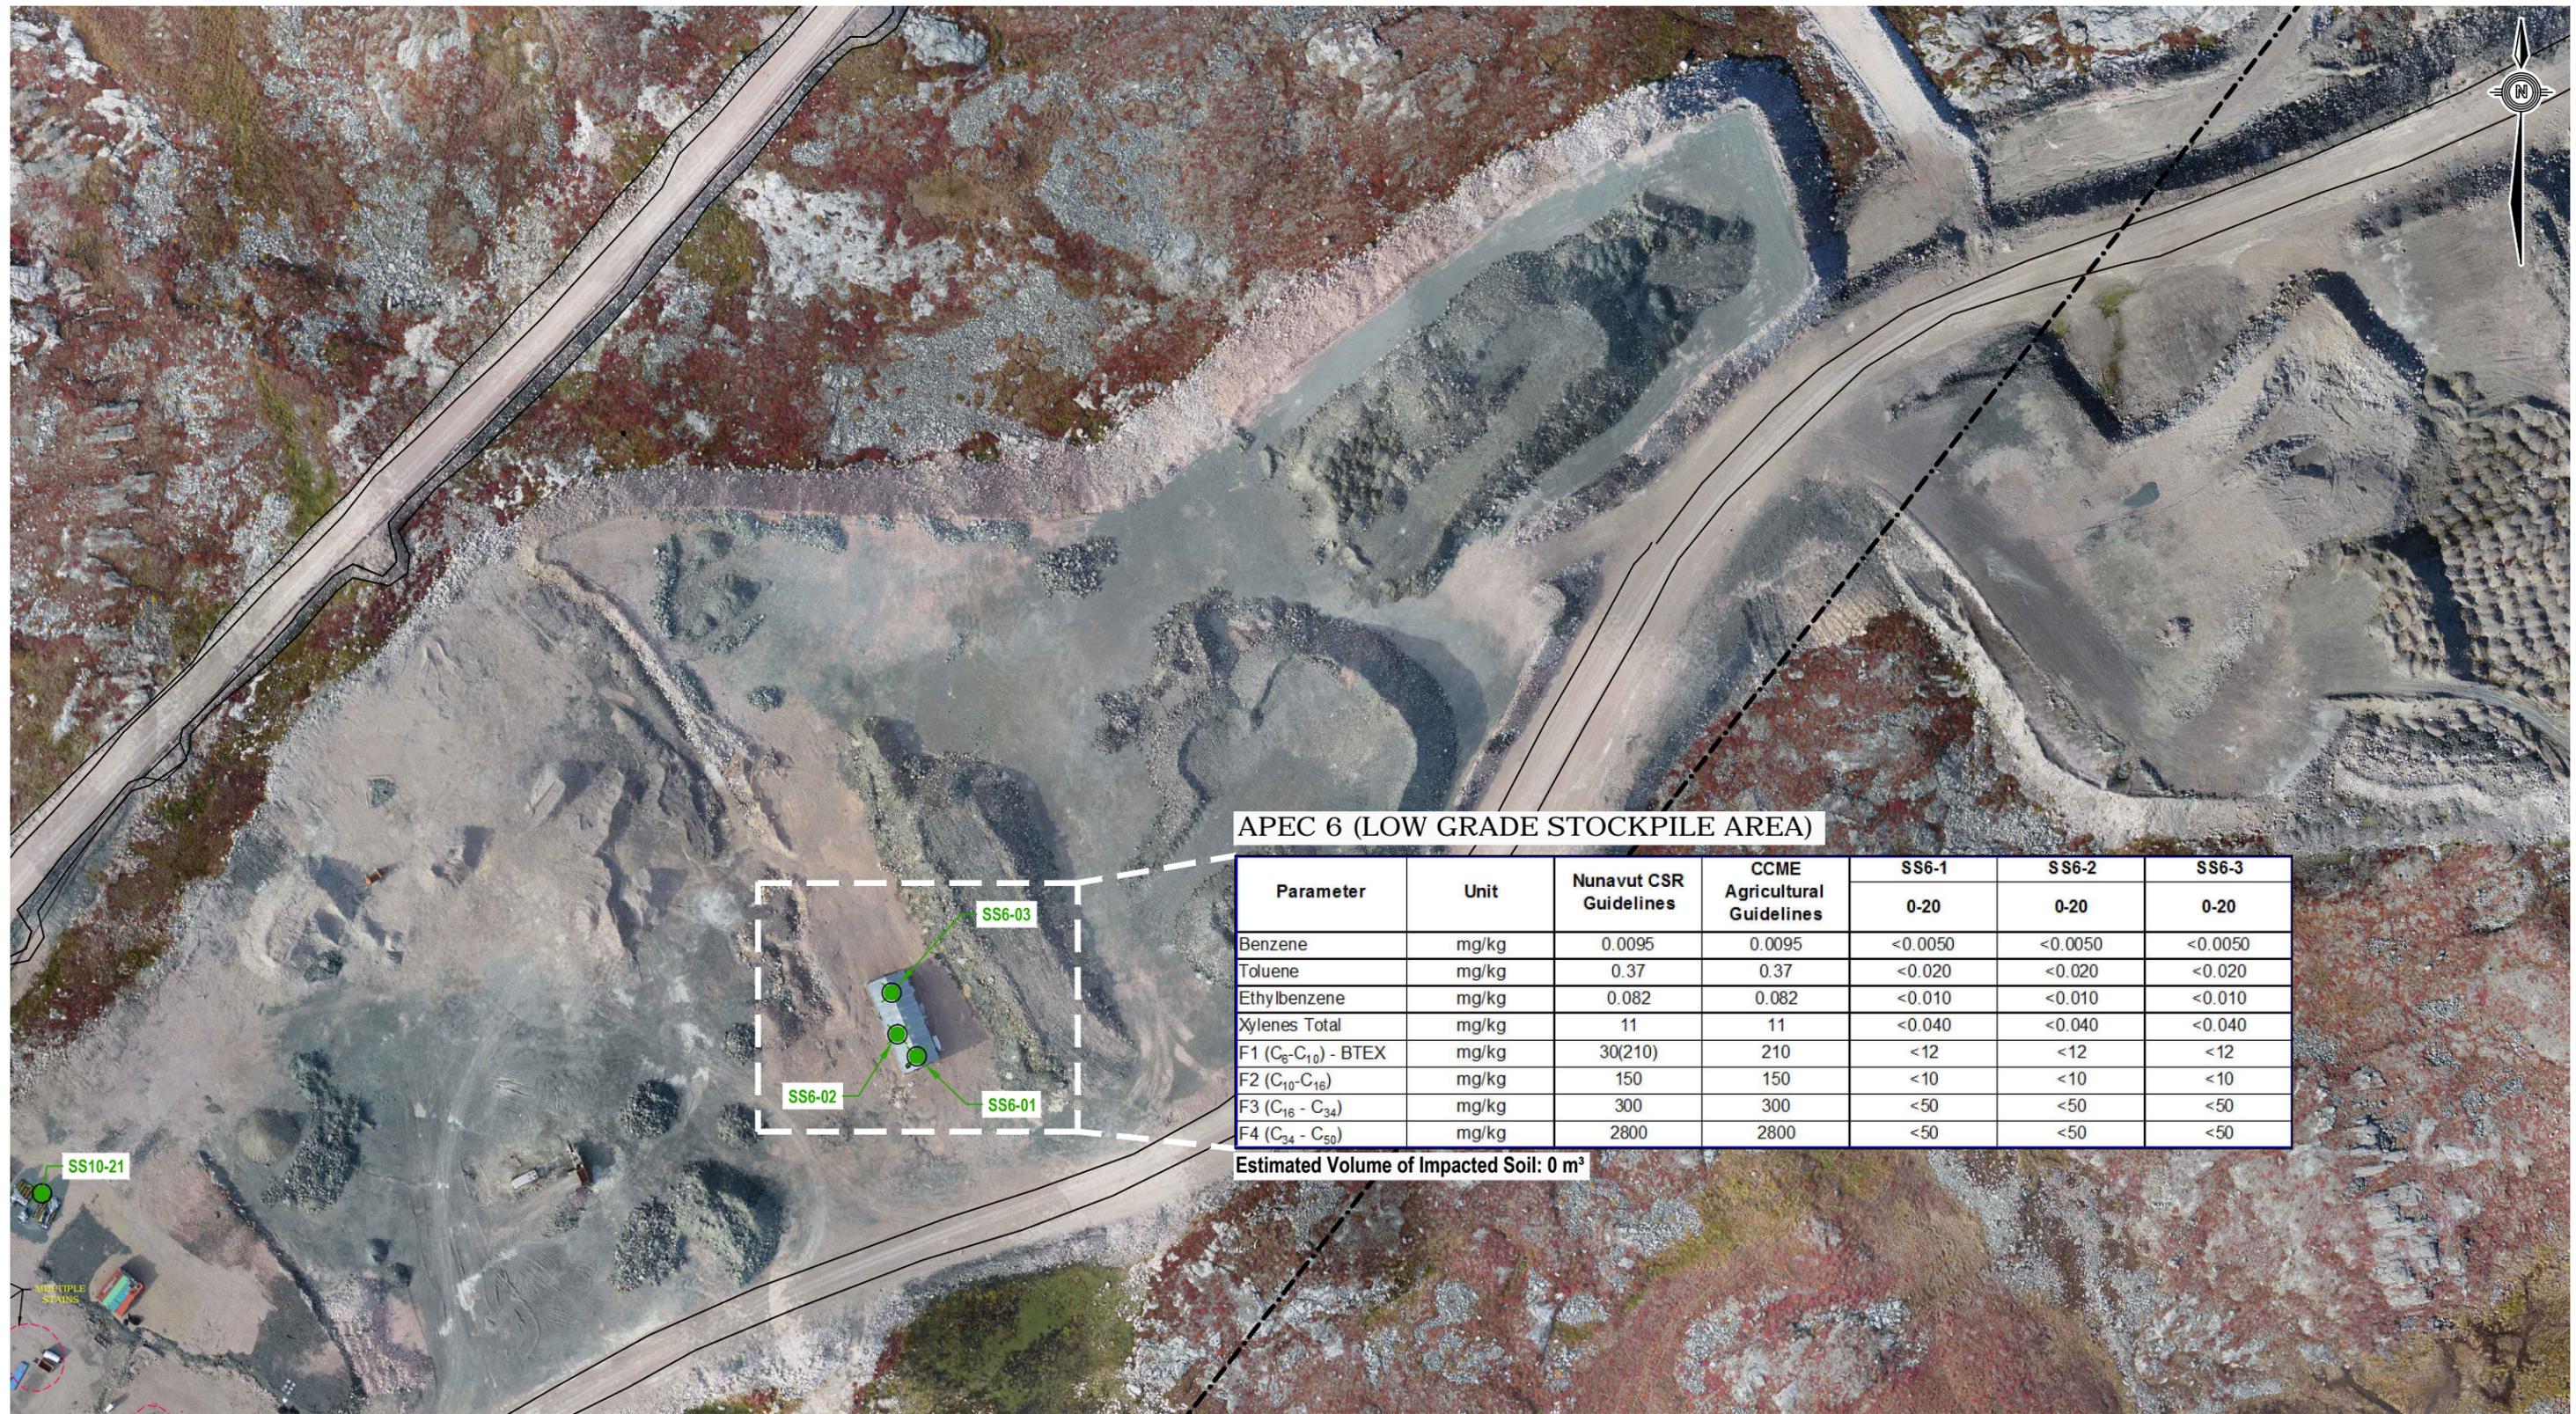
Figure B.10

APEC 6 (LOW GRADE STOCKPILE AREA)

Parameter	Unit	Nunavut CSR Guidelines	CCME Agricultural Guidelines	SS6-1	SS6-2	SS6-3
				0-20	0-20	0-20
Benzene	mg/kg	0.0095	0.0095	<0.0050	<0.0050	<0.0050
Toluene	mg/kg	0.37	0.37	<0.020	<0.020	<0.020
Ethylbenzene	mg/kg	0.082	0.082	<0.010	<0.010	<0.010
Xylenes Total	mg/kg	11	11	<0.040	<0.040	<0.040
F1 (C ₆ -C ₁₀) - BTEX	mg/kg	30(210)	210	<12	<12	<12
F2 (C ₁₀ -C ₁₆)	mg/kg	150	150	<10	<10	<10
F3 (C ₁₆ - C ₃₄)	mg/kg	300	300	<50	<50	<50
F4 (C ₃₄ - C ₅₀)	mg/kg	2800	2800	<50	<50	<50

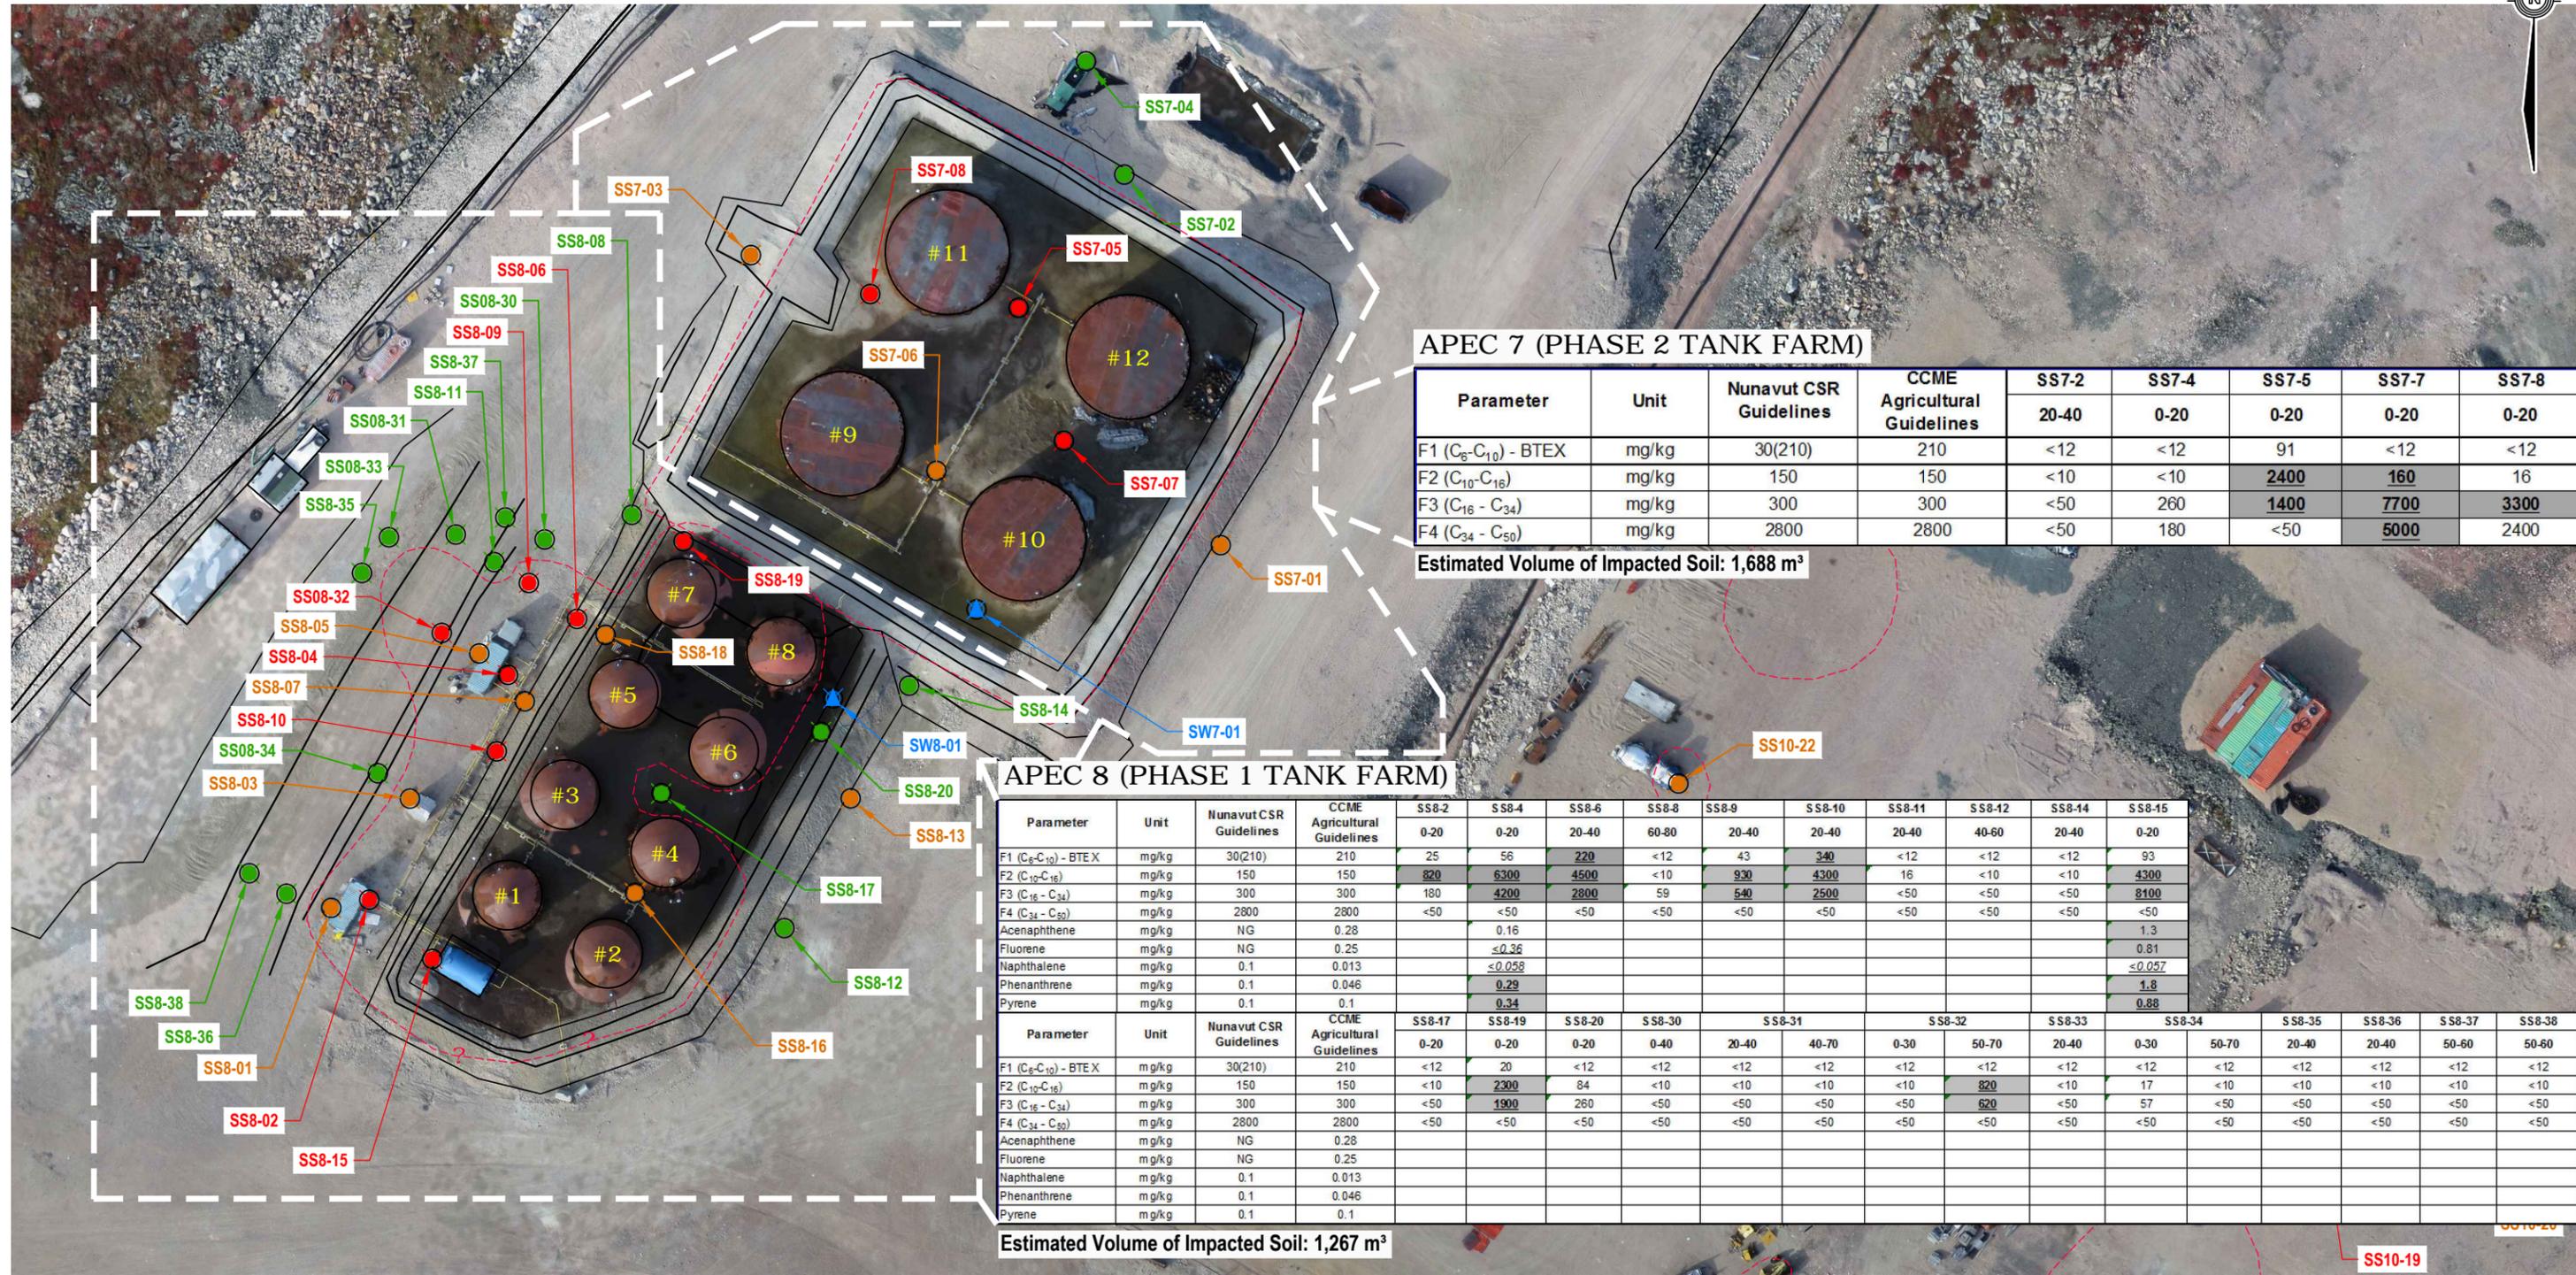
Figure B.11

APEC 7 (PHASE 2 TANK FARM)

Parameter	Unit	Nunavut CSR Guidelines	CCME Agricultural Guidelines	SS7-2	SS7-4	SS7-5	SS7-7	SS7-8
				20-40	0-20	0-20	0-20	0-20
F1 (C ₆ -C ₁₀) - BTEX	mg/kg	30(210)	210	<12	<12	91	<12	<12
F2 (C ₁₀ -C ₁₆)	mg/kg	150	150	<10	<10	2400	160	16
F3 (C ₁₆ - C ₃₄)	mg/kg	300	300	<50	260	1400	7700	3300
F4 (C ₃₄ - C ₅₀)	mg/kg	2800	2800	<50	180	<50	5000	2400

Estimated Volume of Impacted Soil: 1,267 m³

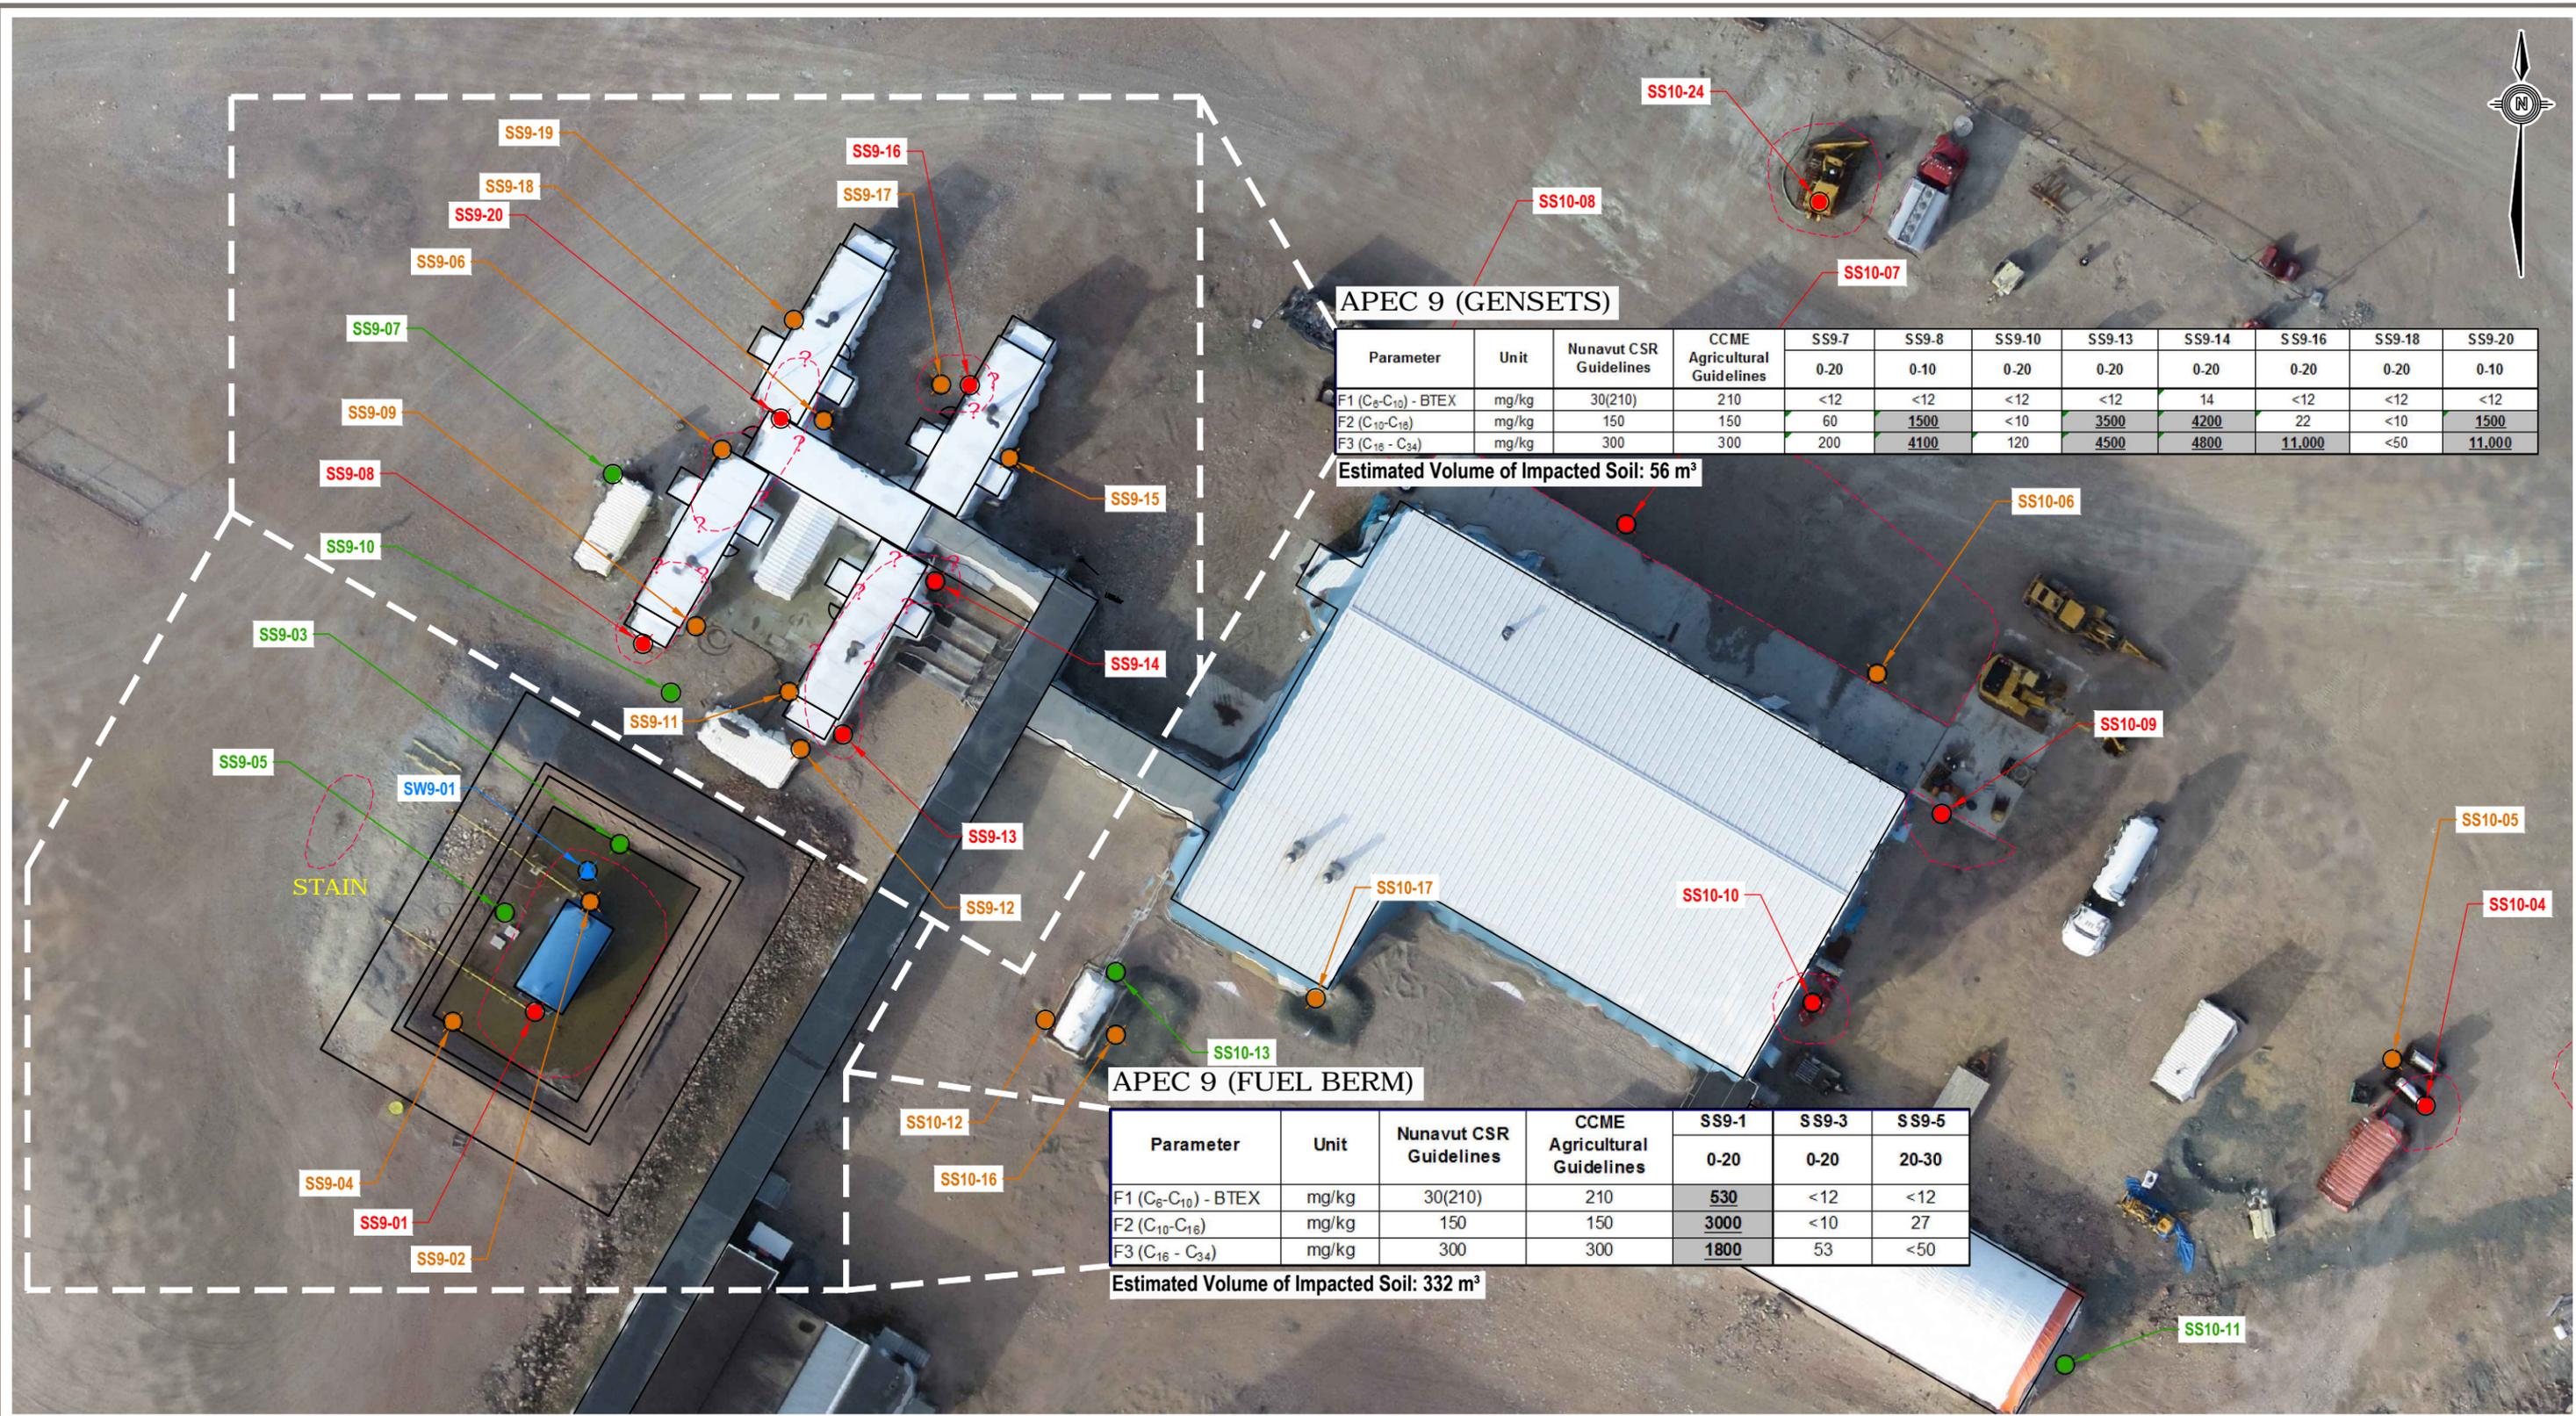
PROJECT NO. E14103202	DWN GDK/DBD	CKD WTH	REV 0	Figure B.12
OFFICE EDM	DATE December 2014

APEC 9 (GENSETS)

Parameter	Unit	Nunavut CSR Guidelines	CCME Agricultural Guidelines	SS9-7	SS9-8	SS9-10	SS9-13	SS9-14	SS9-16	SS9-18	SS9-20
				0-20	0-10	0-20	0-20	0-20	0-20	0-10	
F1 (C ₆ -C ₁₀) - BTEX	mg/kg	30(210)	210	<12	<12	<12	<12	14	<12	<12	<12
F2 (C ₁₀ -C ₁₆)	mg/kg	150	150	60	1500	<10	3500	4200	22	<10	1500
F3 (C ₁₆ -C ₃₄)	mg/kg	300	300	200	4100	120	4500	4800	11,000	<50	11,000

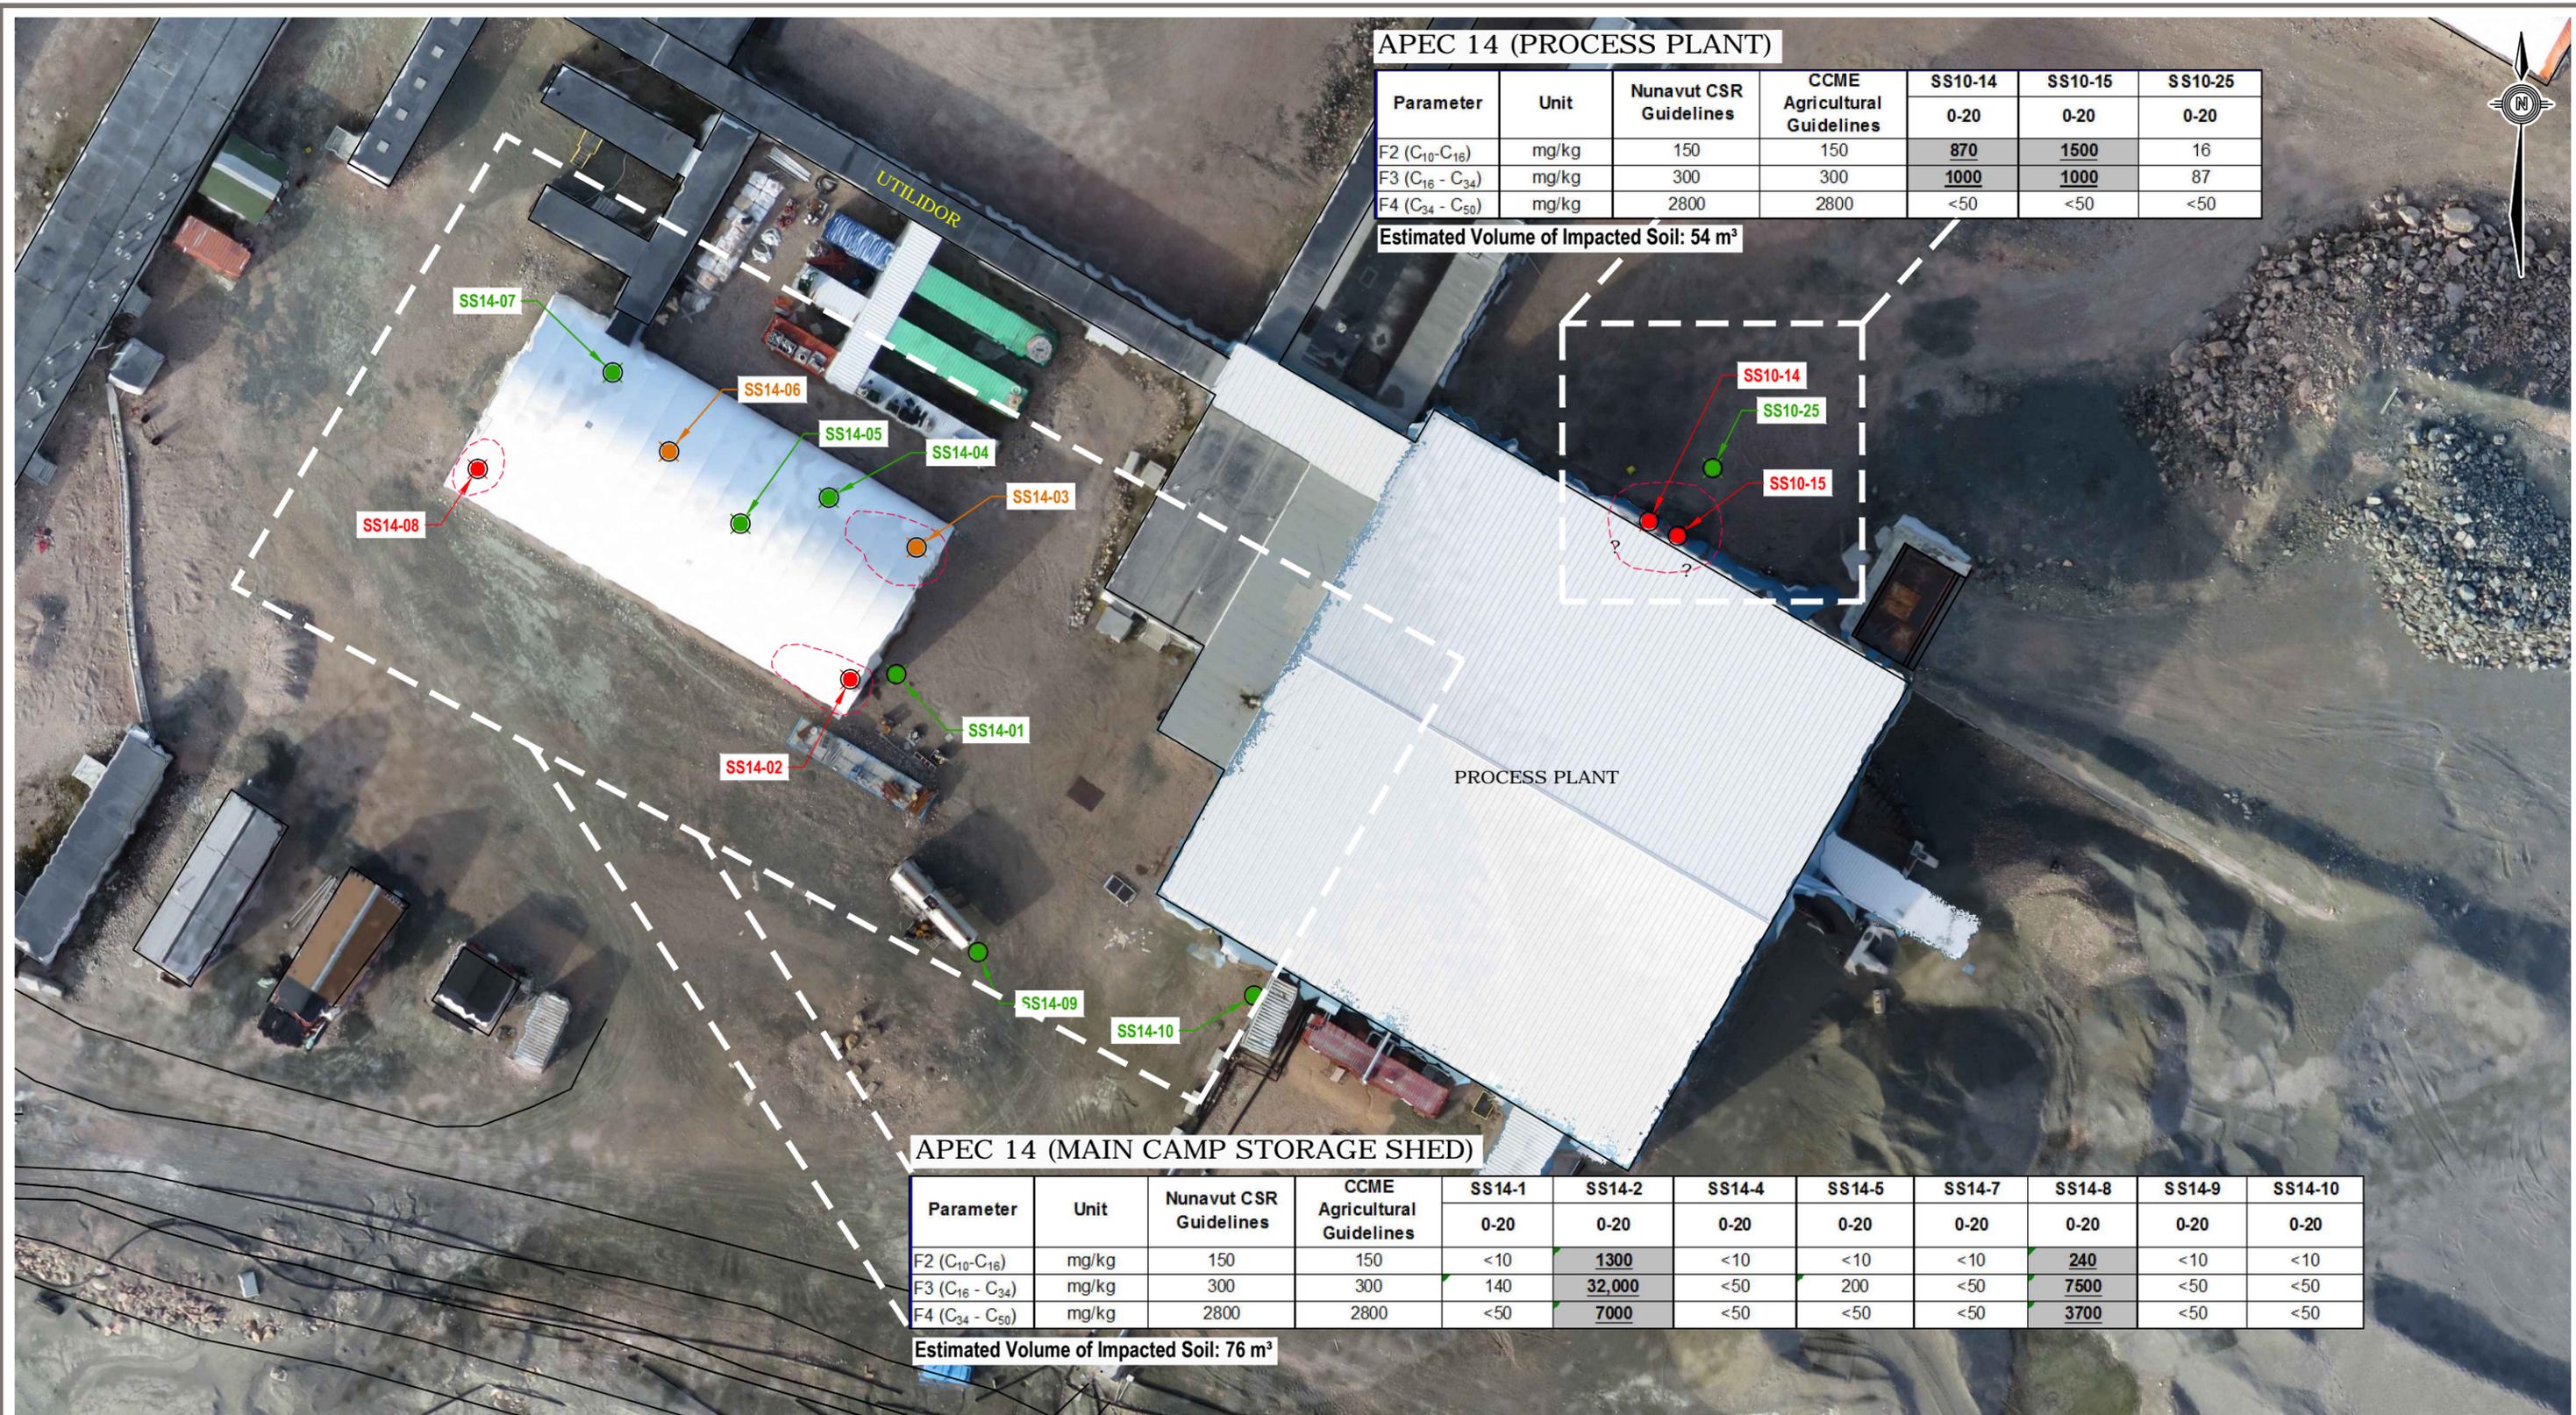
APEC 14 (PROCESS PLANT)

Parameter	Unit	Nunavut CSR Guidelines	CCME Agricultural Guidelines	SS10-14	SS10-15	SS10-25
				0-20	0-20	0-20
F2 (C ₁₀ -C ₁₆)	mg/kg	150	150	870	1500	16
F3 (C ₁₆ - C ₃₄)	mg/kg	300	300	1000	1000	87
F4 (C ₃₄ - C ₅₀)	mg/kg	2800	2800	<50	<50	<50
