**Inspection Report for:**  
**D Jetty Fender System**  
**CFB Esquimalt**

**96272**  
**October 1996**

Reference: Inspection Report for D Jetty Fender System

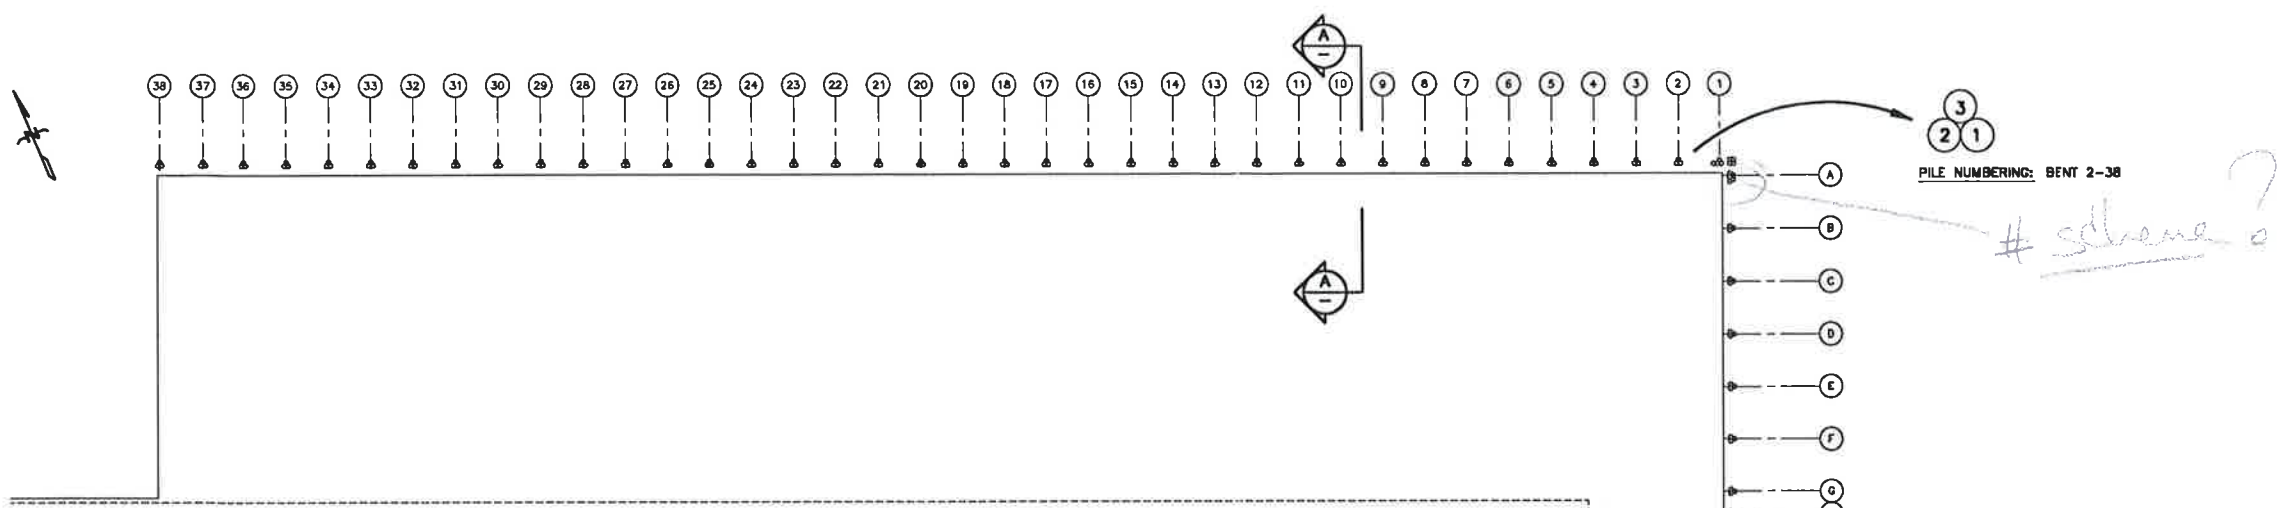
FENDER PILE PLAN  
1:250

Bent	Pile No.	Observation
1A	1	75% MBC in 1.8 m of water. Top of Pile is crushed, has no hat, and appears rotten.
	2	Vertical fracture at top bolted connection, both front and back. Pile has no hat.
	3	Pile is missing.
5A	3	Lower connection bolt is missing.
7A	3	10% CSL in the intertidal zone due to abrasion. - MONITOR
9A	3	Top 1.2 m of Pile is crushed.
13A	3	75% of hat is missing.
15A	3	15% CSL in the intertidal zone due to abrasion.
18A	-	Connection of fender Pile group to Jetty is loose.
19A	1	100% MBC in 1.8 m of water.
	2	100% MBC in 1.8 m of water.
	3	Lower connection bolt is missing and Pile is loose.
	4	10% CSL due to abrasion from camel log.
	7	Top of Pile is rotten. ? quantify recommended.
25A	1	10% CSL due to abrasion from loose fender Pile 3.
	3	10% MBC at lower bolt connection; bolt is missing and Pile is loose.
33A	1	10% CSL on bottom 1.2 m due to abrasion from camel log.
39A	3	25% MBC at lower bolt connection. Pile is loose.

39A - 41A	-	Top rubbing strip is broken.
43A	3	Lower connection bolt is missing, and Pile is loose causing CSL in intertidal zone due to abrasion.
47A	3	25% CSL in intertidal zone due to abrasion.

Bent	Pile No.	Observation
47A - 55A	-	Fender log is missing.
A	-	Chain connection between concrete pilecap and timber fender Piles is too loose.
	-	4 Pile cluster on corner, adjacent to Bent A, does not appear to be connected to the jetty.
	5	50% CSL at lower bolt connection; bolt is missing and Pile is loose. 50% of hat is missing.
B	-	Chain connection between concrete pilecap and timber fender Piles is broken.
	2	Bolt hole is elongated at lower connection.
	3	One bolt is loose due to an elongated bolt hole and the other bolt is missing, at the lower connection.
D	3	50% CSL in intertidal zone due to abrasion.
F	3	20% CSL in intertidal zone due to abrasion. Pile is loose at bottom due to elongated lower connection bolt hole.
2	3	Lower connection is loose.
4	3	10% CSL in intertidal zone due to abrasion.
5	3	50% MBC at lower bolt connection; bolt is loose. 25% CSL in intertidal zone due to abrasion.
7	3	Lower bolt connections are loose. 30% CSL in intertidal zone due to abrasion.

8	3	15% CSL in intertidal zone due to abrasion. Pile is loose at bottom due to elongated lower connection bolt holes, and a missing bolt.
11 - 14	-	Top rubbing strip is split.
16	3	15% CSL in intertidal zone due to abrasion. Minor borer activity near mudline.
17	2	OBH 300 mm above mudline.
	3	Lower connection bolt is loose.

Bent	Pile No.	Observation
28	3	15% CSL in intertidal zone due to abrasion.
29	3	15% CSL in intertidal zone due to abrasion.
30	-	Eye-bolt has sheared from concrete pile cap, and therefore chain is no longer attached.
31	3	Lower connection bolt is loose.
32	3	Only one lower connection bolt, and it is loose.
36	2	Pile stops short of mudline by 450 mm.

BENT	PILE NO.	RECOMMENDATION
5A	3	INSTALL LOWER CONNECTION BOLTS
18A	-	INSTALL ADDITIONAL EYEBOLTS AND RESTRAINT CHAINS
19A	3	REPLACE UPPER AND LOWER CONNECTION BOLTS
25A	3	INSTALL REPLACEMENT LOWER CONNECTION BOLTS AT DIFFERENT ELEVATION
39A-41A	-	REPLACE TOP RUBBING STRIP
39A	3	REMOVE EXISTING BOLTS; INSTALL REPLACEMENT BOLTS AT DIFFERENT ELEVATION
43A	3	INSTALL LOWER CONNECTION BOLTS
47A-55A	-	REPLACE FENDER LOG
*A	-	TIGHTENED UP RESTRAINT CHAIN
	-	REPLACE RESTRAINT CHAIN
B	2	INSTALL NEW CONNECTION BOLTS AT DIFFERENT ELEVATION
	3	
F	3	INSTALL NEW LOWER CONNECTION BOLTS AT DIFFERENT ELEVATION
2	3	INSTALL NEW LOWER CONNECTION BOLTS
8	3	INSTALL NEW LOWER CONNECTION BOLTS AT DIFFERENT ELEVATION
11-14	-	REPLACE TOP RUBBING STRIP
17	2	INSTALL TREATED DOWEL
	3	REPLACE LOWER CONNECTION BOLTS
30	-	REPLACE EYEBOLT
31	3	REPLACE LOWER CONNECTION BOLTS
32	3	INSTALL ADDITIONAL CROSS BOLT
