**Client: DEPARTMENT OF NATIONAL DEFENCE****Date: November 9, 2005****Project: INSPECTION AND REPAIRS OF D JETTY****Project No.: 05673****Subject: INSPECTION SUMMARY****Page 1 of 6**

PROJECT MEMORANDUM  
INSPECTION AND REPAIRS OF D JETTY  
Inspection Summary

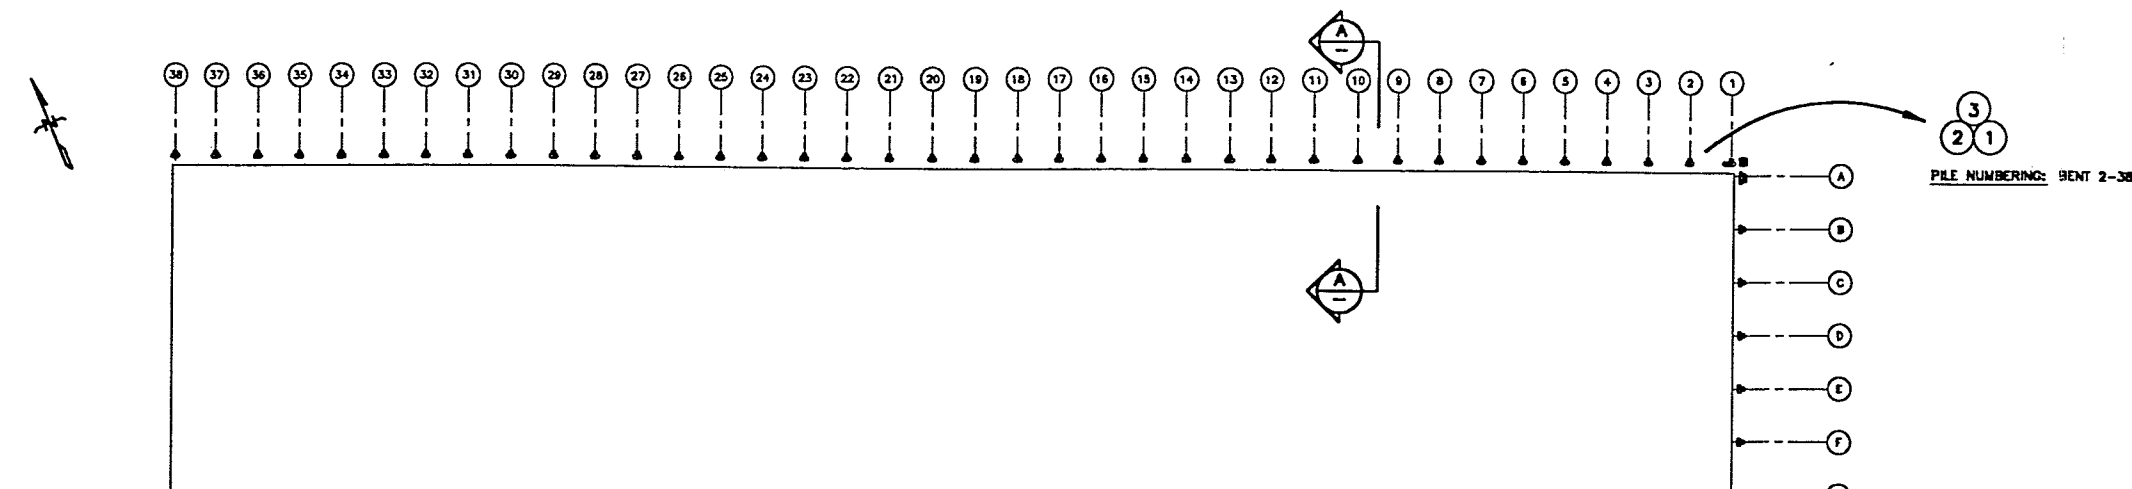
FENDER PILE PLAN  
1:250

TABLE 1: FENDER PILES TO BE REPLACED (TOTAL NO. : 5)

BENT	PILE NO.	BENT	PILE NO.
1A	1	19A	1
	2	36	2

TABLE 3: MISCELLANEOUS REPAIRS

BENT	PILE NO.	RECOMMENDATION
5A	3	INSTALL LOWER CONNECTION BOLTS
18A	-	INSTALL ADDITIONAL EYEBOLTS AND RESTRAINT CHAINS
19A	3	REPLACE UPPER AND LOWER CONNECTION BOLTS
25A	3	INSTALL REPLACEMENT LOWER CONNECTION BOLTS AT DIFFERENT ELEVATION
39A-41A	-	REPLACE TOP RUBBING STRIP
39A	3	REMOVE EXISTING BOLTS; INSTALL REPLACEMENT BOLTS AT DIFFERENT ELEVATION
43A	3	INSTALL LOWER CONNECTION BOLTS
47A-55A	-	REPLACE FENDER LOG
* A	-	TIGHTENED UP RESTRAINT CHAIN
	-	REPLACE RESTRAINT CHAIN
B	2	INSTALL NEW CONNECTION BOLTS AT DIFFERENT ELEVATION
F	3	INSTALL NEW LOWER CONNECTION BOLTS AT DIFFERENT ELEVATION
2	3	INSTALL NEW LOWER CONNECTION BOLTS
8	3	INSTALL NEW LOWER CONNECTION BOLTS AT DIFFERENT ELEVATION
11-14	-	REPLACE TOP RUBBING STRIP
17	2	INSTALL TREATED DOWEL
	3	REPLACE LOWER CONNECTION BOLTS
30	-	REPLACE EYEBOLT
31	3	REPLACE LOWER CONNECTION BOLTS
32	3	INSTALL ADDITIONAL CROSS BOLT

\* INSTALL ADDITIONAL EYEBOLTS AND RESTRAINT CHAINS TO SECURE THE 4 PILE CLUSTER AT THE CORNER OF THE JETTY
