**INTRUSIVE DESIGNATED SUBSTANCES AND
HAZARDOUS MATERIALS SURVEY OF CELL
BLOCK No.1**

**CORRECTIONAL SERVICE OF CANADA,
COLLINS BAY INSTITUTION,
KINGSTON, ONTARIO**

FINAL REPORT

February 4, 2008

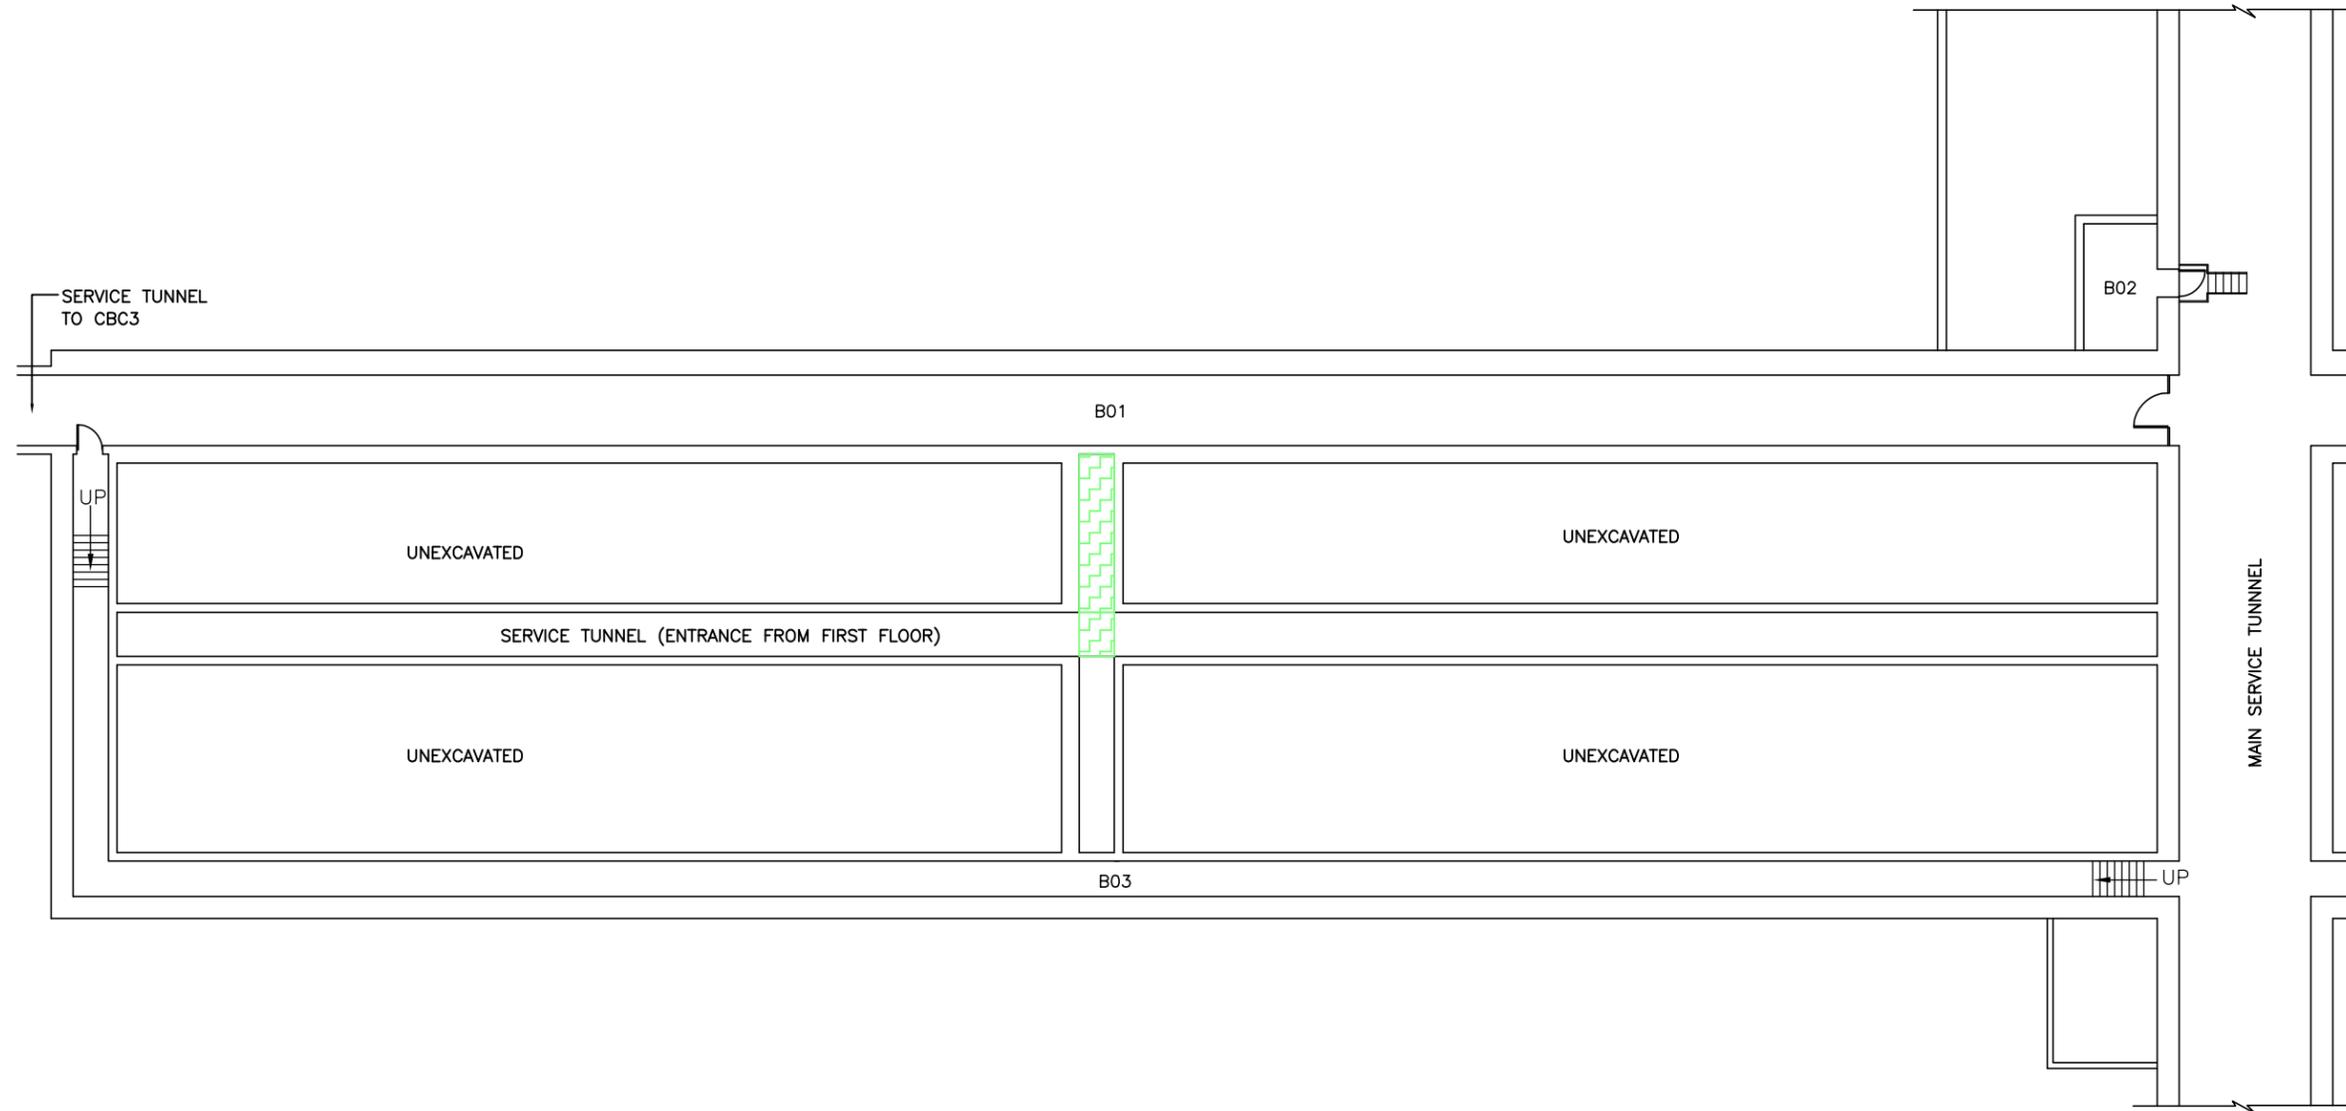
Client/Location: PWGSC COLLINS BAY INSTITUTION KINGSTON, ONTARIO		Title: SAMPLING LOCATIONS - CBB1 CELL BLOCK No. 1 (SERVICE TUNNEL)	
Project No: 07120	Filename: 07120-CBB1-BSMT-2	Date: NOVEMBER 2007	Dwg No: FIGURE 3
Drawn: EM	Verified: CVH	Project Manager: MRF

There are three service tunnels that run east to west under the building, B01, at the south end of the building, B03, at the north end, and a central service tunnel. Both B01 and B03 are accessed via the institution's main service tunnel. The central tunnel (as shown in Appendix A, Photo10) can only be accessed from the first floor of Cell Block No.1. The tunnel walls and ceiling are constructed of poured concrete. Tunnel B01 contains various pipes, insulated and non insulated, and conduits secured to racks, walls and ceiling. Tunnel B03 (as shown in Appendix A, Photo 9) contains conduits and fire protection pipes mounted on the walls and ceiling. The central tunnel contains various water supply and sewer pipes and debris. Figure 3 shows the approximate layout of the tunnels.

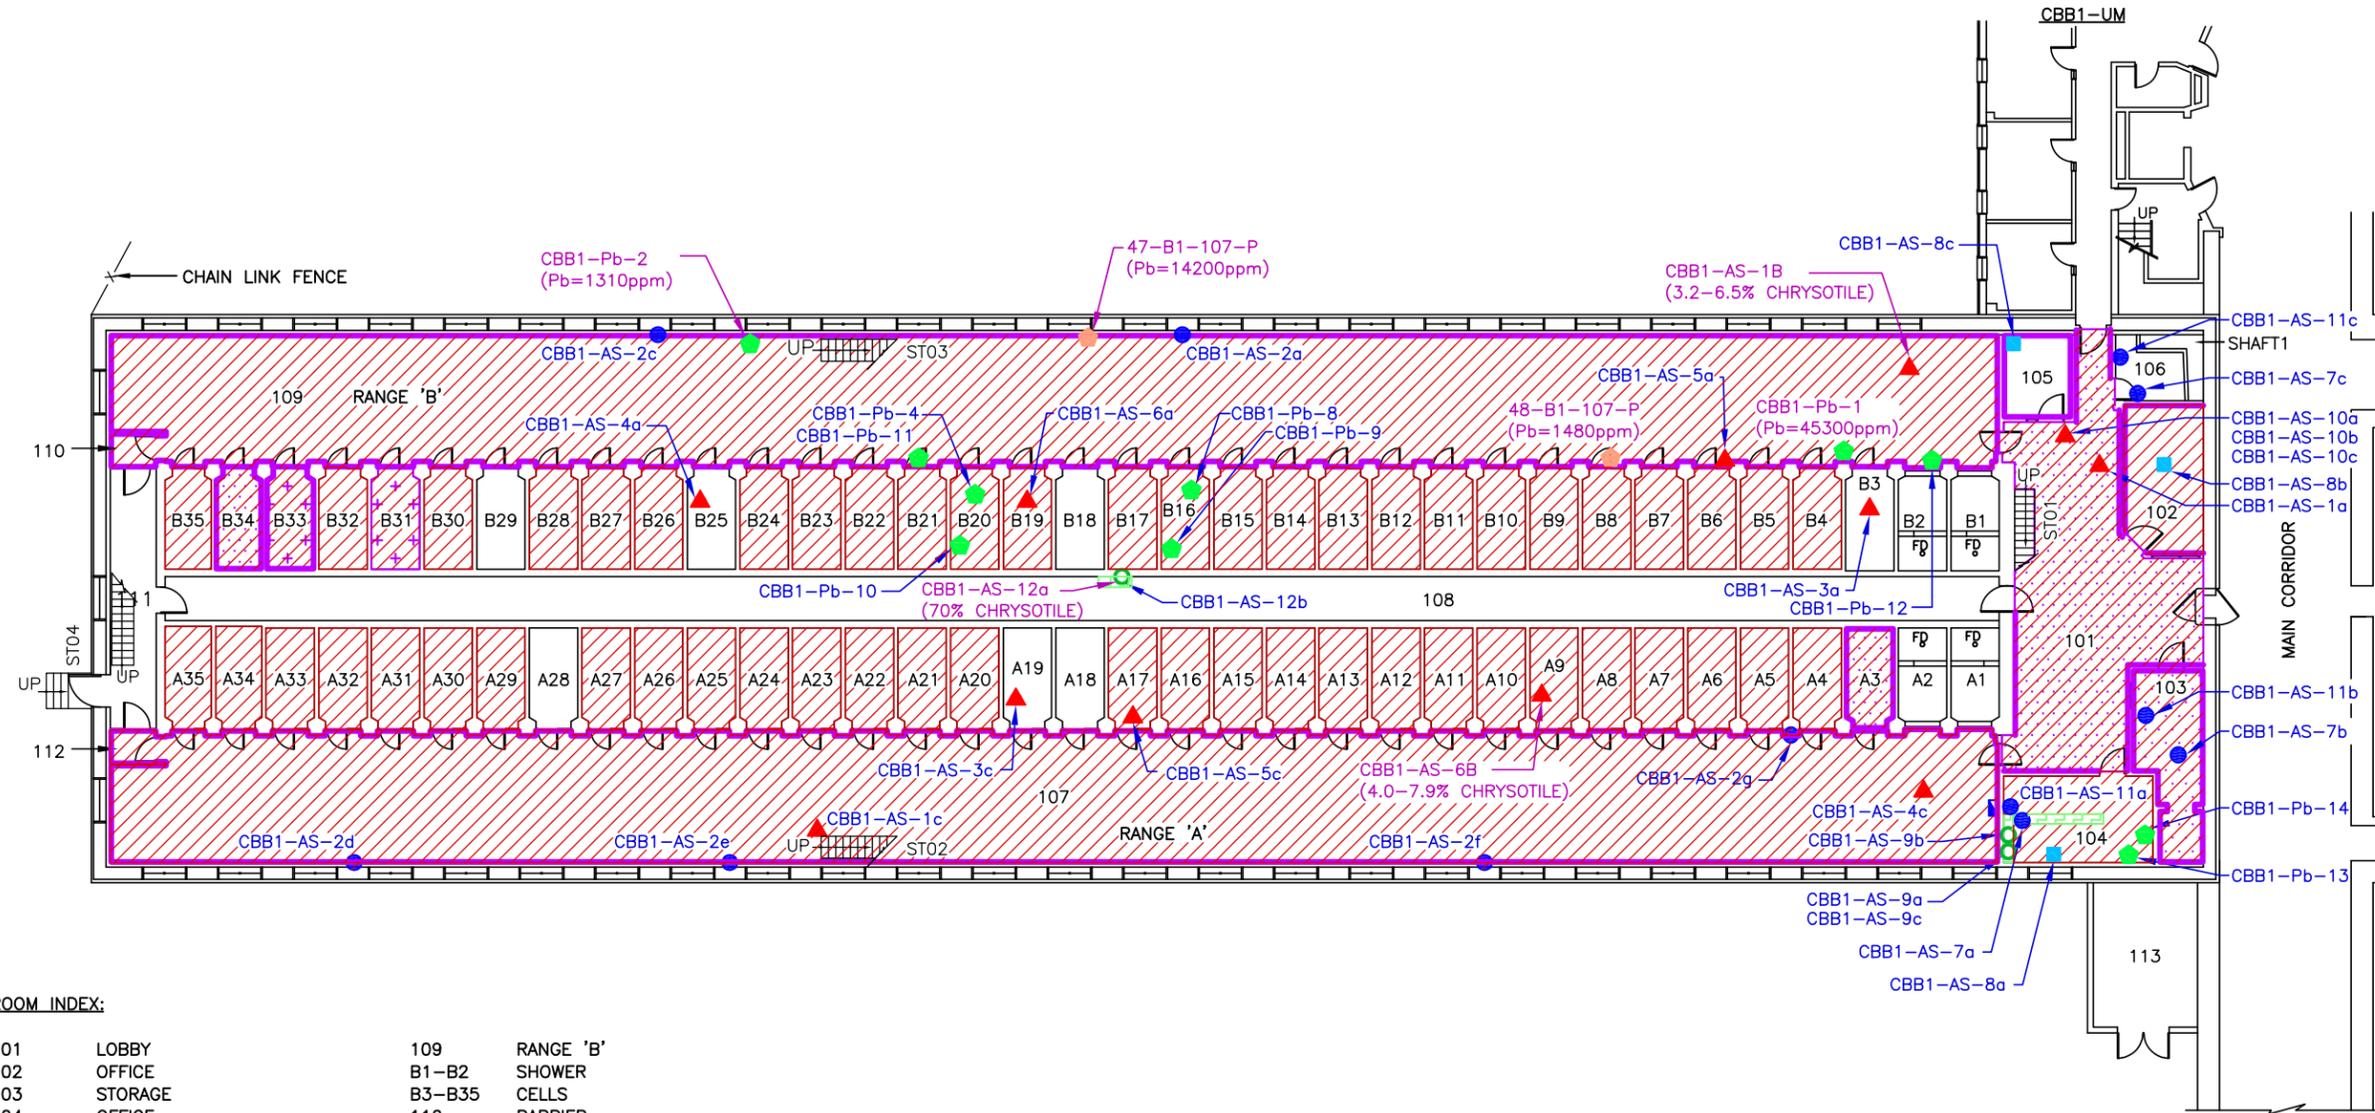
Client/Location:	PWGSC COLLINS BAY INSTITUTION KINGSTON, ONTARIO	Title:	SAMPLING LOCATIONS - CBB1 CELL BLOCK No. 1 (FIRST FLOOR)		
Project No:	07120	Filename:	07120-CBB1-1FLR-2	Date:	NOVEMBER 2007
Drawn:	EM	Verified:	CVH	Project Manager:	MRF
				Dwg No:	FIGURE 4

Ten (10) paint samples were collected from the first floor and submitted for laboratory analysis of lead. A summary of the lead paint survey is provided in Table 4.2. The sample identification numbers, room number (where paint samples are also found), description and sample location, condition, layers, lead content and approximate area are also included in Table 4.2. Sample locations and areal extent of paint containing greater than 600 ppm of lead are shown in the floor plans in Figure 4.

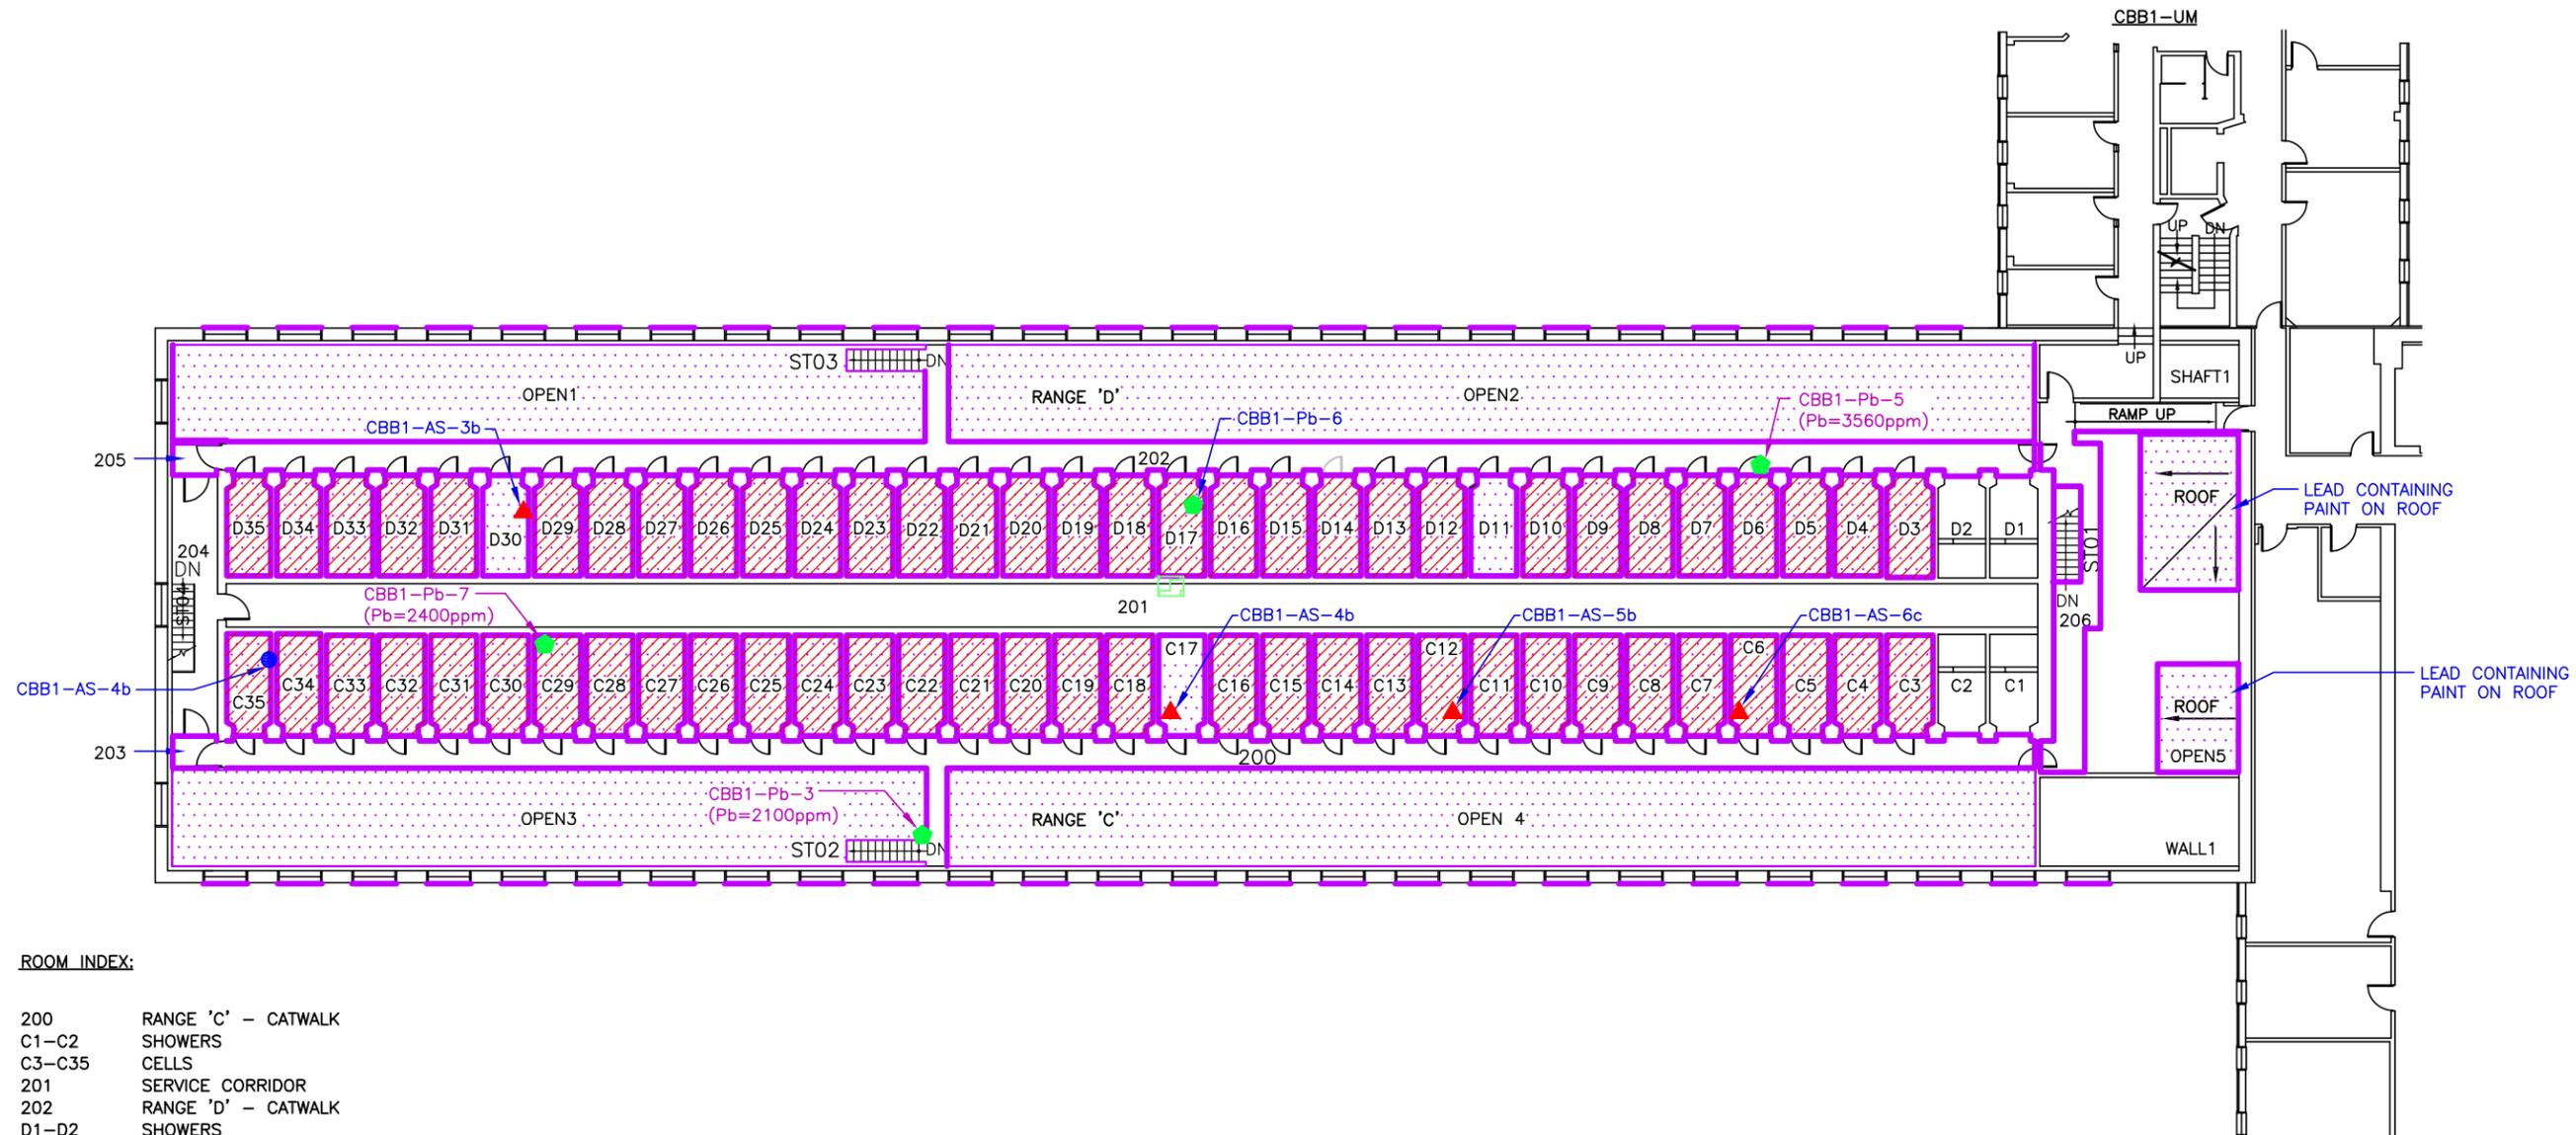
Client/Location: PWGSC COLLINS BAY INSTITUTION KINGSTON, ONTARIO		Title: SAMPLING LOCATIONS - CBB1 CELL BLOCK No. 1 (SECOND FLOOR)	
Project No: 07120	Filename: 07120-CBB1-2FLR-2	Date: NOVEMBER 2007	Dwg No: FIGURE 5
Drawn: EM	Verified: CVH	Project Manager: MRF

Five (5) samples were collected from the second floor on August 27 and 28, 2007 for bulk asbestos analysis using the PLM and/or the TEM (Chatfield) method. Vinyl floor tile and sheet floor samples were submitted for bulk asbestos analysis using the TEM (Chatfield) method. All other samples were submitted for bulk asbestos analysis using the PLM method. Results are presented in Table 5.1. The sample identification numbers, room number (where sampled and/or observed), description of material, friability, condition, accessibility, recommended action, asbestos content and estimated quantity (only for ACMs) are also included in Table 5.1. Approximate sampling locations and areal or lateral extent of ACMs (if present) are shown on the floor plan in Figure 5.

Four (4) samples of paint were collected from the second floor and submitted for laboratory analysis of lead. A summary of the lead paint survey including sample identification numbers, room number (where sampled), description, condition, layers, lead content and approximate area is provided in Table 5.2. Sample locations and areal extent of paint containing greater than 600 ppm of lead are shown in the floor plans in Figure 5. The light blue grey paint found on the walls throughout the second floor is the same as that found on the walls throughout the first floor (CBB1-Pb-1, lead = 45300 ppm).

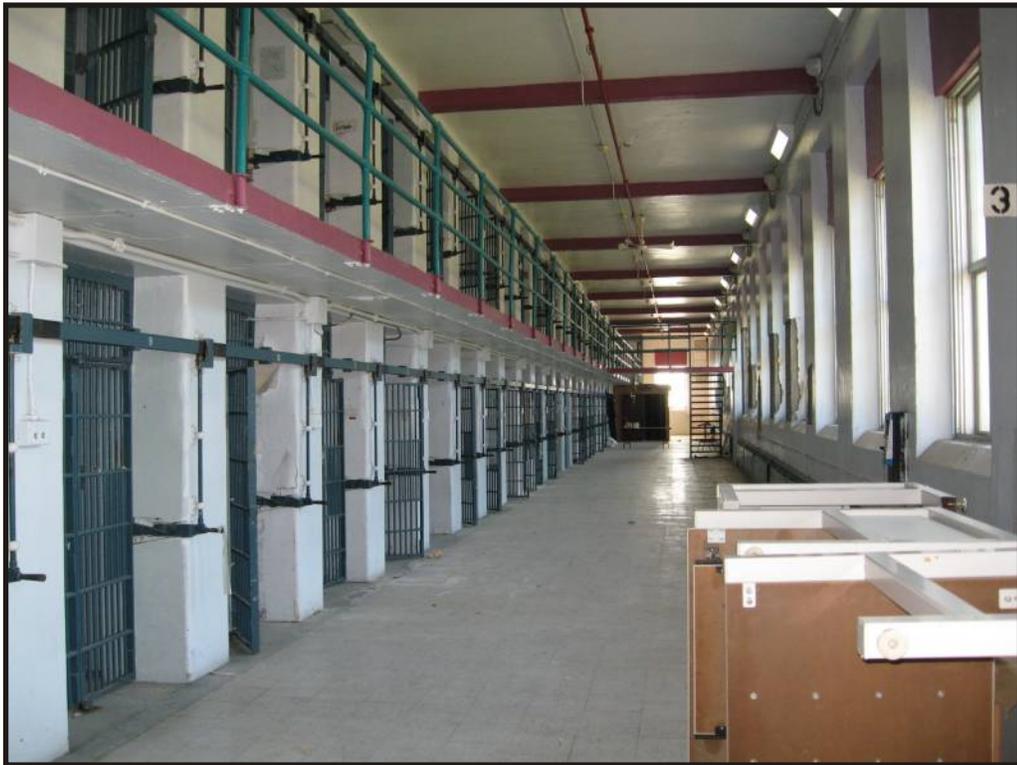
PHOTO 2: RANGE B (ROOM 109) LOOKING EAST (img_2335.jpg)

The range walls are constructed of poured concrete covered with painted plaster (Appendix A, Photo 2). Many of the concrete columns between the windows are damaged and have deteriorated likely due to water damage. Some of these have been repaired with concrete blocks and plaster. The walls and ceiling of the cells are poured concrete with 1 inch thick metal bars on the front side. Office furniture and new cell mattresses are found throughout the first floor (as shown in Appendix A, Photos 1, 2, 3 and 5).

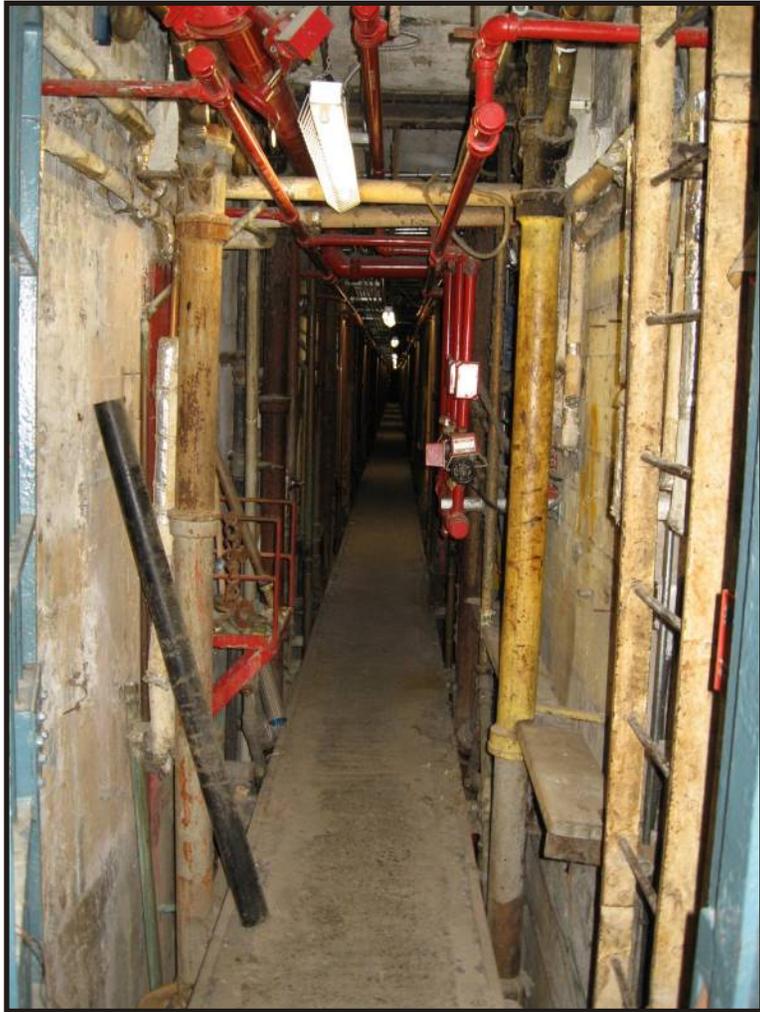
PHOTO 7: FIRST FLOOR SERVICE CORRIDOR ROOM 108 (img_2392.jpg)

Lead-containing batteries may be present in emergency lighting packs. Four (4) emergency lighting packs were observed in the service corridor, room 108 (Appendix A, Photo 7) and one (1) in the electrical vault.
