September 29, 2016

**Subject:** Bulk Asbestos Sampling Program - FINAL  
Northwest Atlantic Fisheries Centre, Pods H7, H17, O17, and All Penthouses  
E. White Hills Road, St. John's, NL  
Our ref.: P-0010737-0-02-202

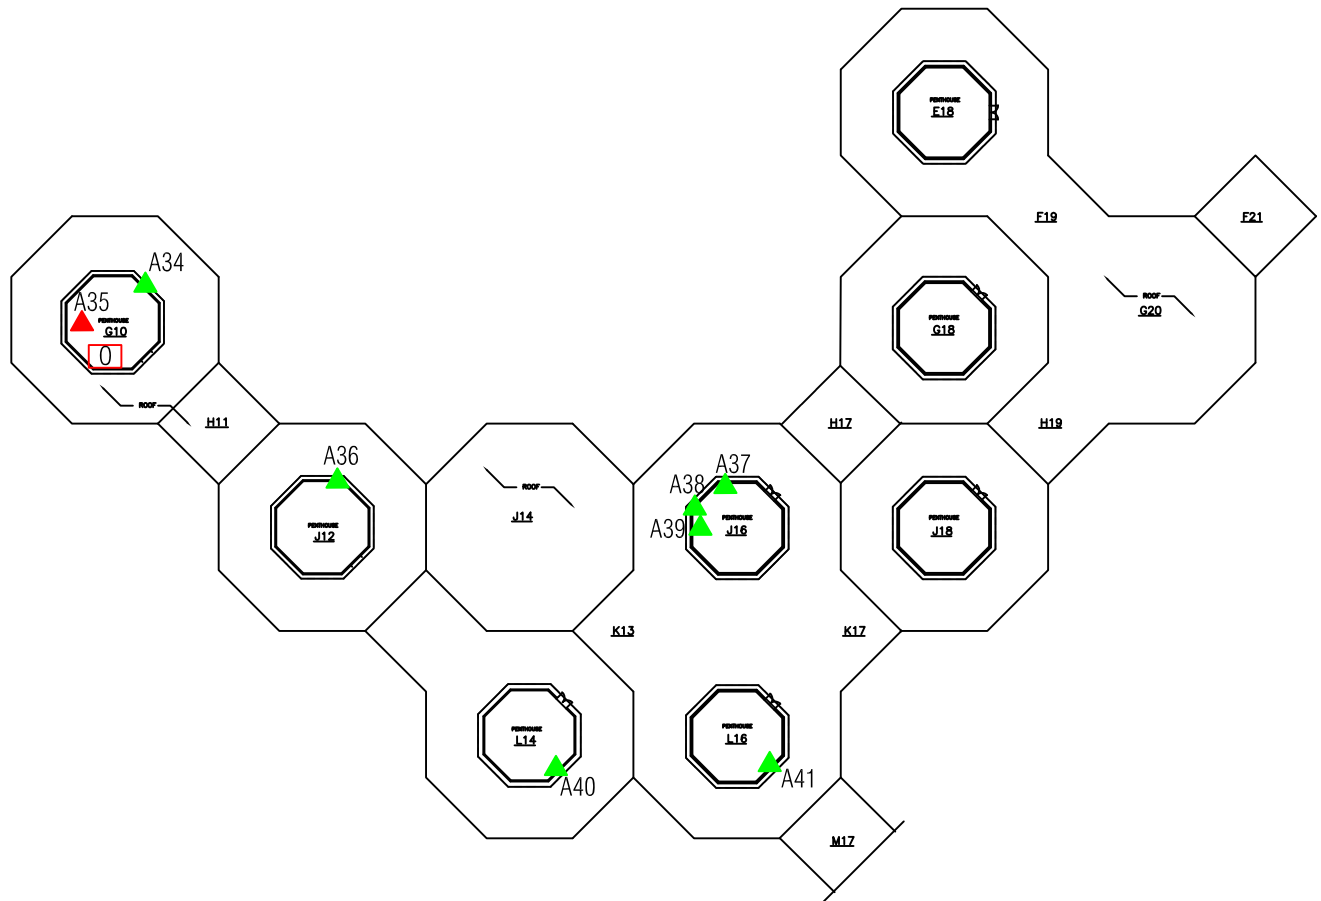
Discipline:	Environment	Prepare by:	AH	Verify by:	AH
Scale:	1:1000	Draw by:	JJ	Approval by:	SF
Date:	2016/09/07	Figure no:	8		
Page setup:	Figure 8	Paper size:	Letter	Register no.:	P-0010737(former 16279)

- Ductwork sealant (caulking), where the ductwork passes through wall, in the penthouse of Pod G10 contains 2% chrysotile asbestos. The sealant is considered non-friable. The sealant was not observed in other penthouses.
