**XCG File No. 1-336-191-01**

December 2, 2014

**DESIGNATED SUBSTANCES AND  
HAZARDOUS MATERIALS SURVEY  
CANADA'S COAST GUARD BASE  
PARRY SOUND, ONTARIO  
R.064667.007**

**PUBLIC WORKS AND GOVERNMENT SERVICES CANADA**

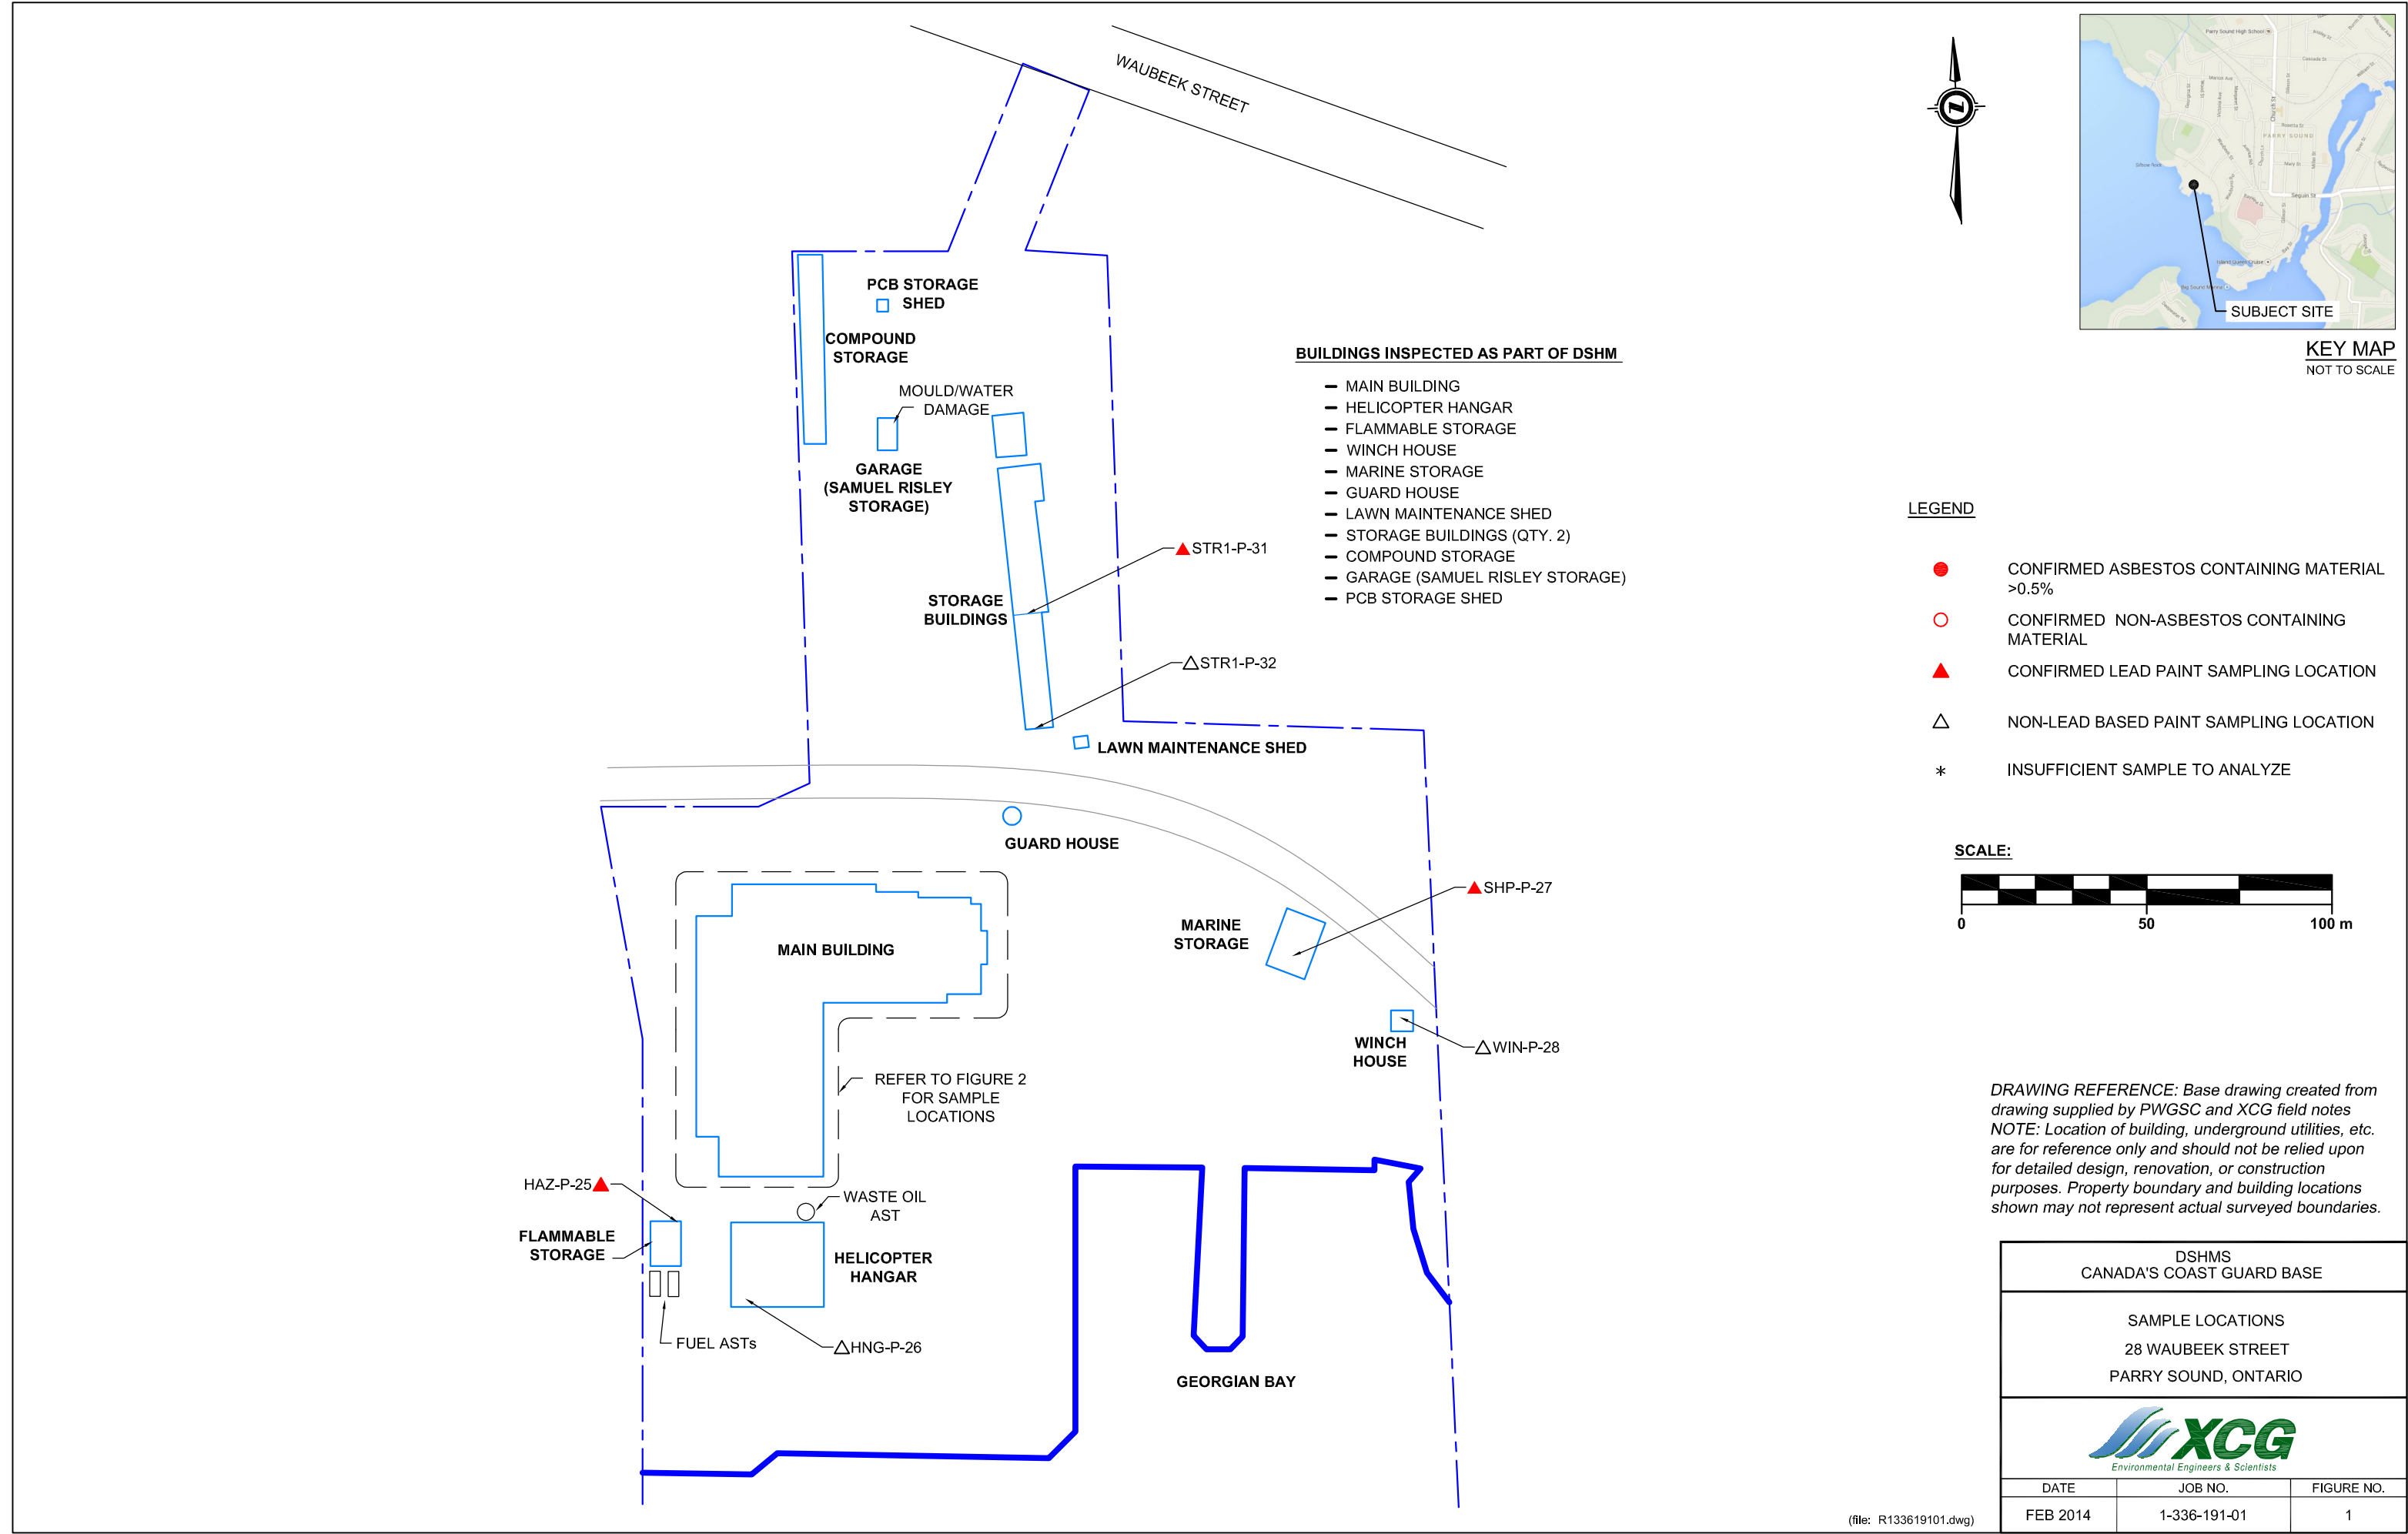
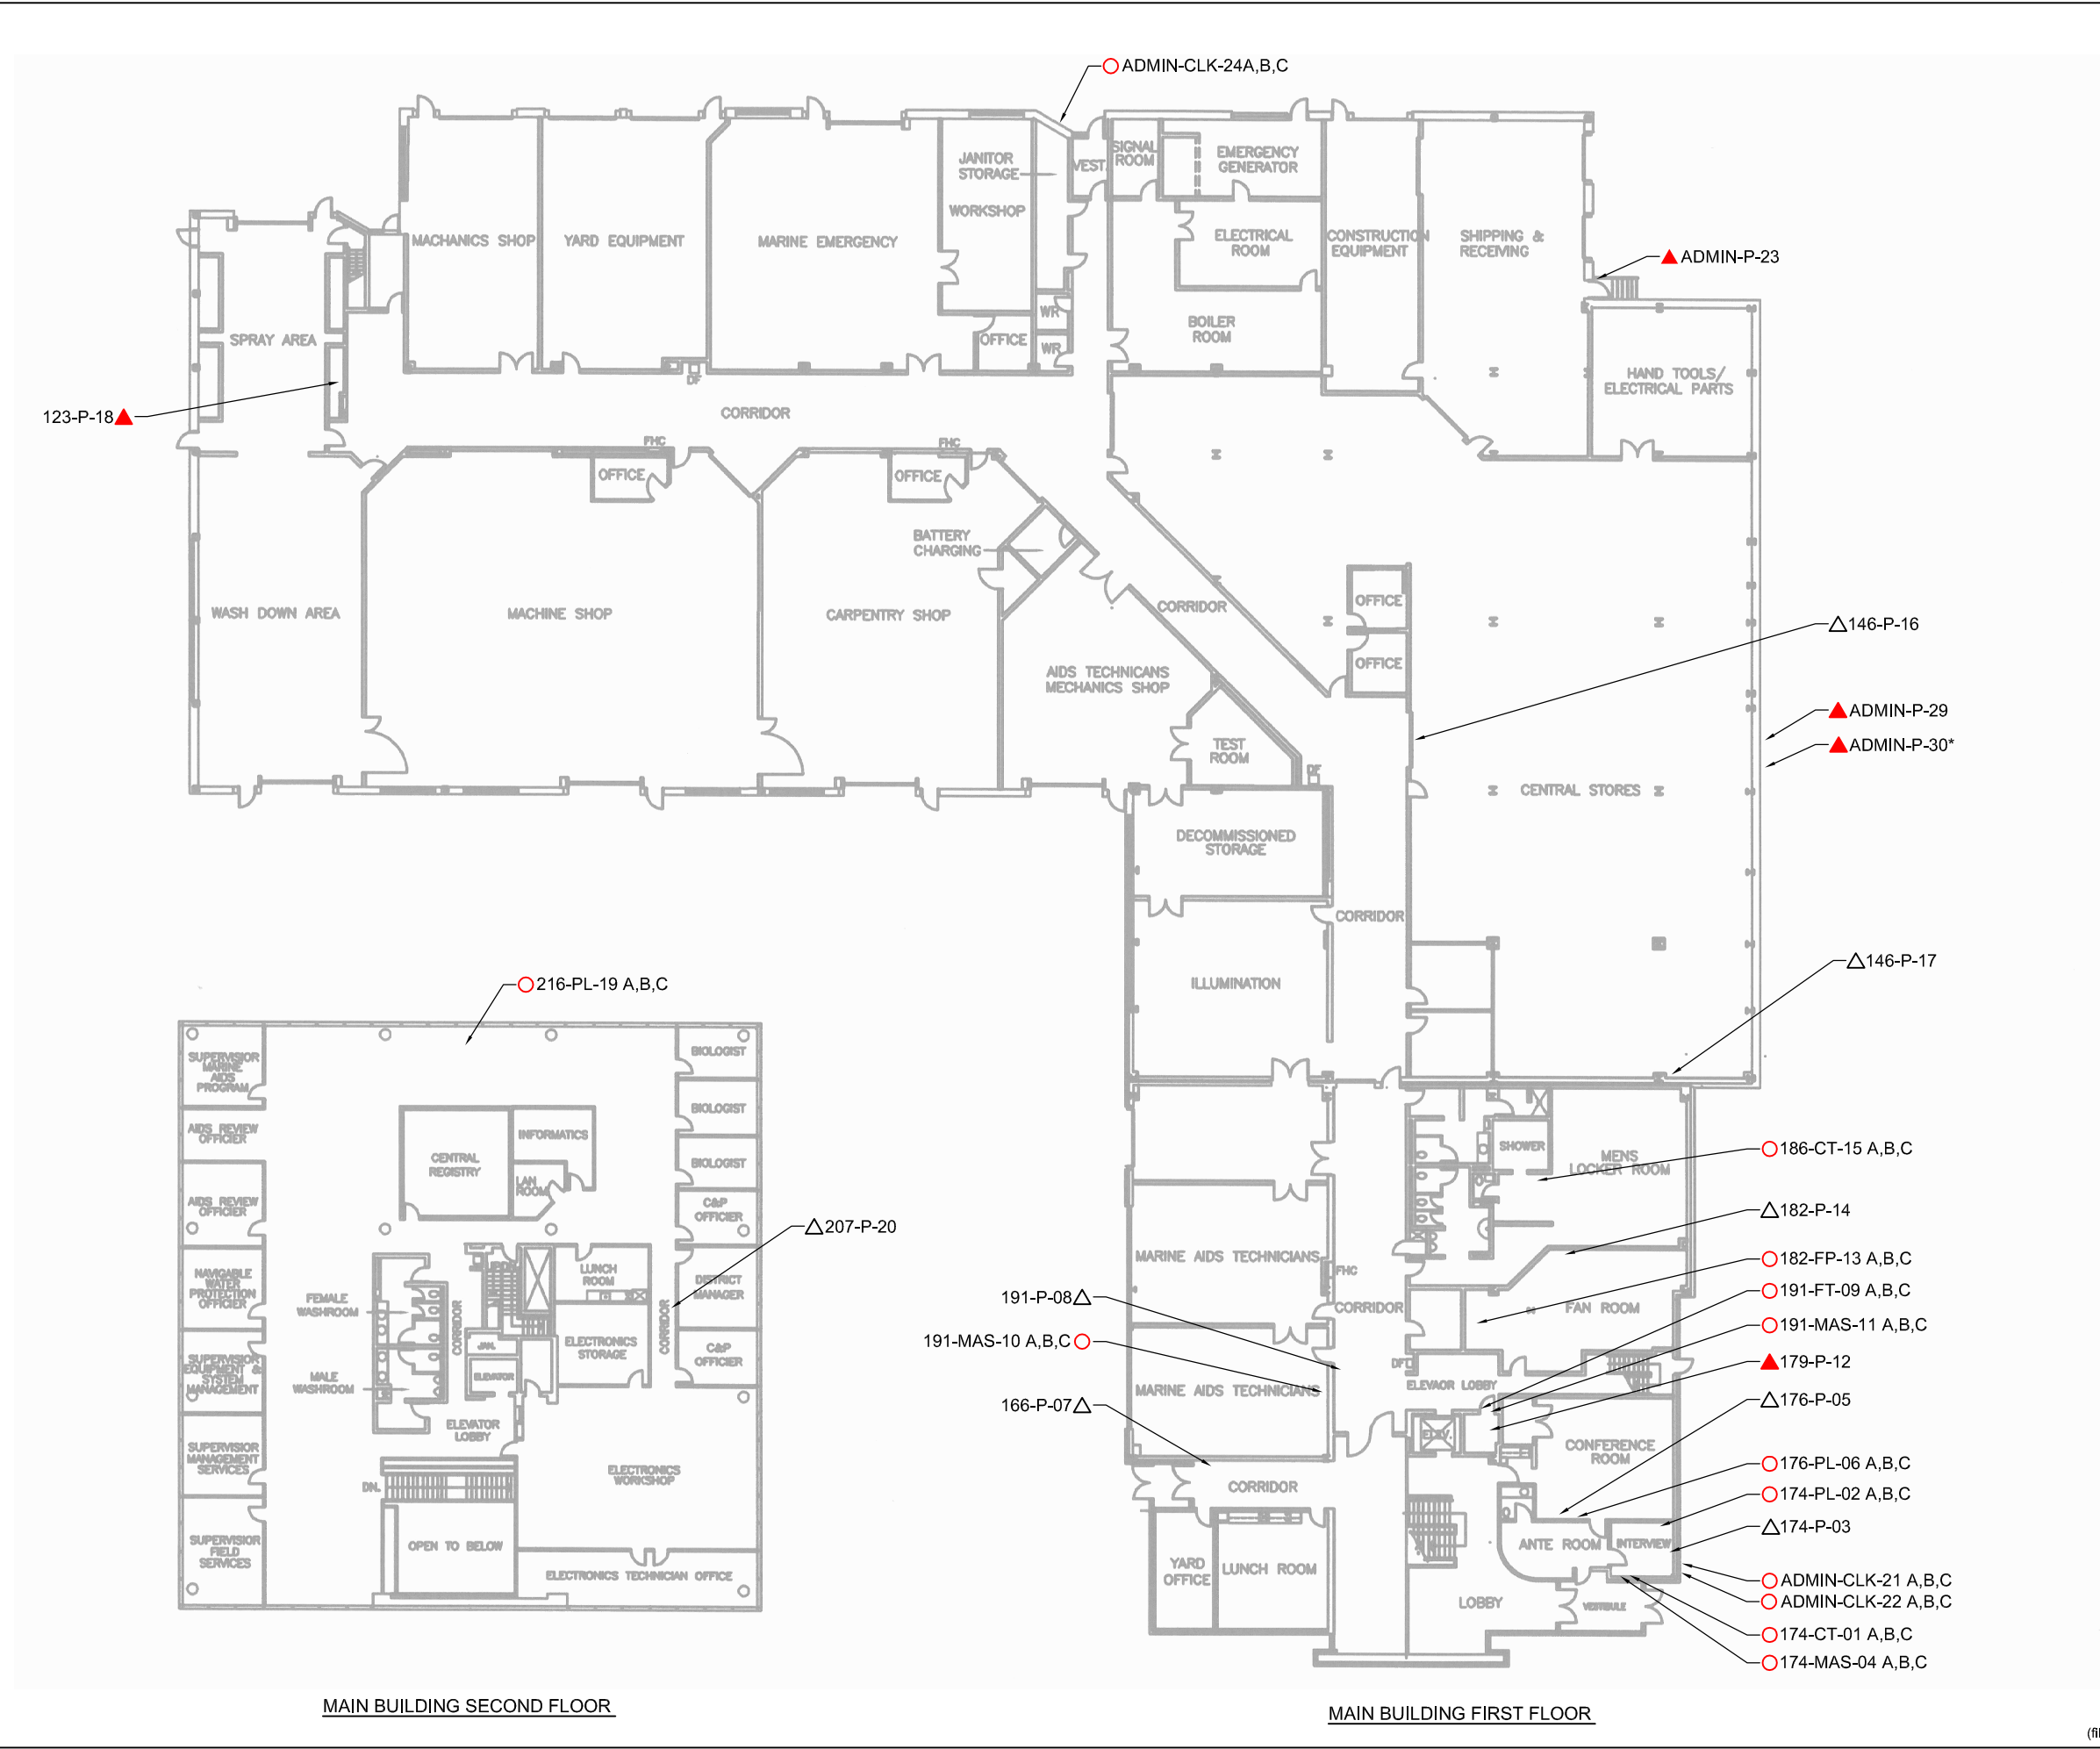
DSHMS CANADA'S COAST GUARD BASE		
MAIN BLDG. SAMPLE LOCATIONS 28 WAUBECK STREET PARRY SOUND, ONTARIO		
DATE	JOB NO.	FIGURE NO.
FEB 2014	1-336-191-01	2
