**KINGSTON MILLS SWING BRIDGE**

**RIDEAU CANAL**

**GEOTECHNICAL INVESTIGATIONS**

**KINGSTON MILLS SWING BRIDGE**  
**RIDEAU CANAL**  
**KINGSTON, ONTARIO**  
**GEOTECHNICAL INVESTIGATION REPORT**

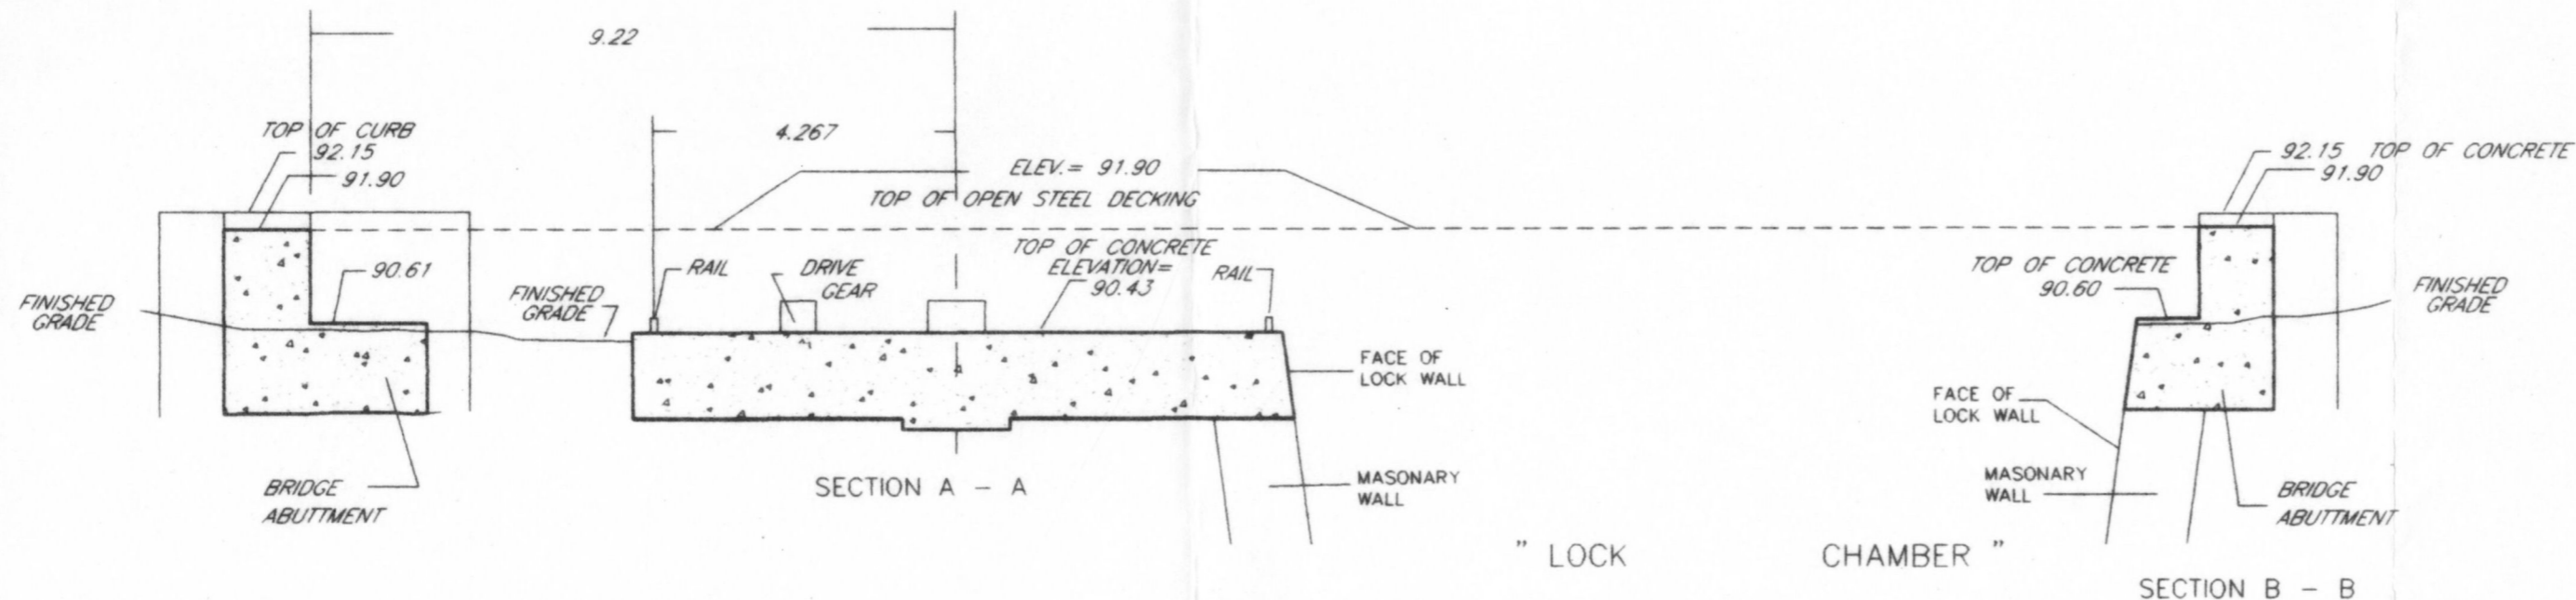
# PLAN SHOWING BRIDGE DETAIL AT KINGSTON MILLS LOCKS

C2 - DENOTES BOREHOLE  
LOCATION OF BOREHOLES WERE TAKEN FROM PLAN  
PREPARED BY INSPC - SOL DATED DEC./1999  
PLAN No. K6160-1
