# SPECIFICATION FOR THE RENOVATION OF COMPARTMENTS FLOORS & WALLS ON UPPER DECK

C.C.G.S. MARTHA L. BLACK | TYPE-1100 NAVAIDS TENDER

CANADIAN COAST GUARD

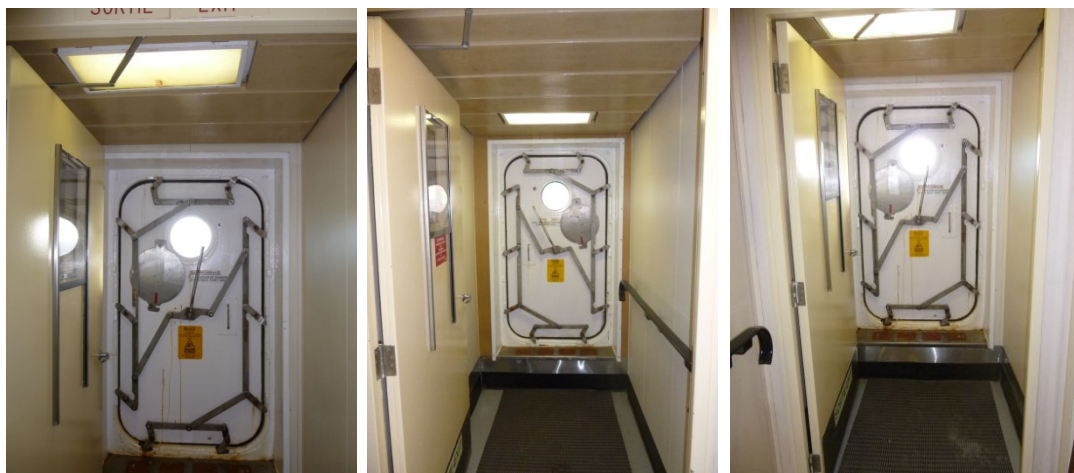
*Figure 9, 10 et 11 : Rooms 206 port et 207 starboard main entrances*

- a. The actual tank measures approximately 35cm high X 50cm wide. See figure 9.

Dismantle and put away, outside room #206 et 207 main entrances, the following:

- a. Outside door frame;
- b. Furniture (desk, dresser and bed) on rear wall adjacent to room #208 next to port entrance;
