REMOVAL OF VARIOUS SURPLUS INFRASTRUCTURE
AT BACCALIEU LIGHT STATION

BACCALIEU ISLAND, NL
PROJECT NUMBER: F6879-171005

Fisheries and Oceans Canada

Project:	DEMOLITION HAZARDOUS BUILDING MATERIALS ASSESSMENT AND INVENTORY, BACCALIEU ISLAND LIGHTSTATION (DFRP 80521), BACCALIEU ISLAND, NL		
Title:	SITE LOCATION PLAN		
Scale:	1:50,000	Project No.:	TF14076579
		Figure No.:	1.1

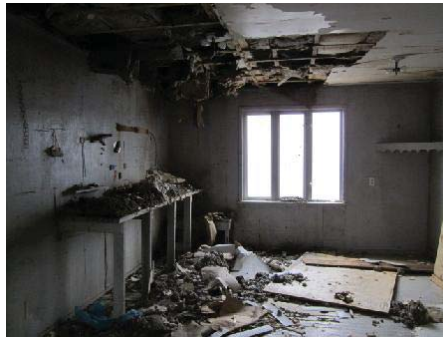
Photo 14: View of Workshop in double dwelling. Note: ceiling debris on floor.

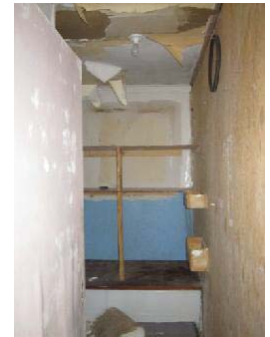
Photo 15: View of Bathroom 2 in double dwelling. Note: flaking paint.

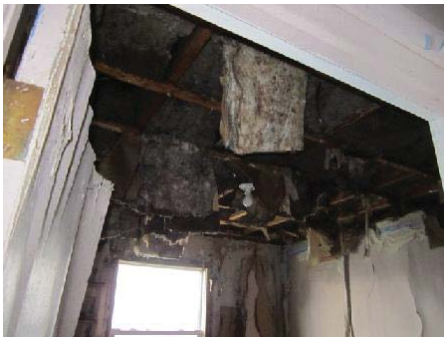
Photo 16: View of Bedroom 1-2 in double dwelling. Note: collapsed ceiling.

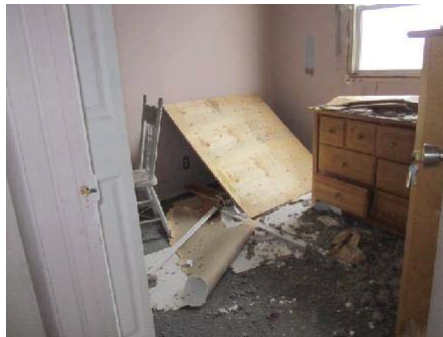
Photo 17: View of Bedroom 2-2 in double dwelling. Note: ceiling debris on floor.

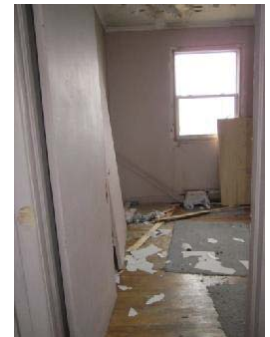
Photo 18: View of Bedroom 3-2 in double dwelling. Note: flaking paint debris on floor.

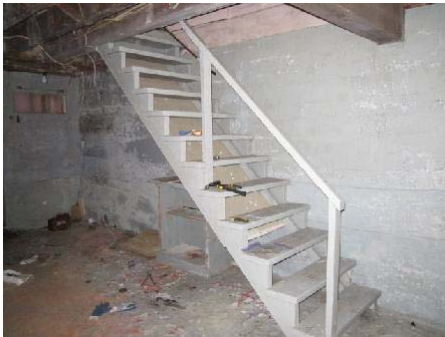
Photo 19: View of Basement 1 in double dwelling. Note: flaking paint on floor.

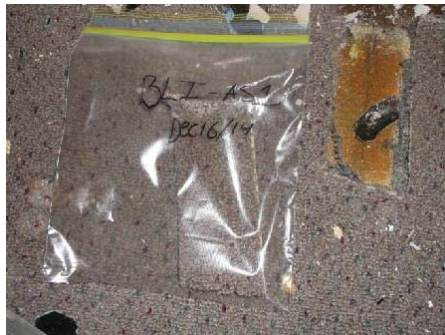
Two (2) types of carpet (grey with coloured specks and solid grey) were observed in Living Room 1. Two (2) samples of carpet and mastic (BLI-AS1 and BLI-AS2) were collected from Living Room 1 and analyzed for asbestos content (refer to Photos 29 and 30, Appendix B2). Note: prior to asbestos analysis, the laboratory separated each sample into sub-samples of carpet and mastic (i.e. BLI-AS1-Carpet, BLI-AS1-Mastic, BLI-AS2-Carpet and BLI-AS2-Mastic). Asbestos was not detected in the carpet and mastic sub-samples.

Photo 29: View of carpet and mastic sample BLI-AS1.

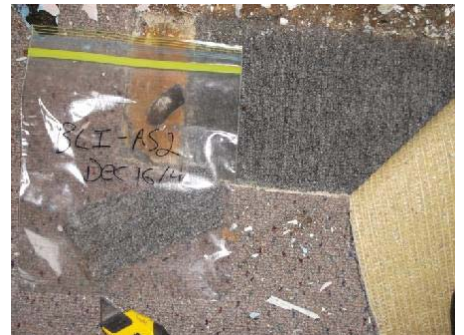
Photo 30: View of carpet and mastic sample BLI-AS2.

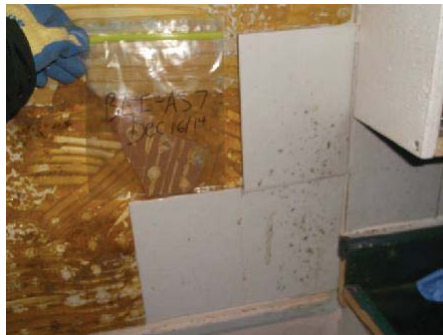
One (1) sample of ceramic tile (white) and mastic (BLI-AS7) was collected from an interior wall in Kitchen 1 and analyzed for asbestos content (refer to Photo 35, Appendix B2). Note: prior to asbestos analysis, the laboratory separated the sample into sub-samples of tile and mastic (i.e. BLI-AS7 Tile and BLI-AS7A Mastic). Asbestos was not detected in the ceramic tile and mastic sub-samples.

Photo 35: View of ceramic tile and mastic sample BLI-AS7.

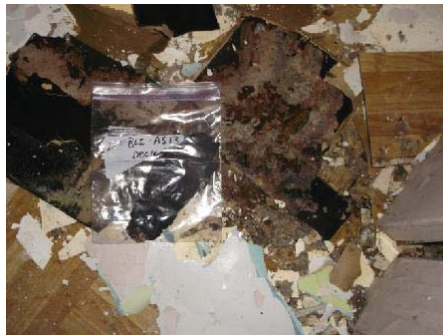
According to the USEPA, PCBs may be present in caulking used in windows, door frames, masonry columns and other building materials in buildings built or renovated between 1950 and 1979. Since the double dwelling was constructed in 1955, four (4) samples of caulking (BLI-AS12, BLI-AS18, BLI-AS28 and BLI-AS29) were collected from interior and exterior surfaces of the building and analyzed for PCB content (refer to Photos 40, 46, 56 and 57, Appendix B2).

Photo 40: View of caulking sample BLI-AS12

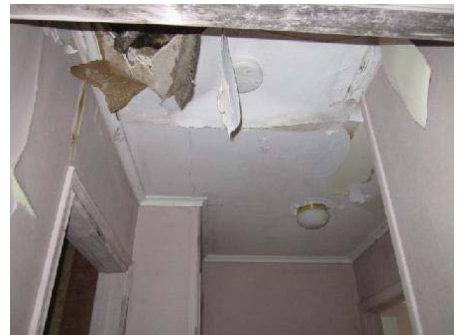
Photo 71: View of collapsed drywall and areas of flaking paint in Hallway 1.

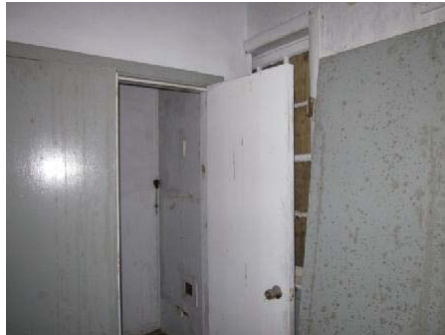
Photo 10: View of Room 2 in old equipment building. Note: fluorescent light fixture.

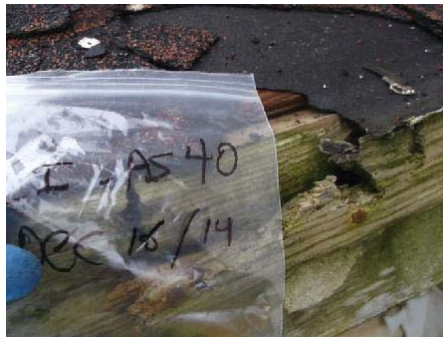
Photo 28: View of asphalt shingle sample BLI-AS39.

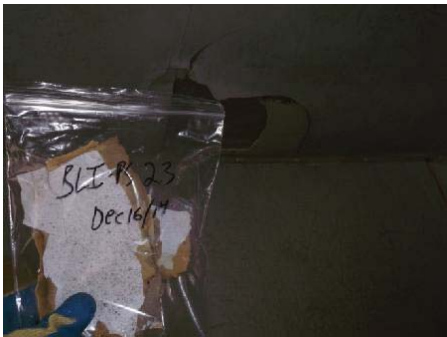
Photo 39: View of paint sample BLI-PS22.

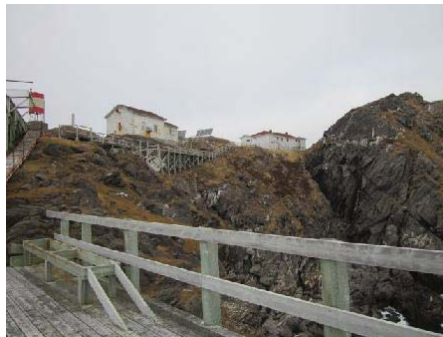
Photo 5: View of upper landing railing and collapsed walkway to double dwelling.

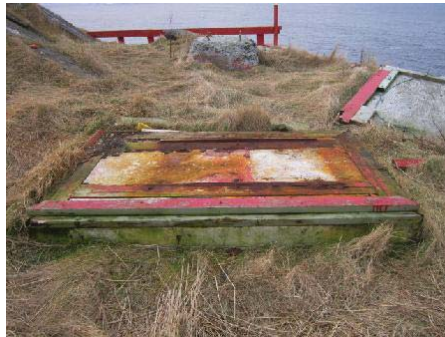
The concentrations of lead in the paint samples ranged from 49 mg/kg to 1,000 mg/kg (refer to Table C6-1, Appendix C6). One (1) paint sample (BLI-PS27) contained lead at a concentration below the Federal HPA criterion of 90 mg/kg (refer to Photo 8, Appendix B6). Three (3) paint samples (BLI-PS26, BLI-PS28 and BLI-PS31) contained lead at concentrations above the Federal HPA criterion of 90 mg/kg but below the former Federal HPA criterion of 5,000 mg/kg (refer to Photos 16 to 18, Appendix B6).

Photo 8: View of concrete foundation at location of former winch house (BLI-PS27).

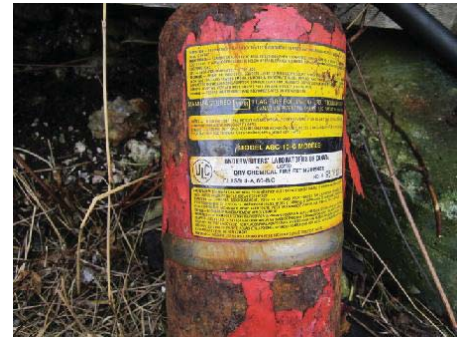
One (1) fire extinguisher was observed on the Site exterior next to one of the footings of the helicopter landing pad; however, the label on this extinguisher did not indicate the presence of halon or other ODS ingredients (refer to Photos 20 and 21, Appendix B6). Fire extinguishers are considered a household hazardous waste material and must be disposed of at a hazardous waste treatment facility.

Photo 21: View of fire extinguisher label (dry chemical).
